Inspection Photos  
Location Name: Roy Dutcher B1  
Location ID: 317870

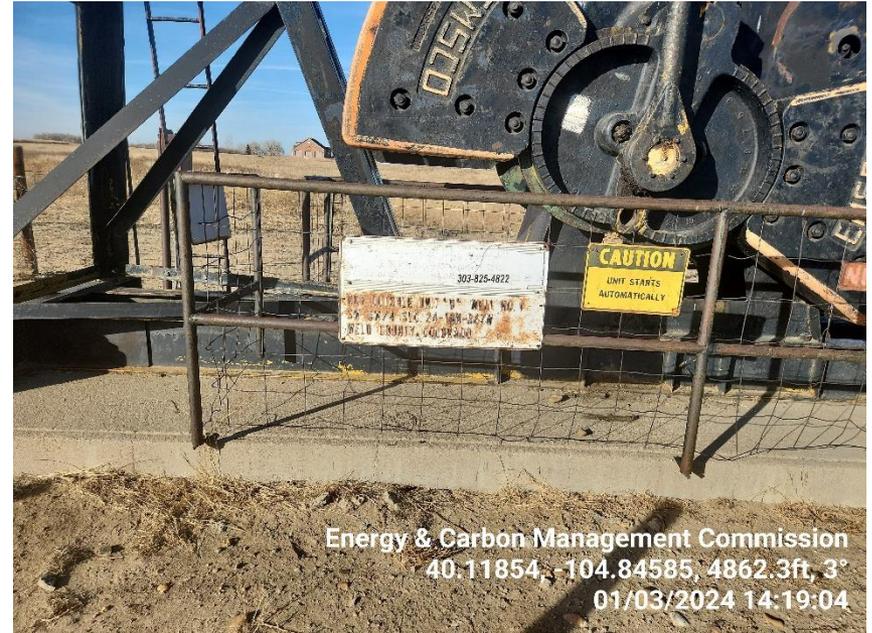
Photo 2 WH sign faded and needs replaced.

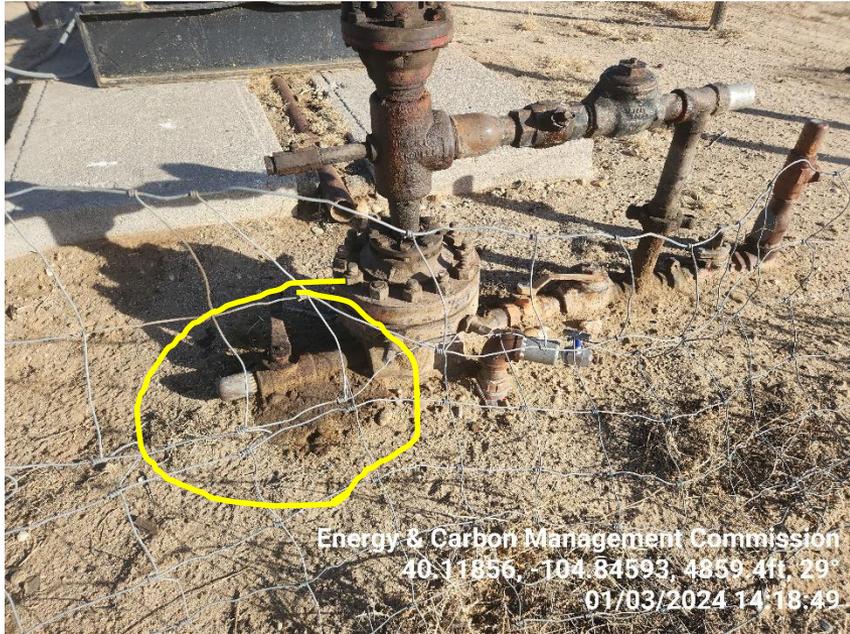
**Photo 3 Stained soil by the WH.**

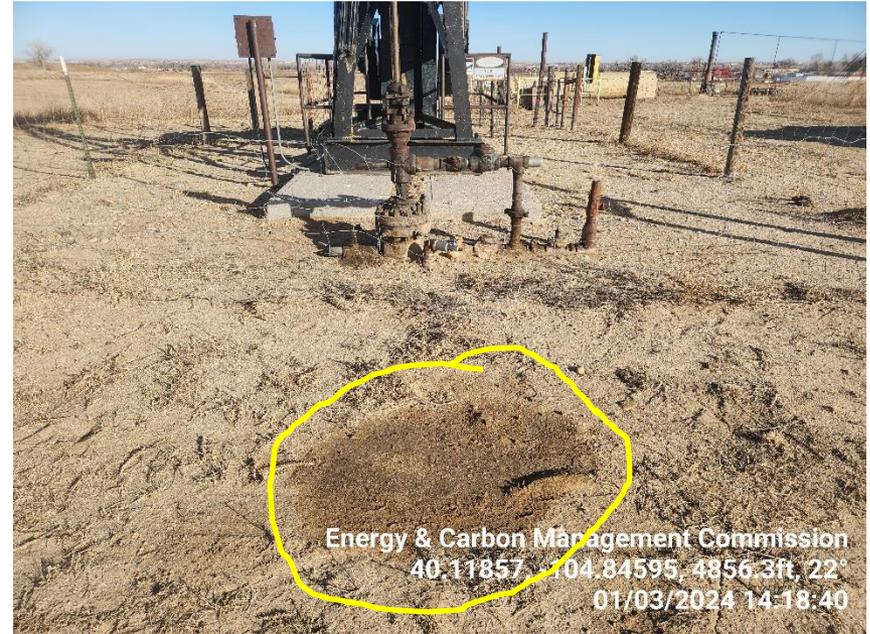
**Photo 4 Stained soil to the west of the WH.**

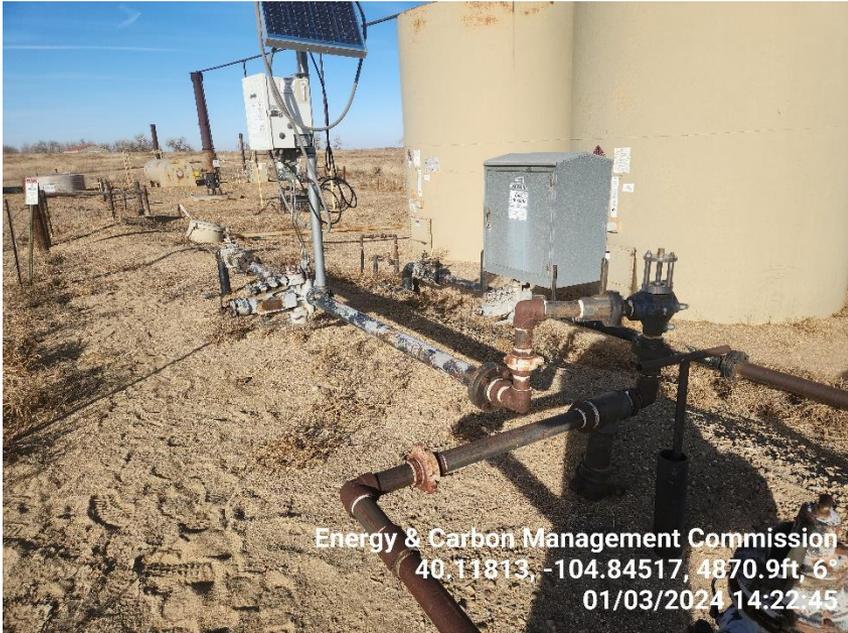
**Photo 7 Gas Meter Run card indicates current calibration.**

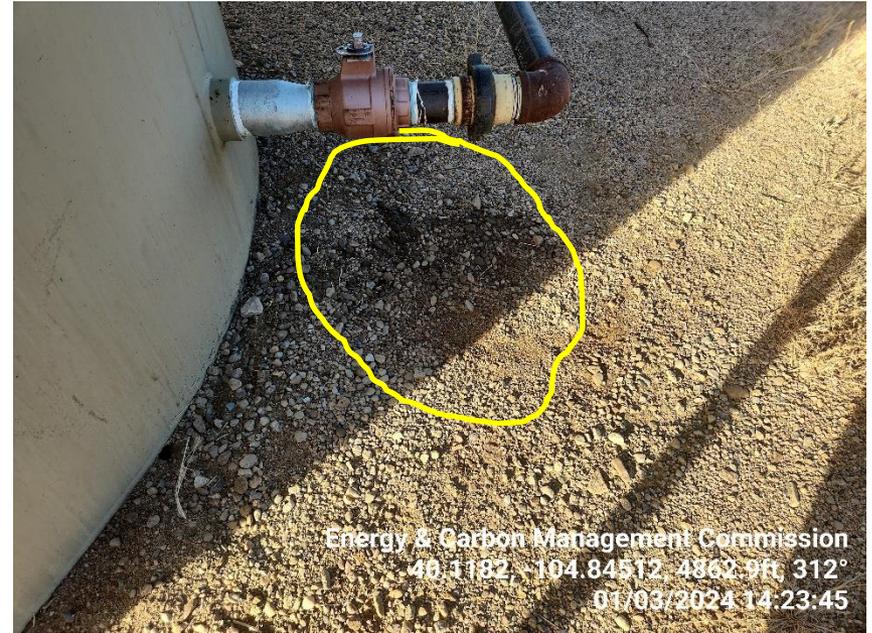
**Photo 8 Stained soil by the TB load out valve**

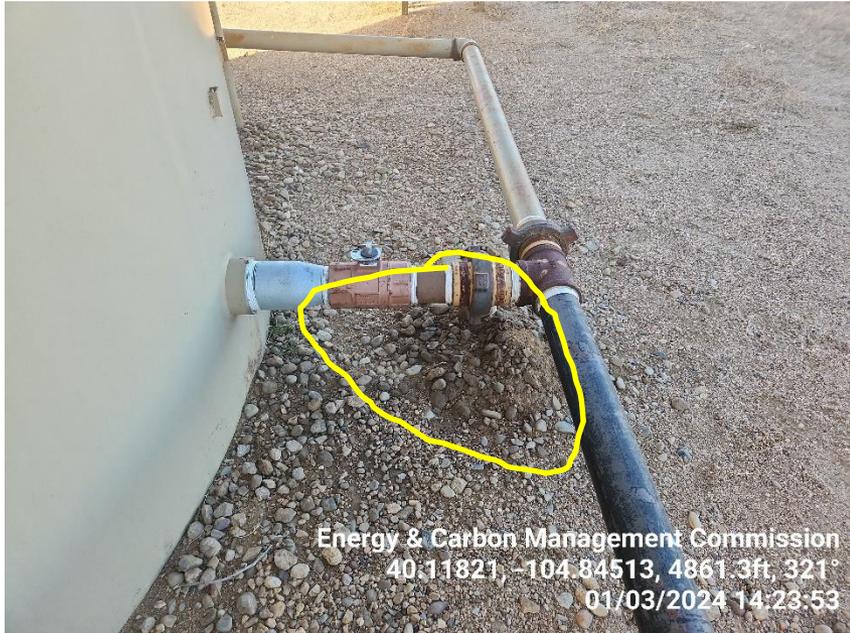
**Photo 9 Stained soil by the TB load out valve.**

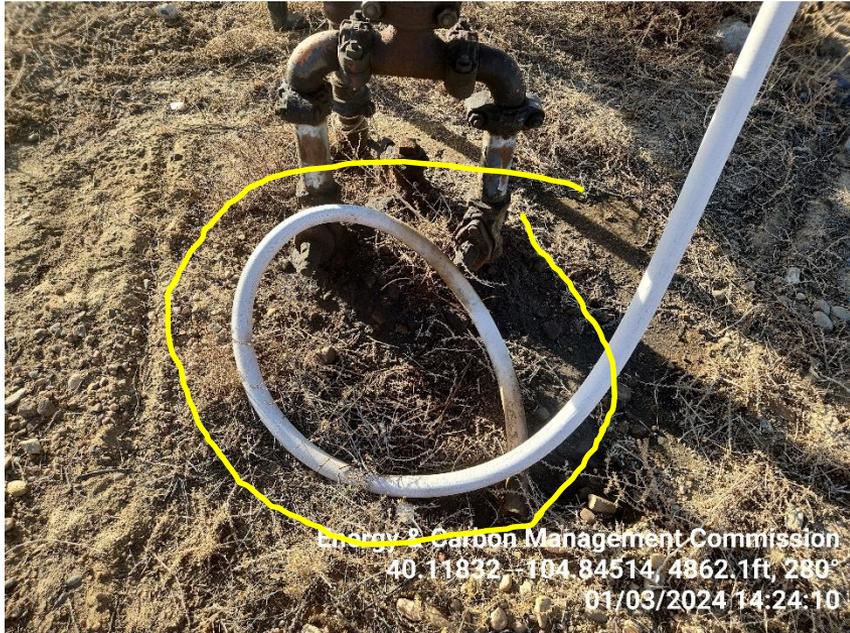
Photo 11 Stained soil by the flow line manifold.

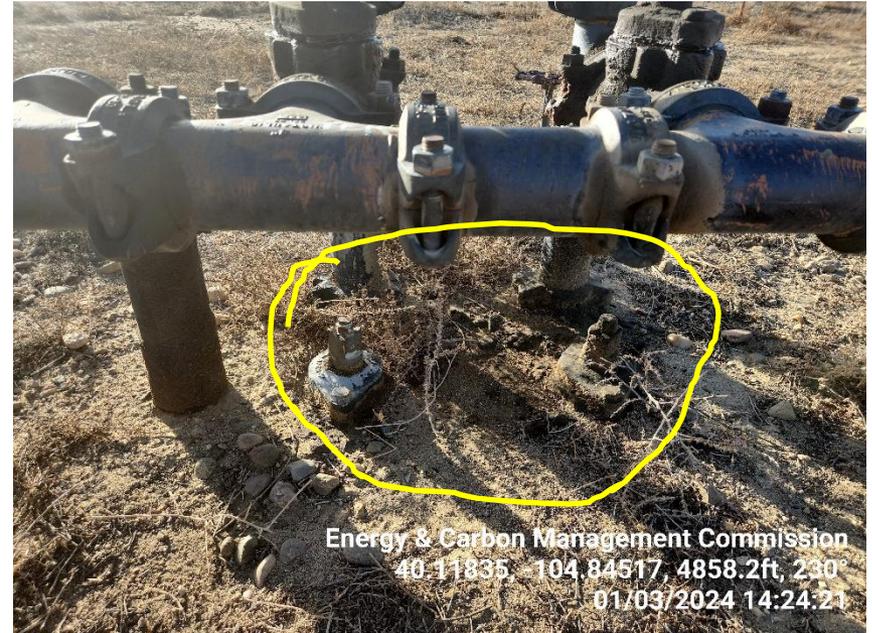
Photo 12 Stained soil by the flow line manifold.
