Interim and Stormwater Inspection

December 8, 2023

Operator: Verdad Oil & Gas Co- #10651

Location ID: 451659

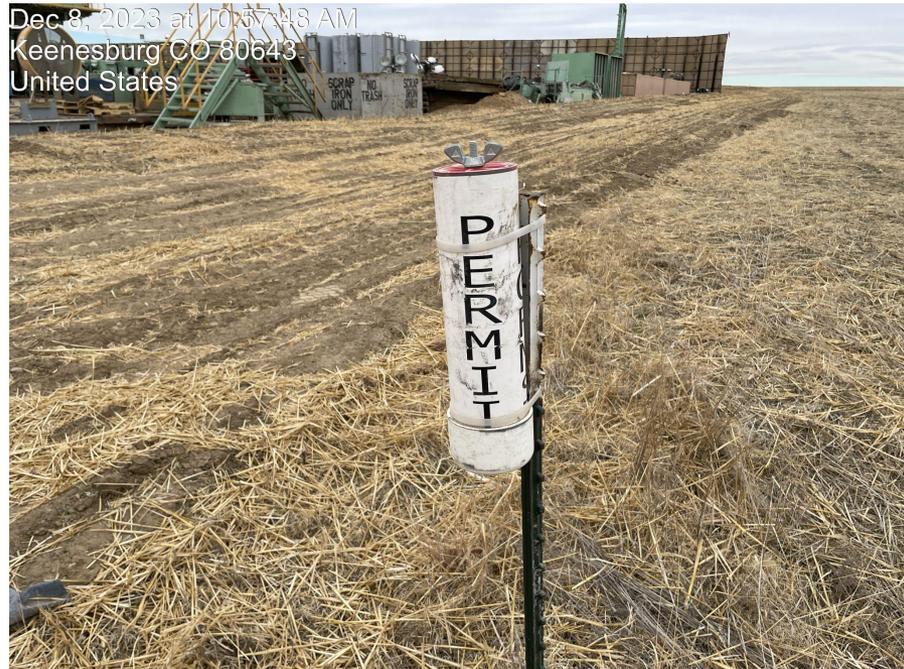
Photo 1. Photo taken of location permits.

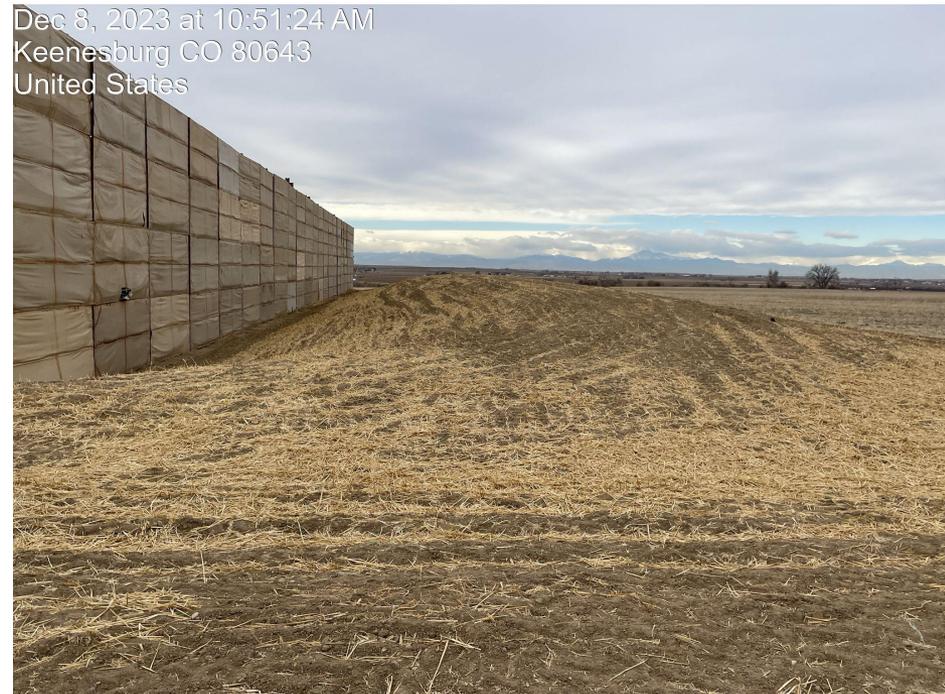
Photo 2. Photo taken of topsoil stockpile. Photo taken facing north.

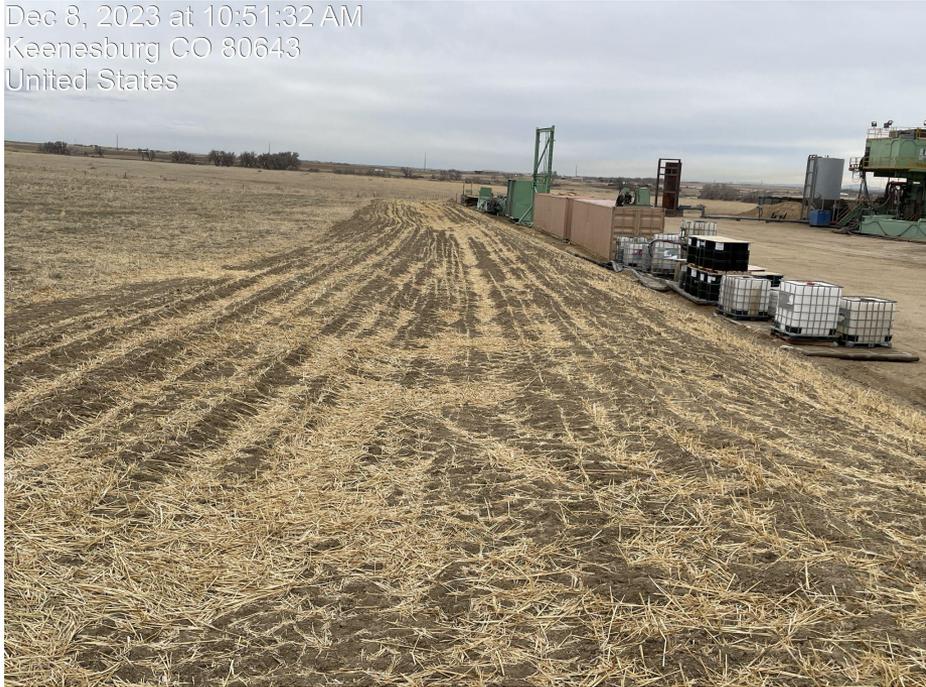
Photo 3. Photo taken of straw crimped soil on south side of pad. Photo taken facing west.

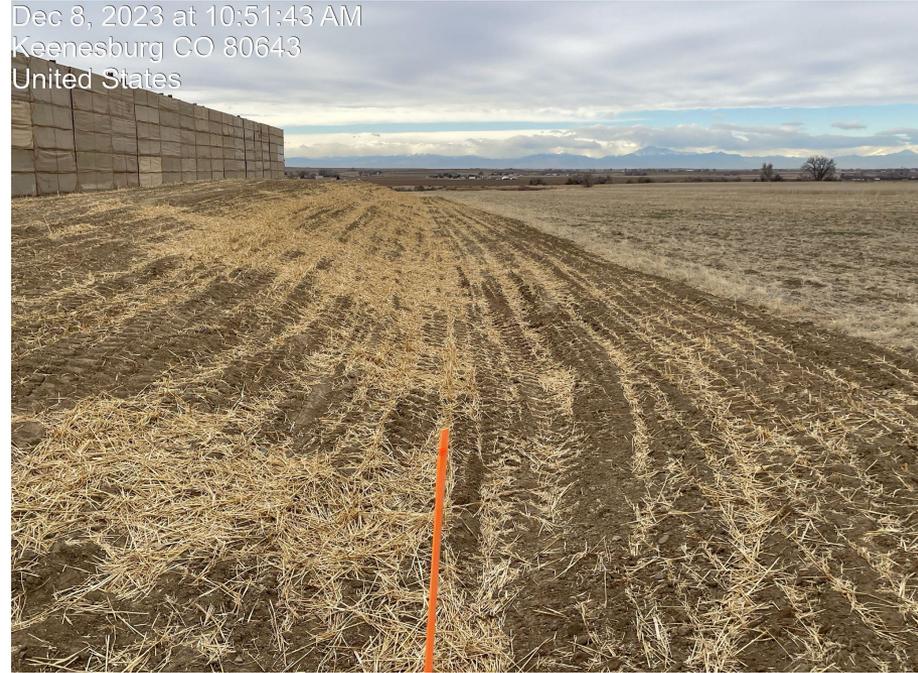
Photo 4. Photo taken of straw crimped topsoil stockpile. Photo taken facing North.

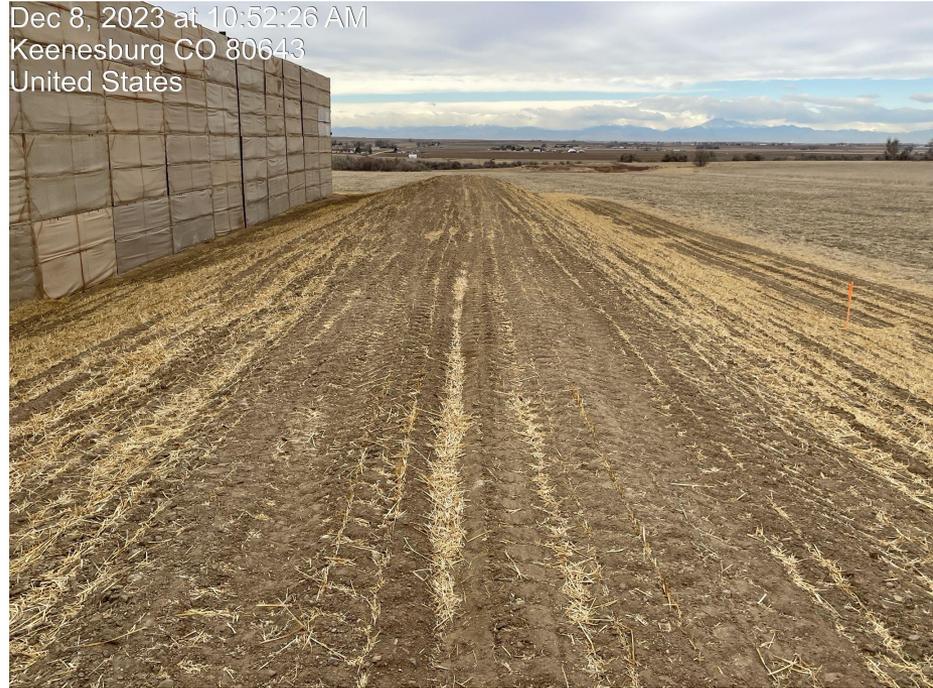
Photo 5. Photo taken on top of topsoil stockpile, lacking proper soil protection. Photo taken facing north

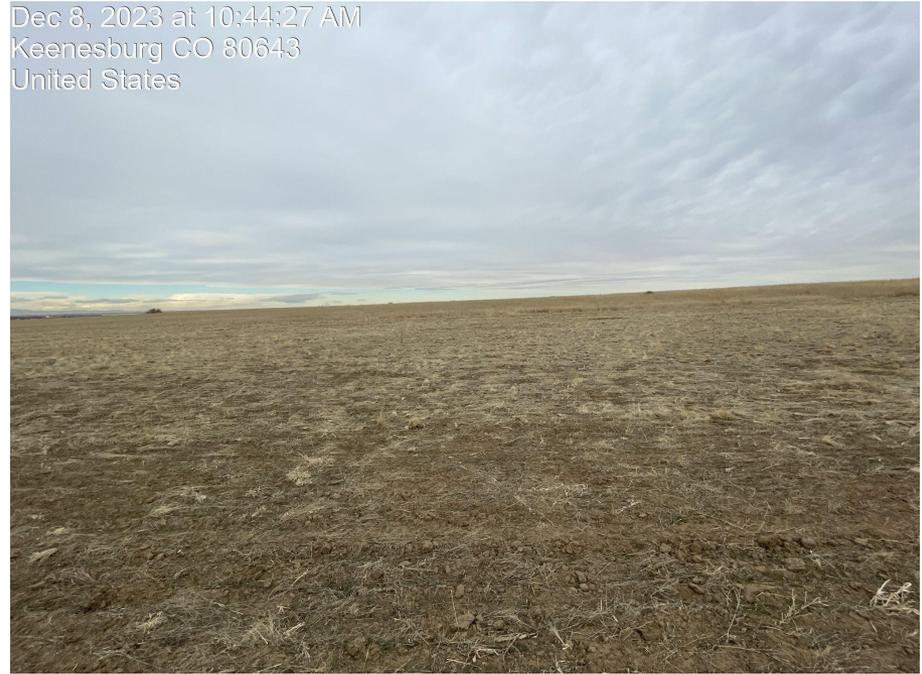
Photo 6. Photo of undisturbed vegetated area for reference next to pad. Photo tank facing east.

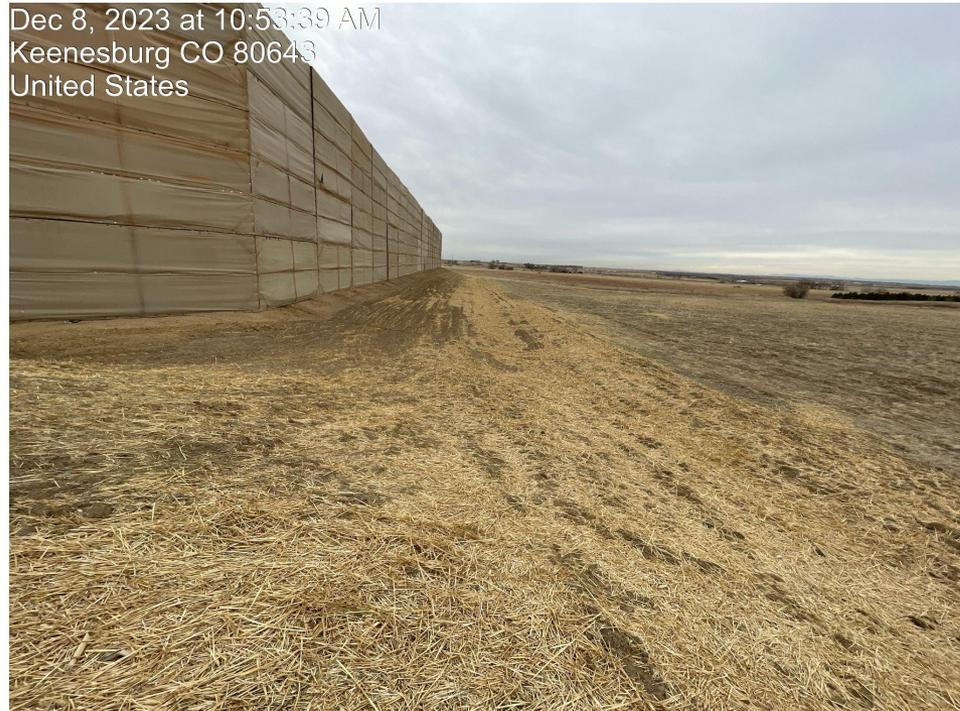
Photo 7. Photo of north side of location. Photo tank facing west.

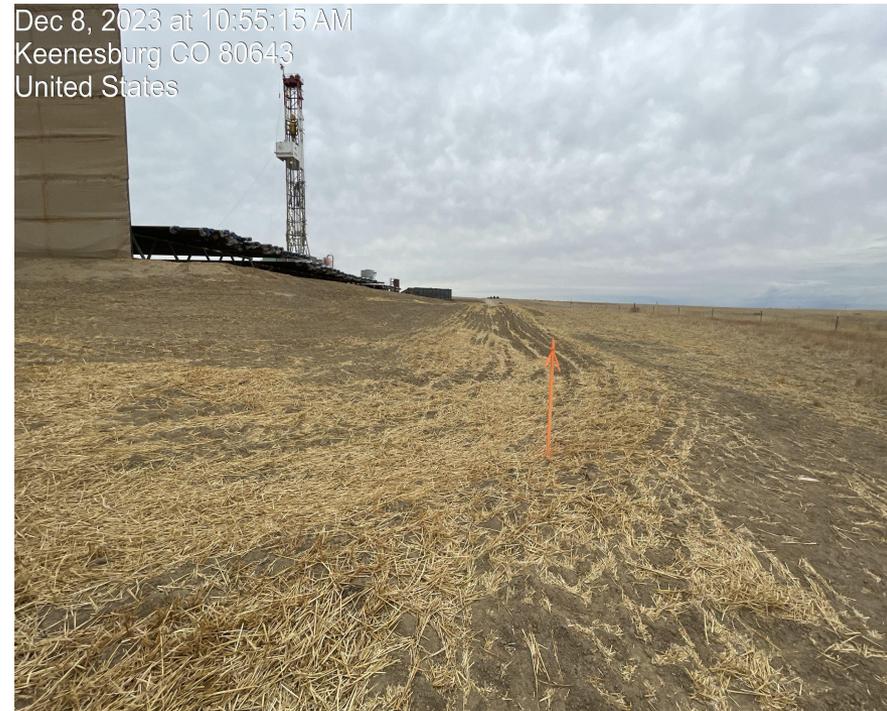
Photo 8. Photo of bare soil on west side of pad. Photo taken facing south.

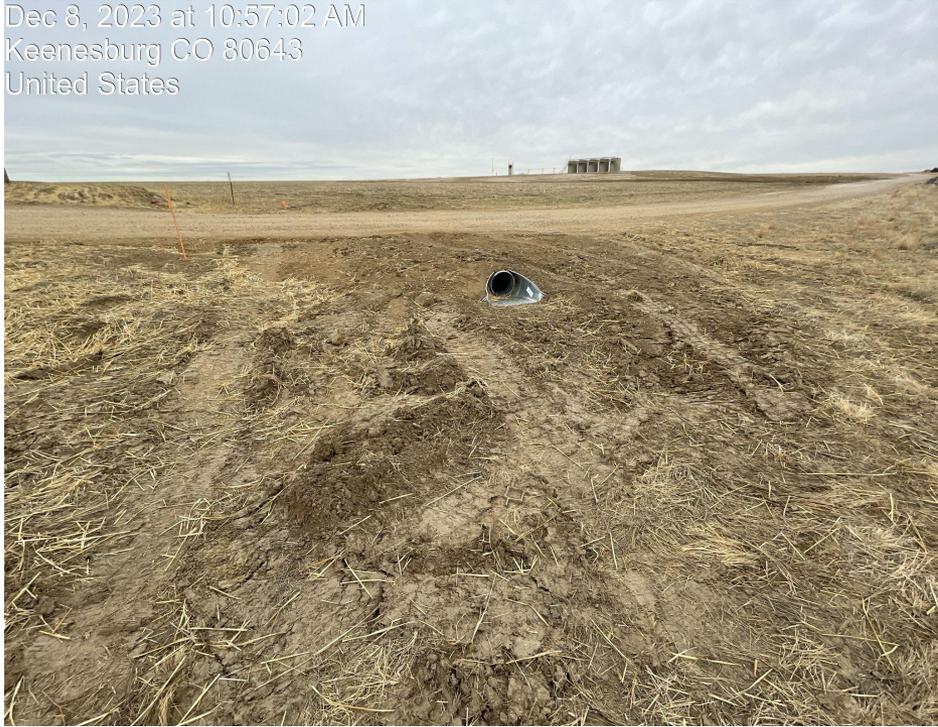
Photo 9. Photo of outlet of culvert in access road, no soil protection observed or outlet protection. Photo tank facing east.

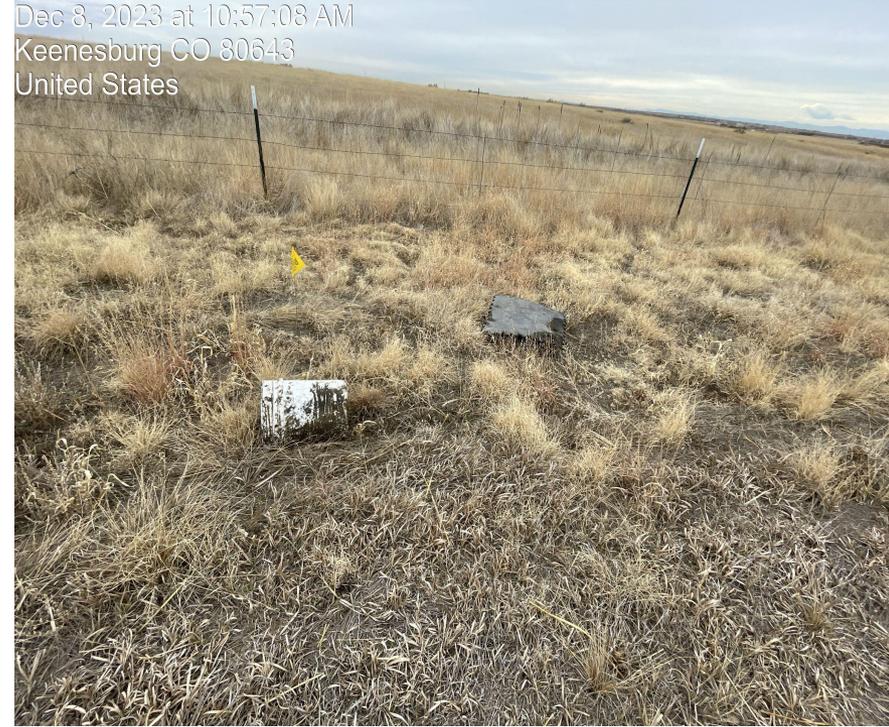
Photo 10. Photo of trash at entrance of on west side of pad. Photo tank facing northwest.

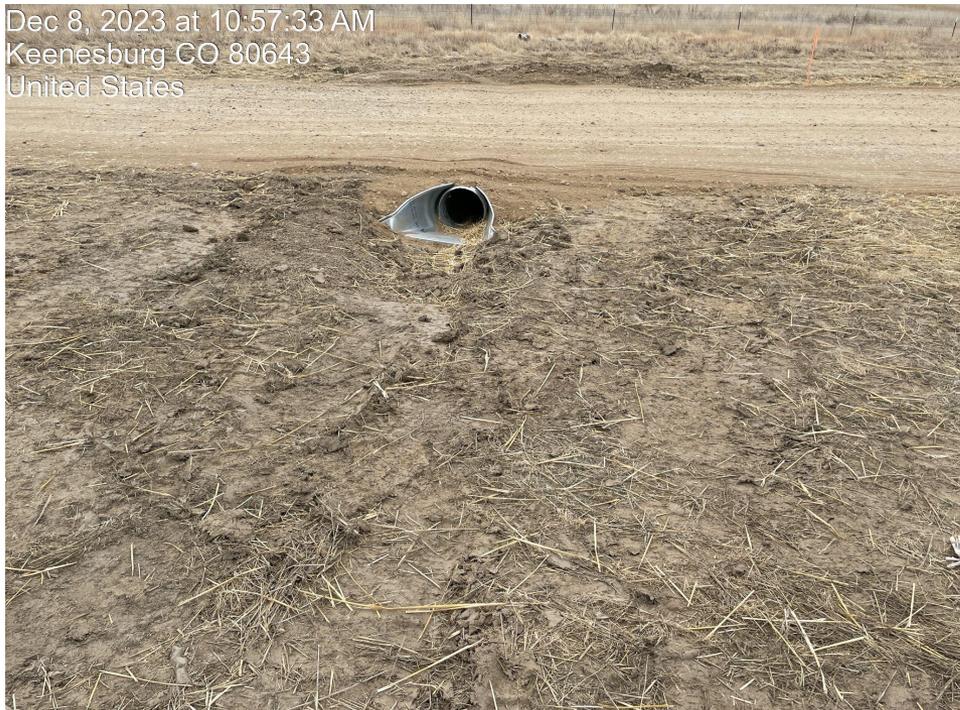
Photo 11. Photo taken of inlet of culver on access road, no ditch flows to culvert, no soil protection observed or inlet protection. Photo taken facing west.
