# Final Reclamation and Stormwater Inspection

Operator: WESTERN OPERATING COMPANY - 95620

Location ID: 313647

Inspection Document #: 708200844

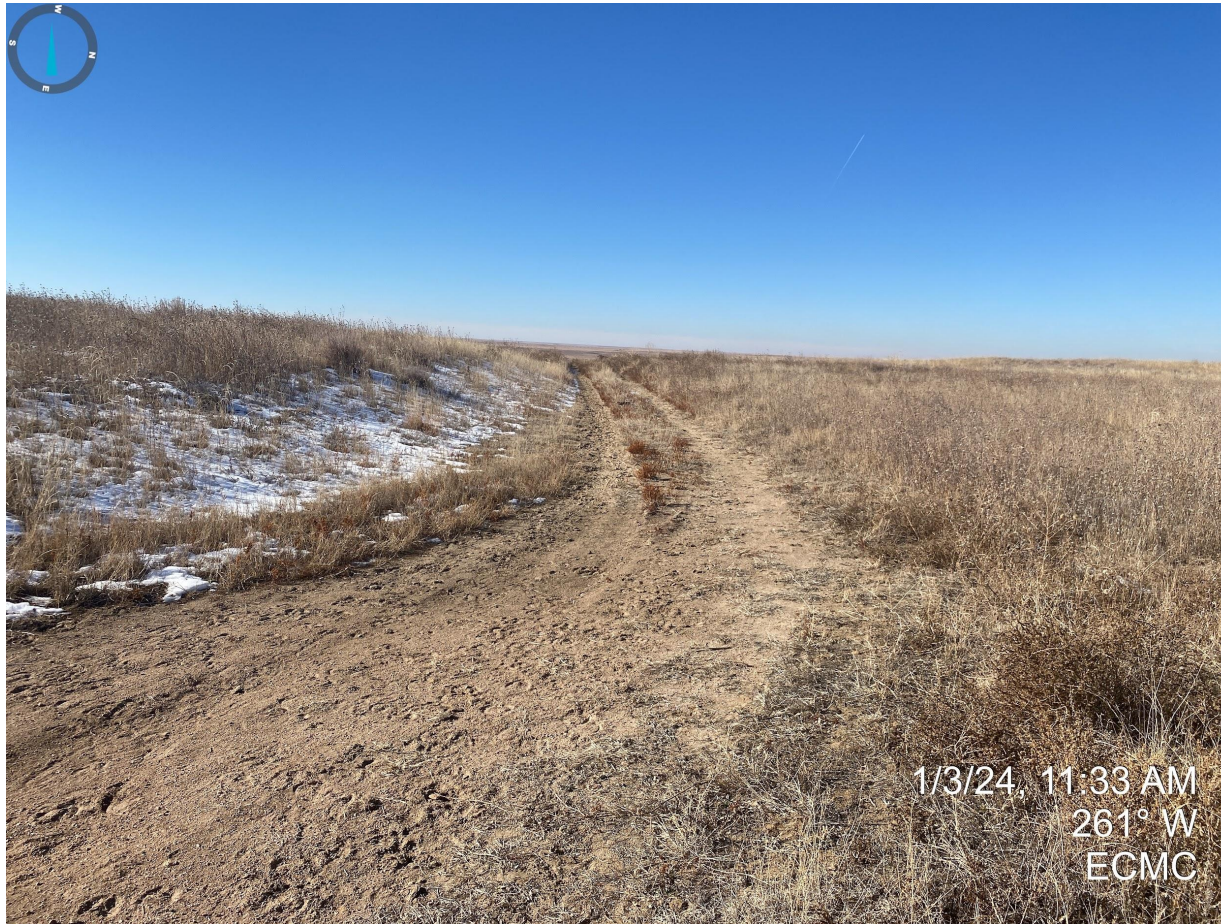
**Photo 1.** Facing west along the eastern part of the access road. The access road has not been reclaimed per Rule 1004; additional reclamation activities are required.

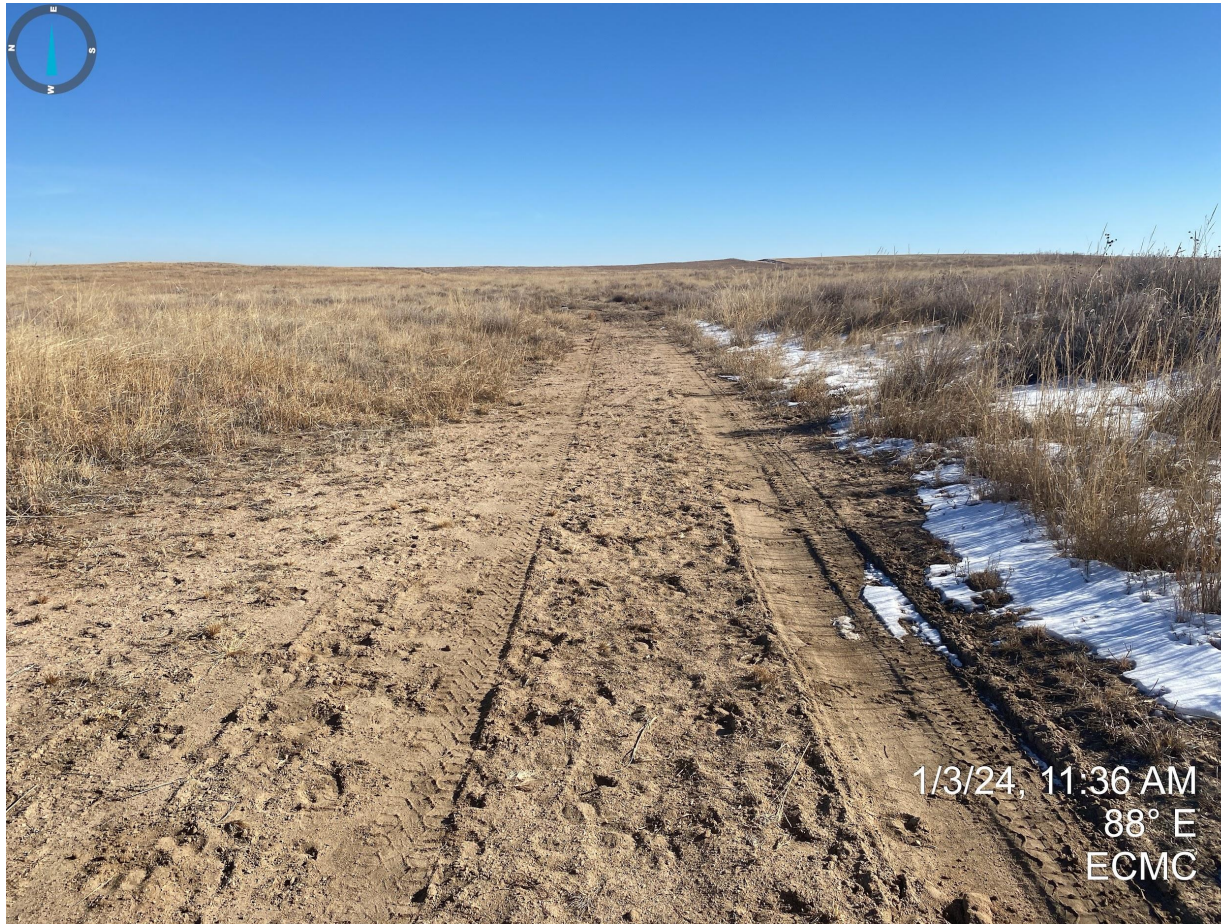
**Photo 2.** Facing east near the former well location; see comments in Photo 1.

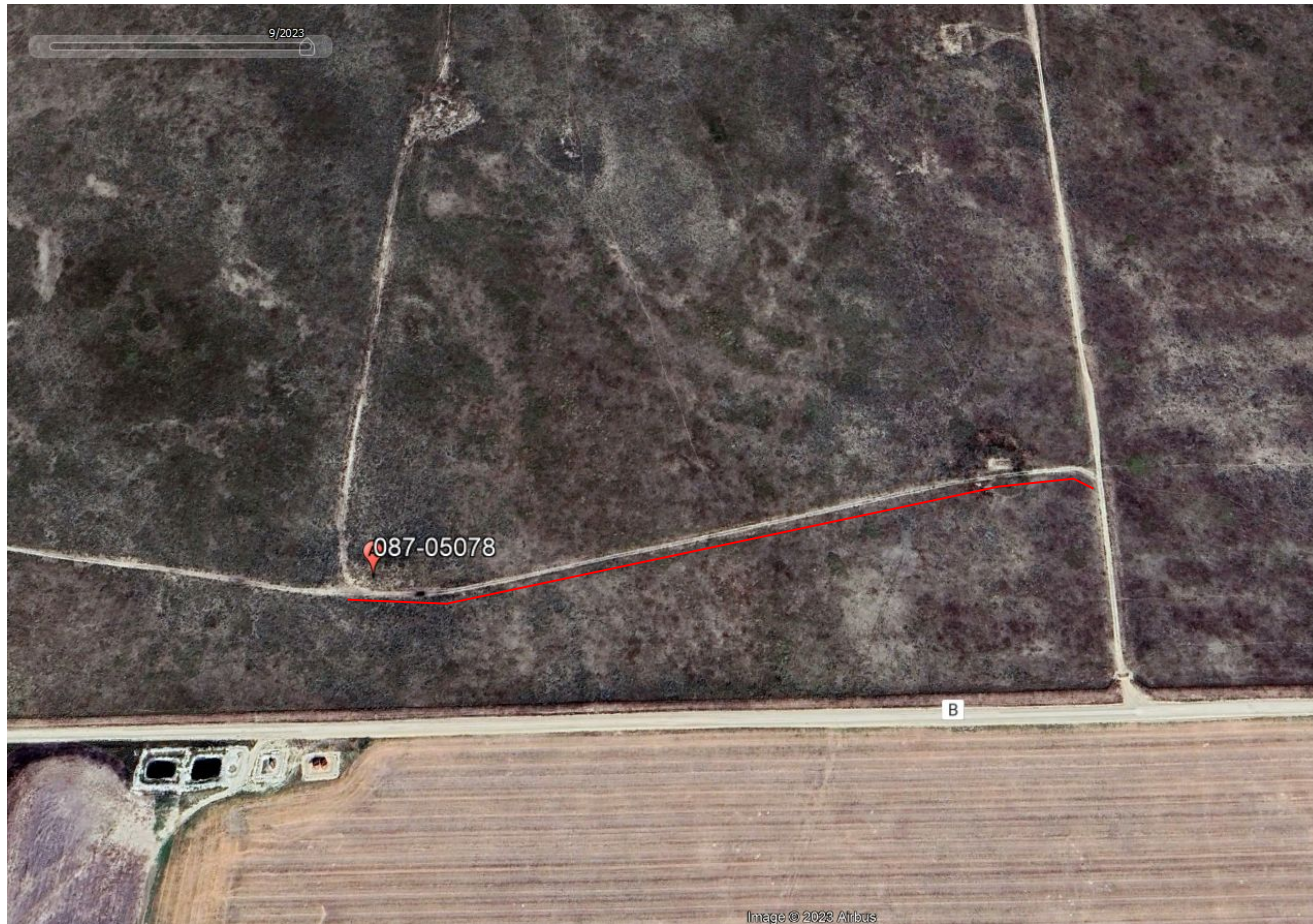
**Photo 3.** Google Earth aerial imagery taken circa 09/2023. Photo illustrates that the access road has not been reclaimed. Portions of the access road associated with Well API #087-05078, highlighted in red, will need to be reclaimed (e.g. contoured, regraded, reseeded, etc).

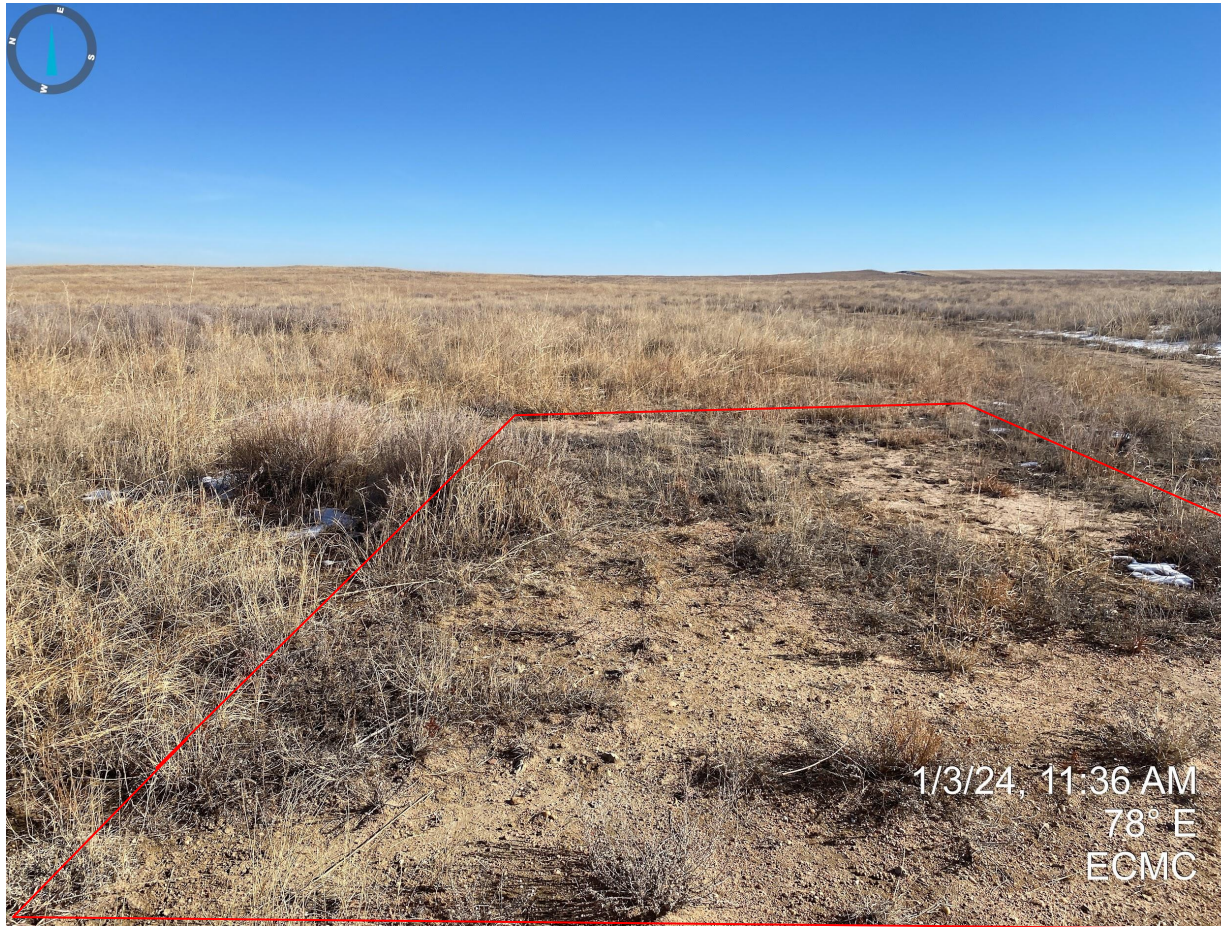
**Photo 4.** Taken from the western portion of the former well. Non-uniform vegetative cover at the former well location. Additional reclamation activities are required.

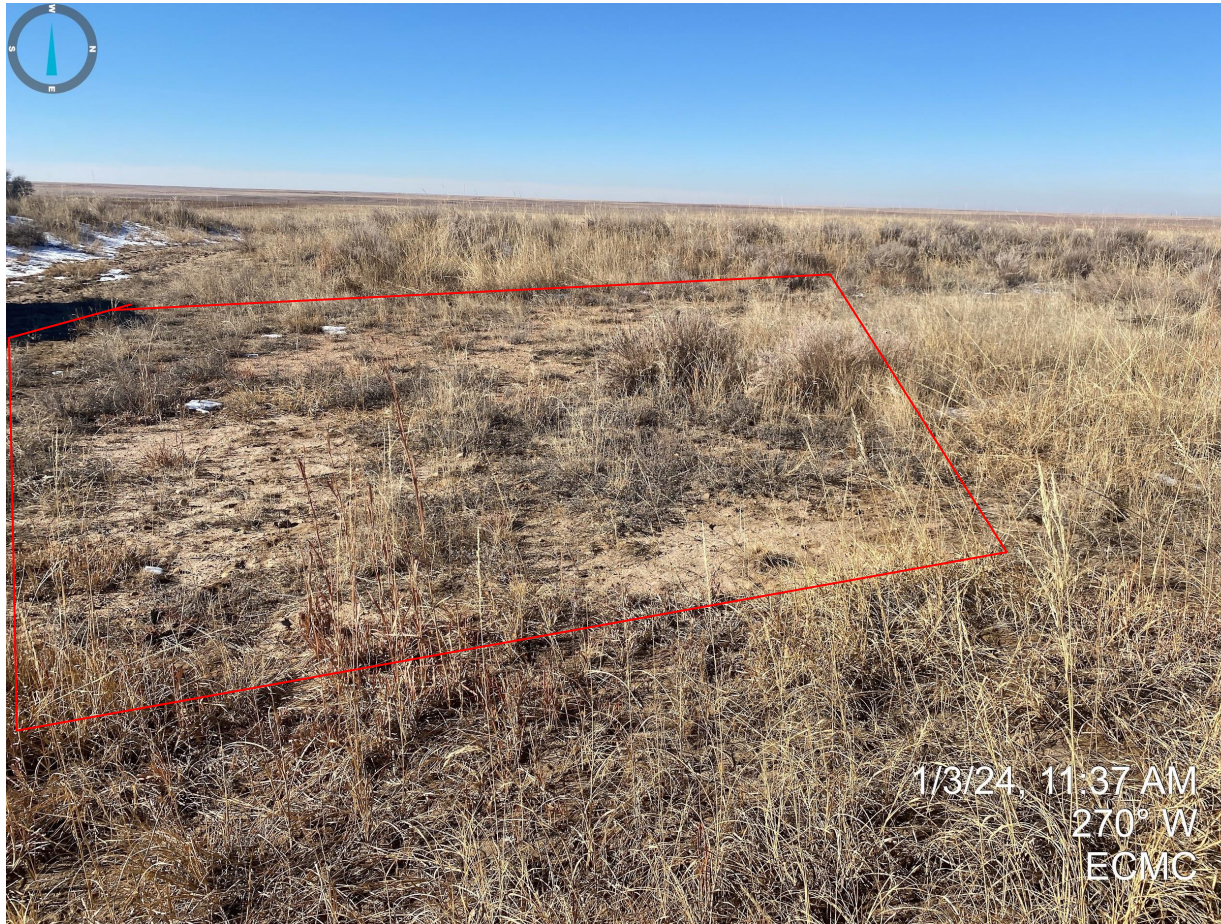
**Photo 5.** Taken from the eastern portion of the former well. See comments in Photo 4.
