# Final Reclamation and Stormwater Inspection

Operator: WESTERN OPERATING COMPANY - 95620

Location ID: 313663

Inspection Photos  
Location Name: Sand River Unit #2  
Location ID: 313663

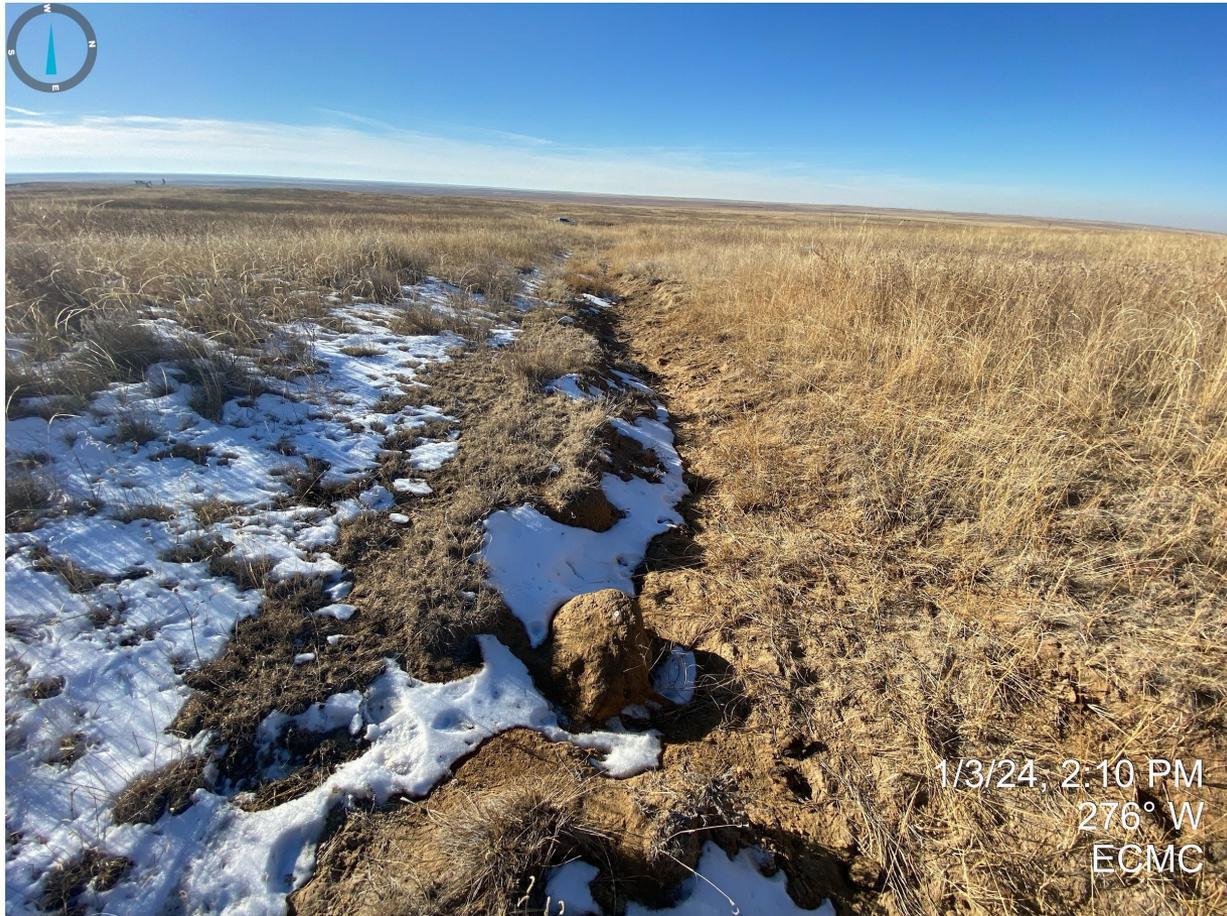
**Photo 1.** Stormwater erosion degradation (e.g. gullying) occurring on the access road, which has not been contoured or regraded to reflect pre-disturbance levels.

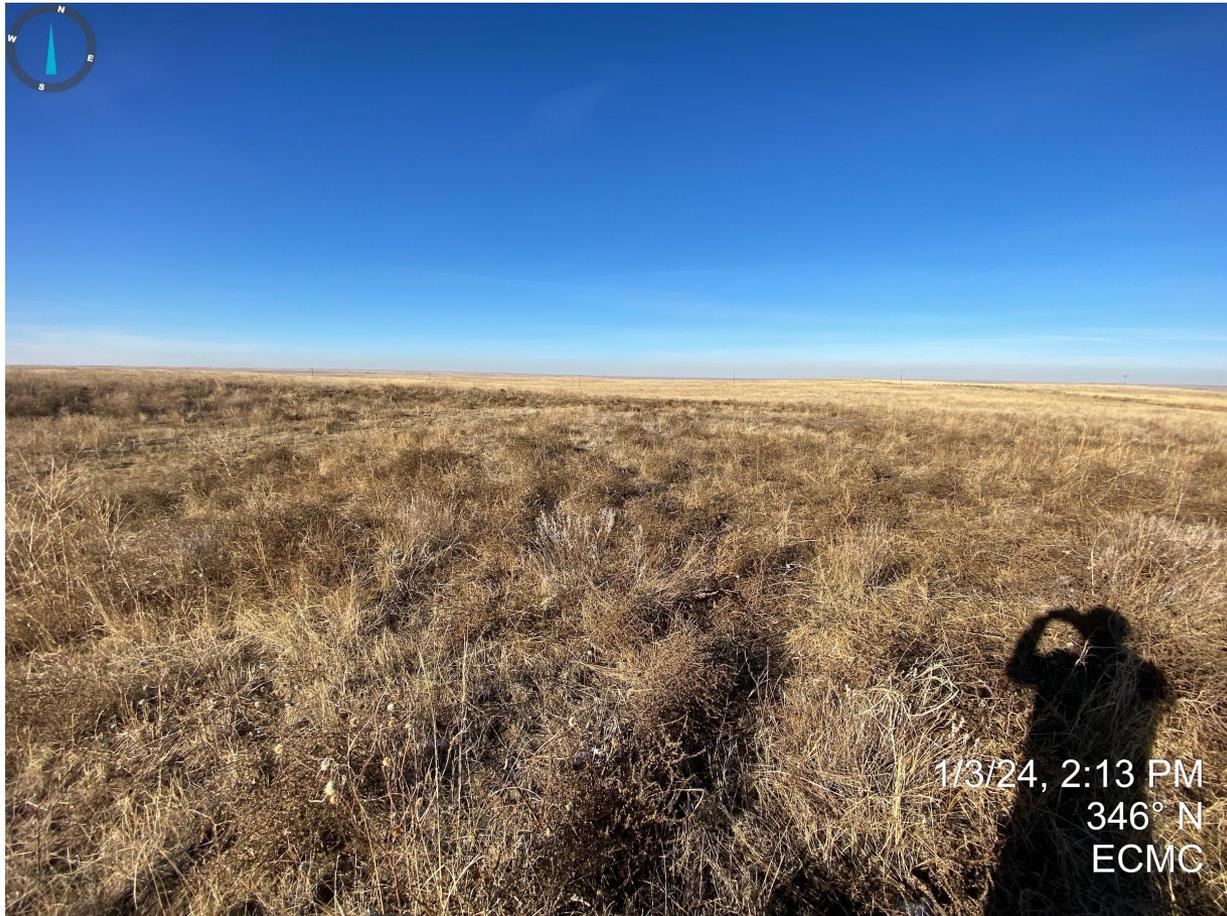
**Photo 2.** Southern portion of the location. The location is not progressing towards Rule 1004 standards as evidenced by a predominant vegetative cover of undesirable species (e.g. russian thistle and kochia). Additionally, the location has not been contoured or regraded to reflect pre-disturbance levels.

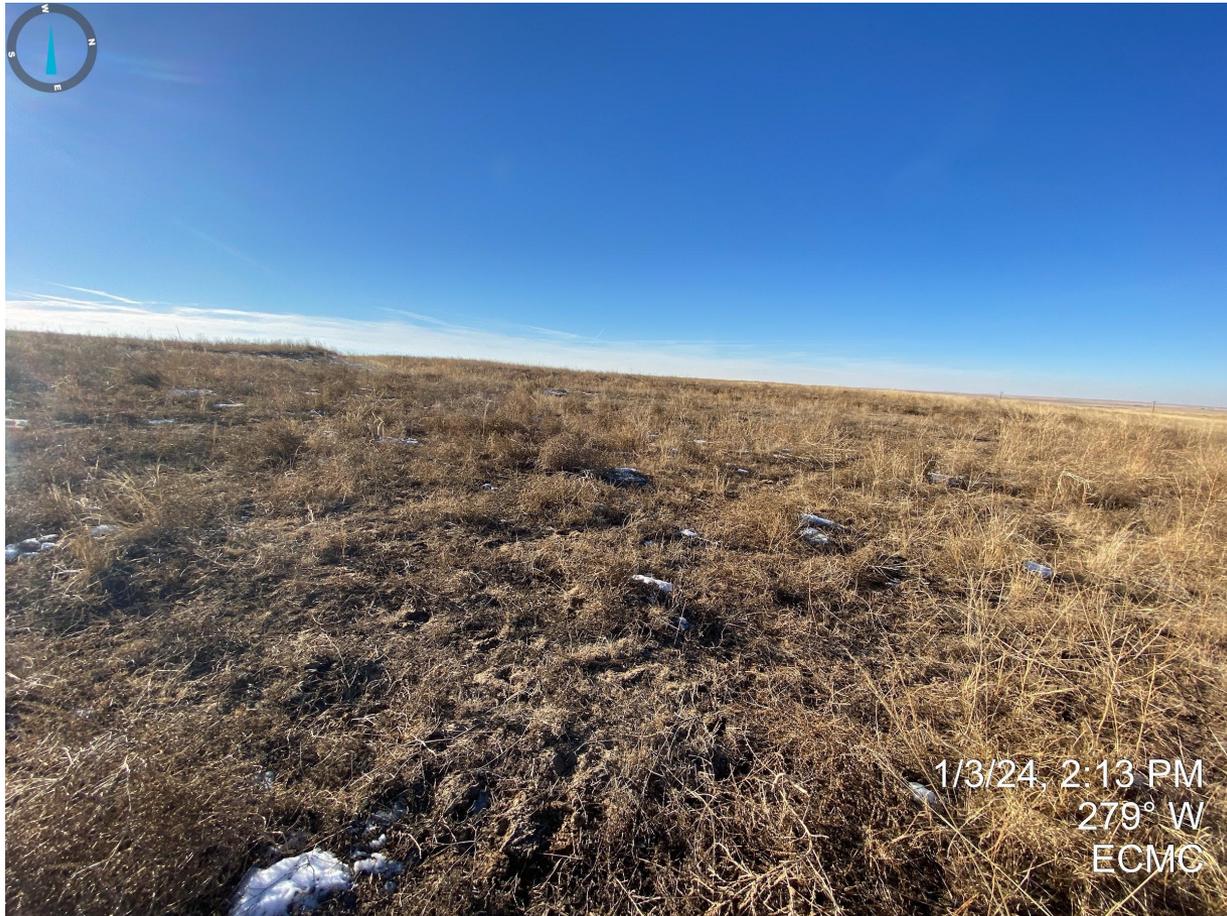
**Photo 3.** Eastern portion of the location; see comments in Photo 1.

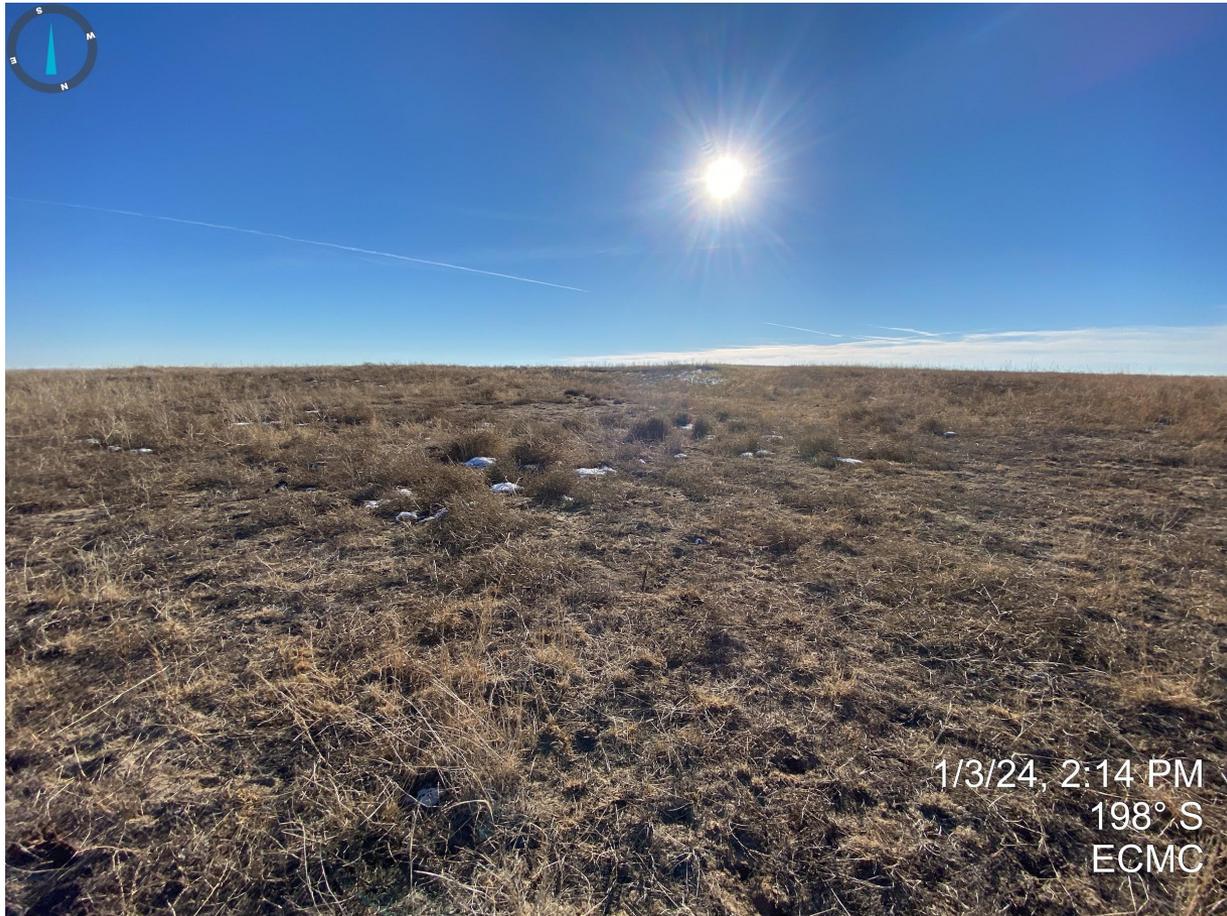
**Photo 4.** Northern portion of the location; see comments in Photo 2.

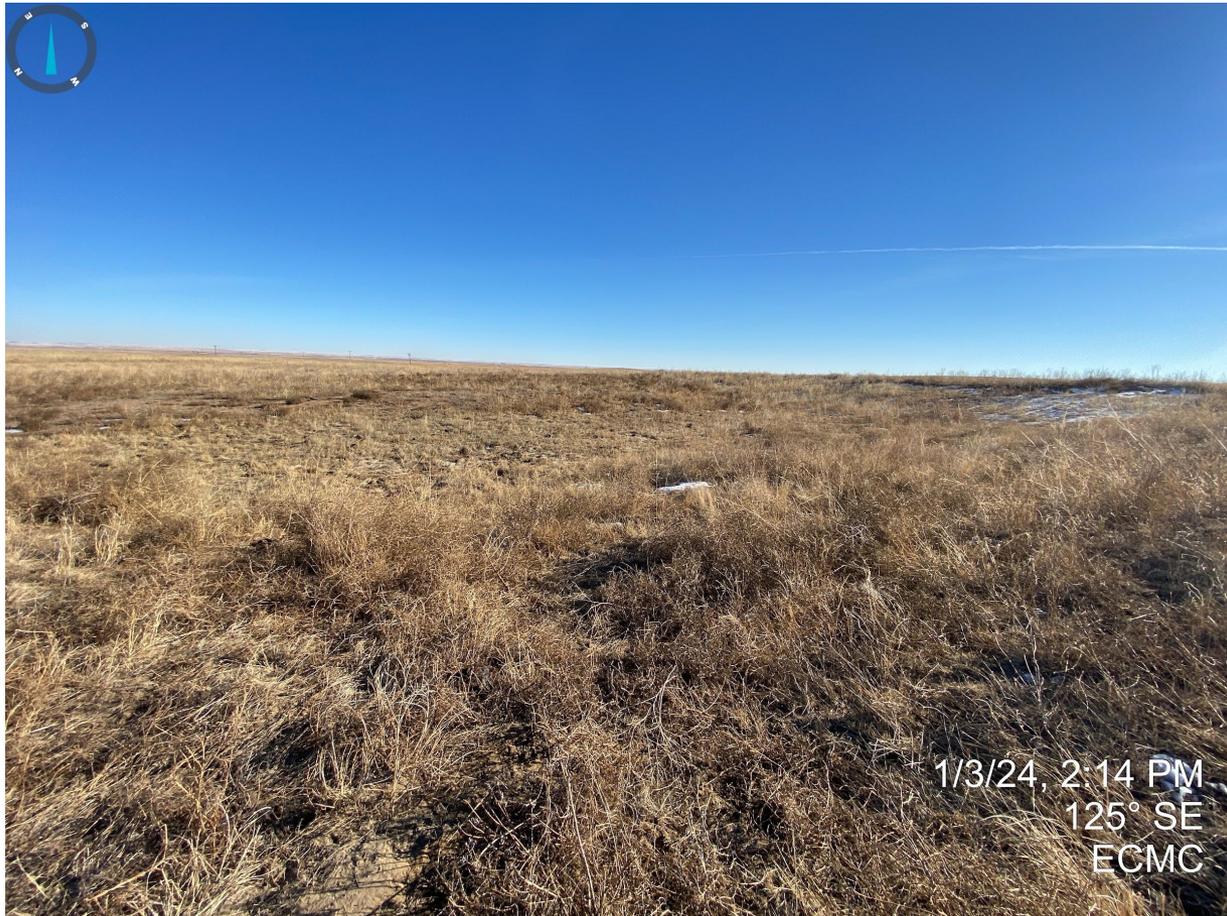
**Photo 5.** Western portion of the location; see comments in Photo 2.

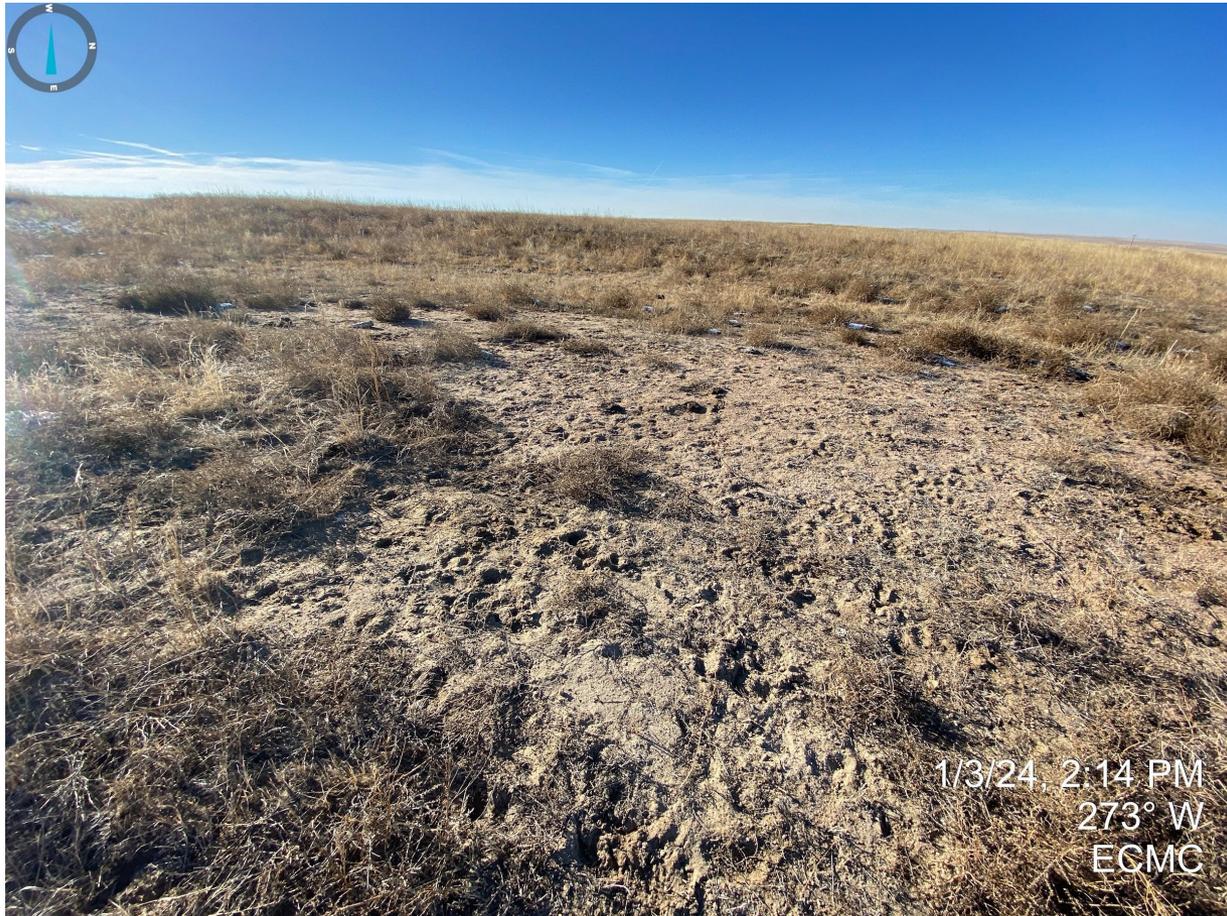
**Photo 6.** Area around the former wellhead is primarily bare/exposed soils.
