## Inspection Photos

Location Name: CAERUS PICEANCE LLC DAYBREAK FEDERAL 19-2 (PJ19) Pad

Location #: 417538

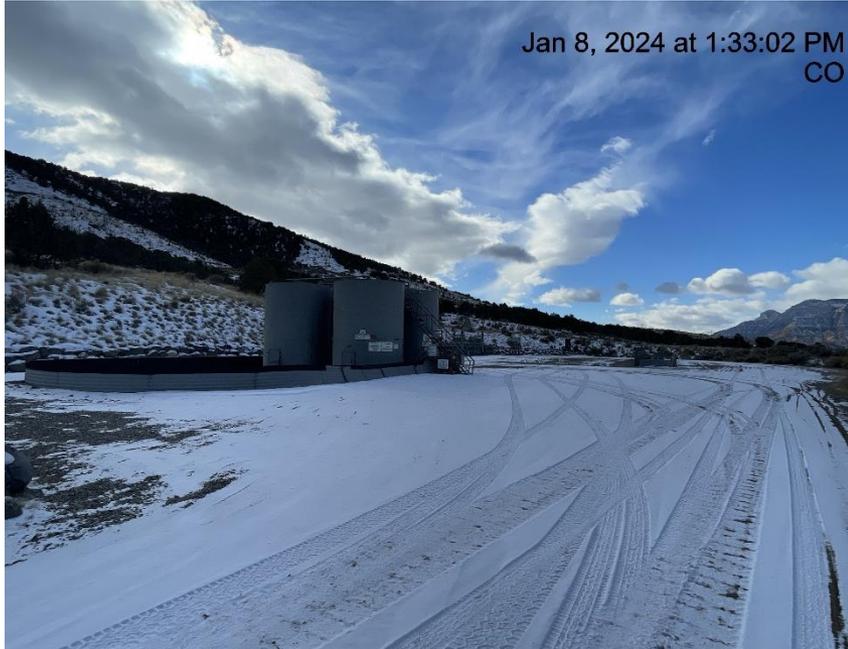
Photo # 2084 From entrance to location

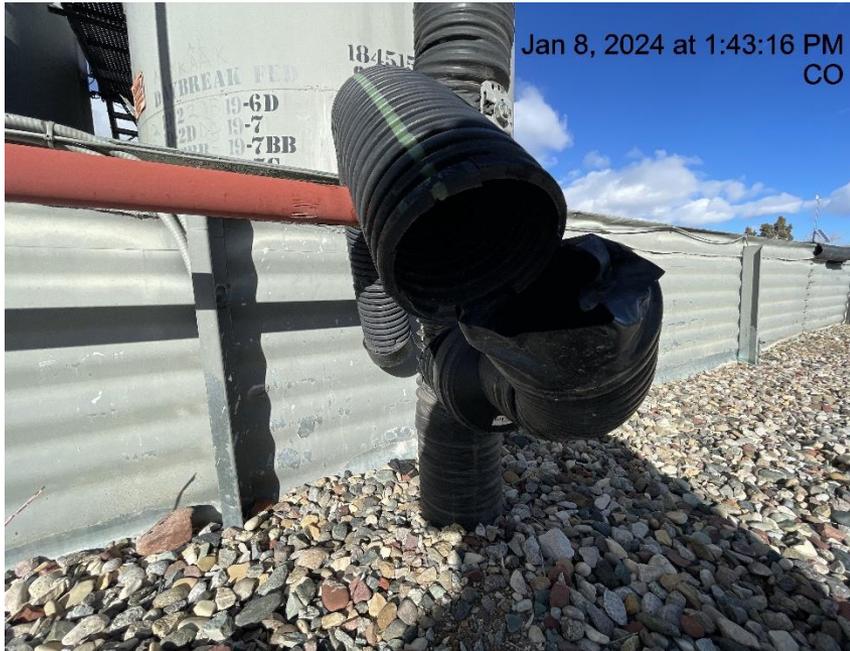
**Photo # 2094 Flowline heating insulation open ended/wildlife hazard**

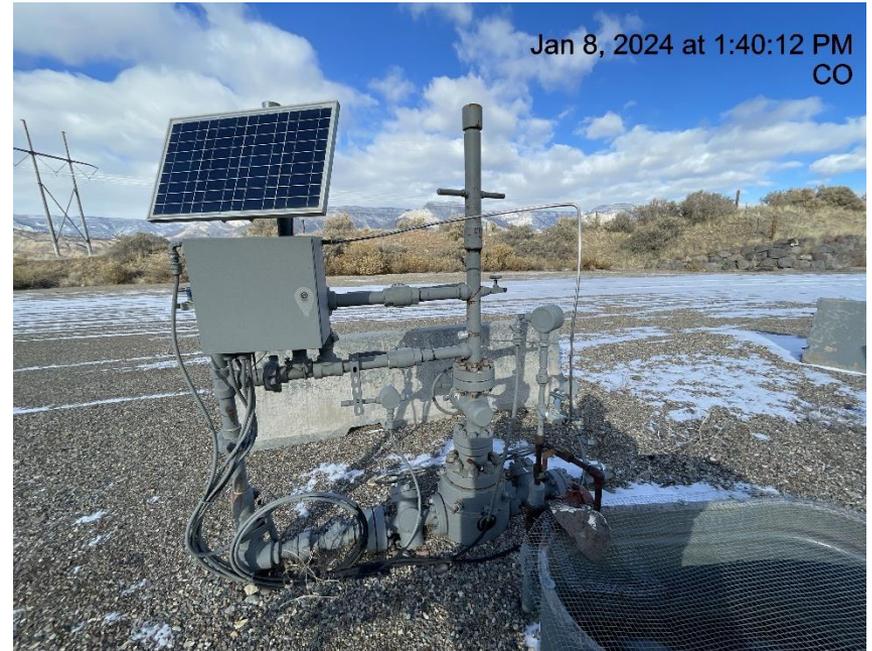
**Photo # 2095 Daybreak FEE 19-8 bradenhead connected to flowline/no FORM 4 Sundry**
