Storm Water Management and Erosion control

Location Name: TEP ROCKY MOUNTAIN LLC ACCO TOSCO W-21-34 Pad

Location #: 335219

COLORADO
Energy & Carbon Management
Commission
Department of Natural Resources

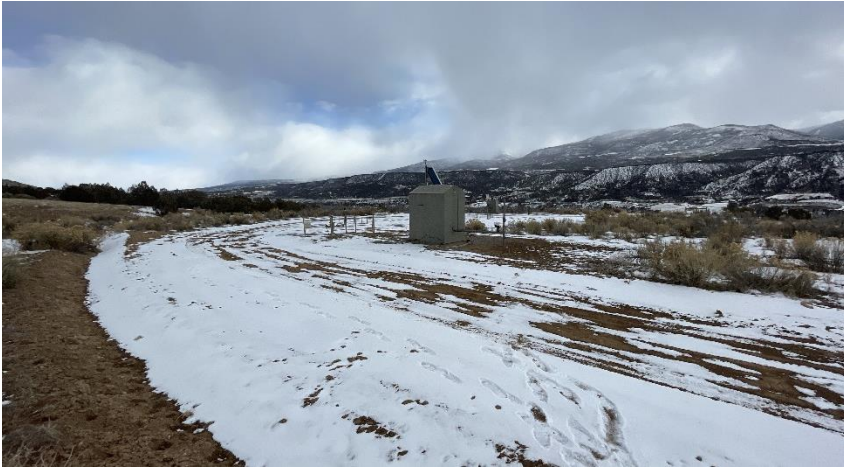
North West corner of location.

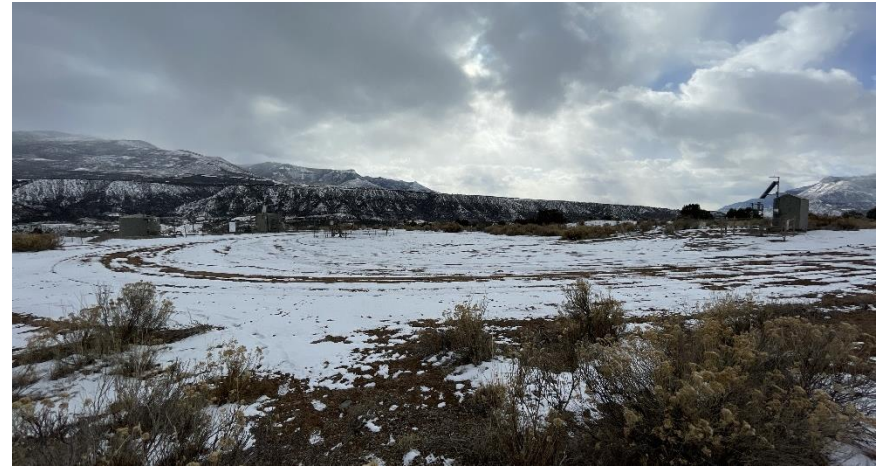
North East corner of location.

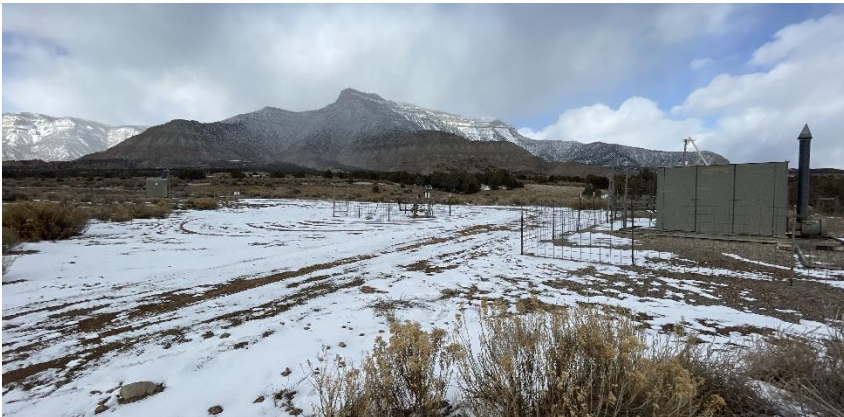
South West corner of location.

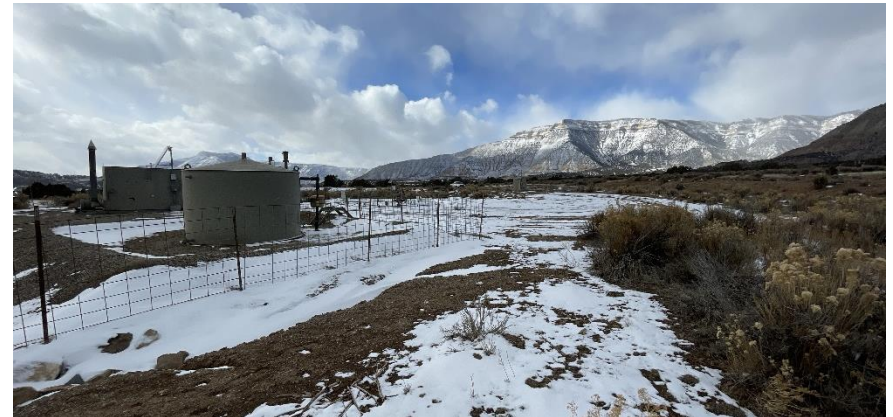
South East corner of location.

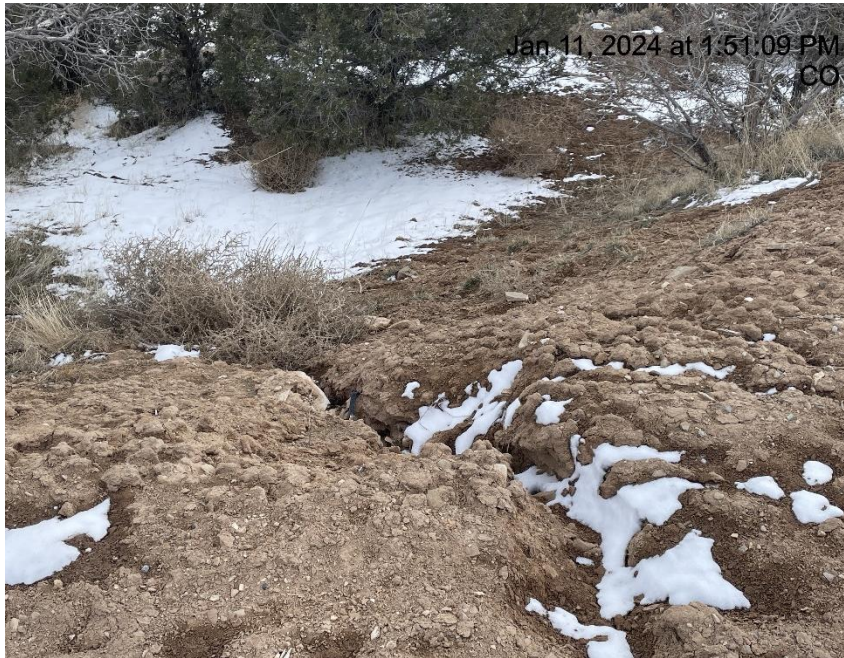
Photo # 2506 Erosion & transport of sediment/insufficient BMP's (S/SE area of location on slope behind separator & production tank.)

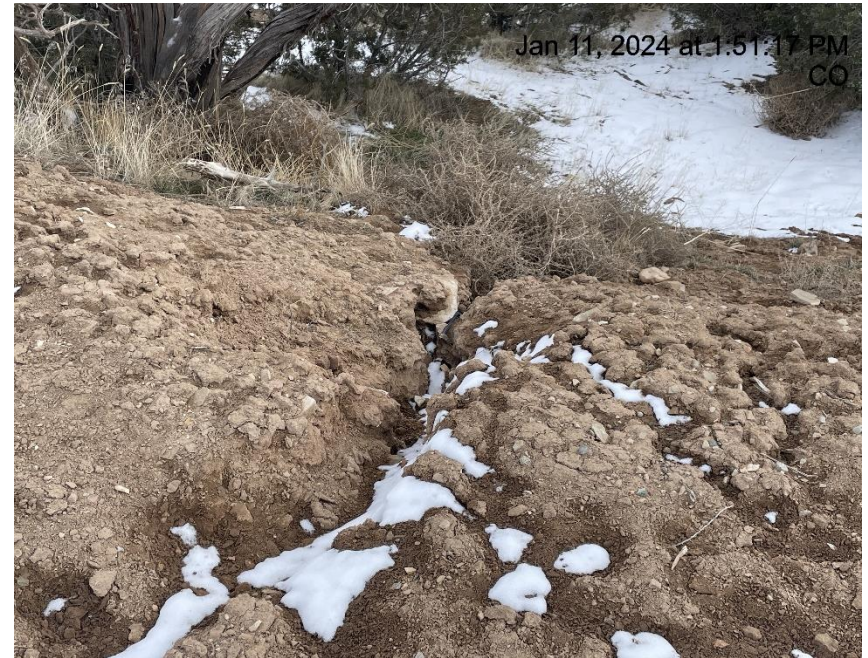
Photo # 2507 Erosion & transport of sediment/insufficient BMP's (S/SE area of location on slope behind separator & production tank.)

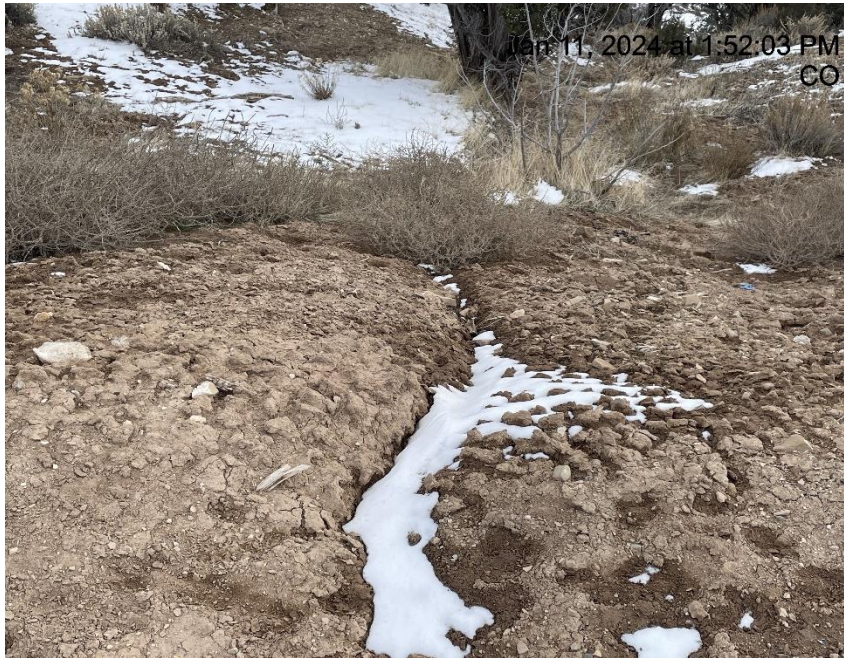
Photo # 2508 Erosion & transport of sediment/insufficient BMP's (S/SE area of location on slope behind separator & production tank.)

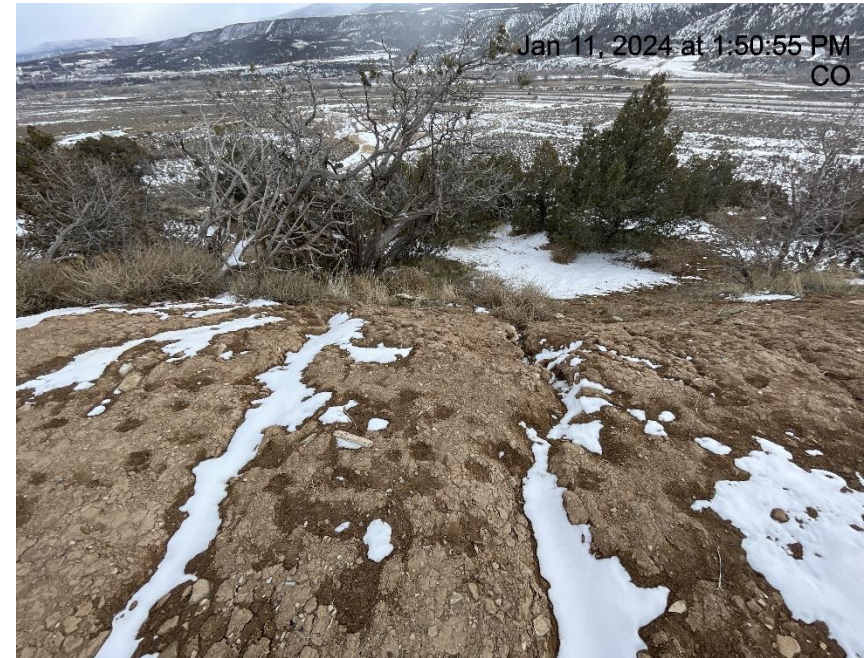
Photo # 2509 Erosion & transport of sediment/insufficient BMP's (S/SE area of location on slope behind separator & production tank.)
