Inspection Photos

Location Name: TEP ROCKY MOUNTAIN LLC MOBILE 11-20 Pad

Location #: 322510

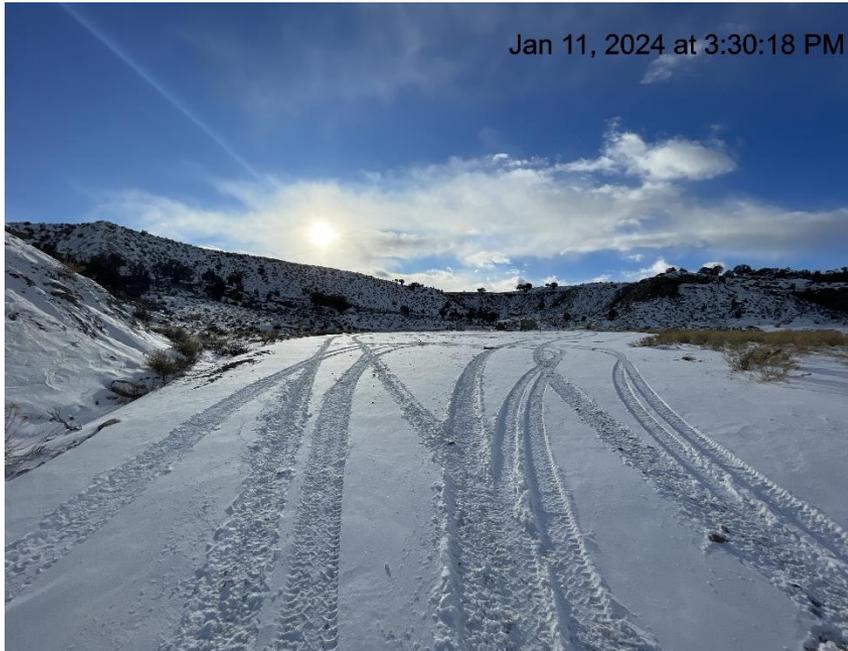
Photo # 2667 From entrance to location

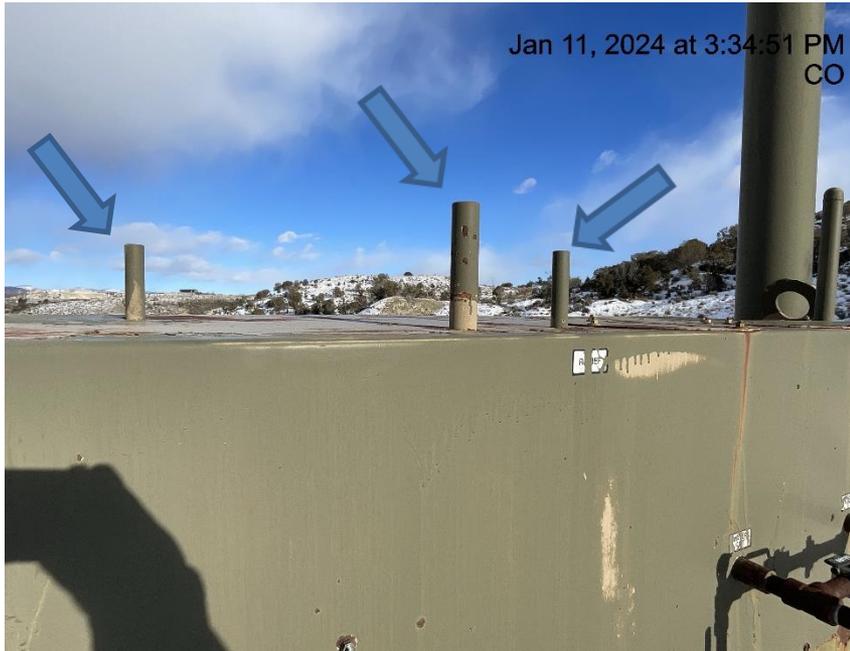
Photo # 2673 PRV & rupture disc vent lines lack caps

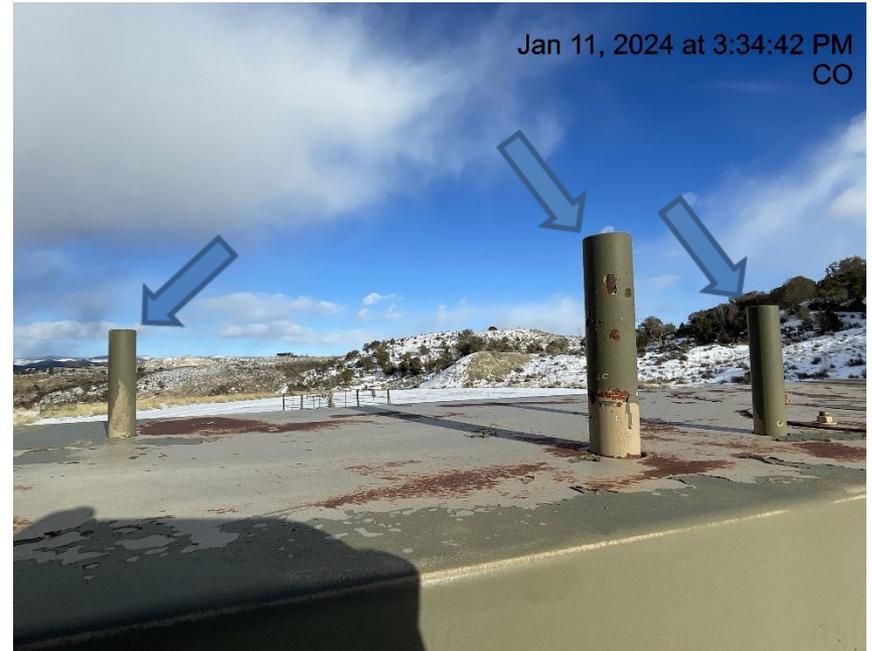
Photo # 2674 PRV & rupture disc vent lines lack caps

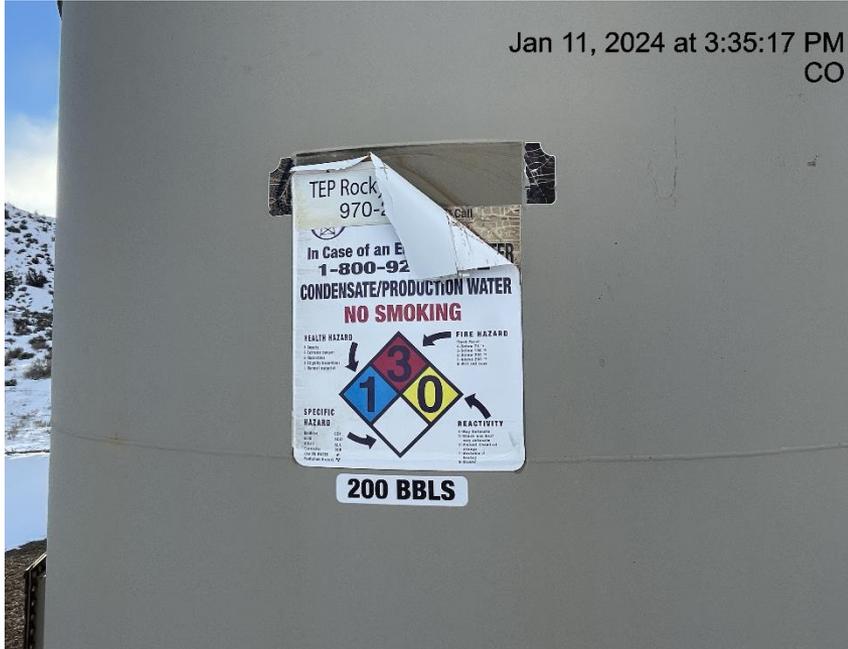
Photo # 2675 Tank label losing adhesion
