Inspection Photos
Location Name: Kilker 1-15
Location ID: 321372

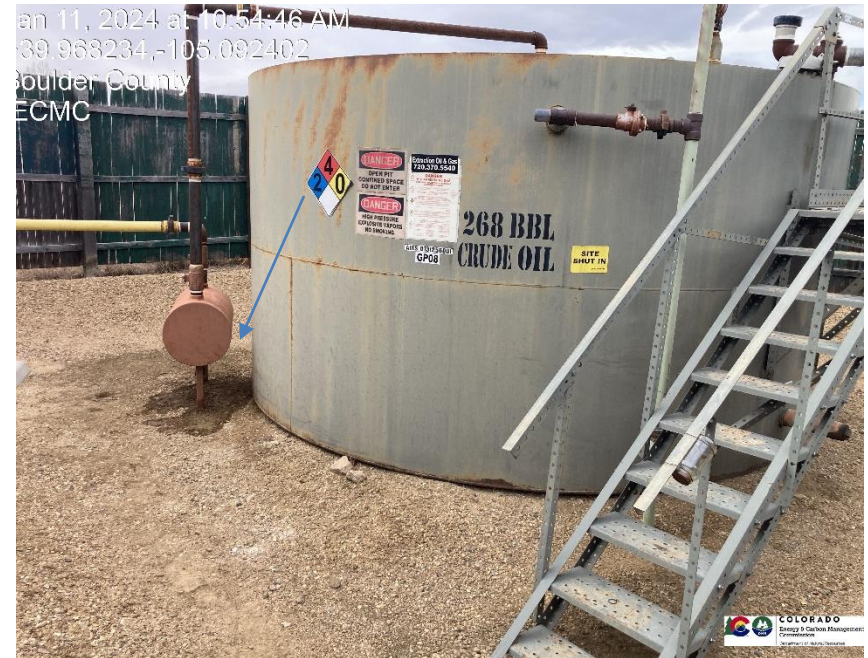
Pic 2 stained soil / leak near tank

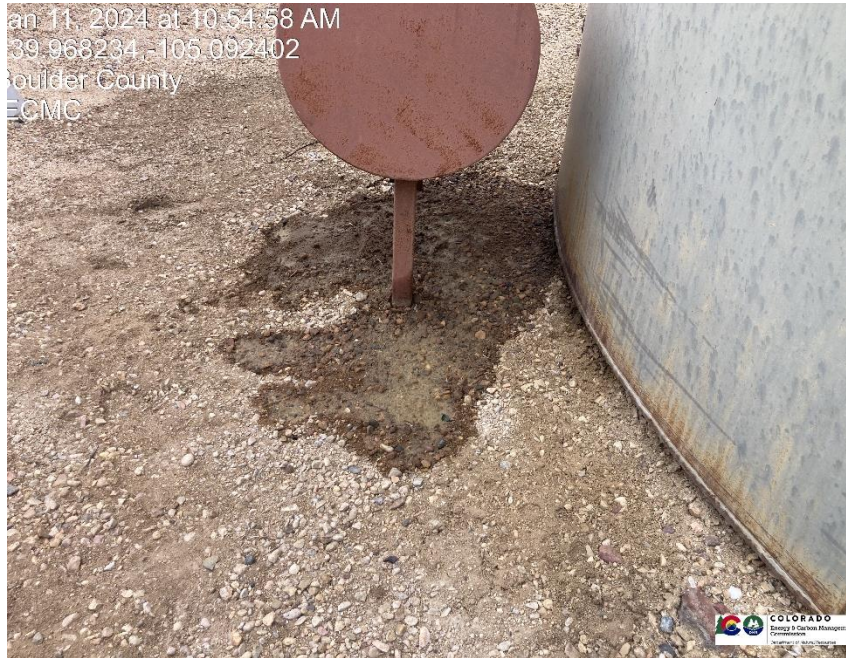
Pic 3 Stained soil / leak

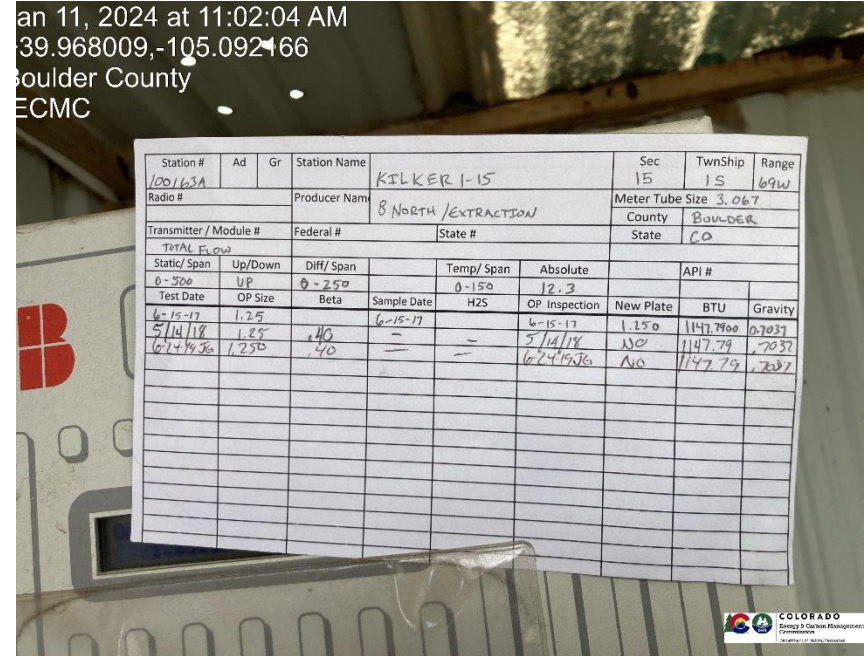
Pic 8 gas meter run has not been calibrated 6/24/19.
 Calibration is needed.
