Inspection Photos

Location Name: TEP ROCKY MOUNTAIN LLC Federal DOE 2-W-27 Pad

Location ID: 335233

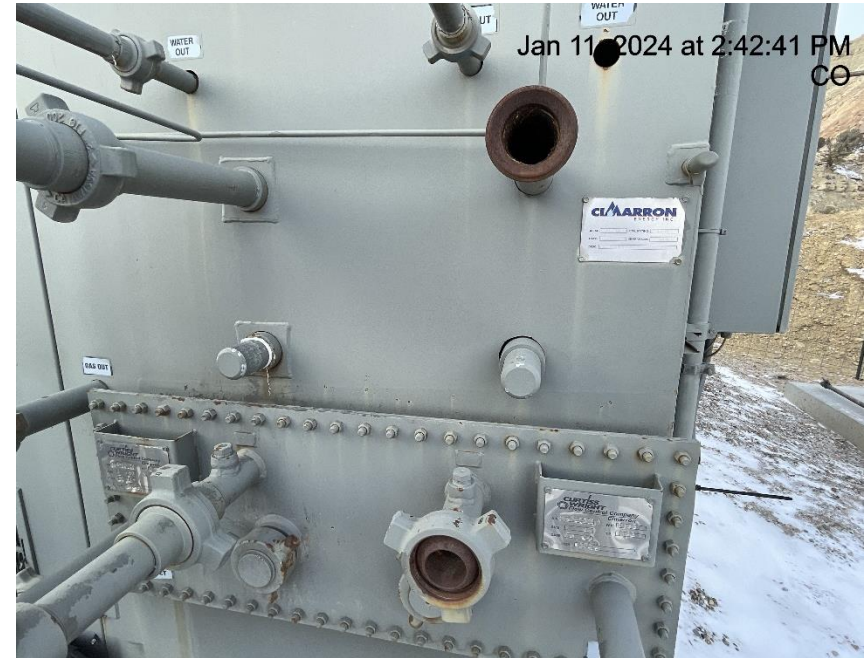
Photo # 2599 Open ended piping/wildlife hazards on separator

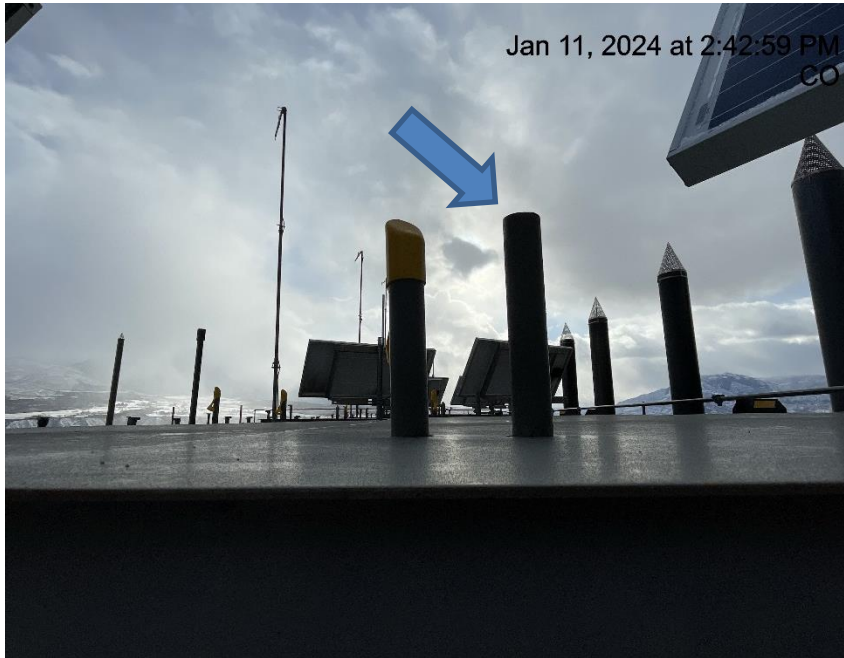
Photo # 2600 PRV vent line lacks cap

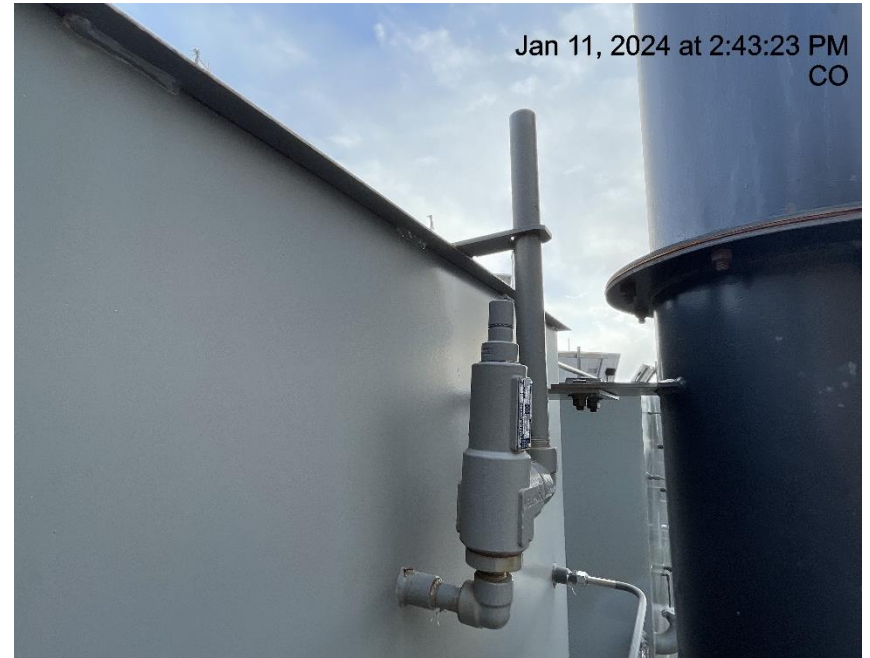
Photo # 2601 PRV vent line lacks cap

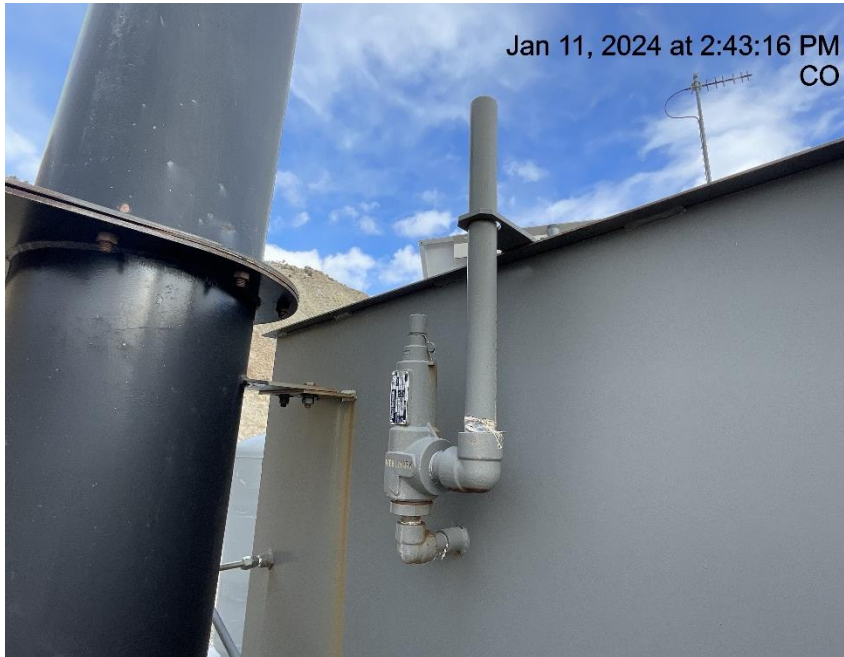
Photo # 2602 PRV vent line lacks cap

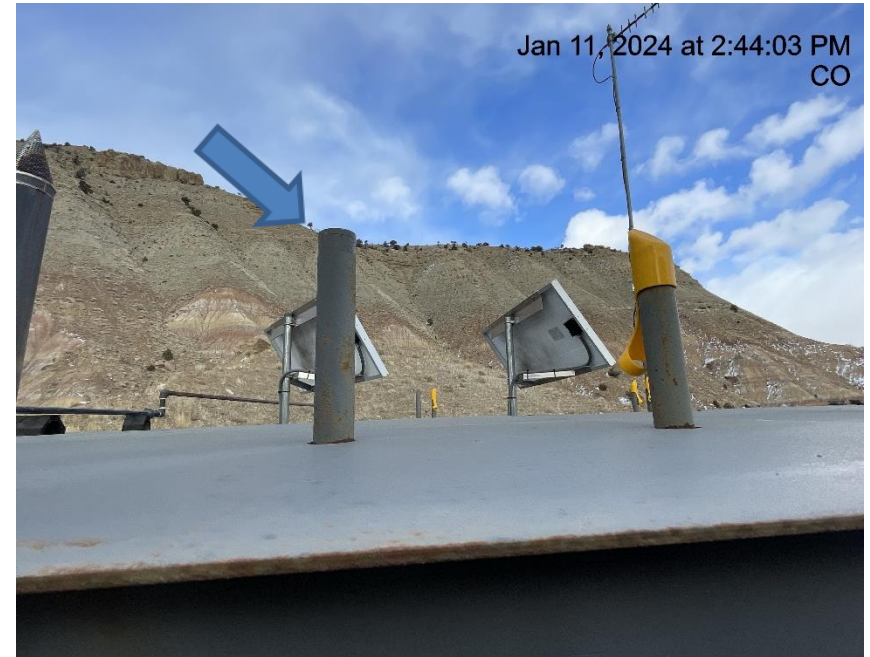
Photo # 2603 PRV vent line lacks cap
