# Final Reclamation and Stormwater Inspection

Operator: Kerr McGee Oil & Gas Onshore LP - 47120

Location ID: 331907

Location Name: Brattain L-63N66W 12NENW

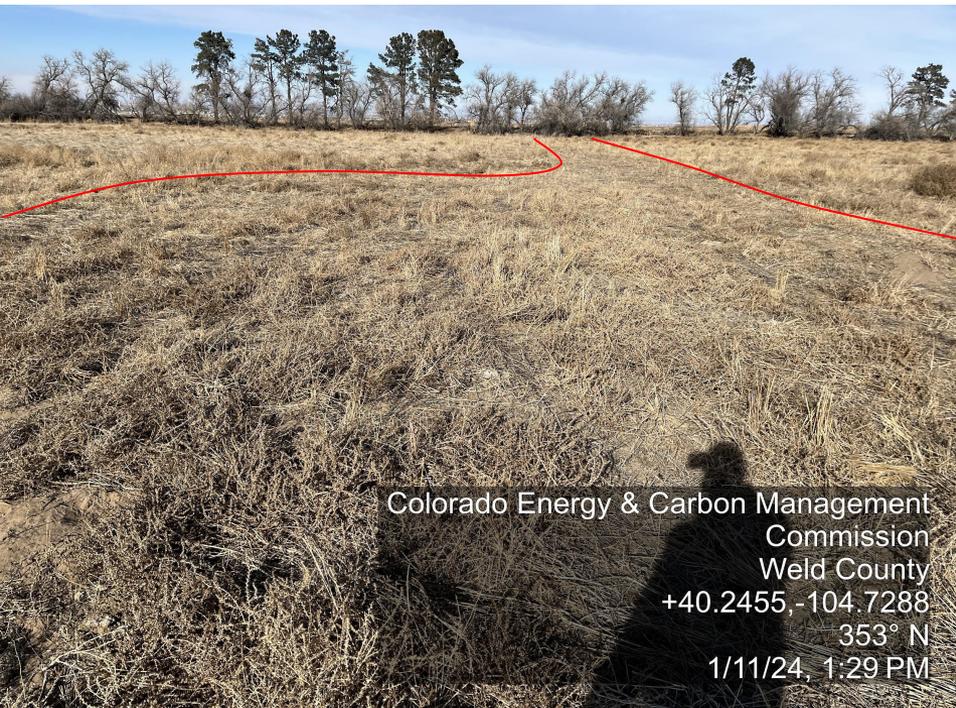
**Photo 1.** The photo was taken at the well location facing North. The photo illustrates the access road into the location and the location are dominated by russian thistle and cereal rye.

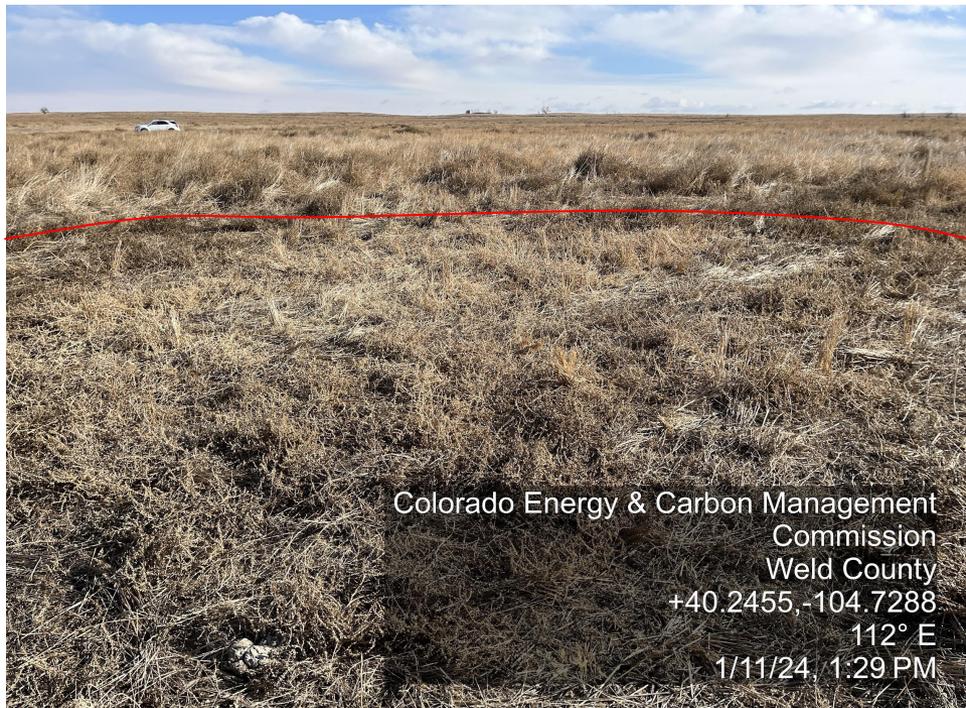
**Photo 2.** The photo was taken at the well location facing East. The photo illustrates the location is dominated by russian thistle and cereal rye.

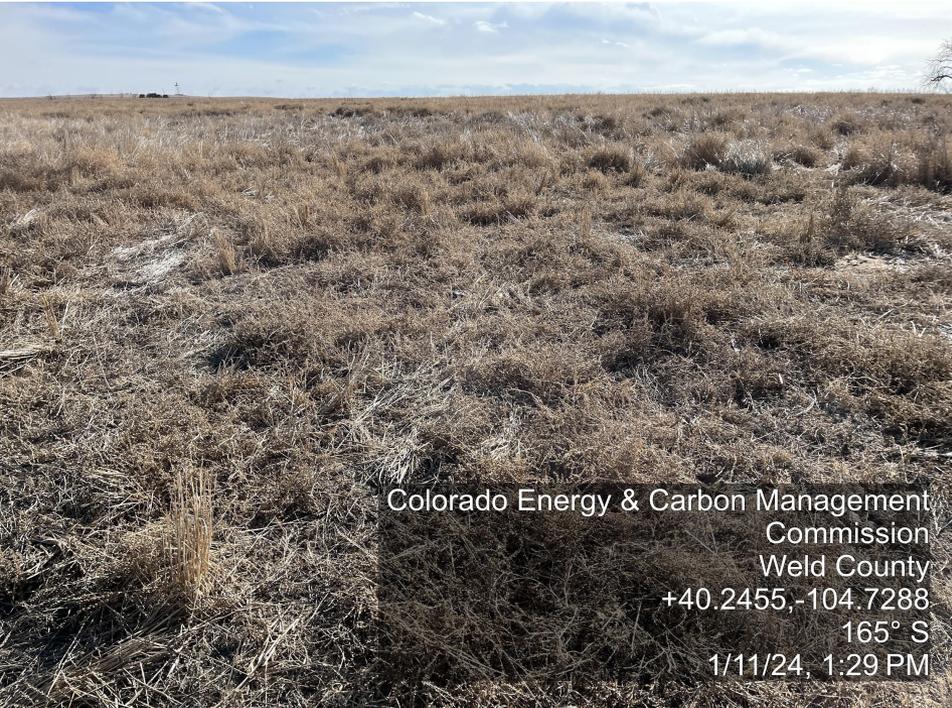
**Photo 3.** The photo was taken at the well location facing South.  
Refer to the comment from photo 2.

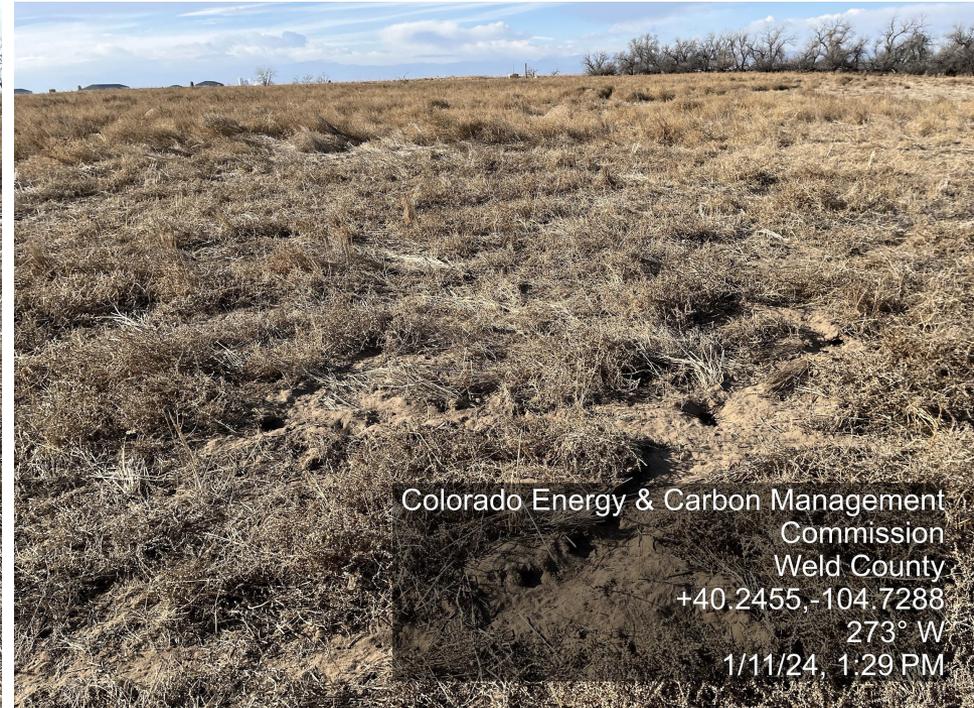
**Photo 4.** The photo was taken at the well location facing West.  
Refer to the comment from photo 2.

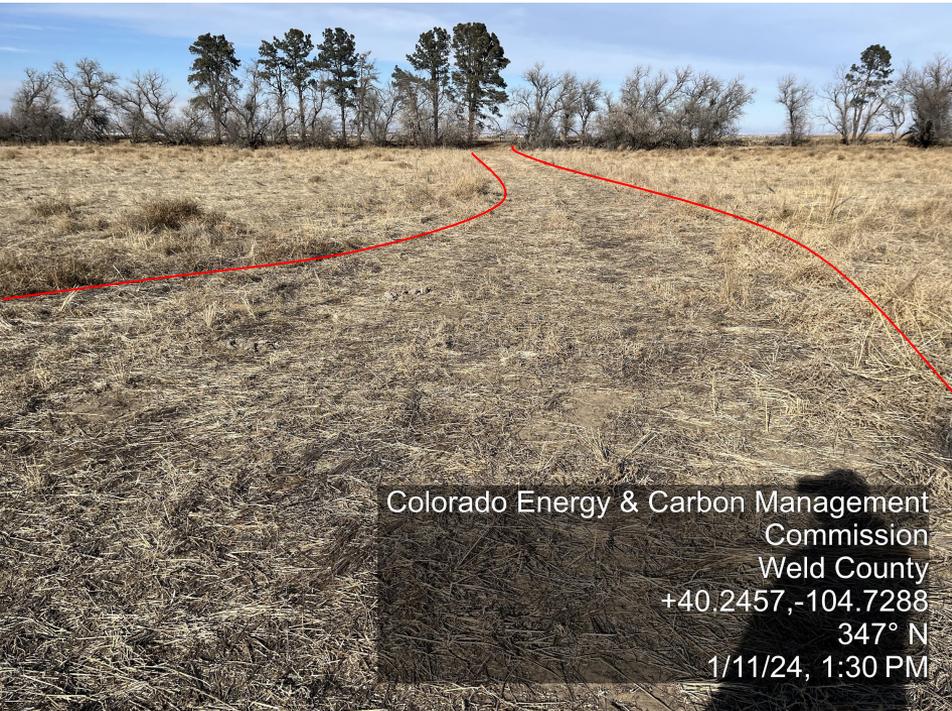
**Photo 5.** The photo was taken at the well location facing North. The photo illustrates the access road.

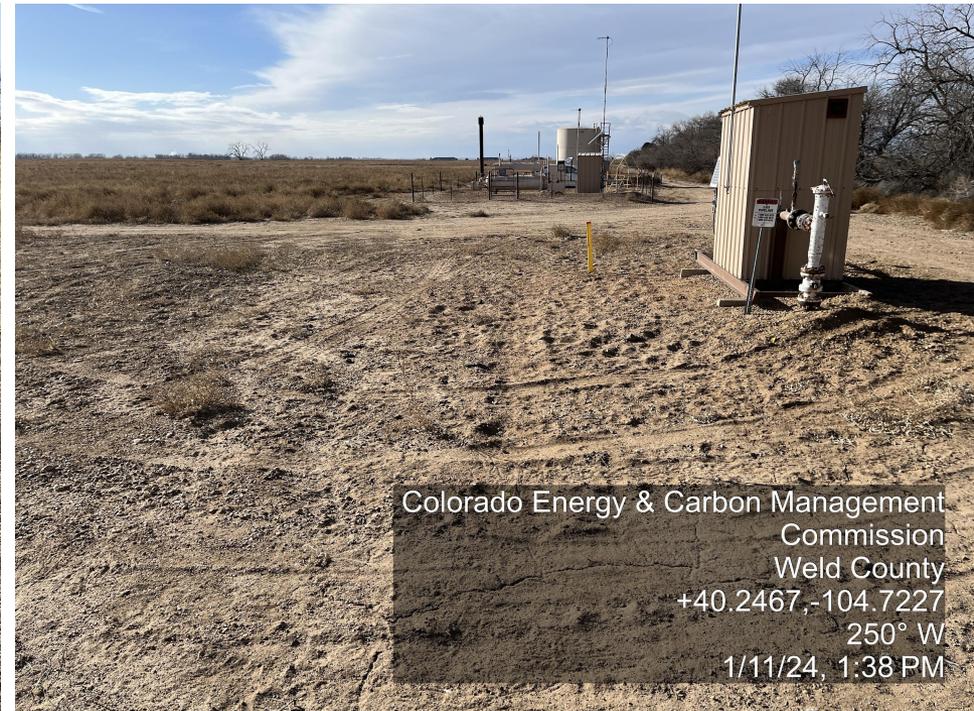
**Photo 6.** The photo was taken at the tank battery location facing West. The photo illustrates equipment remains at the location.

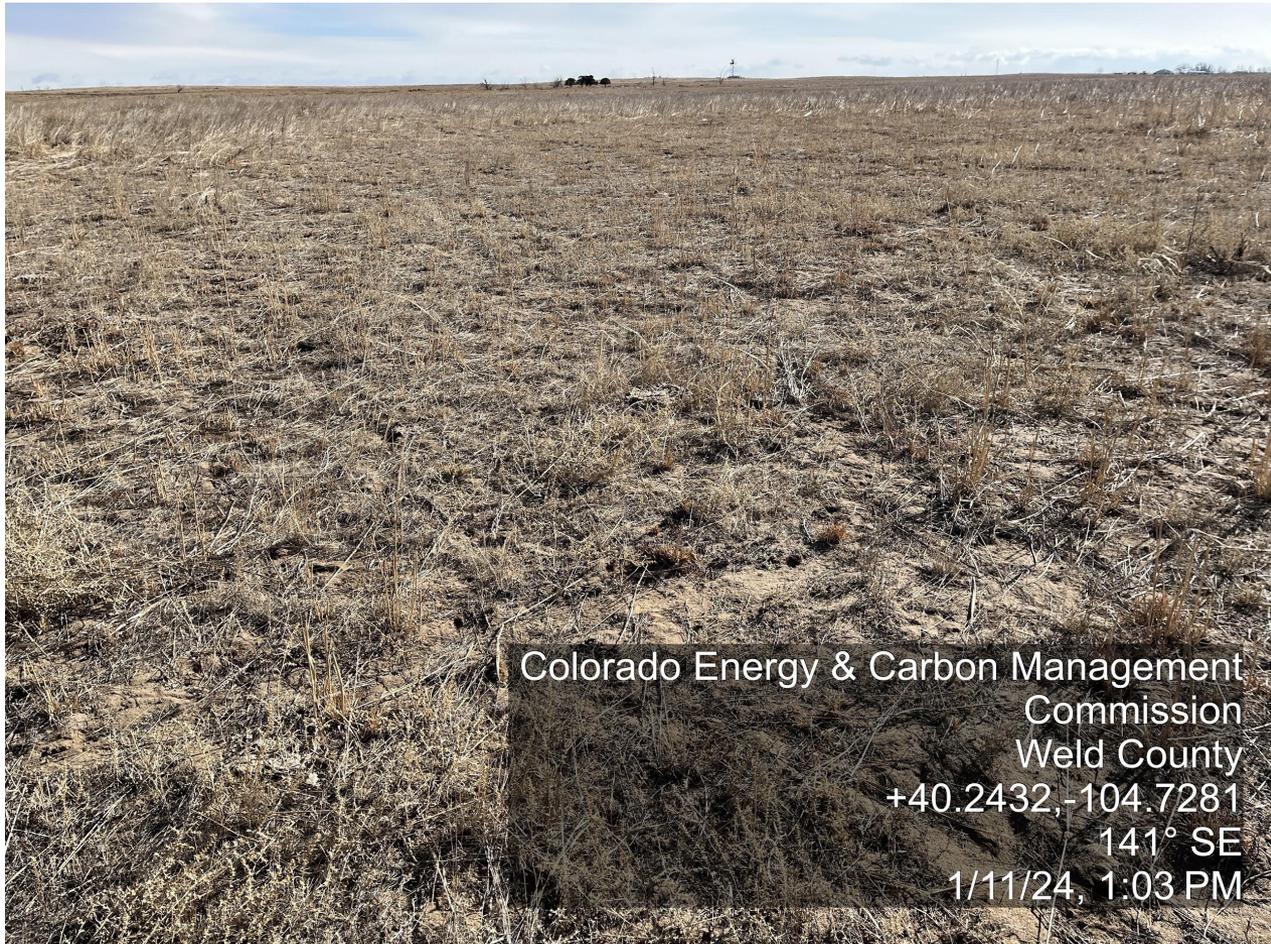
**Photo 7.** The reference photo was taken near the well location facing Southeast.
