Inspection Photos

Location Name: CAERUS PICEANCE LLC FEDERAL 30-15BB (PN30) Pad

Location #: 334060

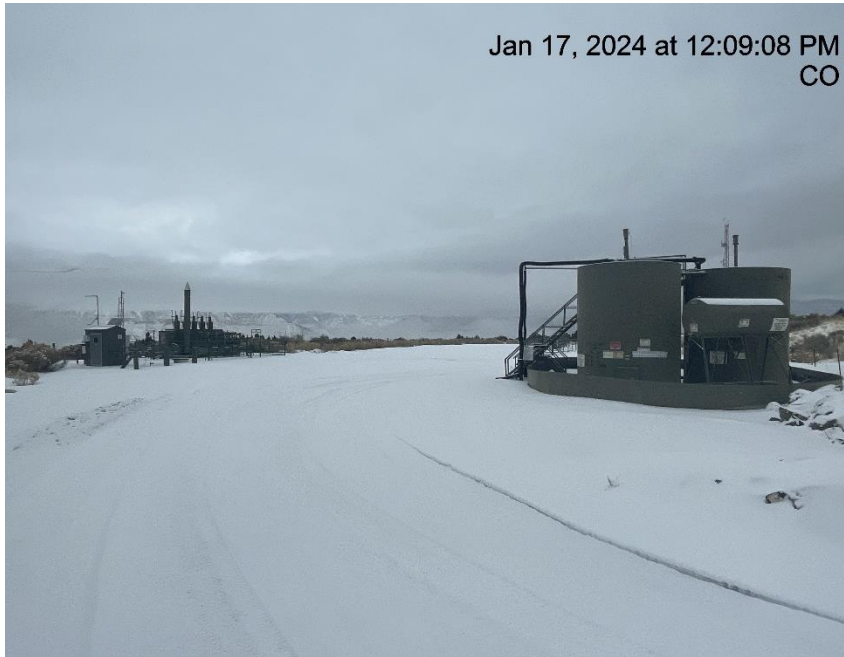
Photo # 2996 From entrance to location

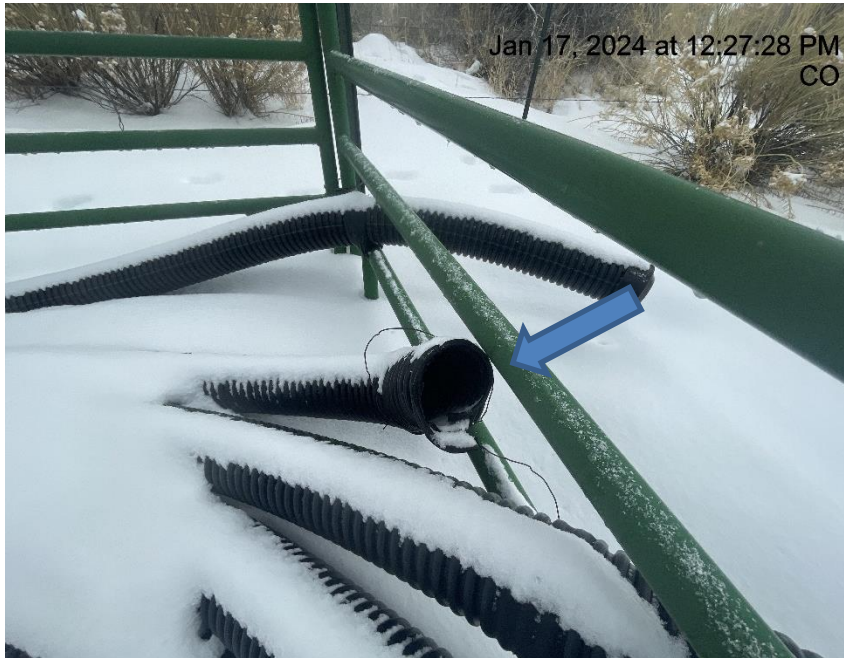
Photo # 3004 Flowline heating insulation open ended/wildlife hazard

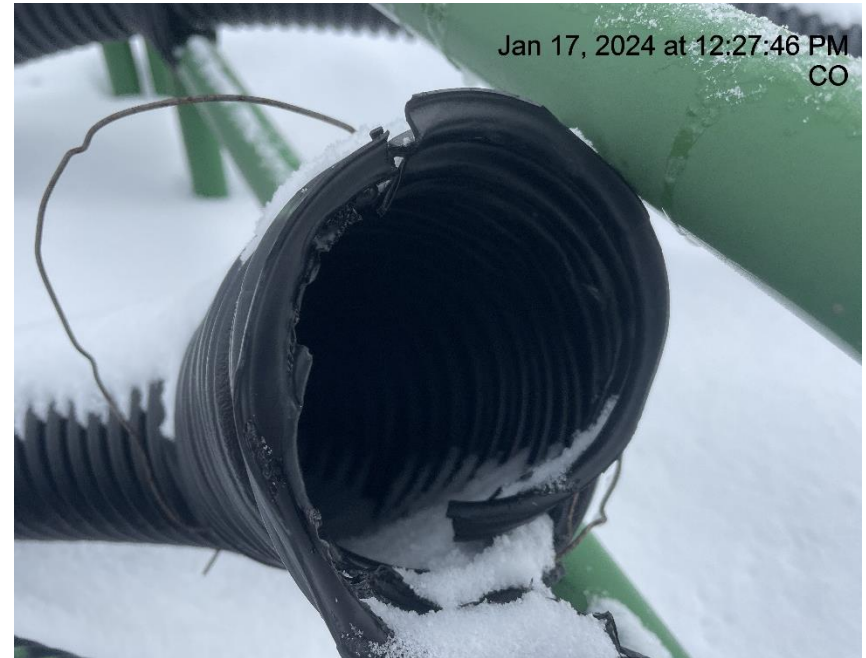
Photo # 3005 Flowline heating insulation open ended/wildlife hazard

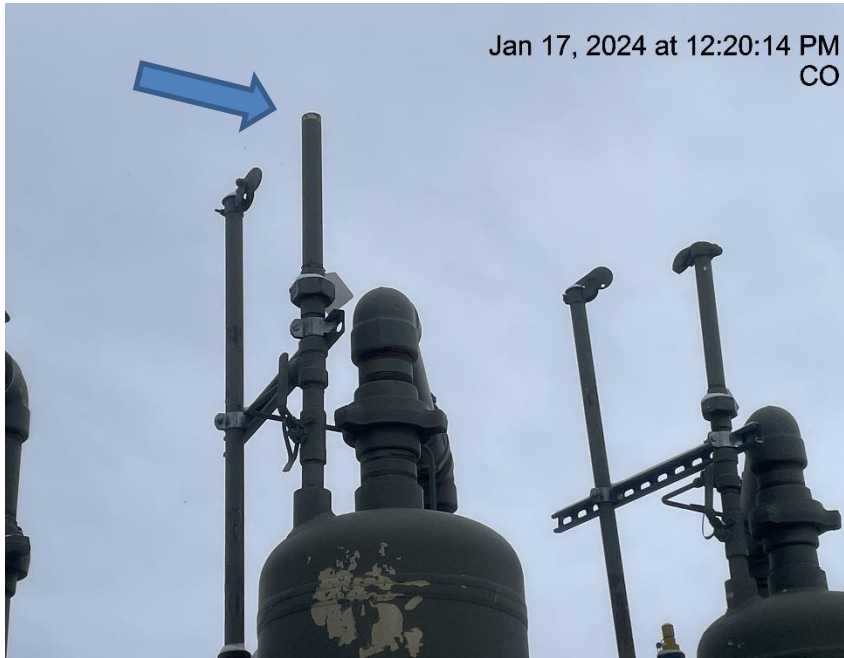
Photo # 3006 Rupture disc vent line lacks cap

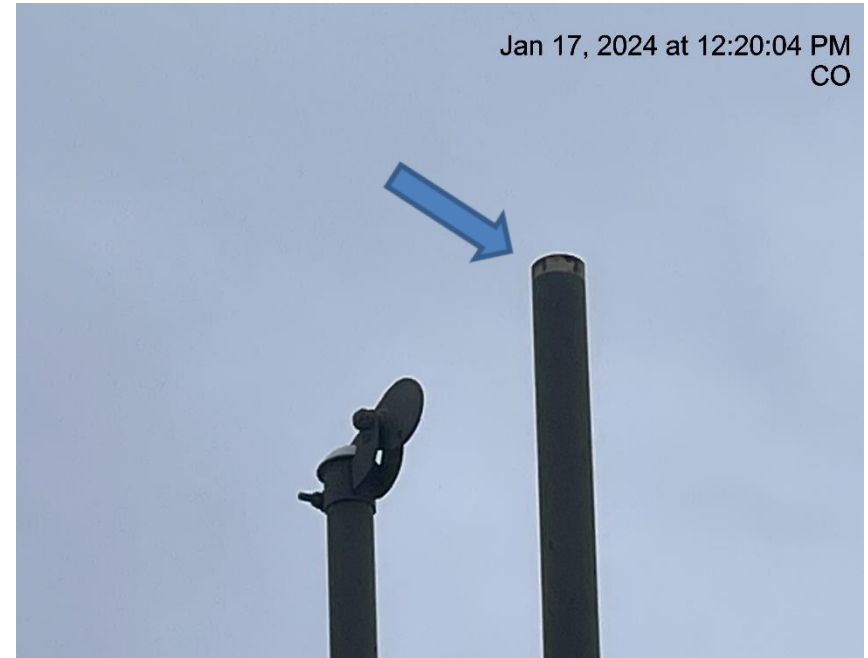
Photo # 3007 Rupture disc vent line lacks cap
