Inspection Photos
Location Name: Robertson 1-31
API Number: 125-06813

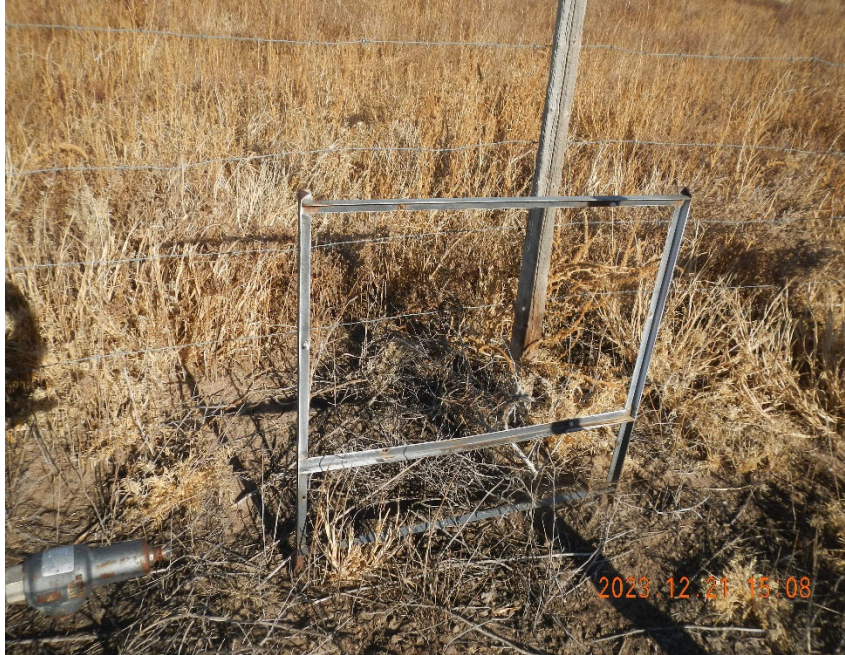
1. Possible sign frame at well location missing sign.

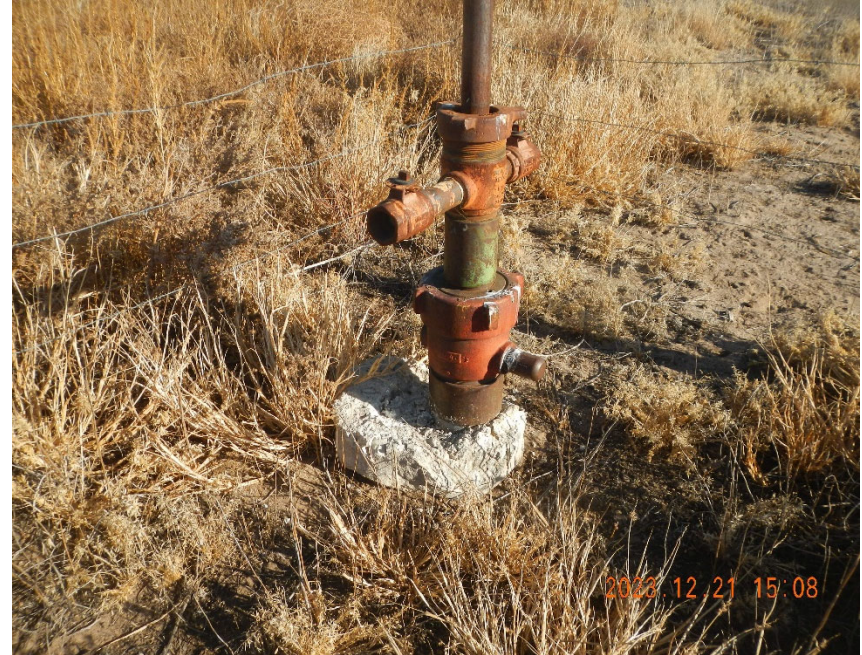
2. View of wellhead.

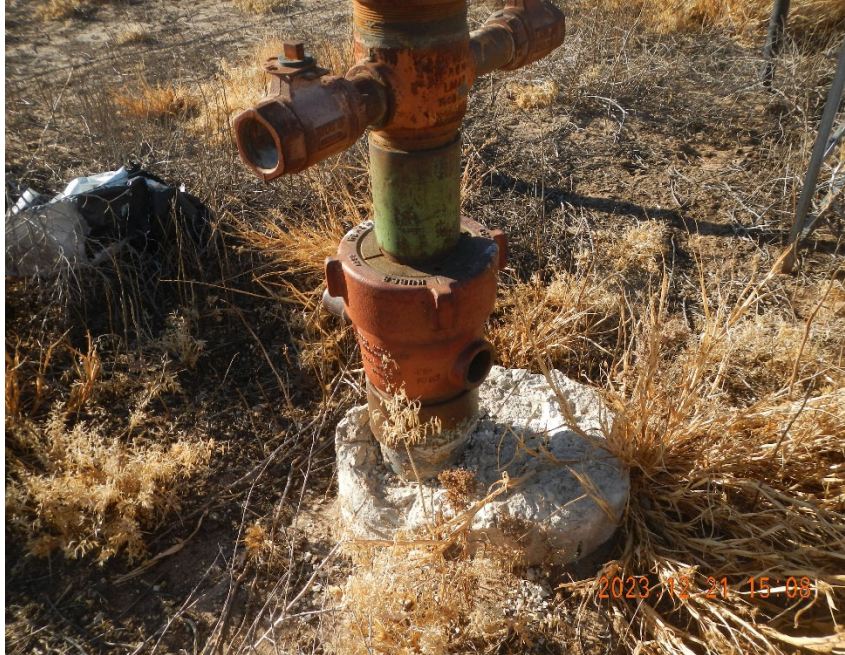
3. Surface casing missing plug.

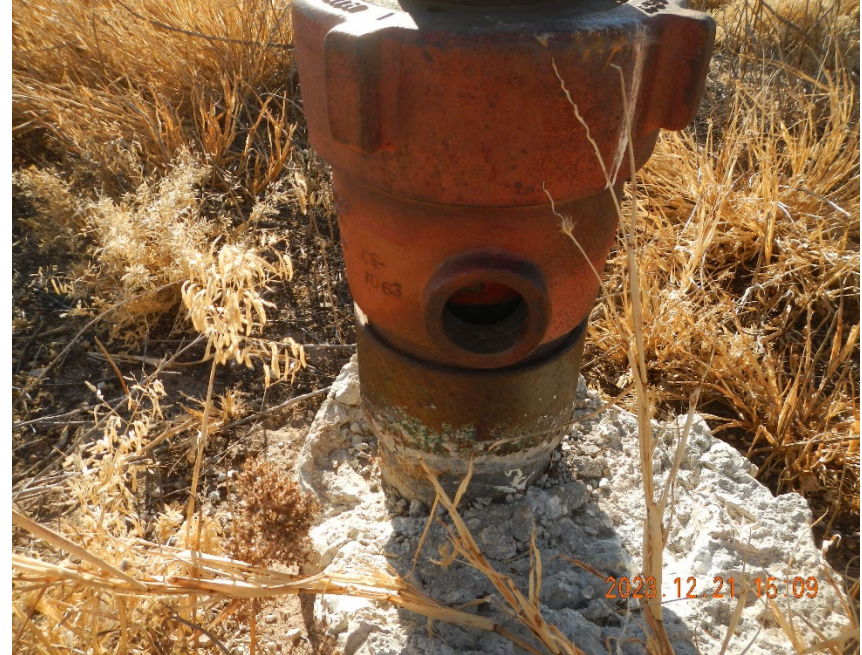
4. Closer view of surface casing open port.

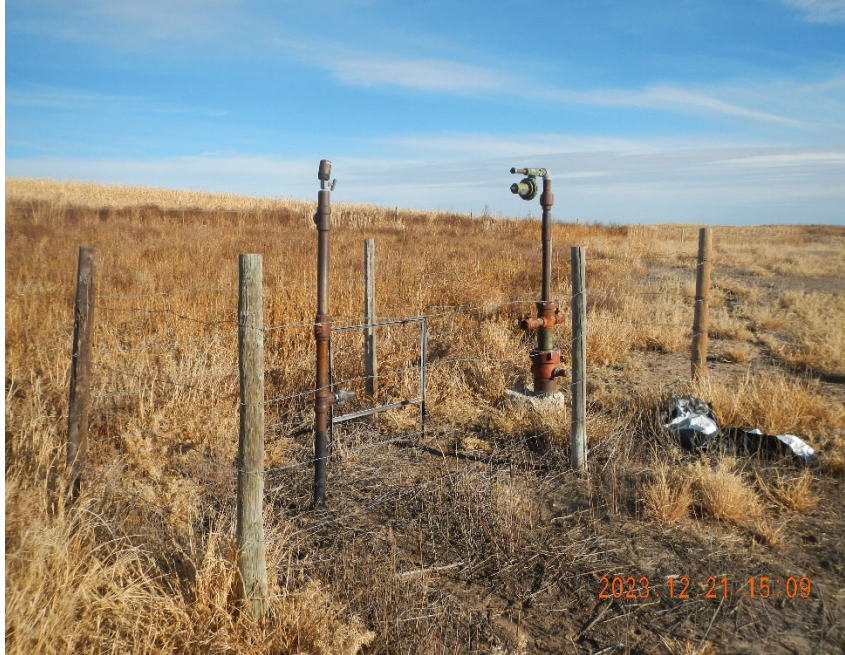
5. Flowline riser at wellhead area with open ended T connection.

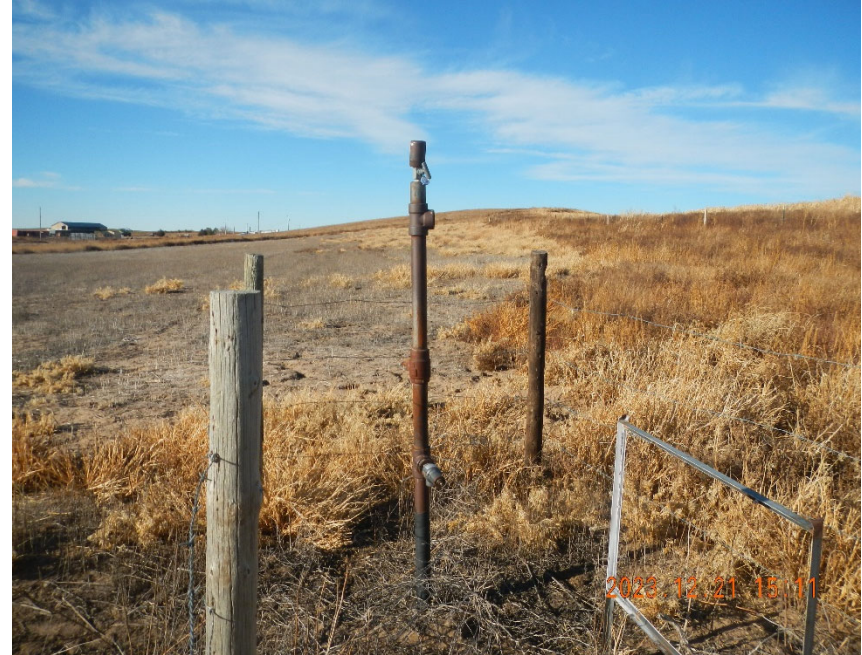
6. Additional view of Flowline riser open at T connection.

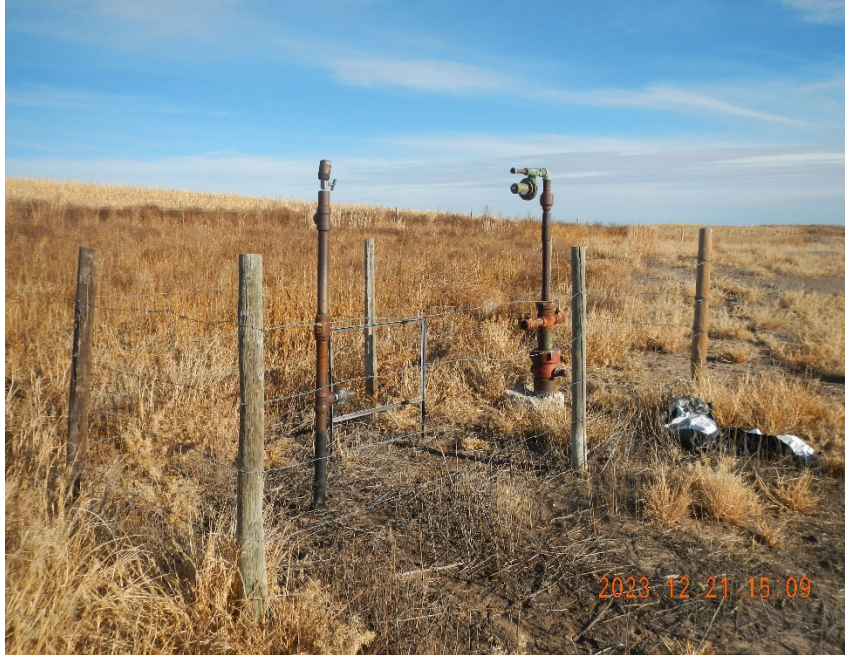
7. Well location overview.

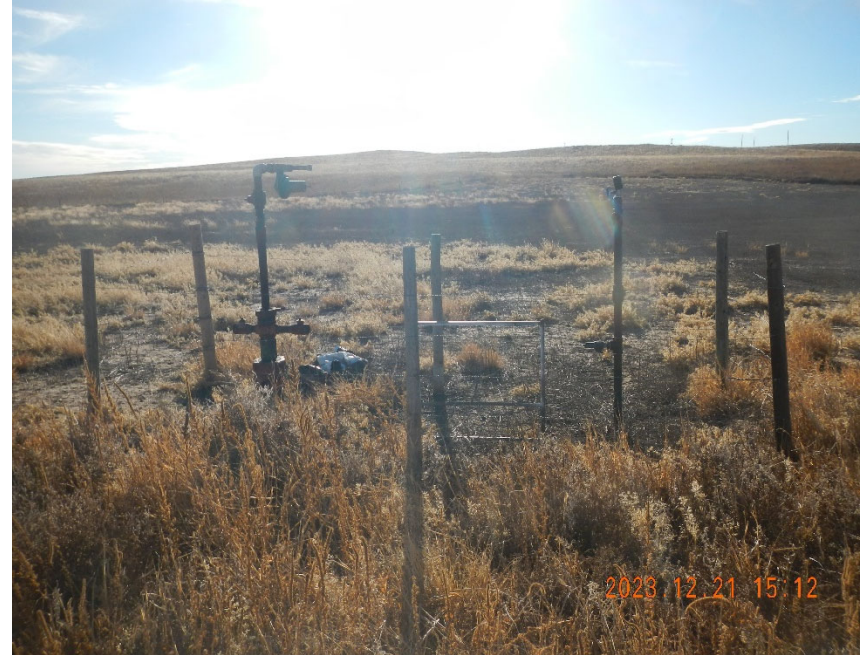
8. Well location overview.
