# Inspection Photos

**Operator:** TEP ROCKY MOUNTAIN LLC #96850

**Location ID:** 335070

**Inspection Doc:** 696205547

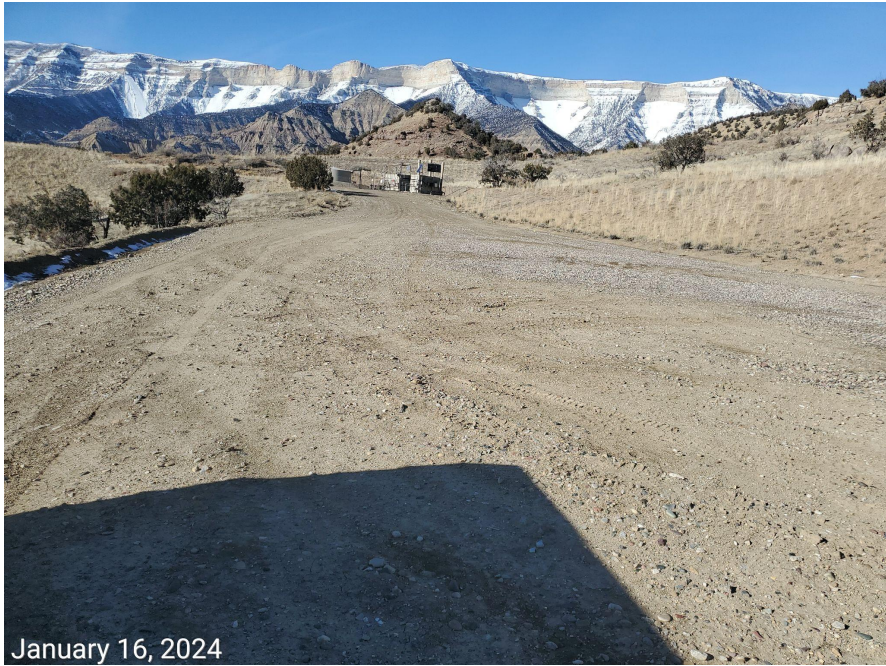
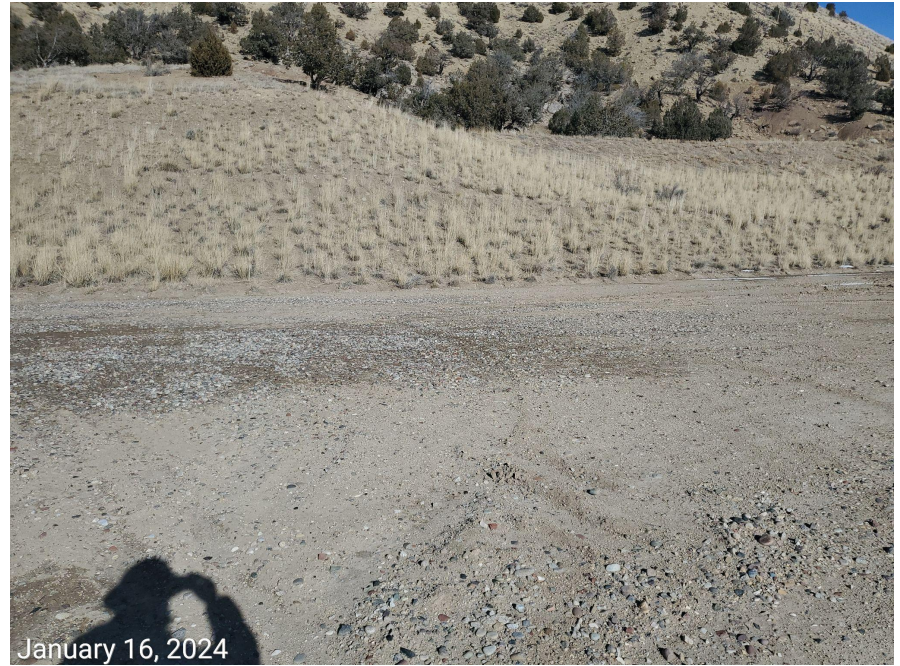
**Photo 1:** Photos taken from the west end of the working pad surface. Photos provide an overview of the Location from northwest, north, east to southeast.

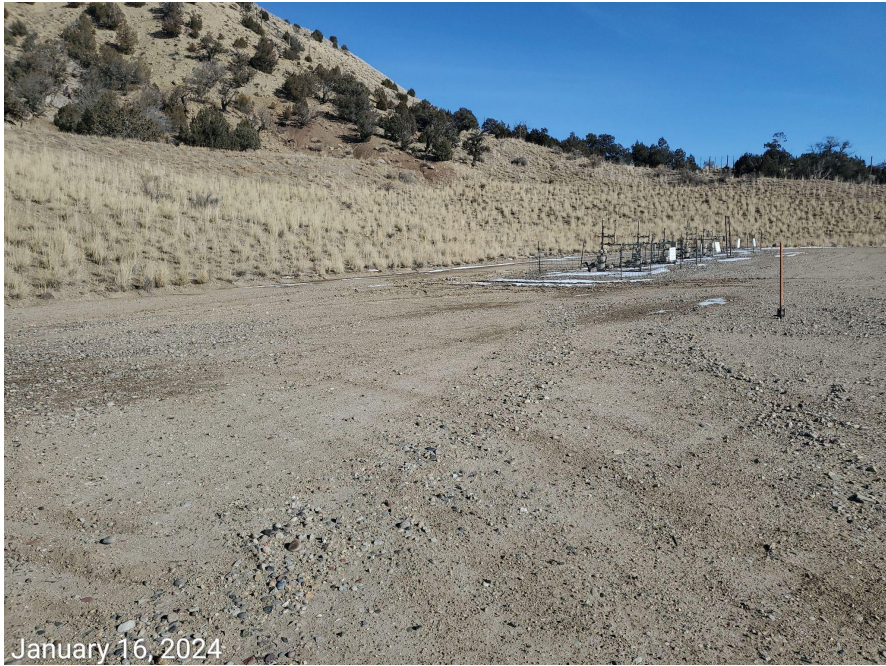
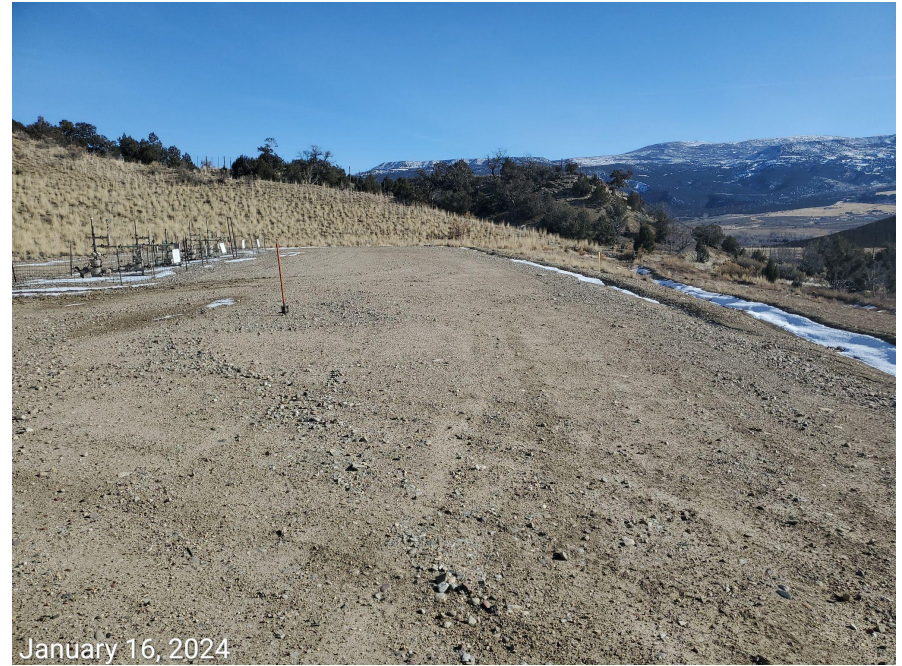
**Photo 2:** See comments under photo 1.

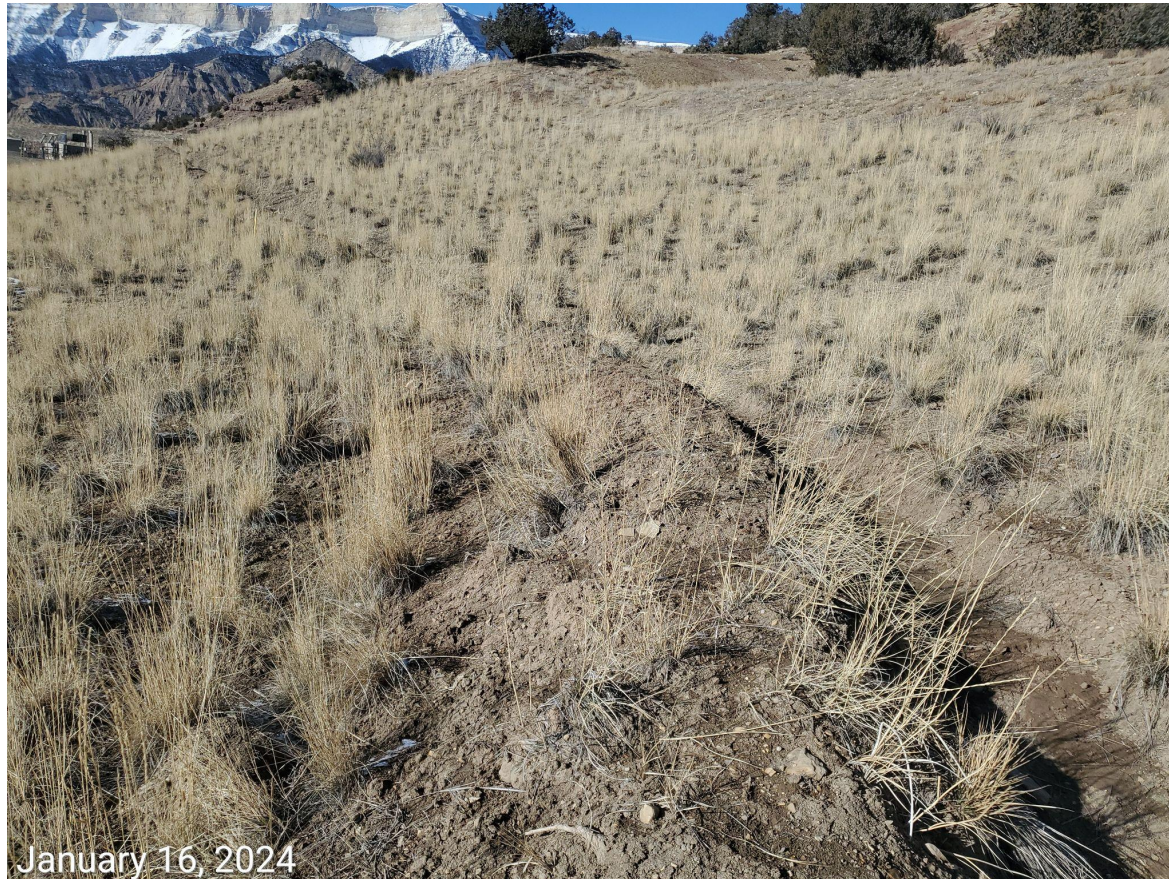
**Photo 3:** Photo taken from the interim areas on the east end of the Location, facing north. Photo shows vegetation within these areas are progressing towards ECMC 1003 Standards.

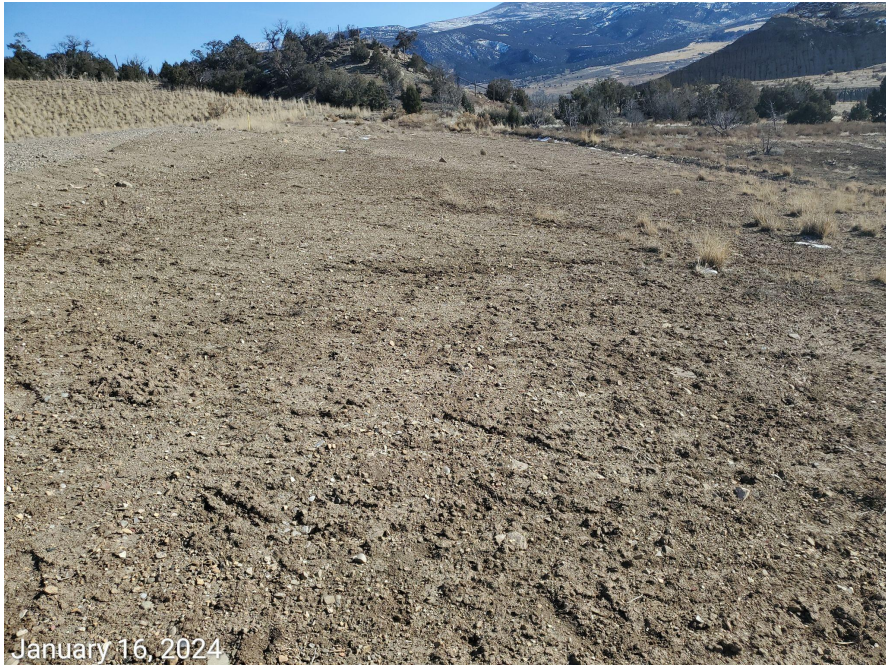
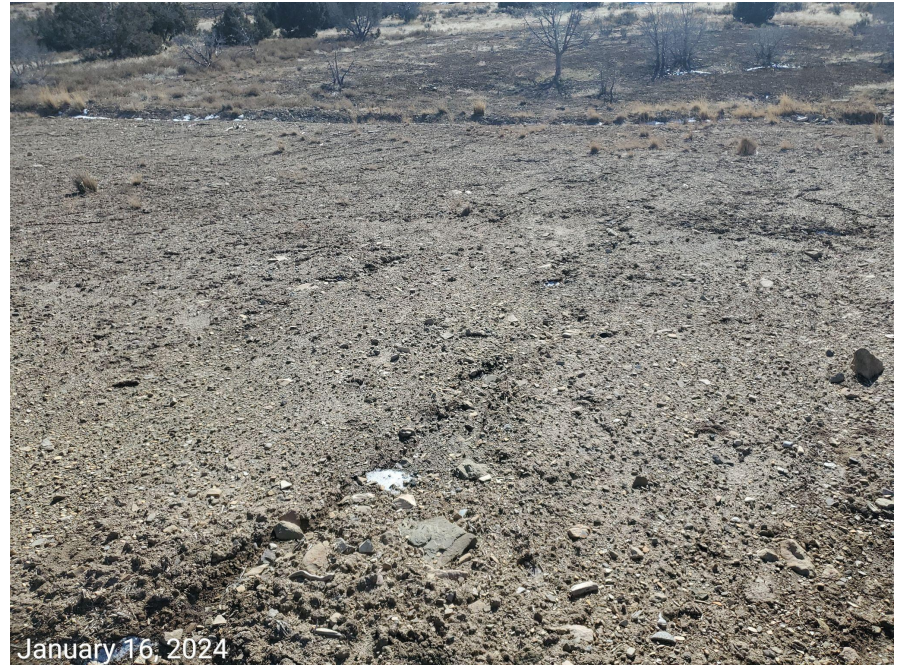
**Photo 4:** Photos taken from the western interim areas of the Location. Areas are predominantly bare and exposed soils. Little to no desirable vegetative establishment is occurring in these areas. BMPs to minimize erosion, degradation and sediment transport also missing or insufficient; rill erosion observed.

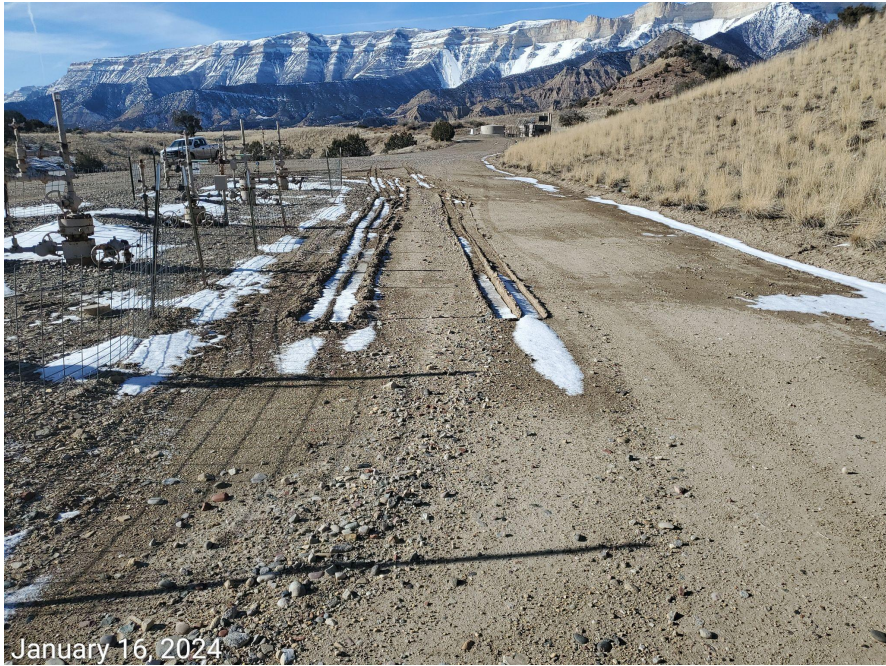
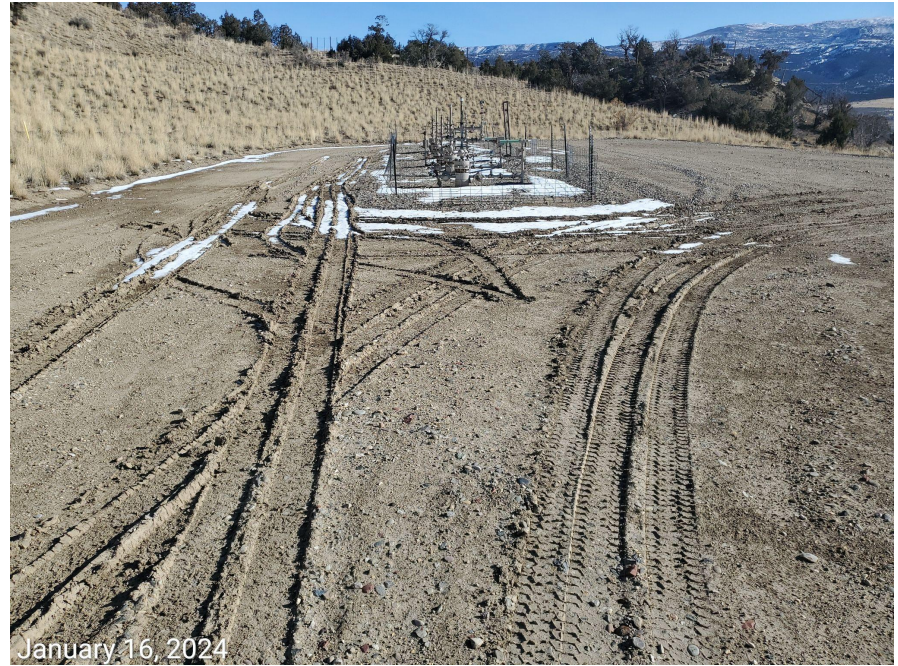
**Photo 5:** Photos taken from the working pad surface around the wells. Photos examples showing BMPs to stabilize the working pad surface are no longer in proper functioning condition; control measures to minimize tracking inadequate; control measures to minimize off-site sediment transport by equipment, such as vehicle tracking pad, also not observed.
