KT Resources LLC
 WRD Dow 20-11
 Loc ID: 316271

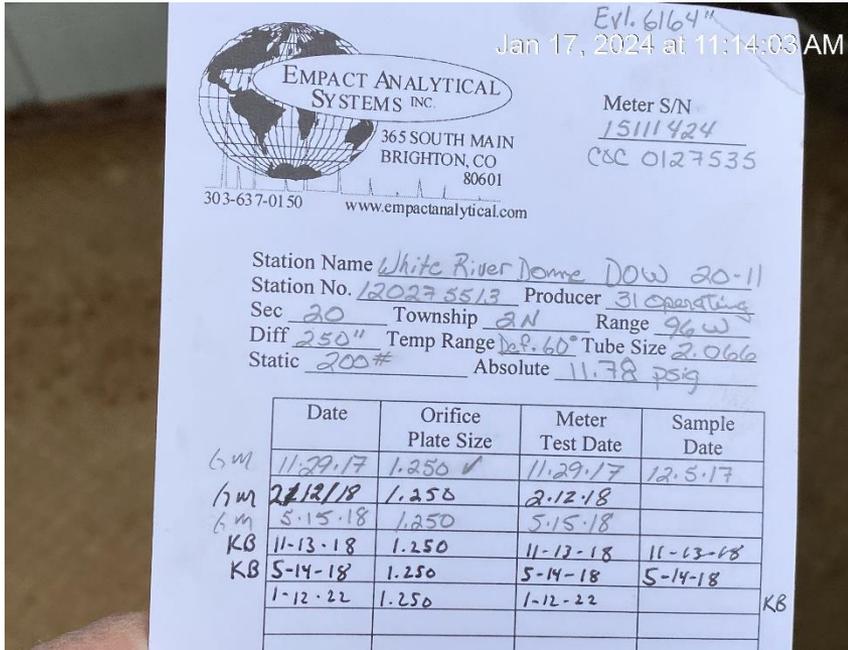
Calibration out of compliance

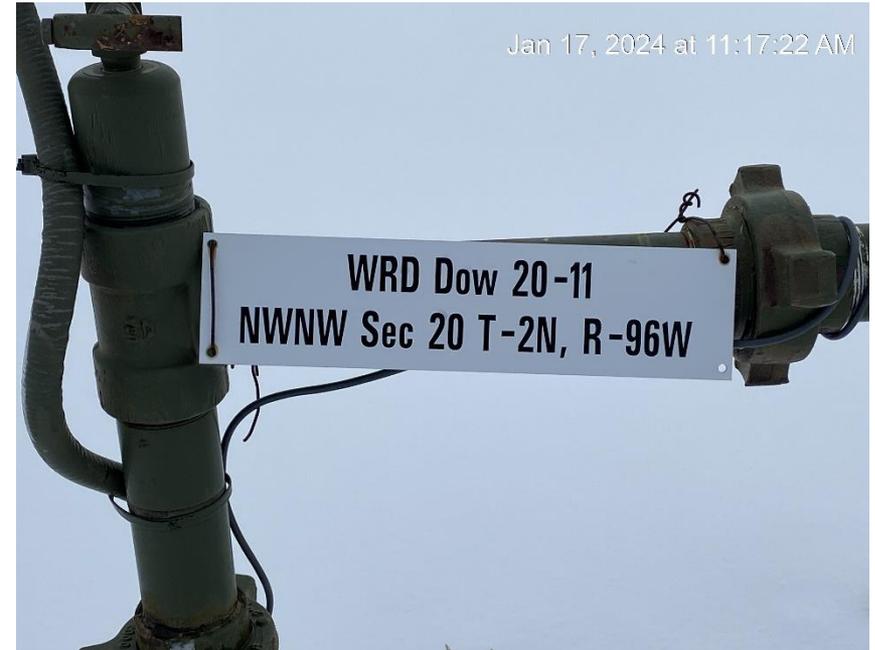
As signs are replaced additional information will be required

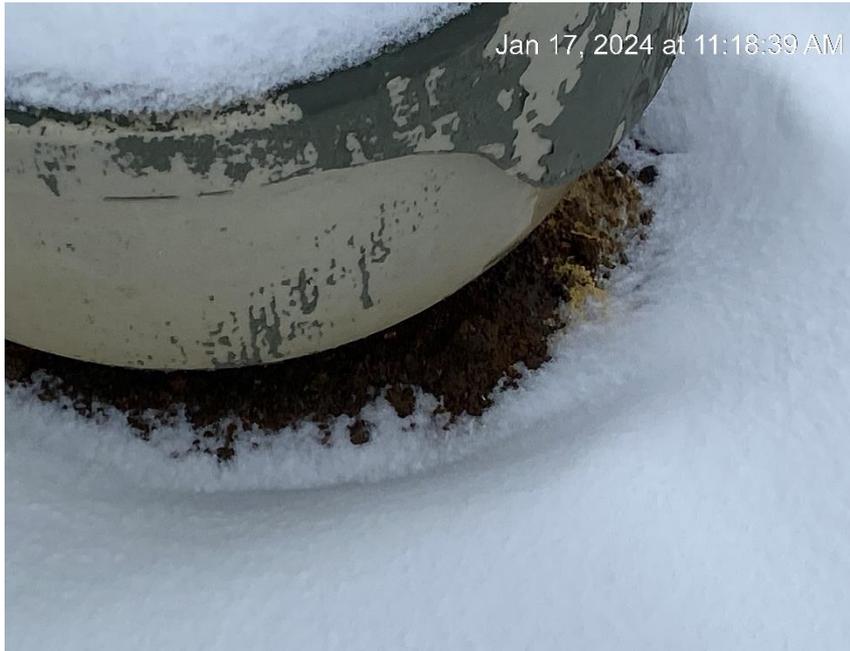
Staining under loadline pot

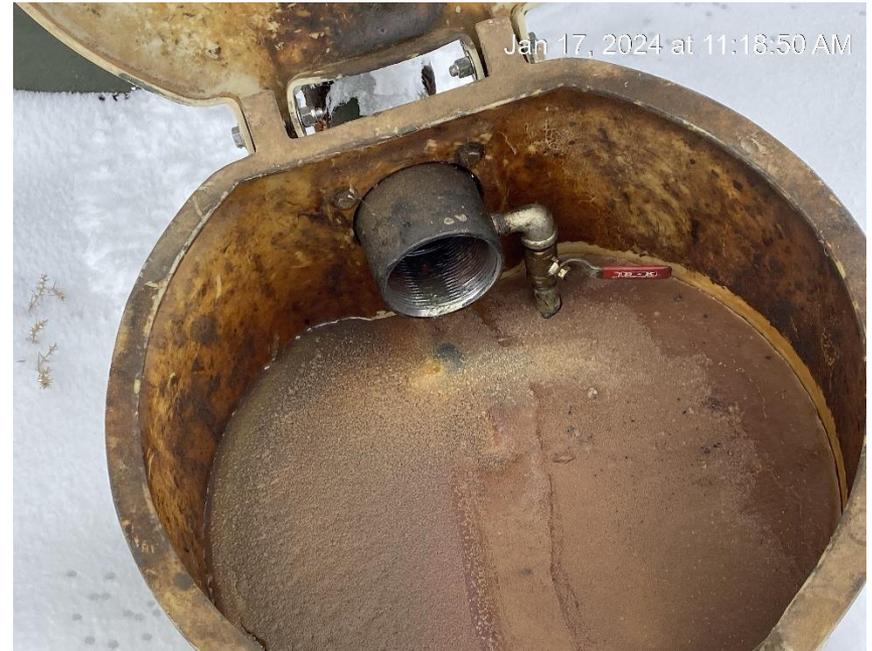
Open ended loadline

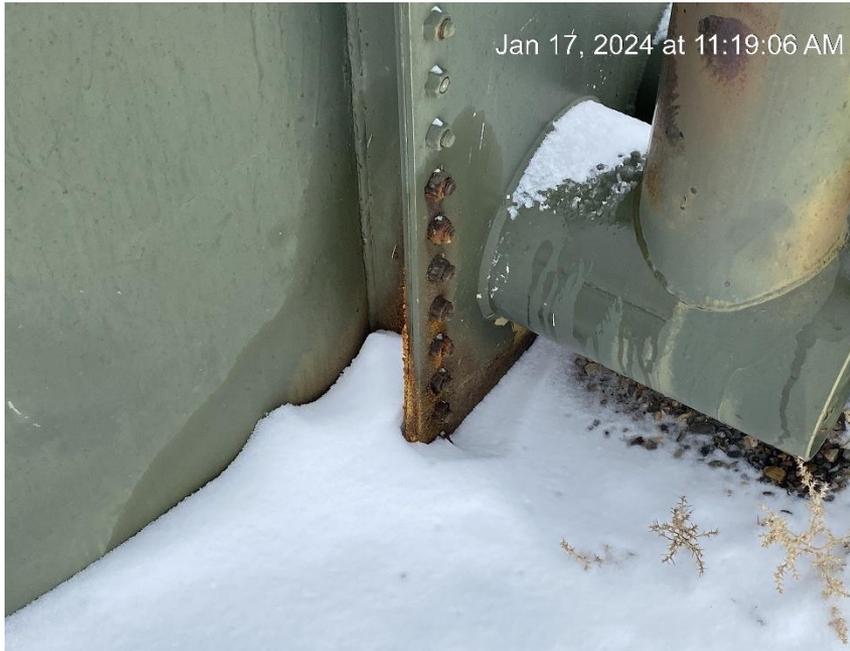
Leaking oil tank

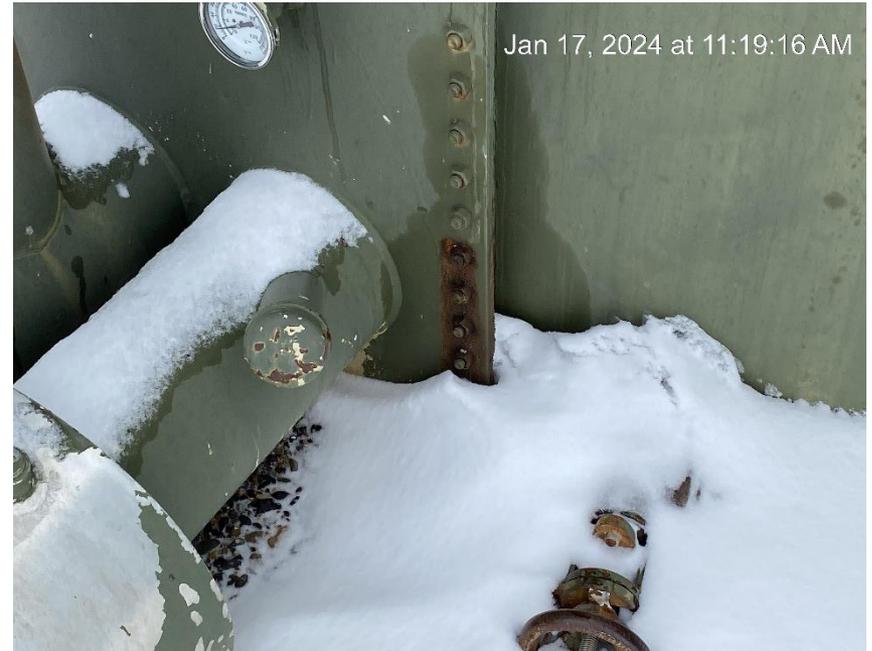
Leaking tank
