Inspection Photos
Location: Cindy H 23-27
Facility ID: 307489

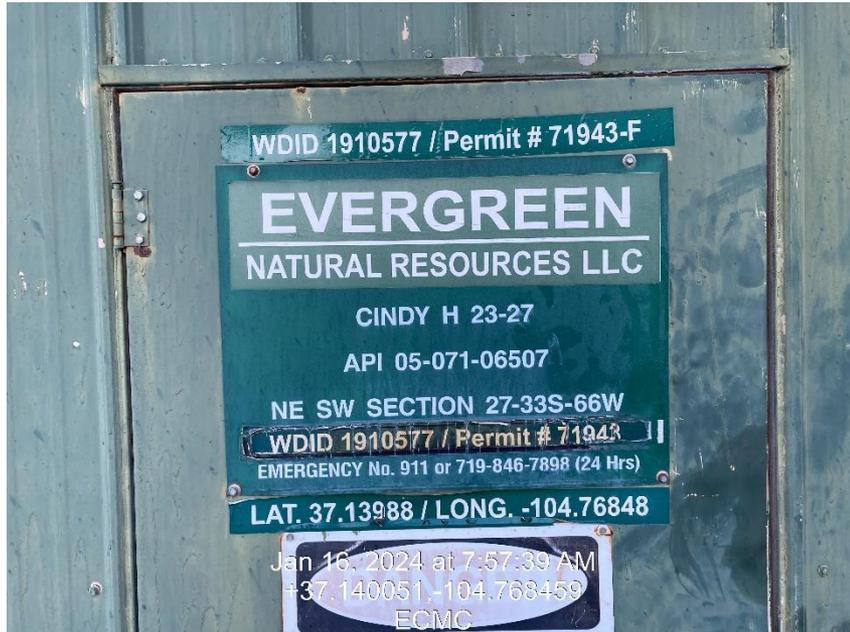
Photo 1 –Well Site Placard on Meter House

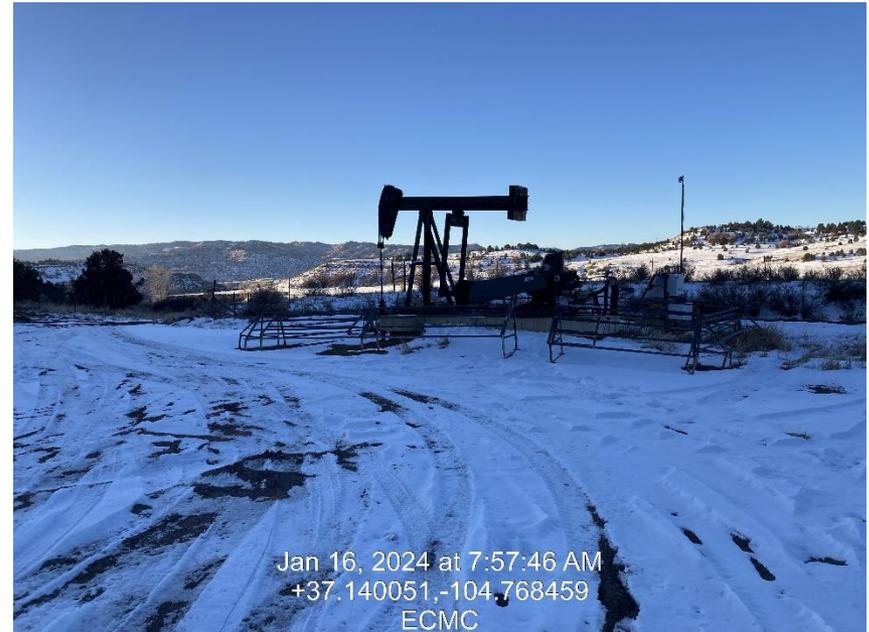
Photo 2 – Wellhead and equipment looking south west

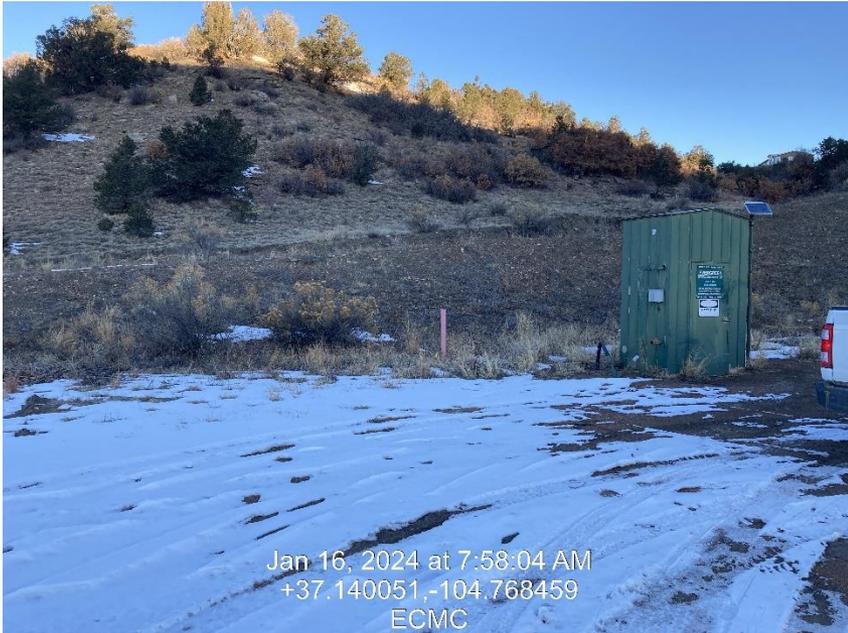
Photo 3 – Meter House looking north east

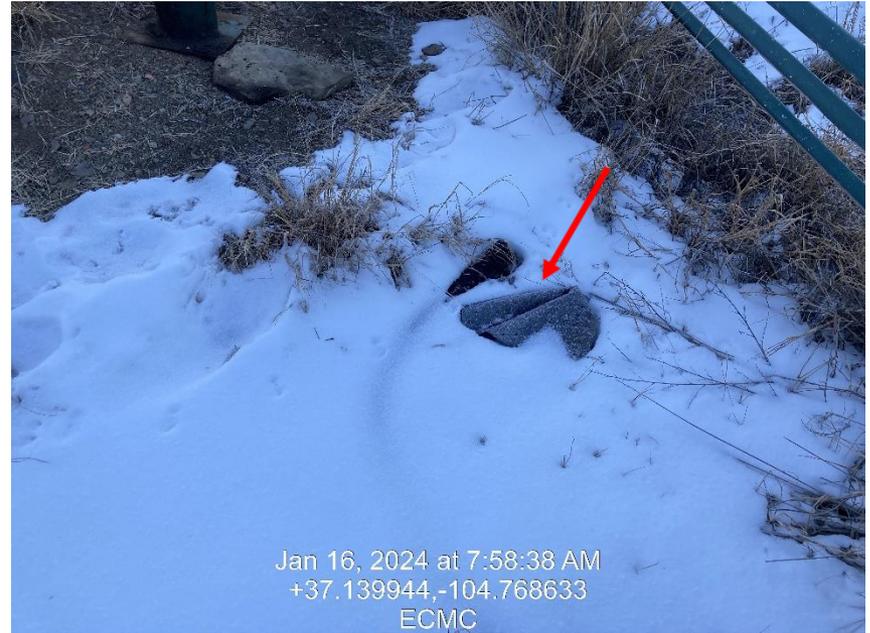
Photo 4 – Exhaust hose and Oil Diaper on location

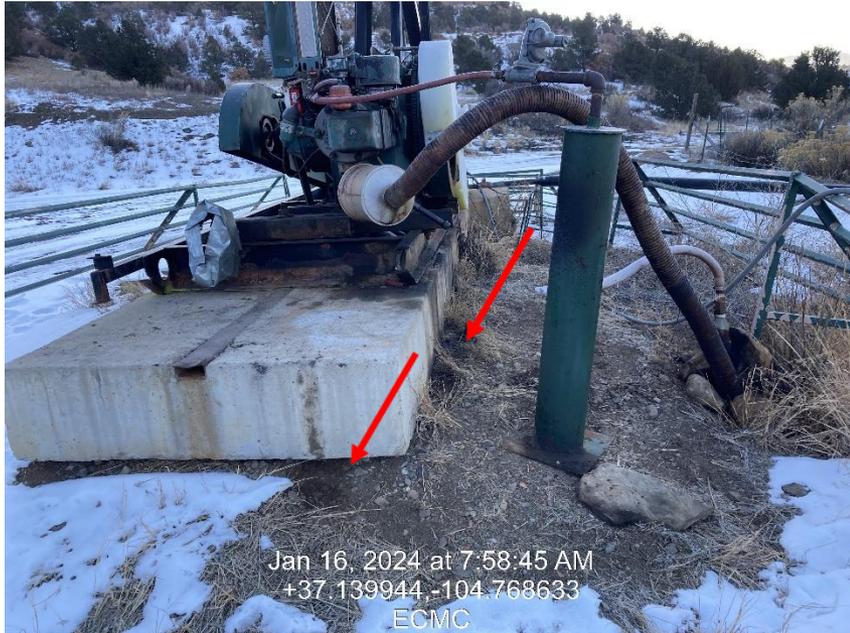
Photo 5 – Equipment

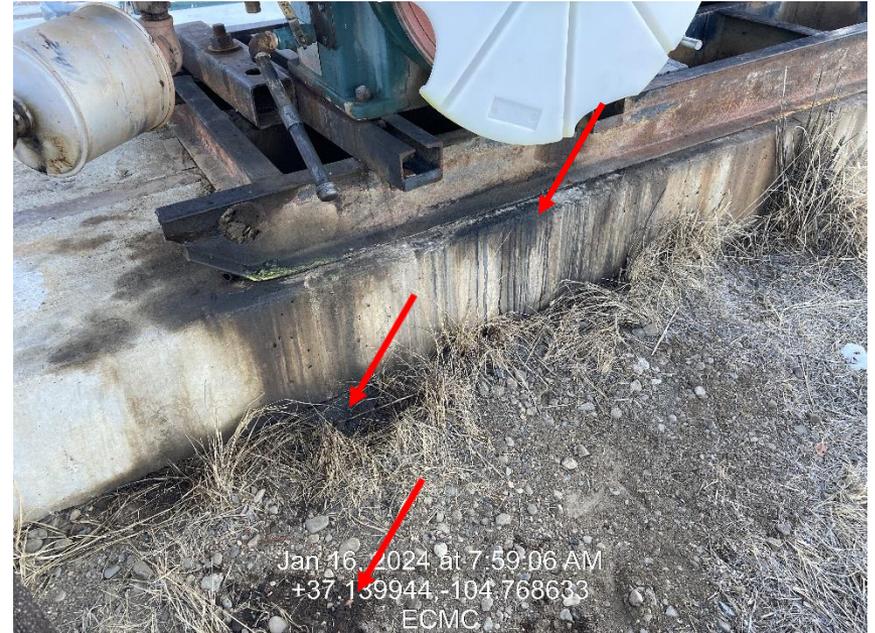
Photo 6 – Oil Leaking from Pumping Unit. Cement block/base and native ground are impacted.

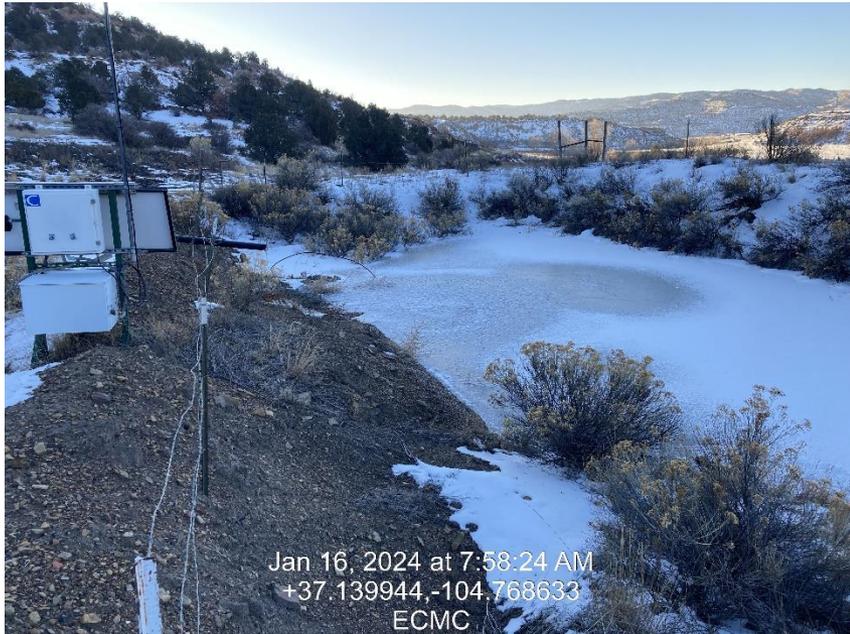
Photo 7 – Pit looking south

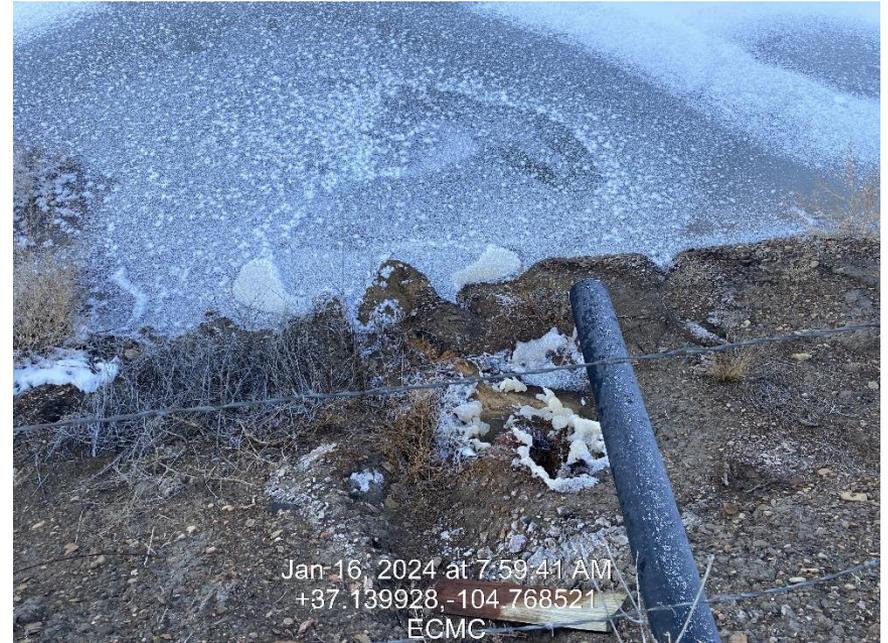
Photo 8 – Flowline to pit

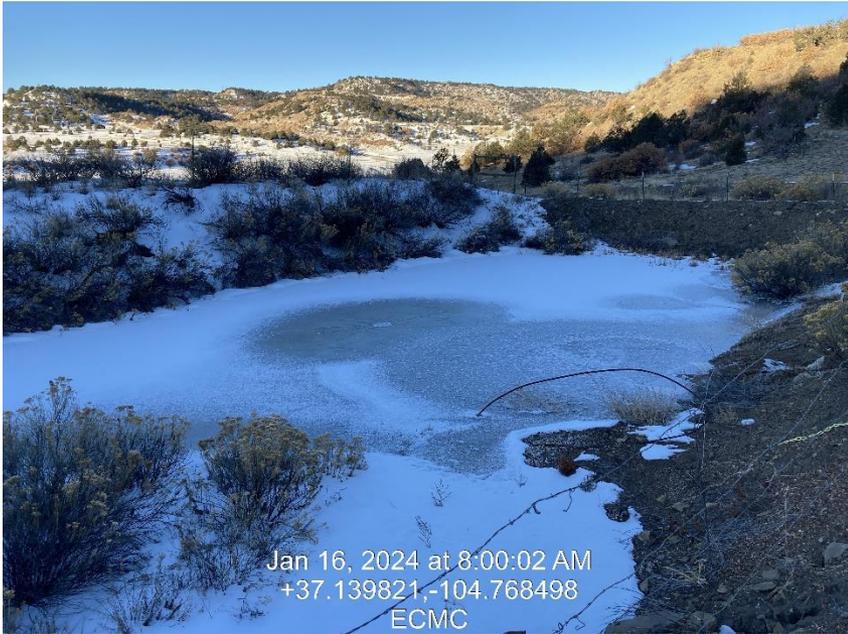
Photo 9 – Pit looking North

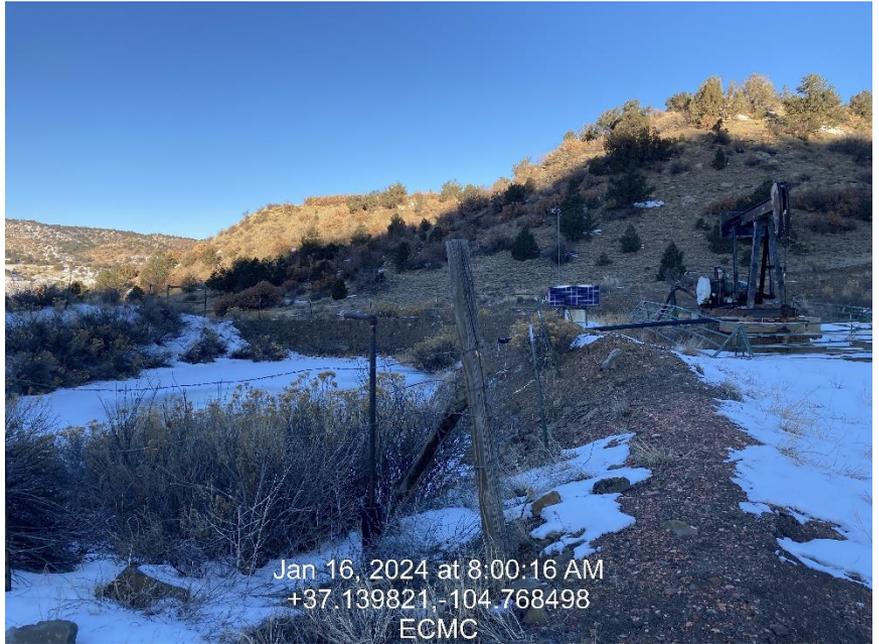
Photo 10 – Pit Fencing and equipment

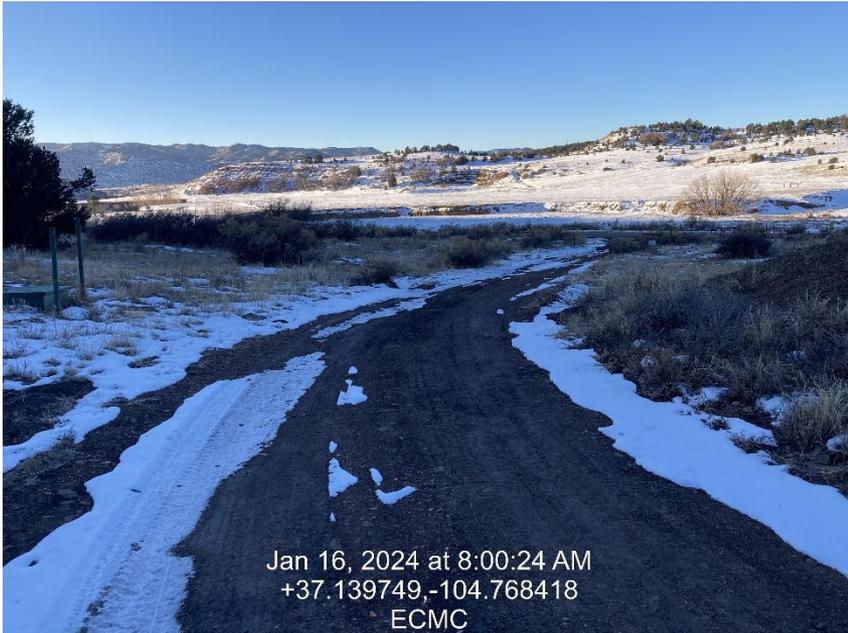
Photo 11 – Access road looking west
