# Inspection Photos

Loc: 484360

Operator: DESERT EAGLE OPERATING LLC

Inspection Date: 1/18/2024

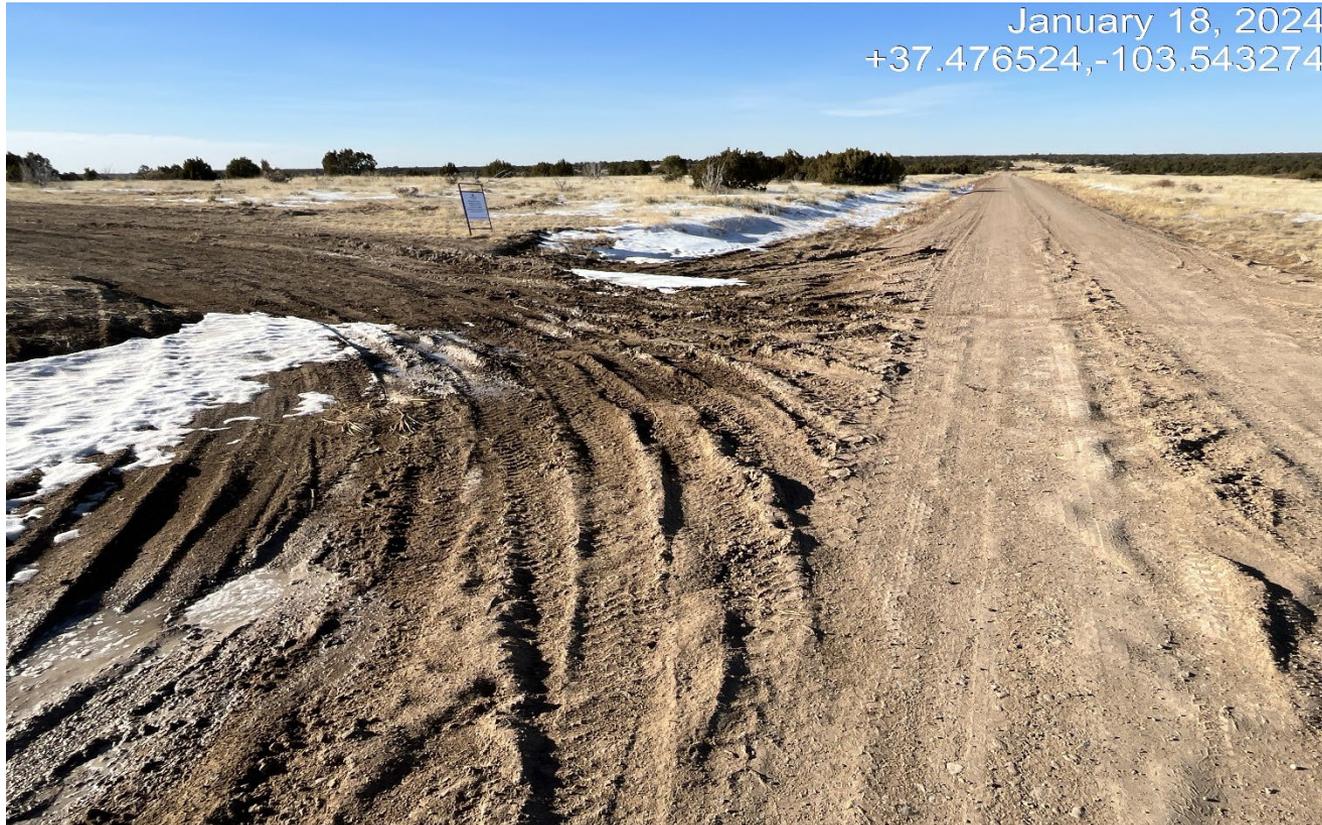
**Photo 1.** Facing northwest toward the access road and County Road 177. There is vehicle rutting and tracking of sediment onto the County Road. BMP's must installed to prevent sediment tracking and road degradation.

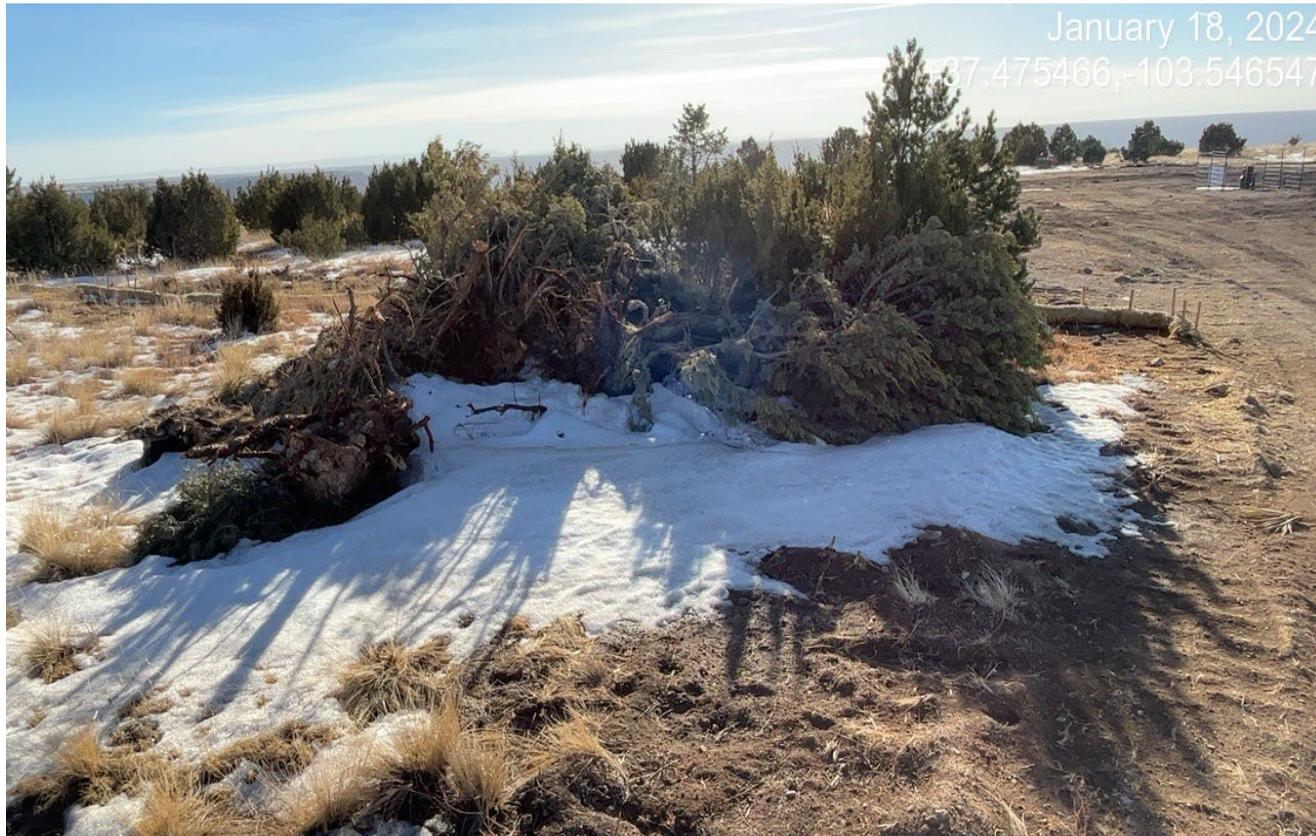
**Photo 2.** Facing west by the location. There is still tree debris that has not been removed..

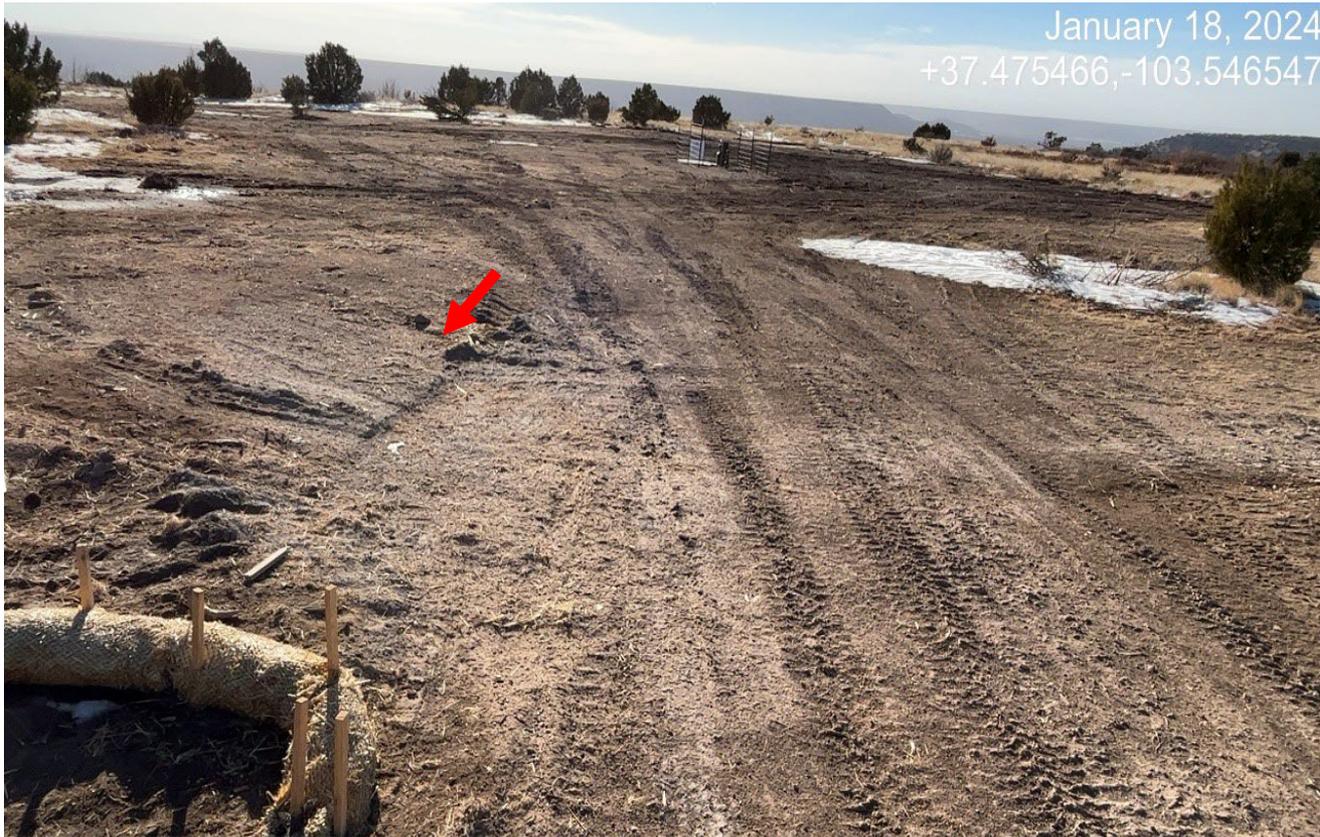
**Photo 3.** Facing west toward the location. The bags of cement have been removed.

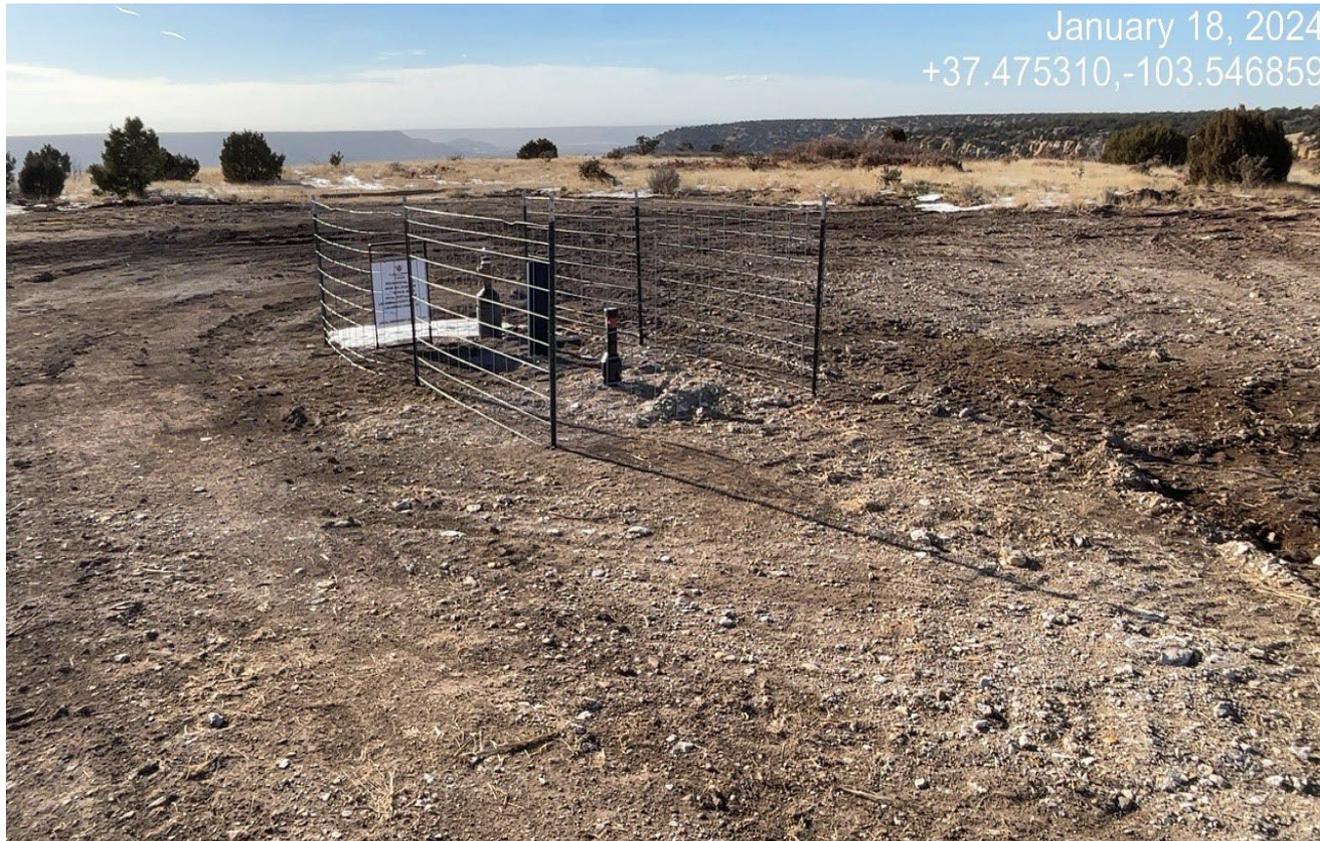
**Photo 4.** Facing toward the well. The excavated area near the well has been backfilled. Most of the rock debris has been removed. It is unknown what topsoil material was replaced since it was not properly salvaged.

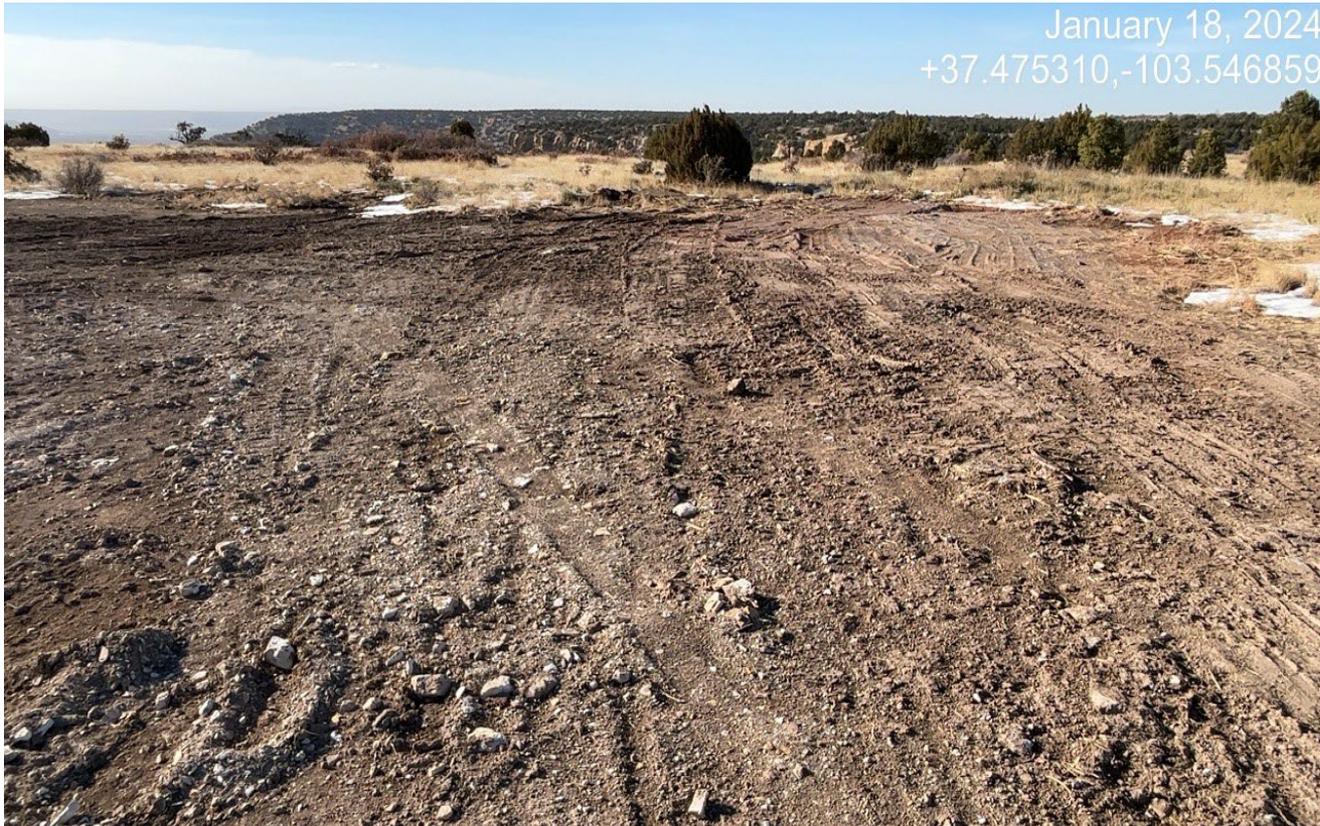
**Photo 5.** Facing northwest at the location where cuttings were improperly stored. It appears most of the drill cuttings have been removed. There are still no stormwater controls present at the northwest downslope side of the location.

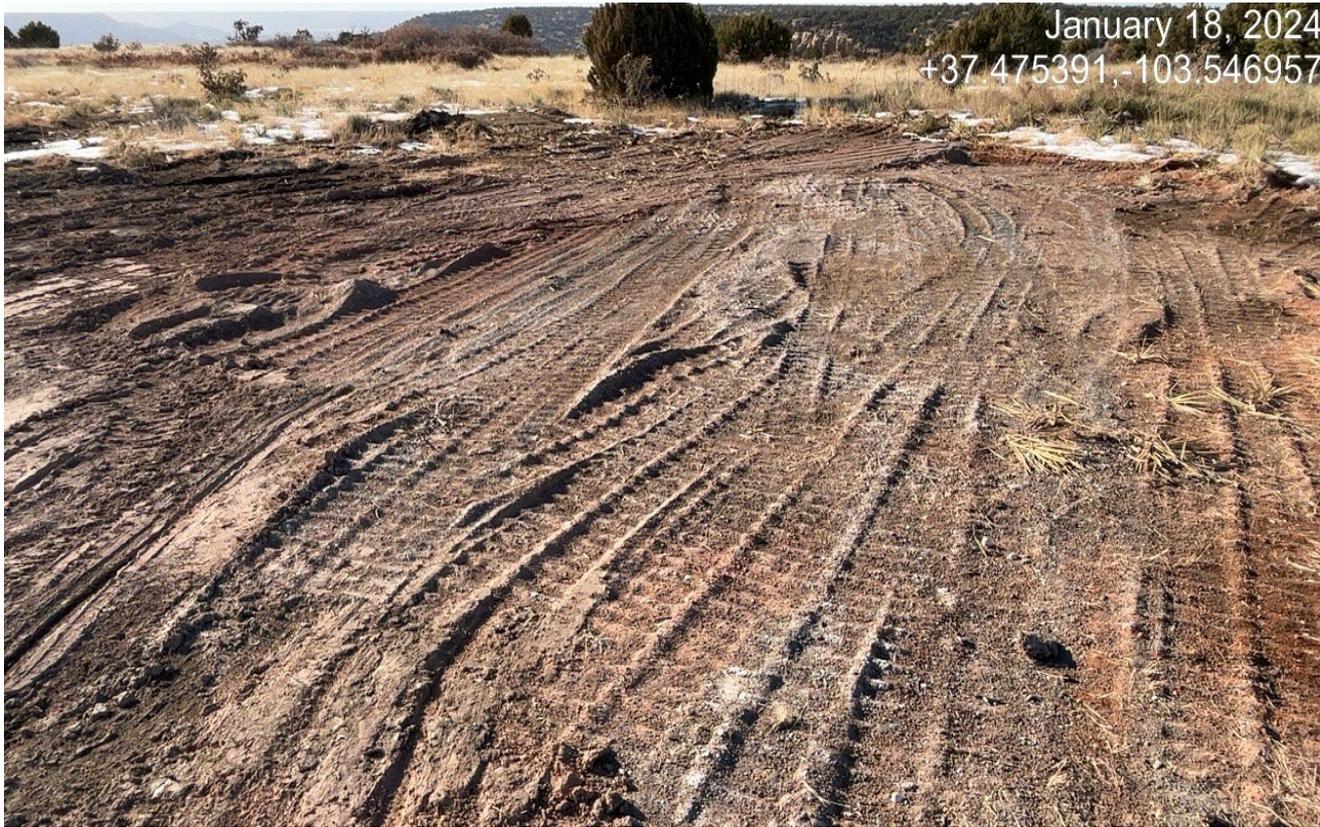
**Photo 6.** Facing toward the northwest side of the location. There is still a reddish color in this area that remains which is indicative of the drill cuttings.

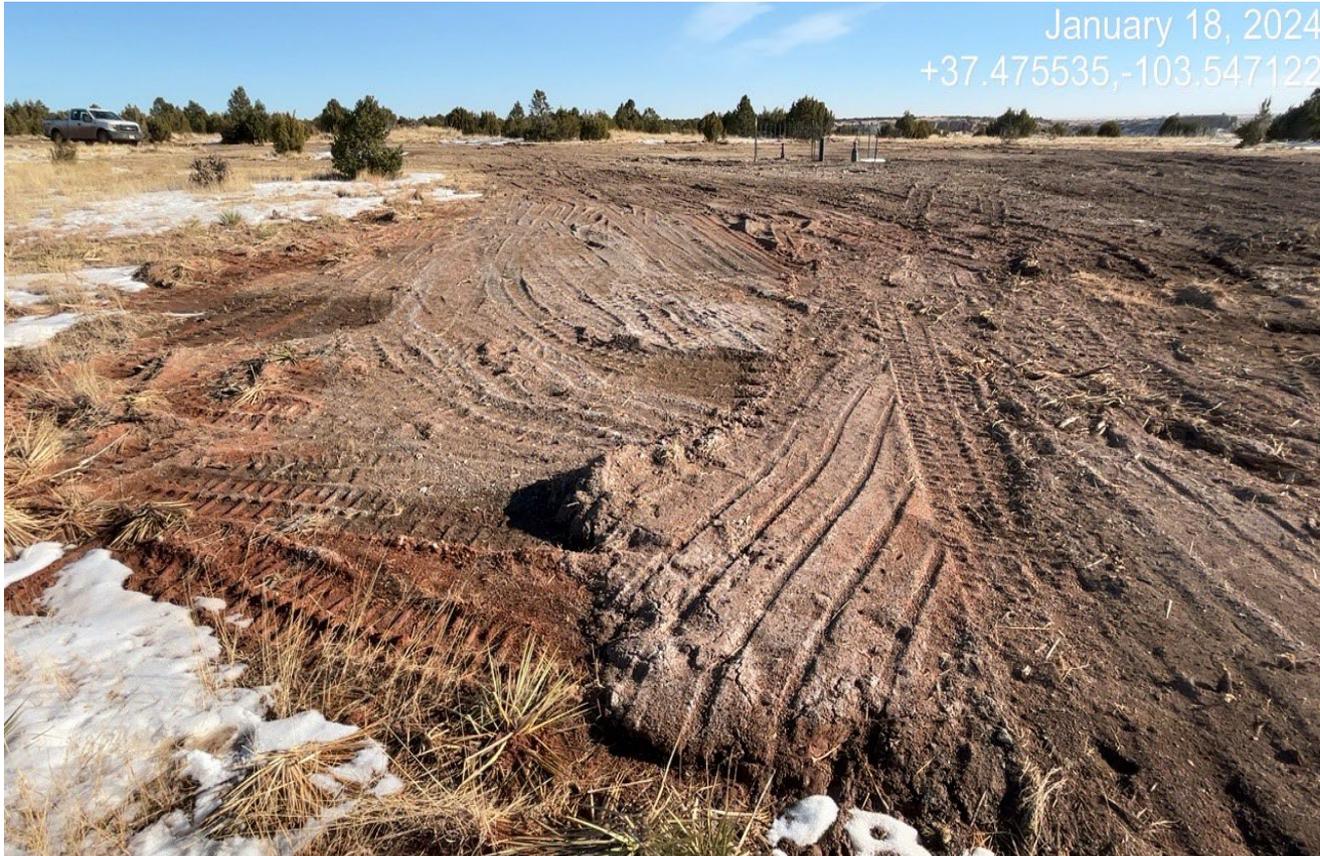
**Photo 7.** Facing southeast at the location. There is still a reddish color in this area that remains which is indicative of the drill cuttings.

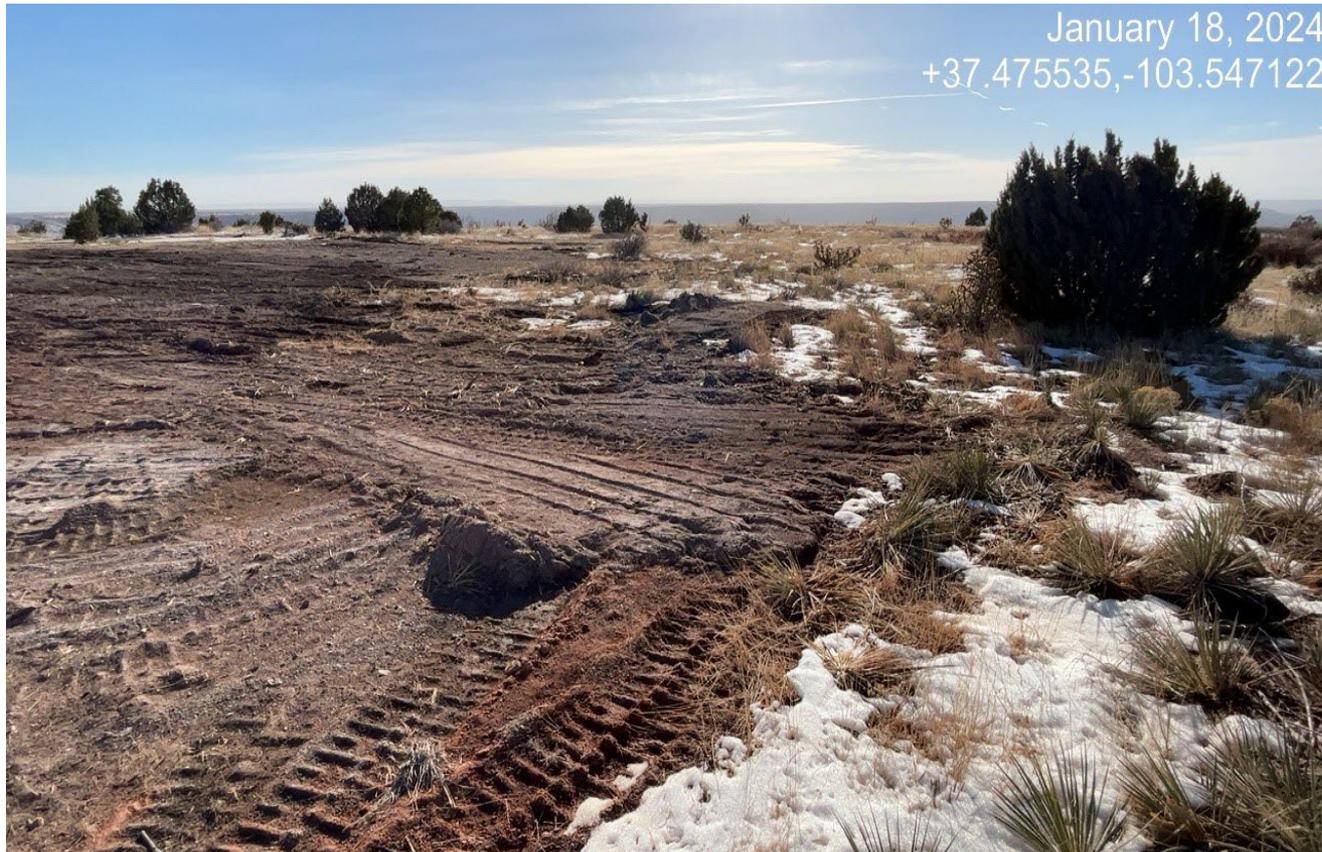
**Photo 8.** Facing southwest at the northwest side of the location. There are still no stormwater controls present at the northwest downslope side of the location. Previous corrective action has not been completed.

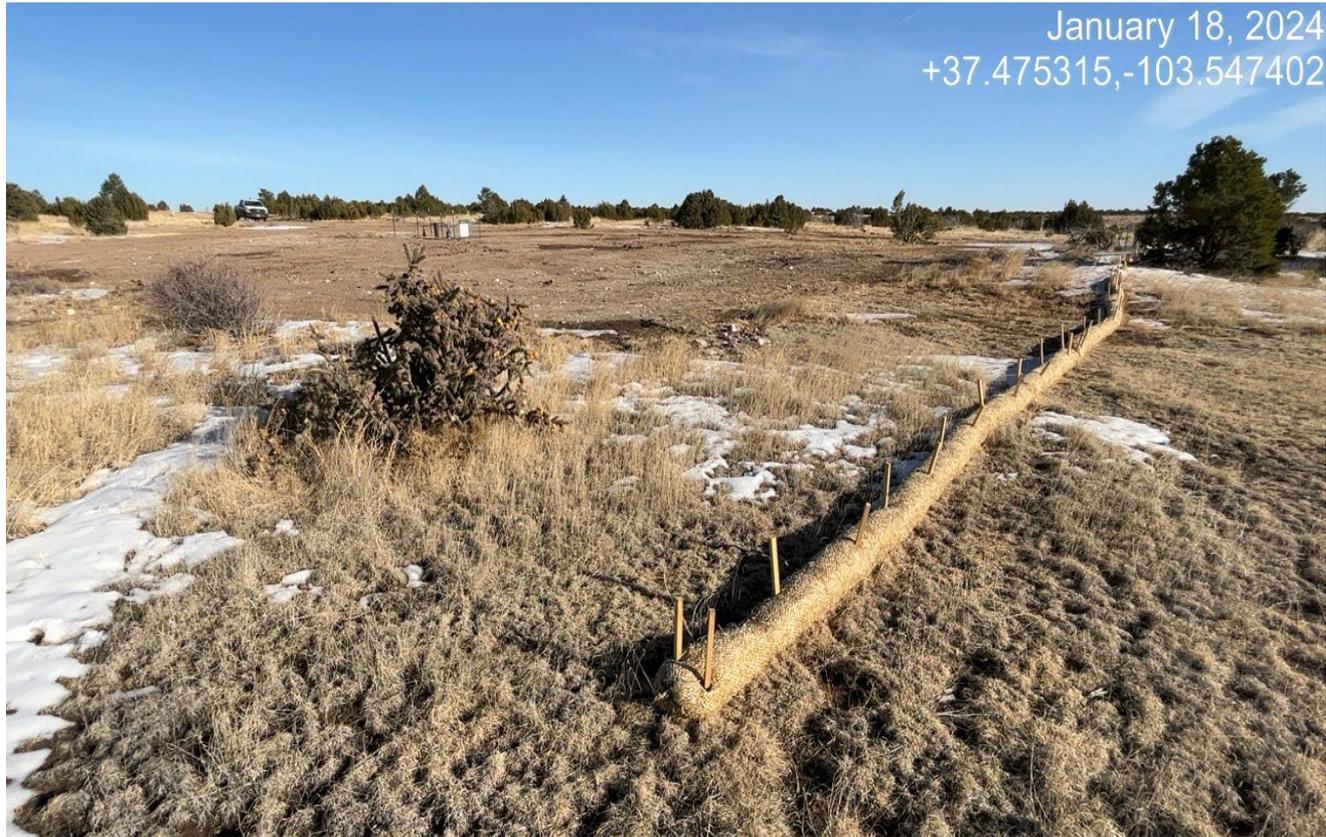
**Photo 9.** Facing southeast at the west side of the location. The perimeter wattles end at this point and do not protect the northwest downhill perimeter where loose soil are present.

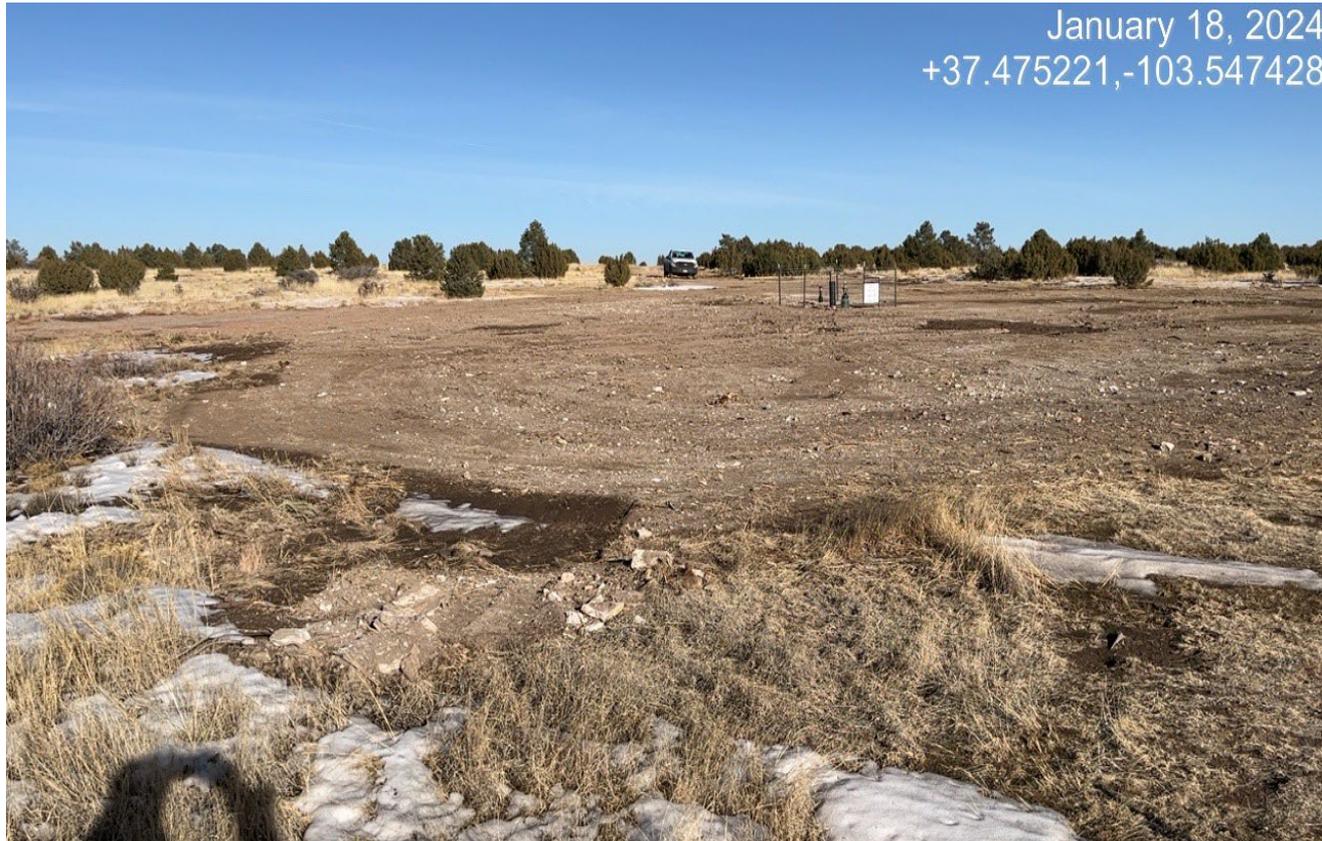
**Photo 10.** Facing east toward the disturbed location. All disturbed soils will need to be decompacted and reclaimed prior to the upcoming growing season.

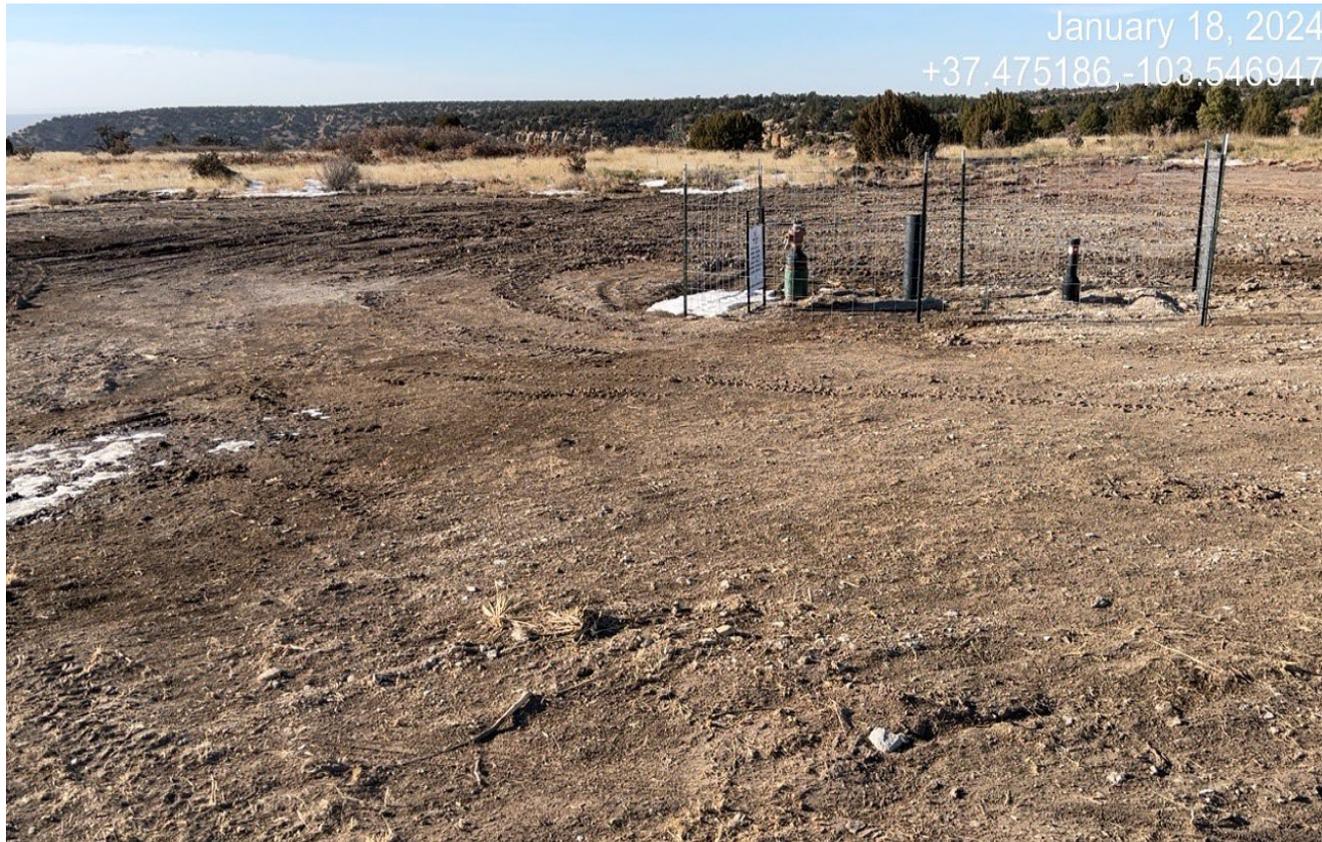
**Photo 11.** Facing northeast toward the disturbed location. All disturbed soils will need to be decompacted and reclaimed prior to the upcoming growing season

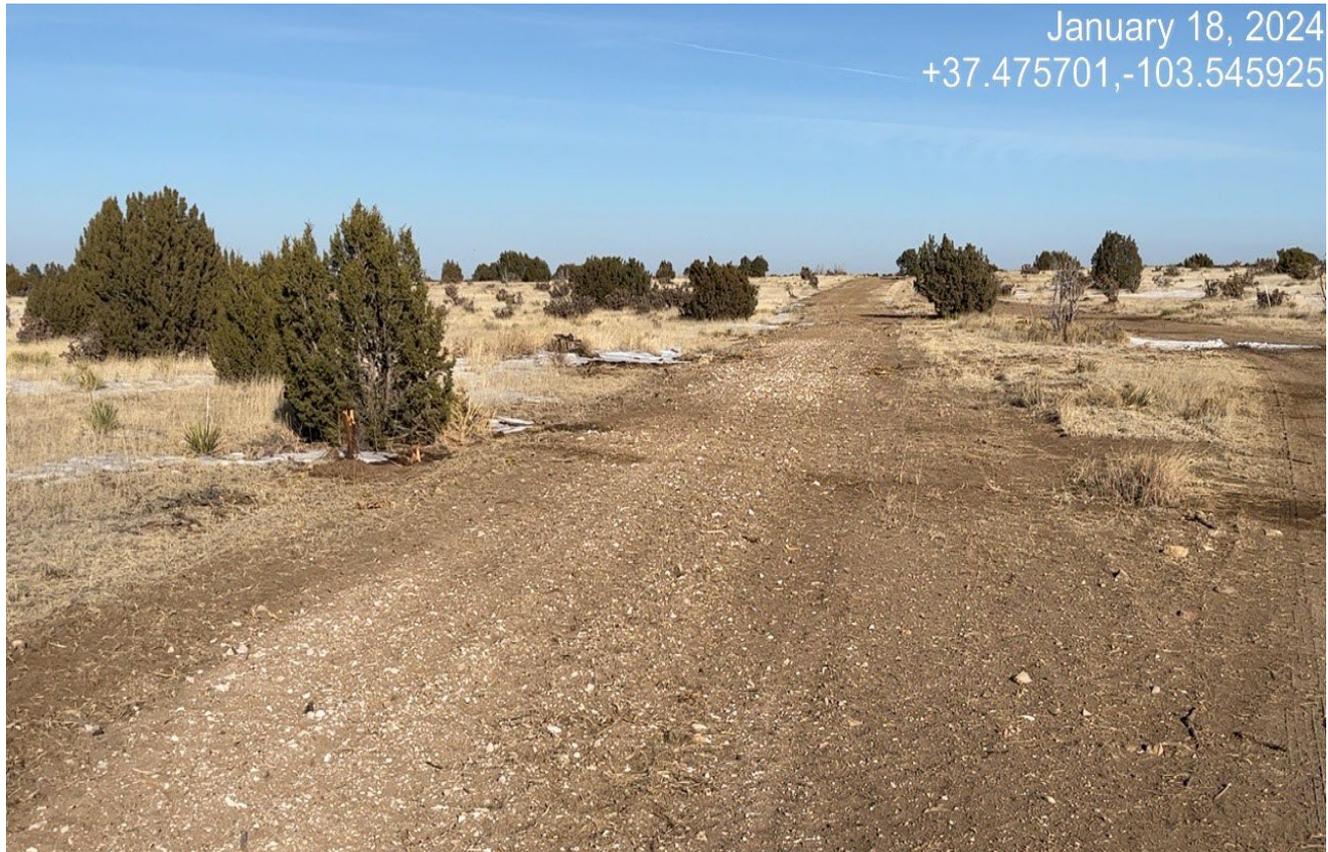
**Photo 12.** Facing east toward the flowline disturbance. The disturbance has been graded and rocks, tree debris appear to be mostly removed.
