## Inspection Photos

Location Name: HERRERA-N33N12W/26NWNE (OWP)

Location ID: 325573

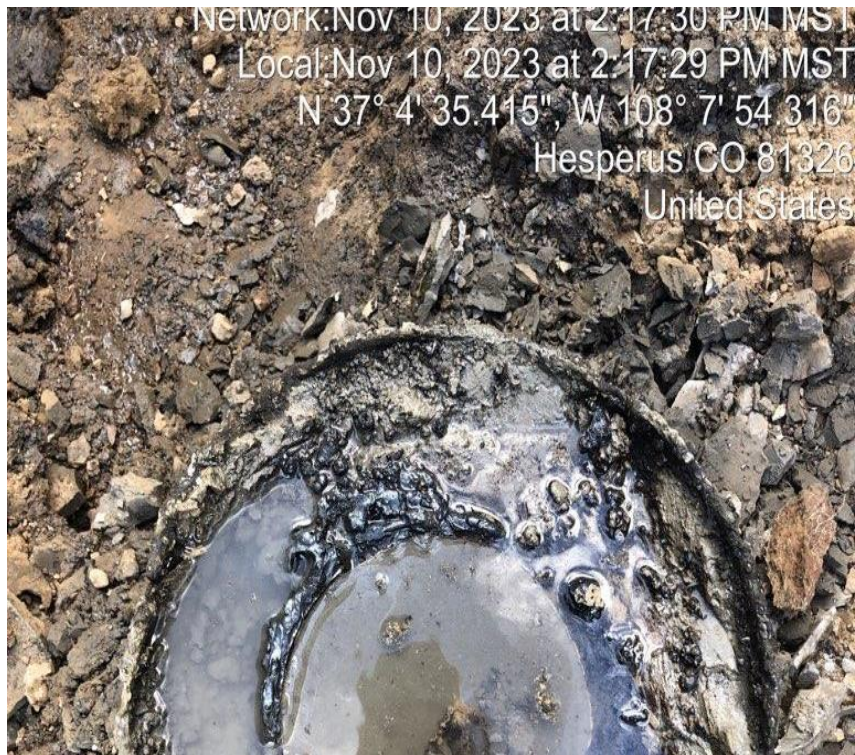
Cement to surface.

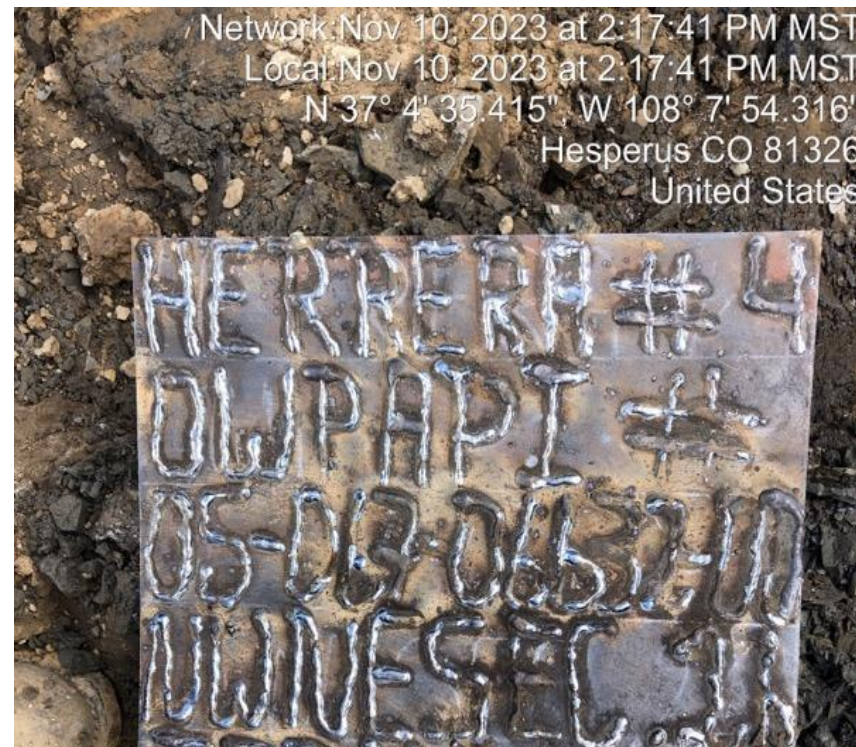
Well cut and cap plate.
