**Inspection Photos**  
**Location: Becks 41-16 and Becks 41-16 TR**  
**Facility ID: 334237**

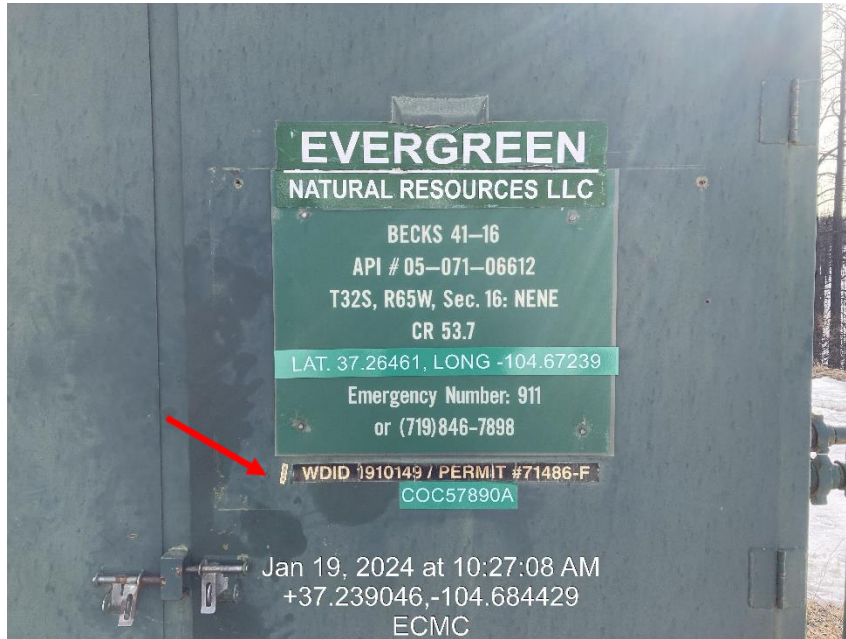
**Photo 1 –Well Site Placard, WDID stickers are illegible**

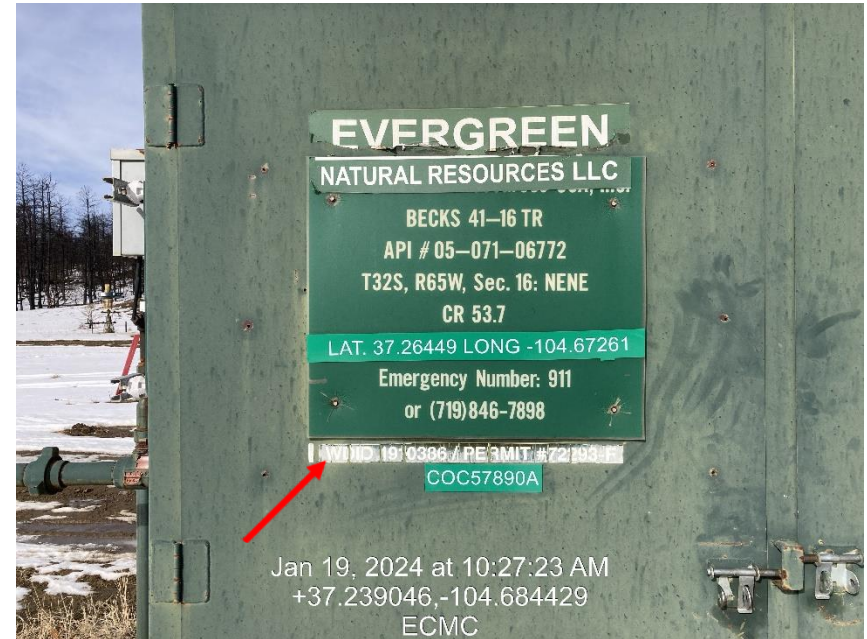
**Photo 2 – Well Site Placard, WDID stickers are illegible**

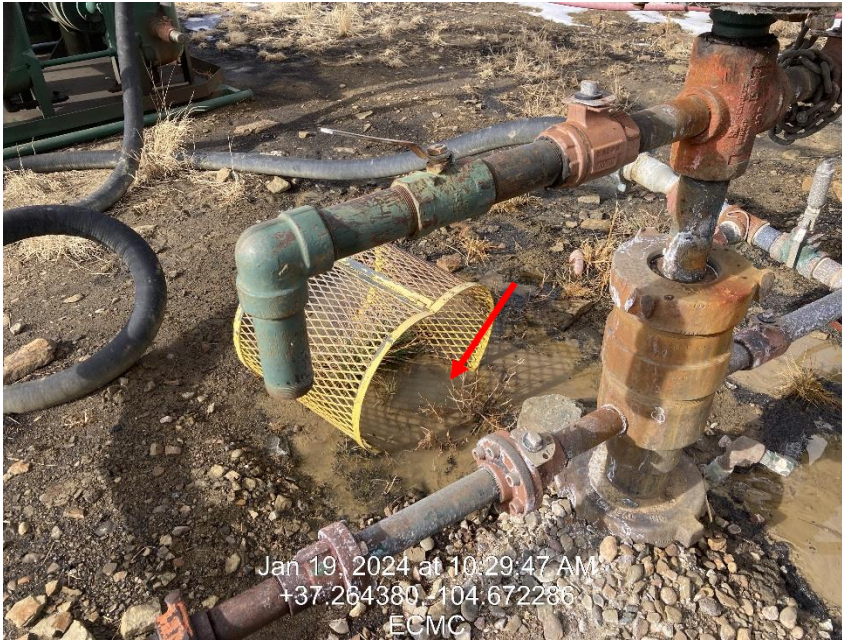
**Photo 3 – Spill at wellhead**

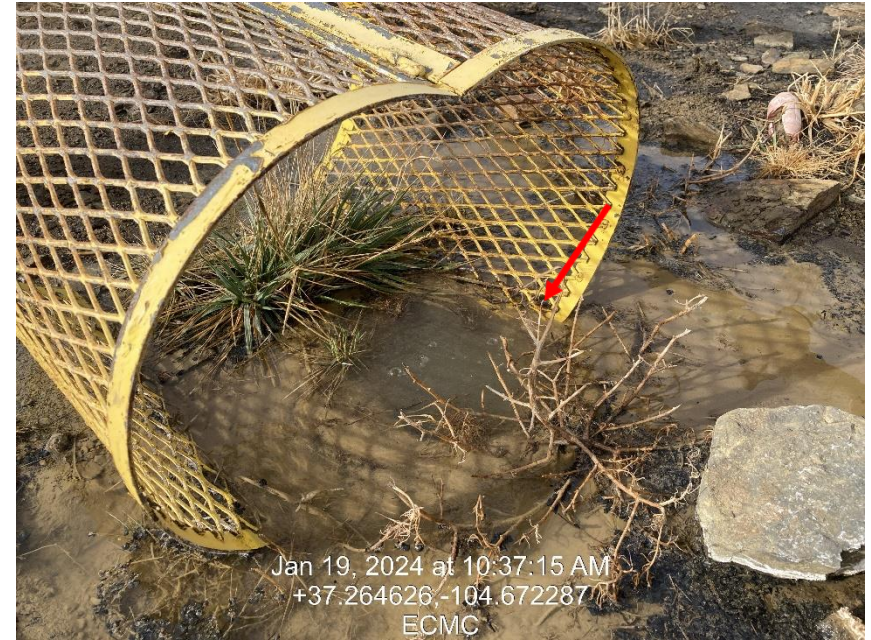
**Photo 4 – Location of Spill**

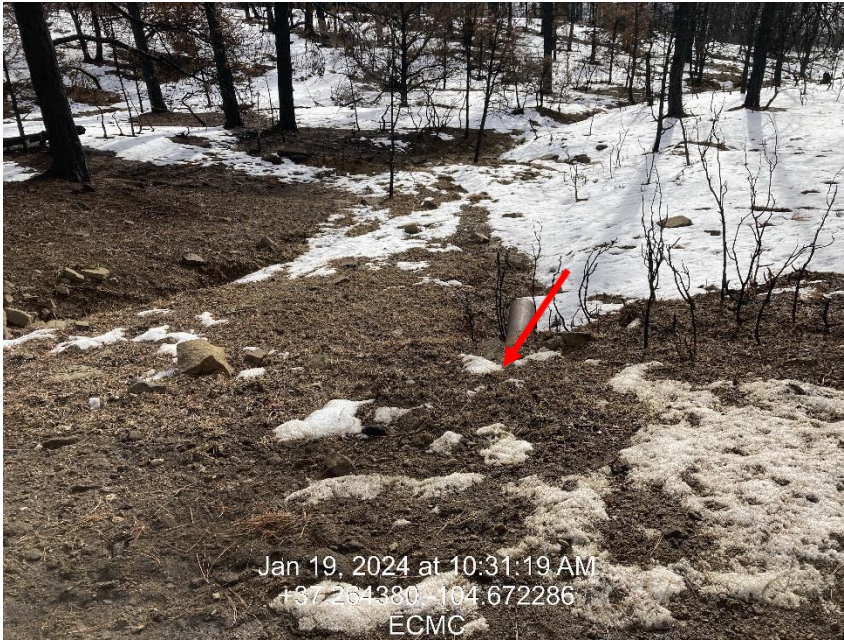
**Photo 5 – Open End of Plugged Culvert at Lat 37.26438; Long -104.67228**

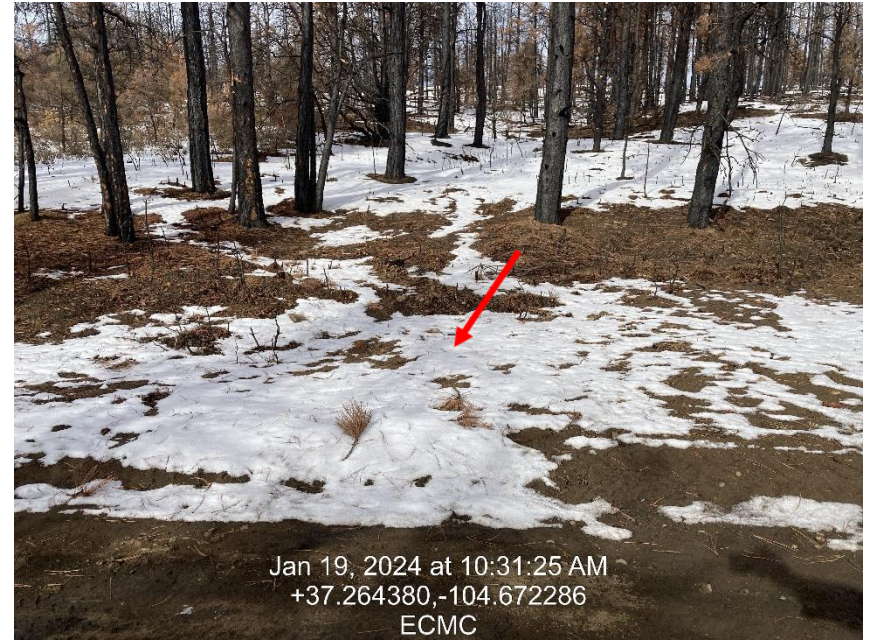
**Photo 6 – Plugged end of Culvert at Lat 37.26438; Long -104.67228**

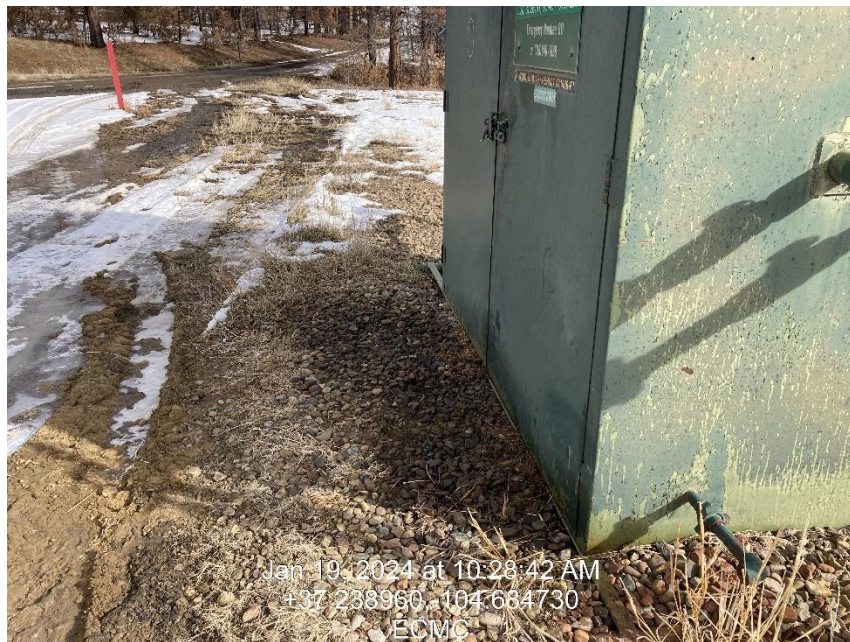
**Photo 7 – Oil Soils/Gravel**

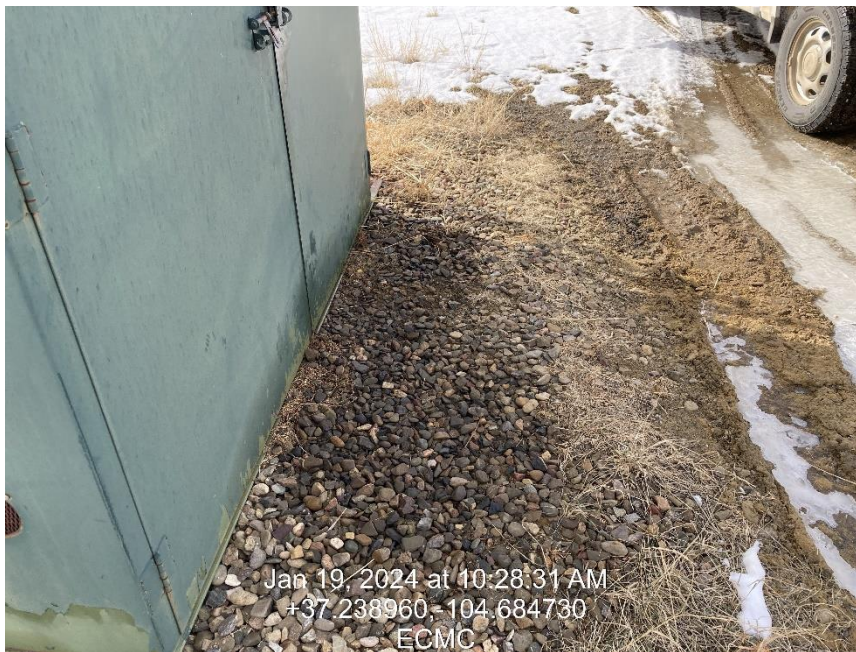
**Photo 8 – Oil Soils/Gravel**

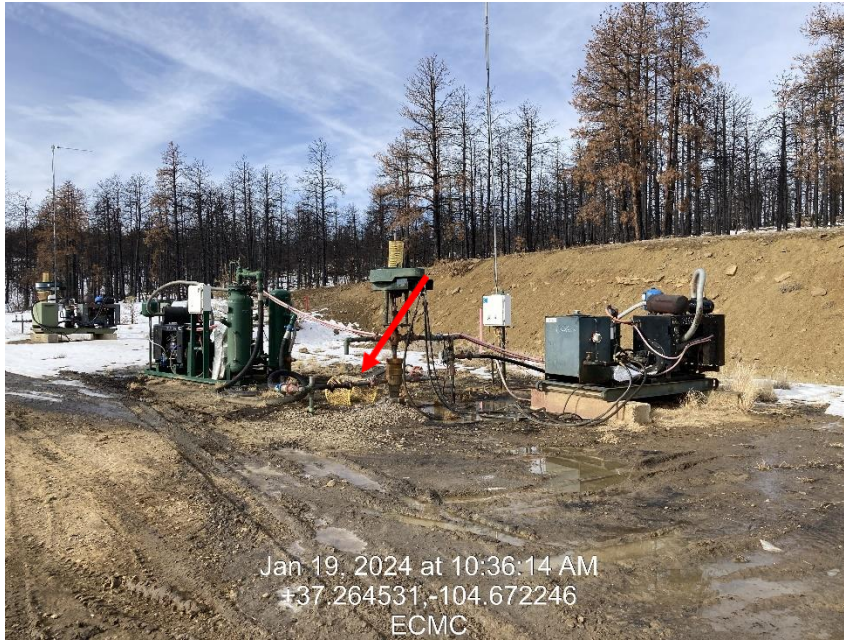
**Photo 9 – Spill location**
