**Operator: BONANZA CREEK ENERGY OPERATING COMPANY LLC**

**Location Name: PRONGHORN-65N61W 21NWNE**

**Loc ID: 302895**

**Inspection: 713900241**

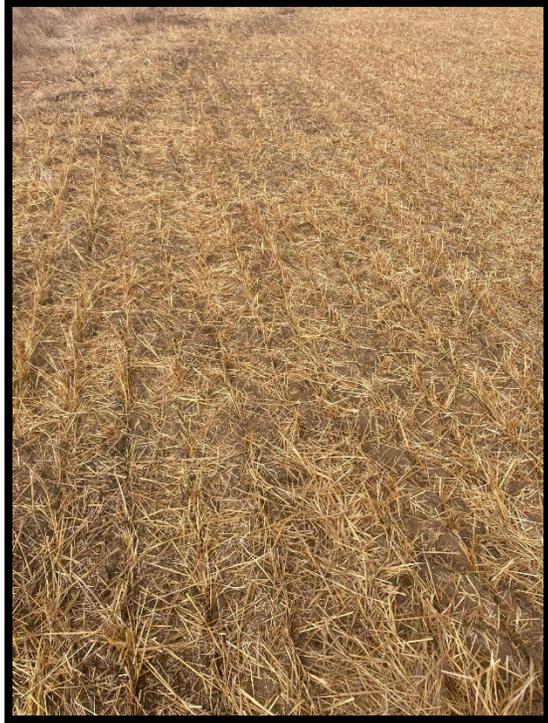
**Exhibit A**

**CA:** This location does not comply with Rule 1004. Reclamation rules require reclamation activities to be conducted within three months of plugging on cropland. Well was plugged 06/22/2018. The well location and access road have not been re-contoured or re-graded. The access road has subsided and the cut slope along the North side of the location has not been re-contoured. Cereal rye also is dominated across the well location and access road. Perform reclamation in accordance to Rule 1004.

**CA Resolution:** Operator has reported that the access road has been recontoured, and the location has been reseeded and straw crimped to establish vegetation to comply with Rule 1004.
