# Inspection Photos

Loc: 322234

Operator: **INCREMENTAL OIL & GAS (FLORENCE) LLC**

Inspection Date: 1/18/2023

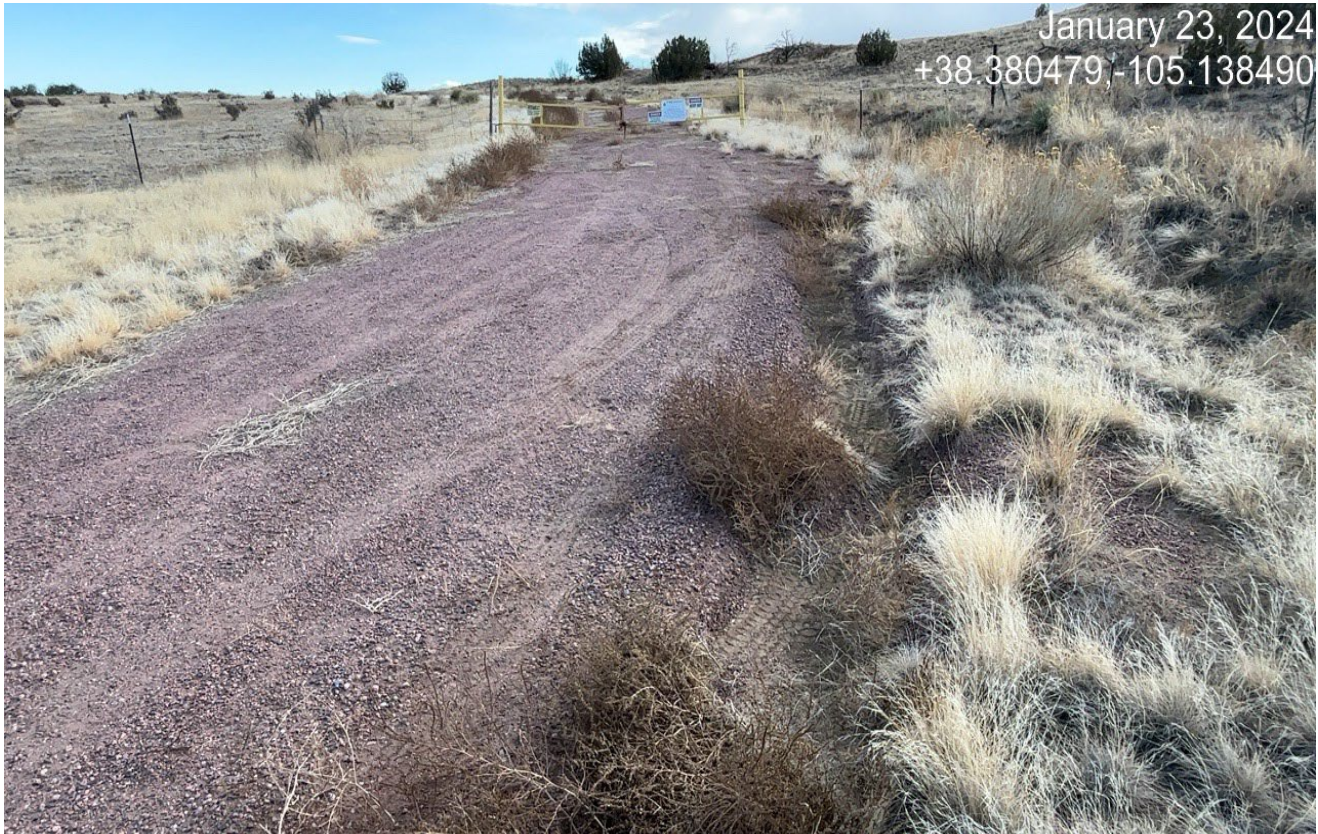
**Photo 1.** Facing southeast at the beginning of the access road. There is erosion occurring along the road.

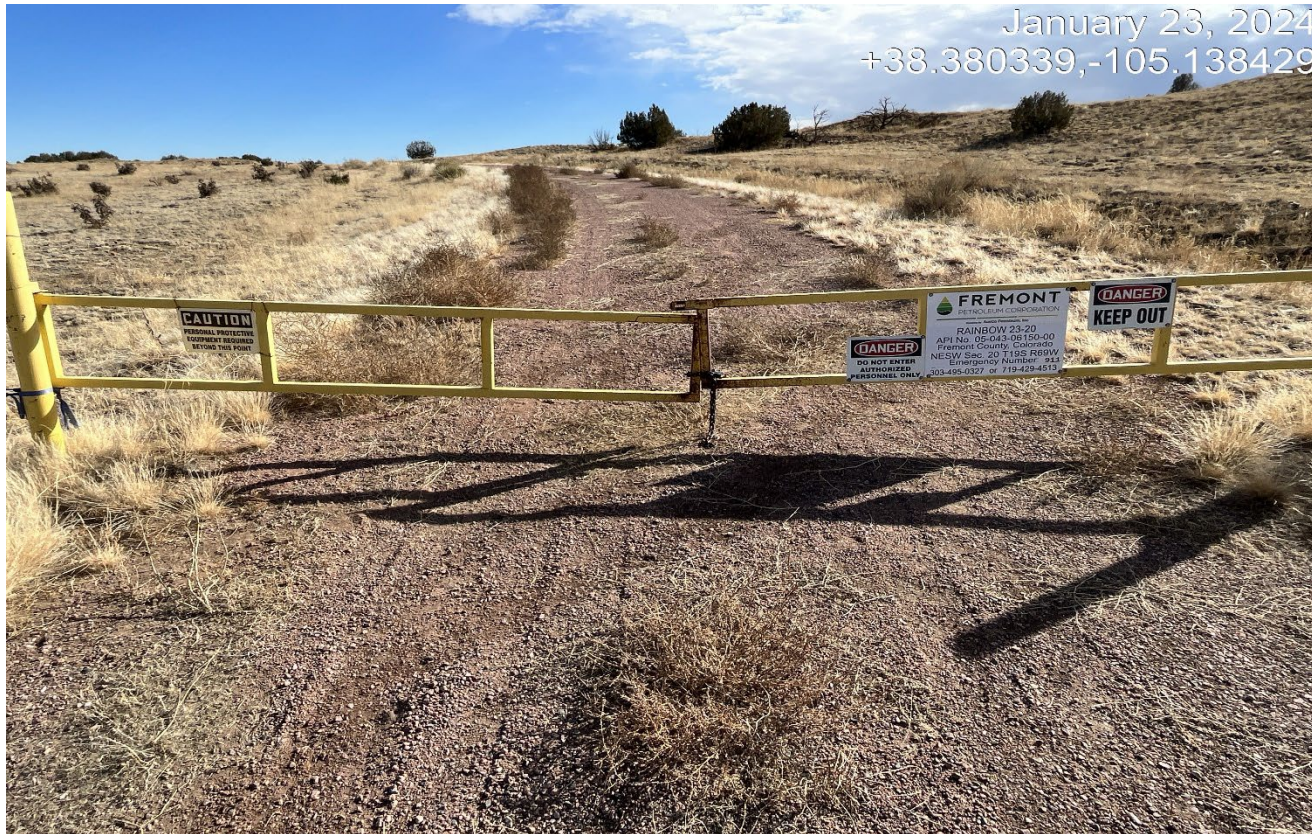
**Photo 2.** Facing southeast along the road. There are undesirable weeds growing along the road side that need to be removed/controlled..

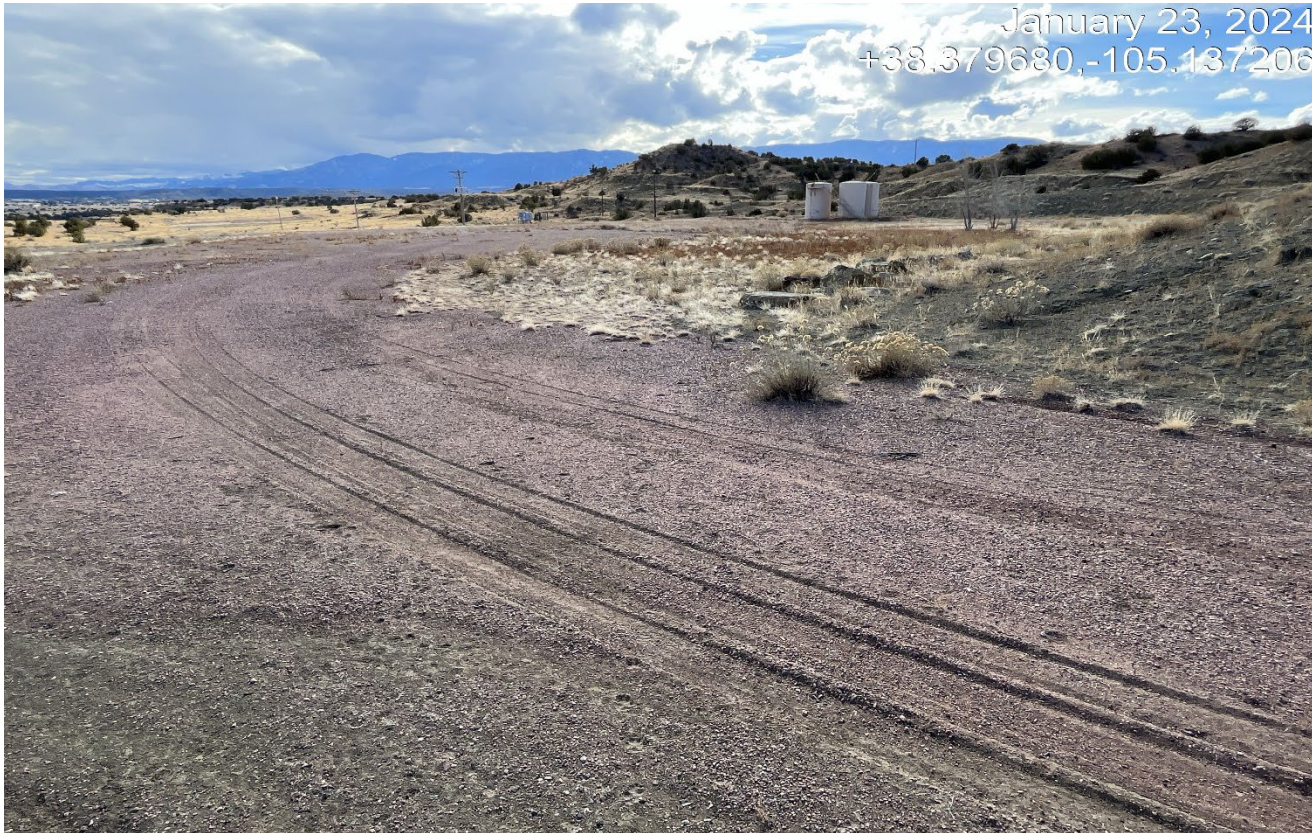
**Photo 3.** Facing south toward the location. The well has been plugged and abandoned however final reclamation has not yet been completed.

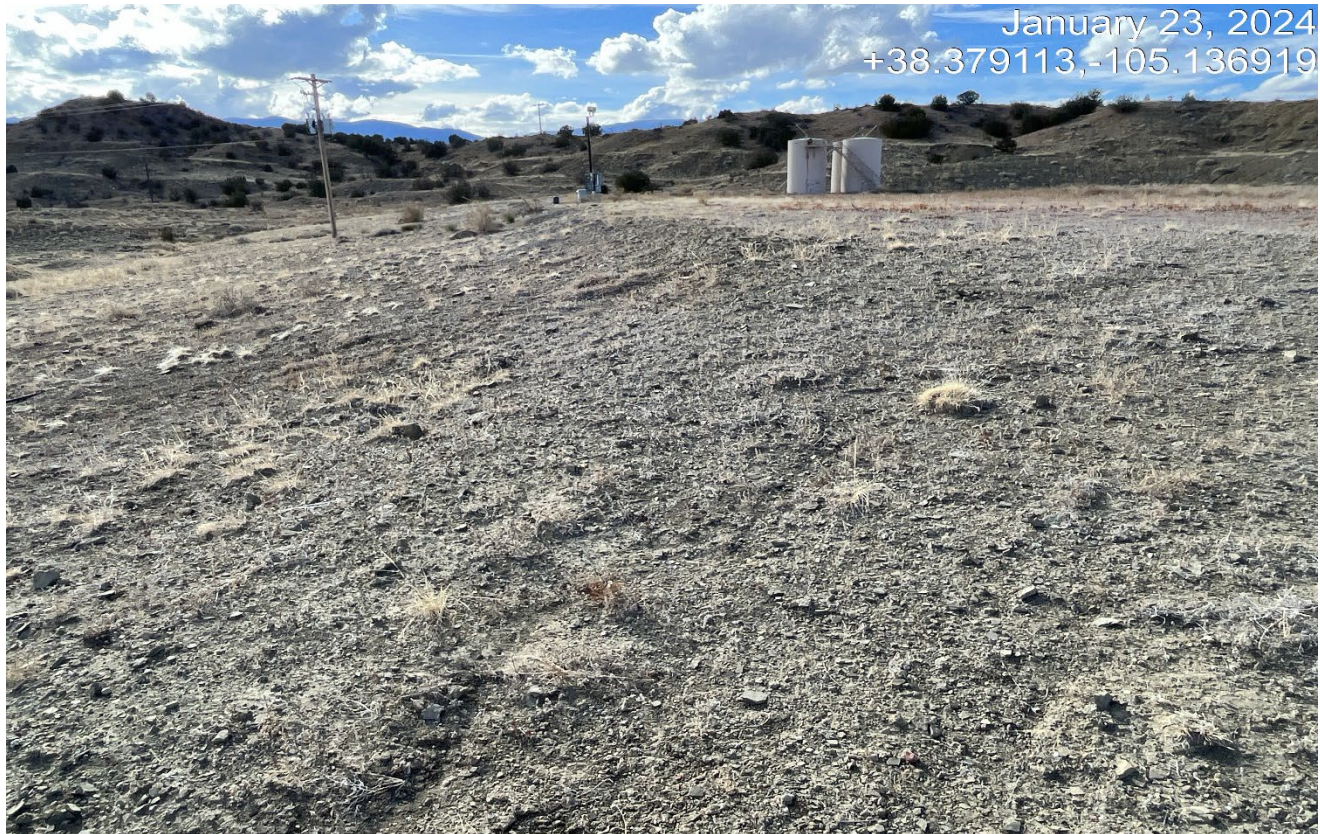
**Photo 4.** Facing southwest along the fill slope. The location will need to be recontoured back to the original slopes

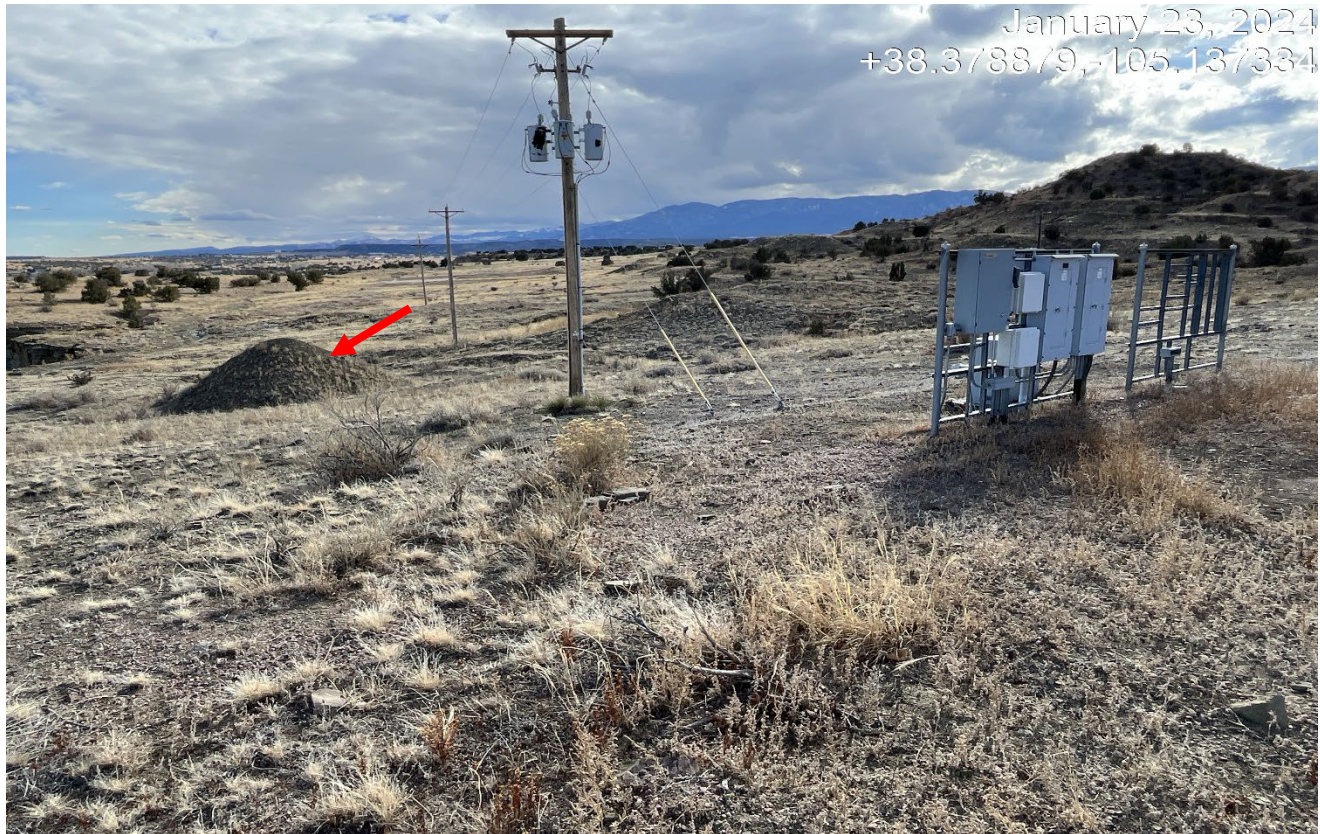
**Photo 5.** The electric utilities remain at the location and should have been removed with 3 months of abandonment. The entire powerline and poles servicing this location must be removed. There is a topsoil pile shown at red arrow.

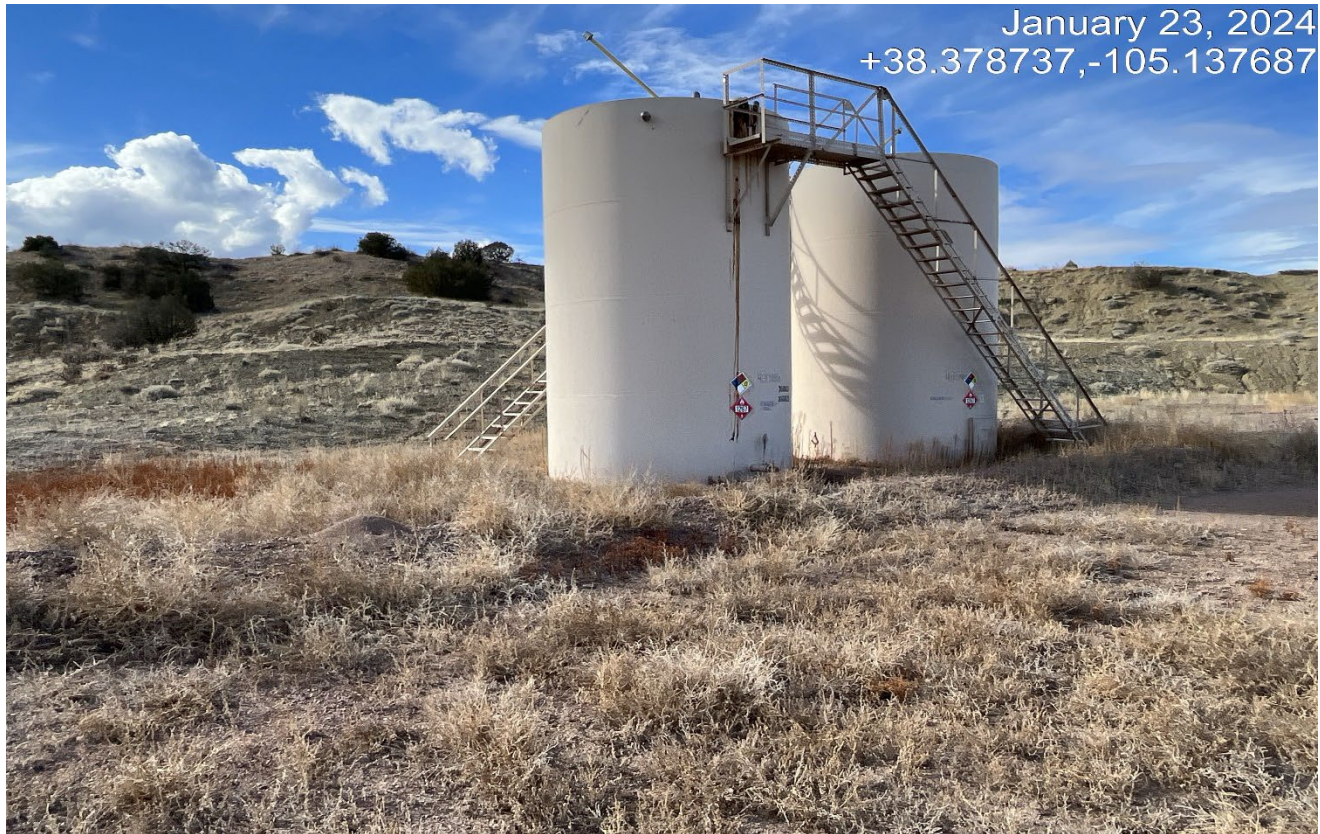
**Photo 6.** Facing toward the south side of the location. There are tanks that have not been removed. All equipment should have been removed within 3 months of abandonment.

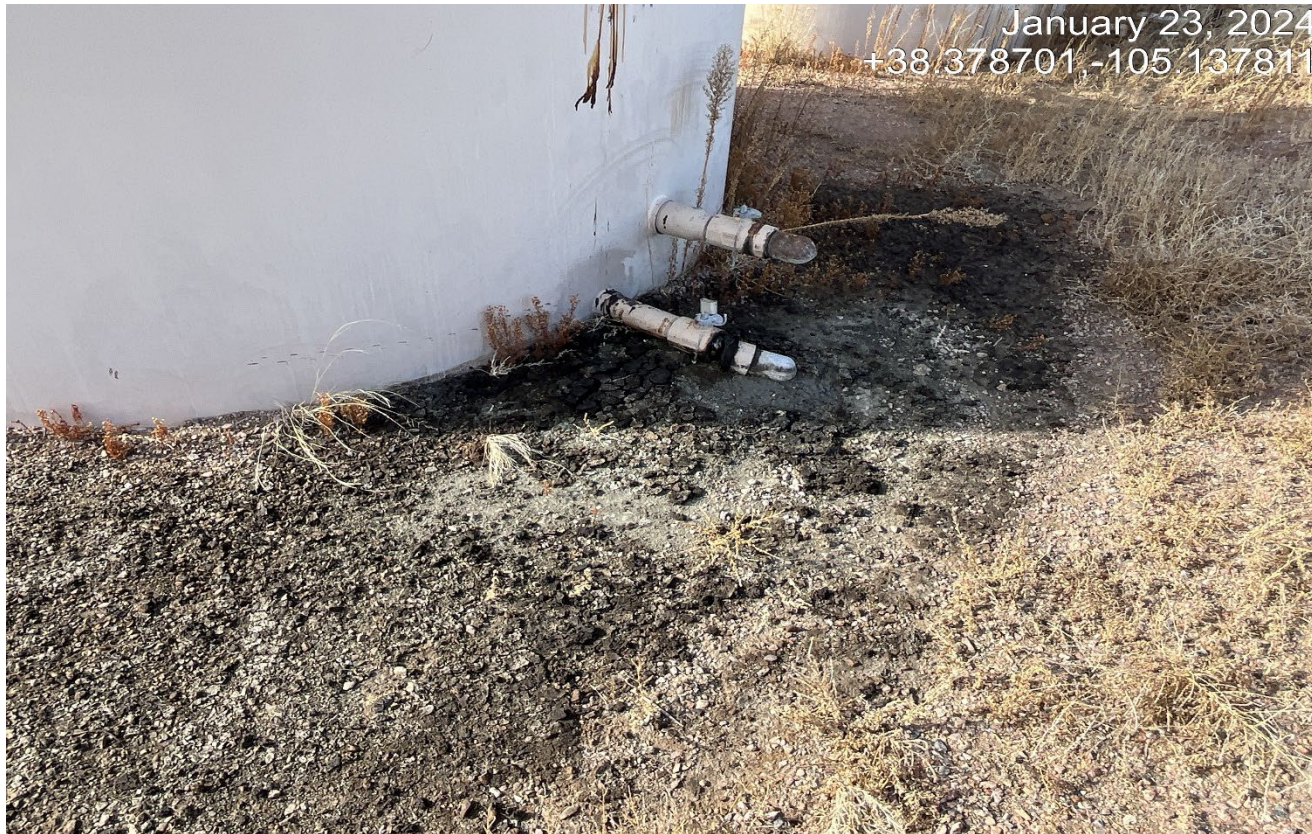
**Photo 7.** Upon closer inspection of the tanks there is a spill that had occurred at the tank outlet. Immediate clean up needs to be performed.

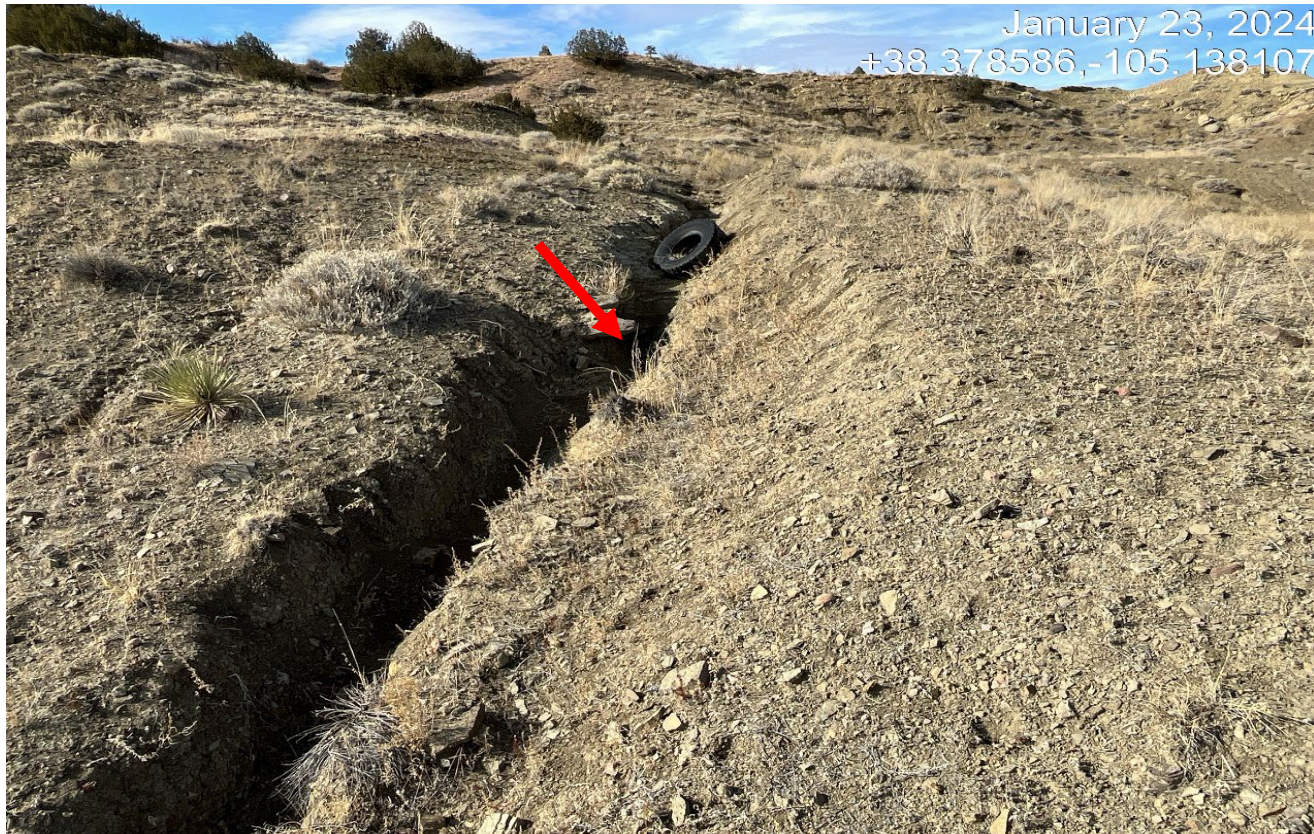
**Photo 8.** Facing west at the south side of the location. There is an erosion channel shown at red arrow which will need to be repaired and stabilized.

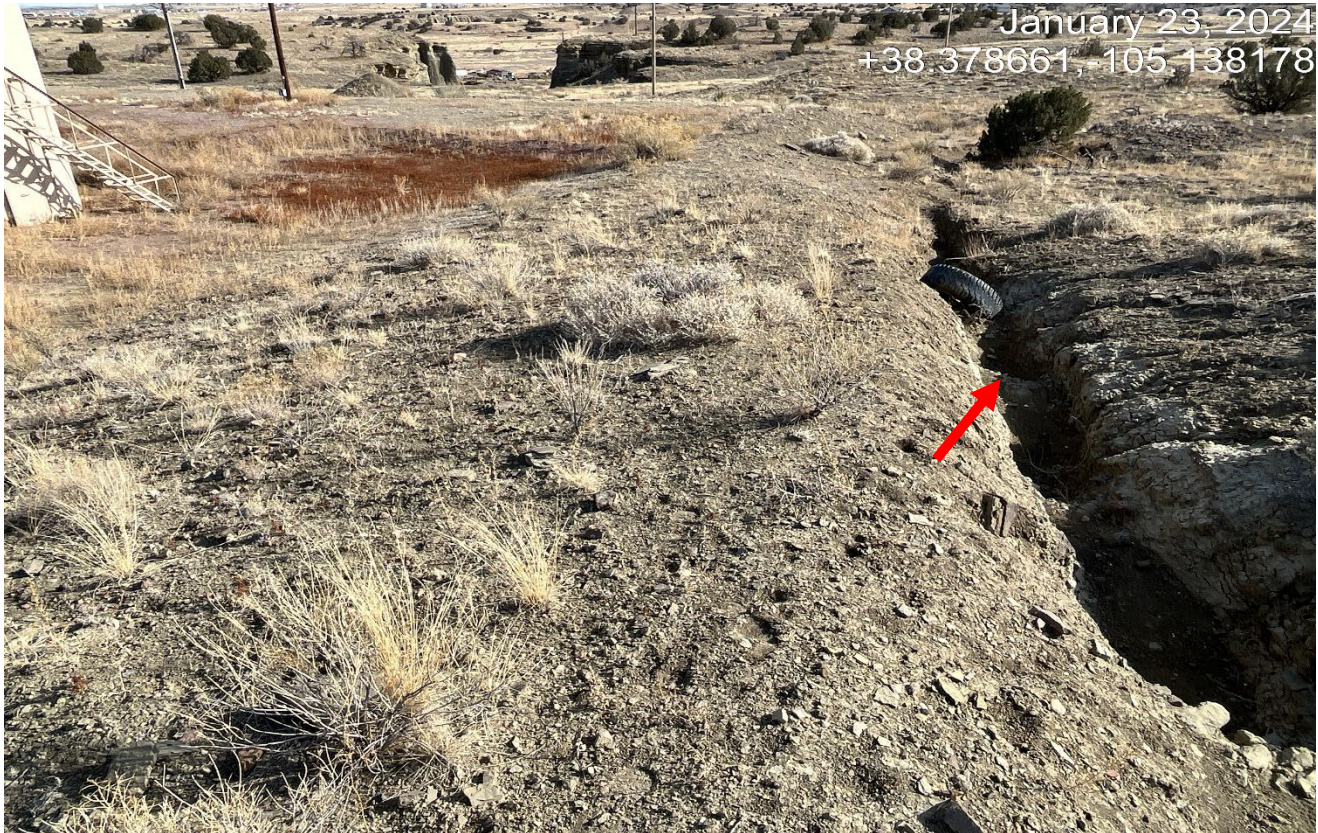
**Photo 9.** Facing southeast at the south side of the location. There is an erosion channel shown at red arrow which will need to be repaired and stabilized.

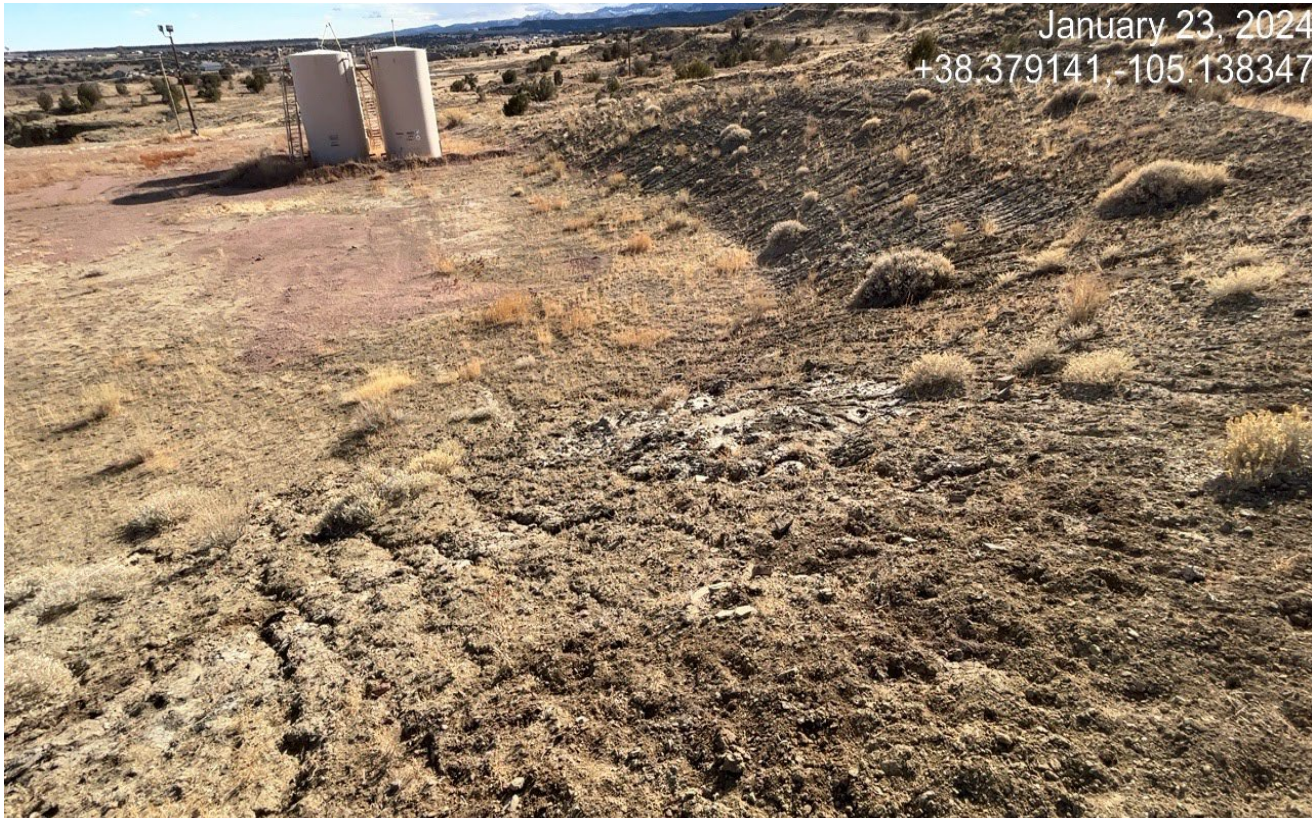
**Photo 10.** Facing east along the cut slope. There is rilling erosion along the cut slope.

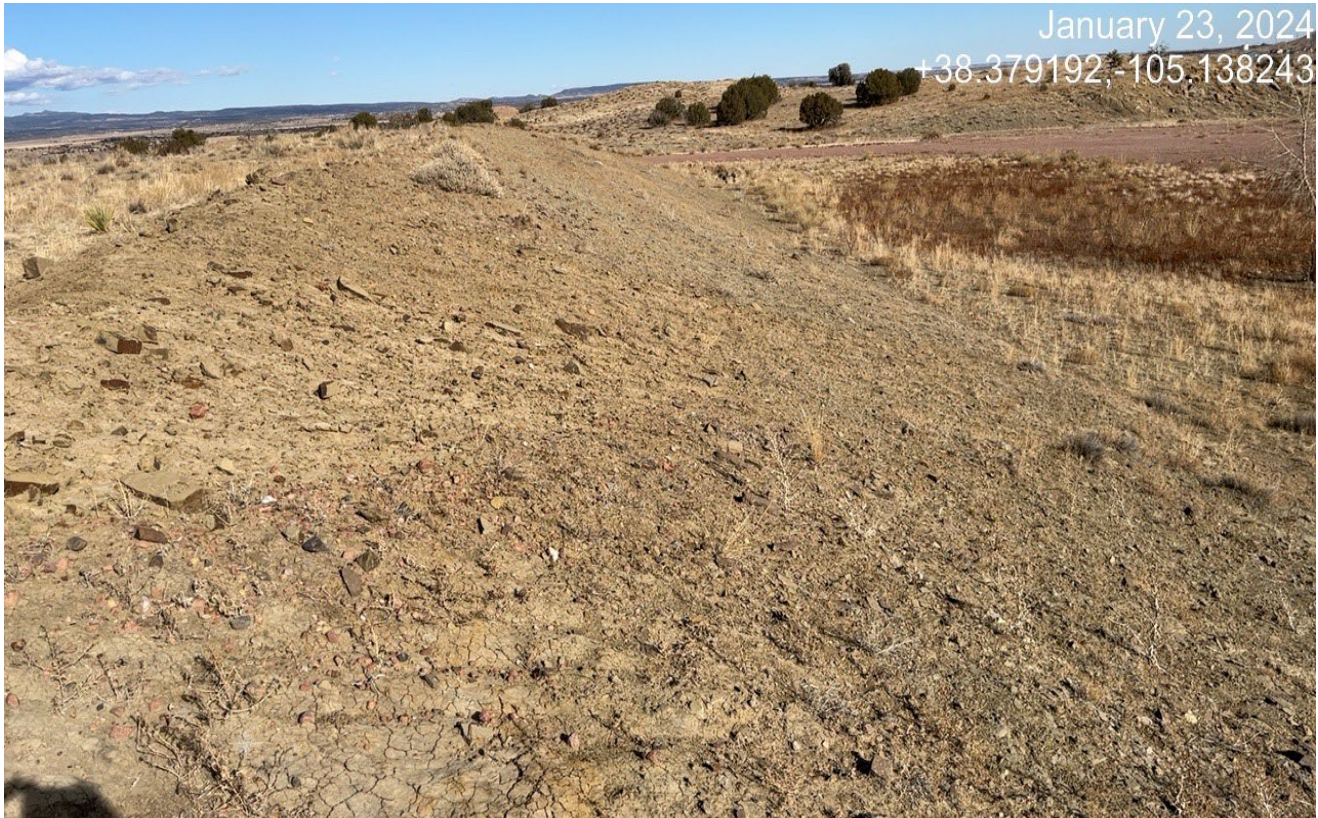
**Photo 11.** Facing north along the cut slope. There cut slope is not stabilized.
