Inspection Photos
Location Name: Adamic #1-20
Location ID: 322219

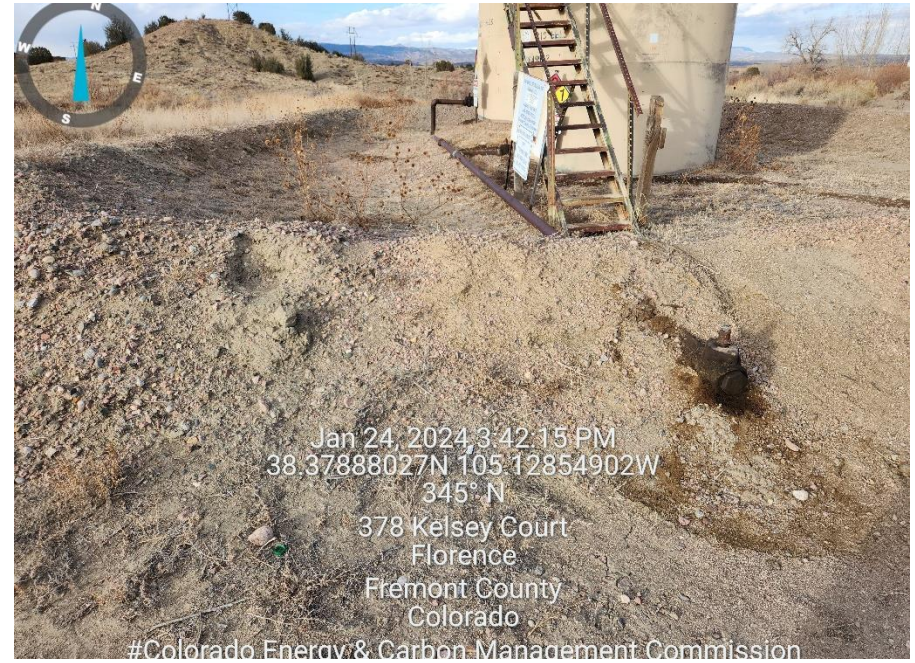
Photo 2 stained soil load line

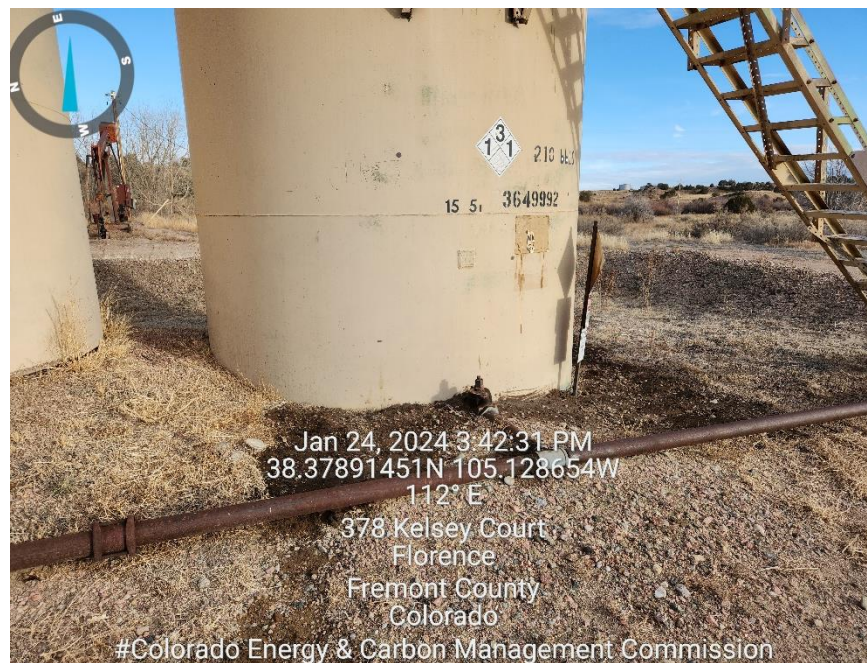
Photo 3 Stained soil and mechanical issue crude oil load lines.

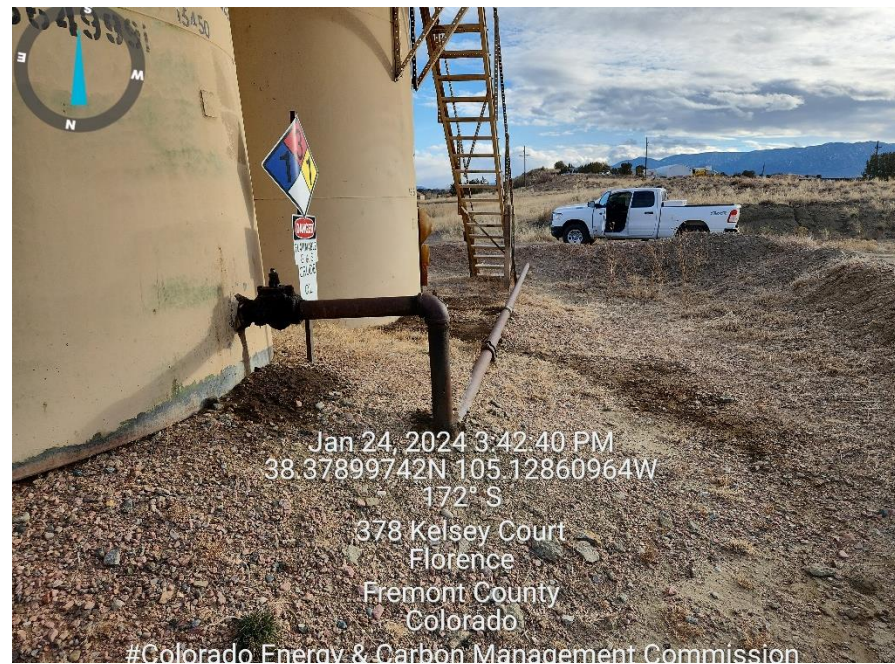
Photo 4 Stained soil and mechanical issue crude oil load lines.

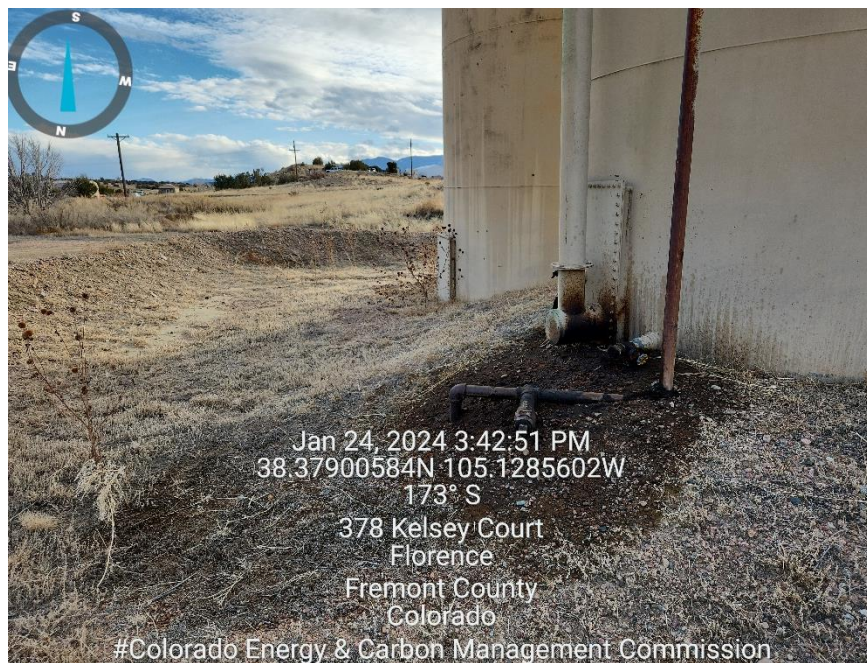
Photo 5 Stained soil and mechanical issue crude oil load lines.

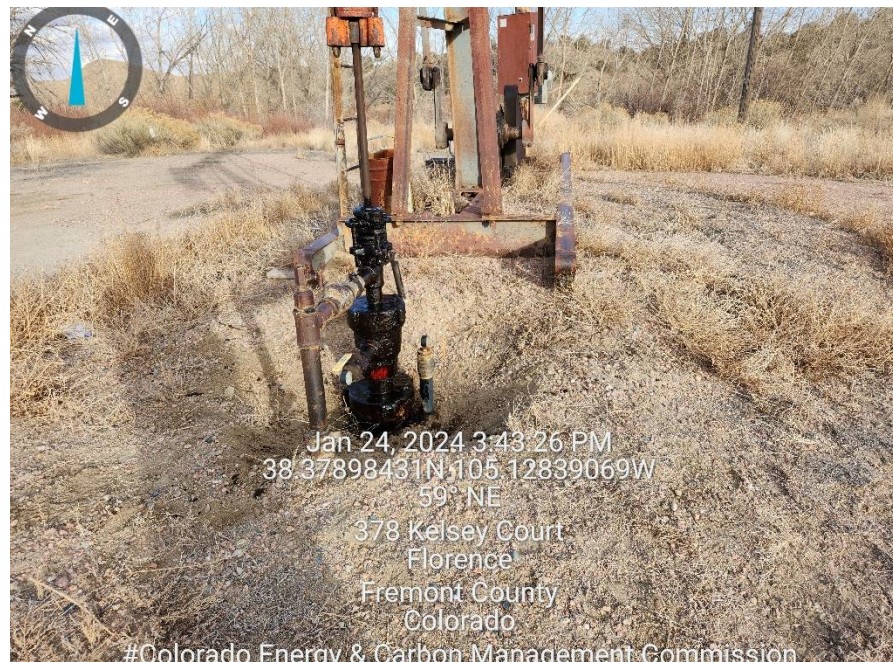
Photo 6 Stained soil mechanical issue well head leaking

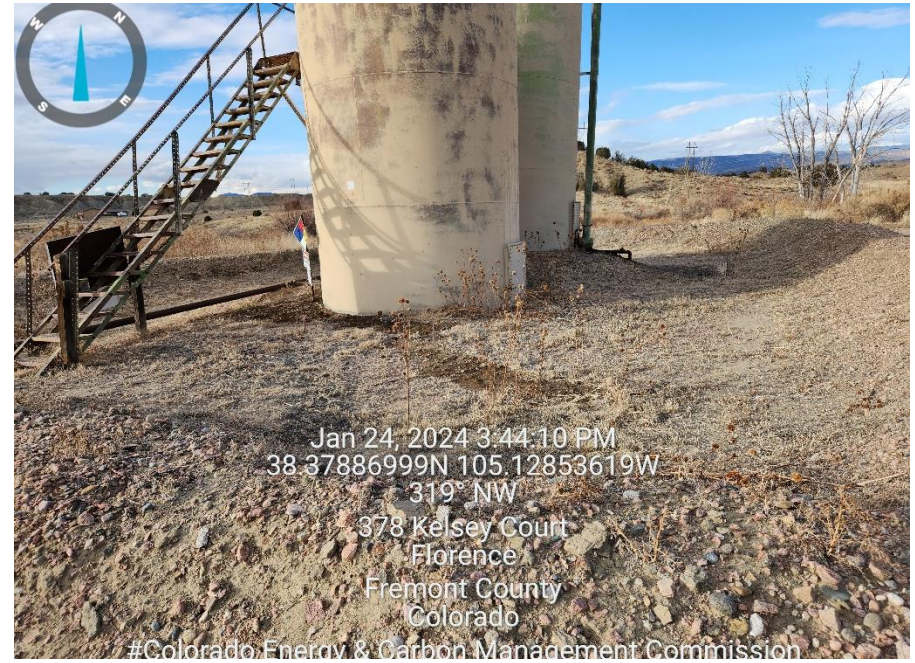
Photo 8 Stained soil and mechanical issue crude oil load lines.
