Inspection Photos

Loc: 322220

Operator: **JAVERNICK OIL**

Inspection Date: 1/23/2024

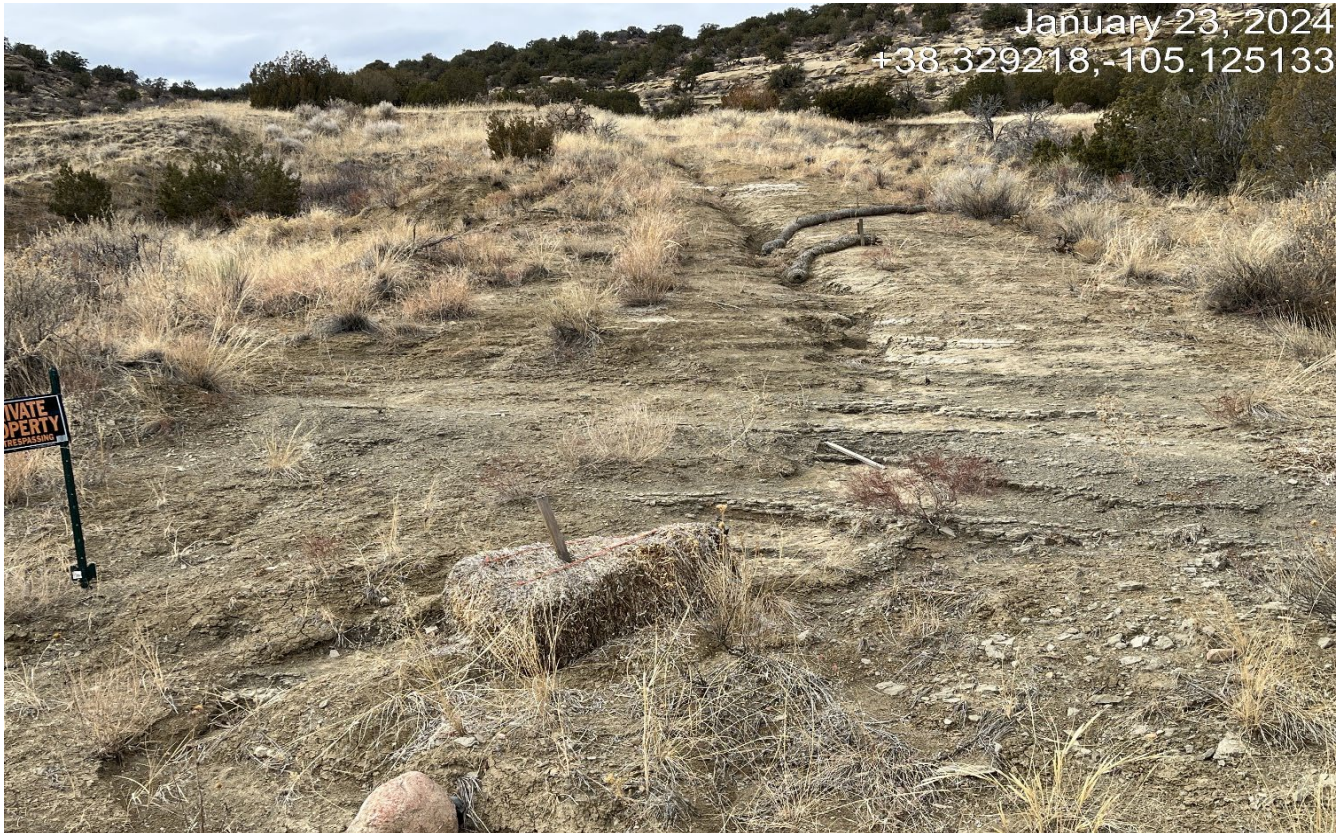
Photo 1. Facing southwest toward the former access road. This area is not stabilized with vegetation and there is erosion has occurred. It appears topsoil has been scoured off this area of the former road. Previous corrective action was not completed.

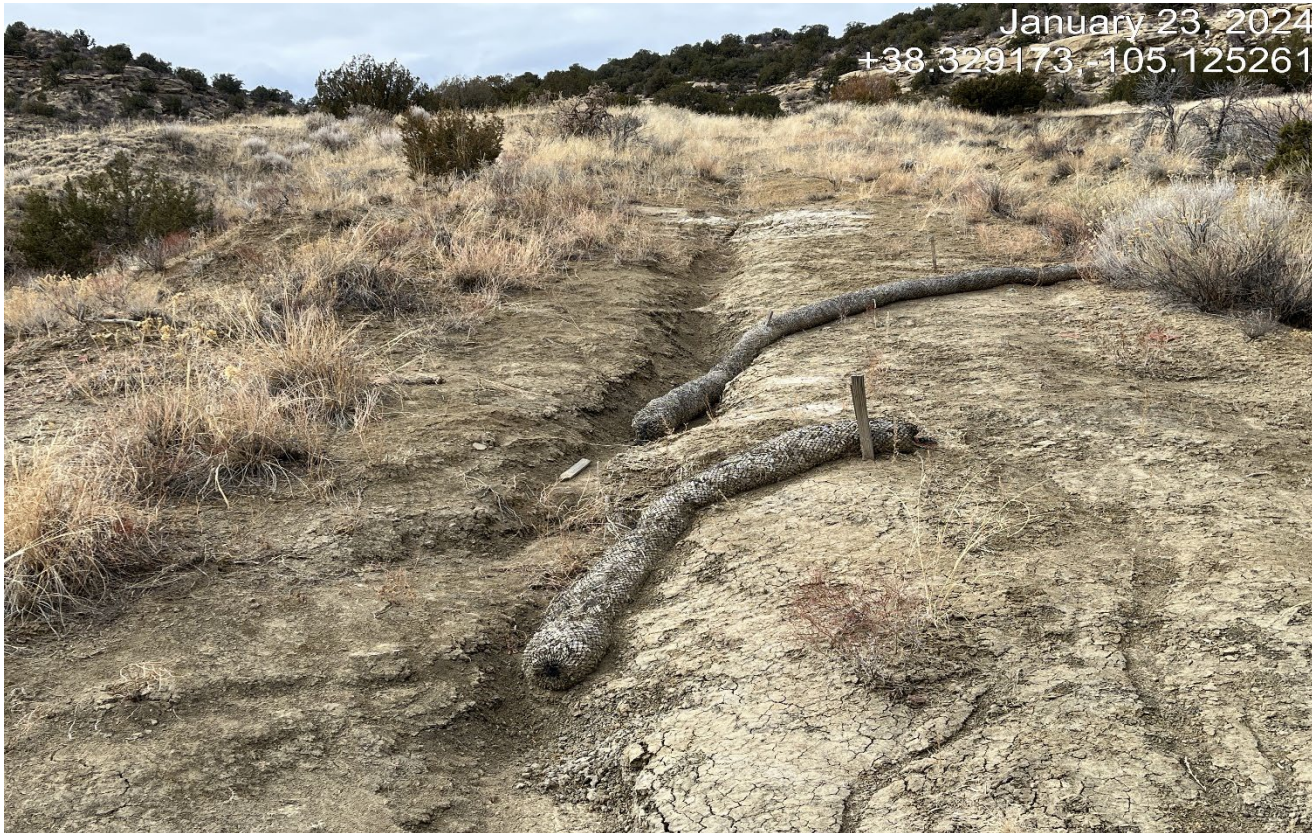
Photo 2. Facing southwest toward the former access road. There were temporary erosion controls installed which have washed out. This area of the access road needs to be reclaimed and stabilized for long term stabilization.

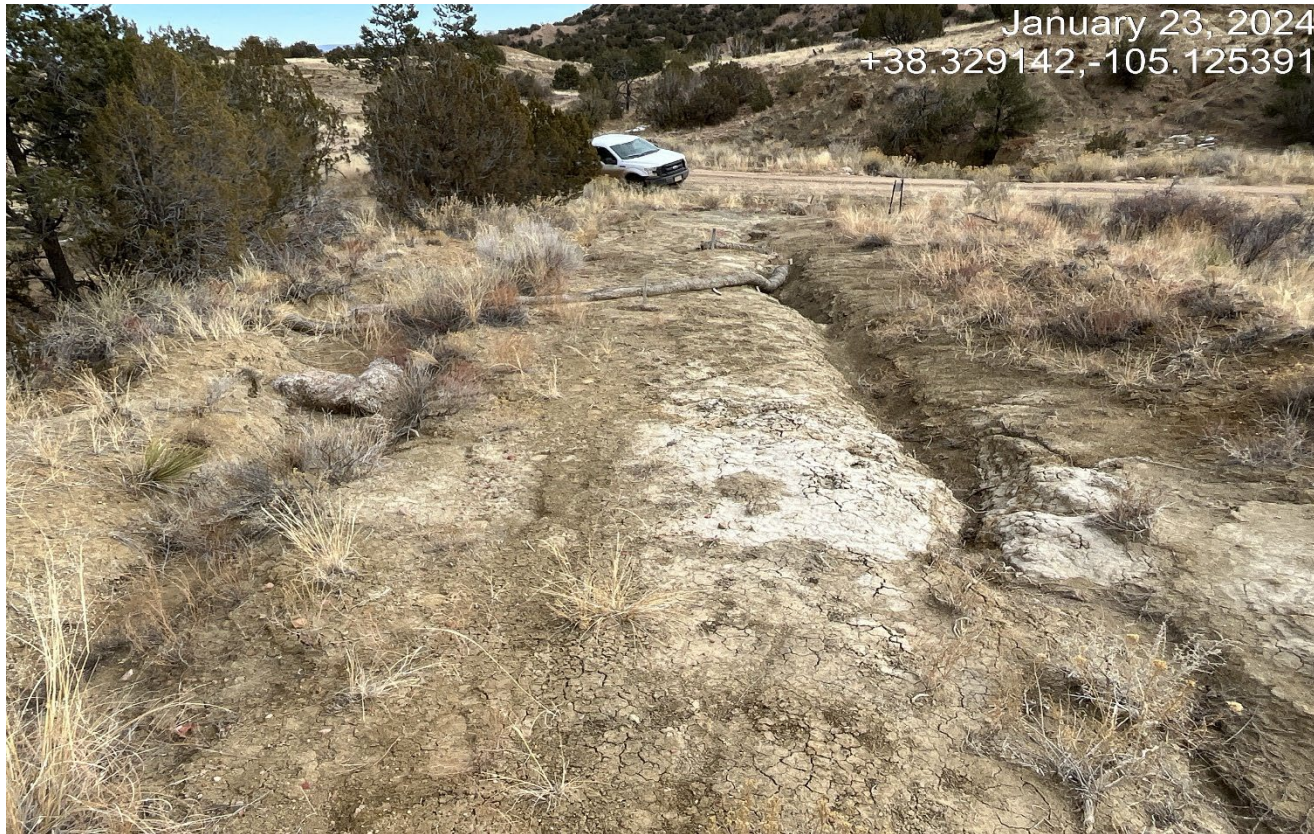
Photo 3. Facing back down the access road. There is stormwater erosion occurring on both side of the former road. Straw bales were placed on the left side and not staked in. The bales are degrading and are insufficient. This area needs to be reclaimed and stabilized for long term stabilization.

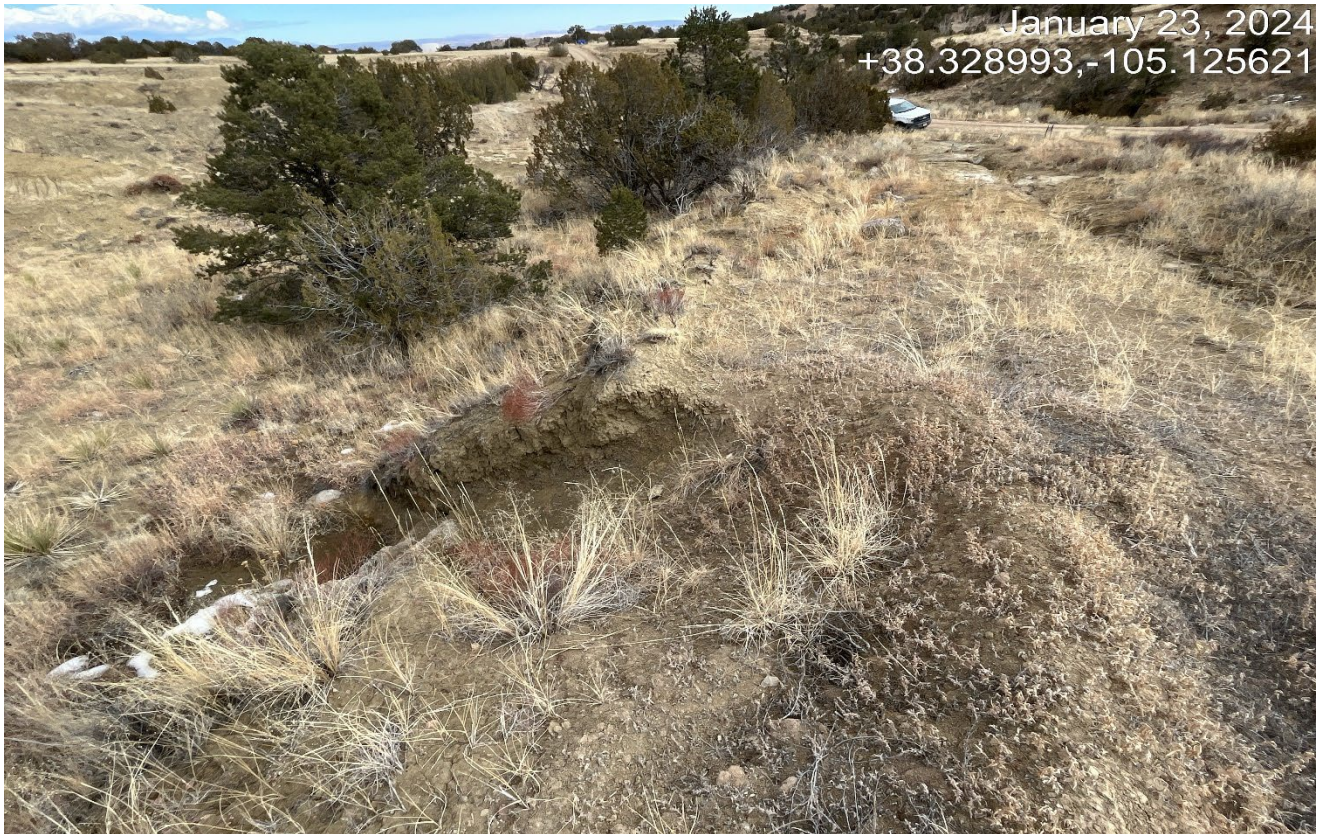
Photo 4. Further up along the access road facing northeast. There is an erosion channel directed down to the left side off the road.

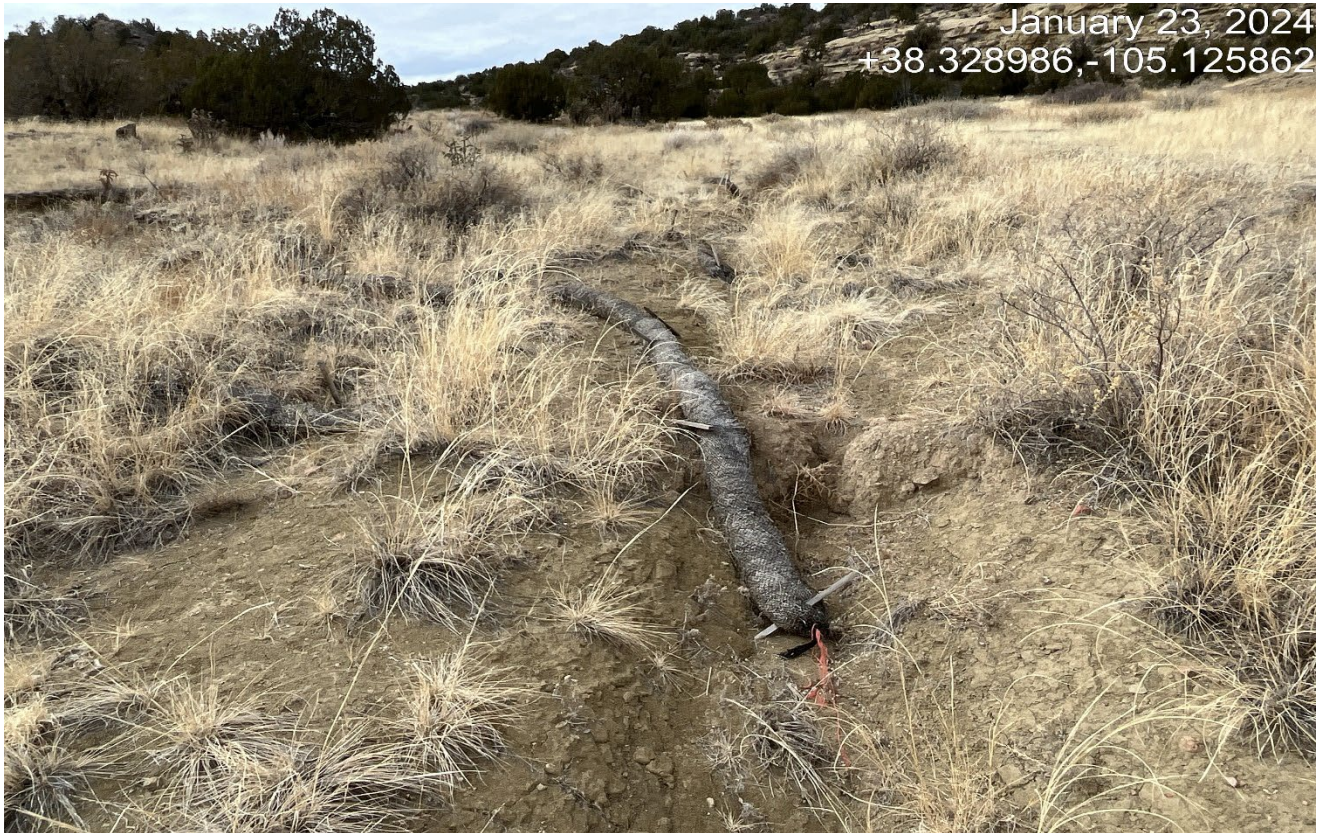
Photo 5. Facing southwest along the former access road. It appears that the stormwater from the location is directed down the road which is causing erosion issues shown in previous photos. Wattles that were installed have been washed out.

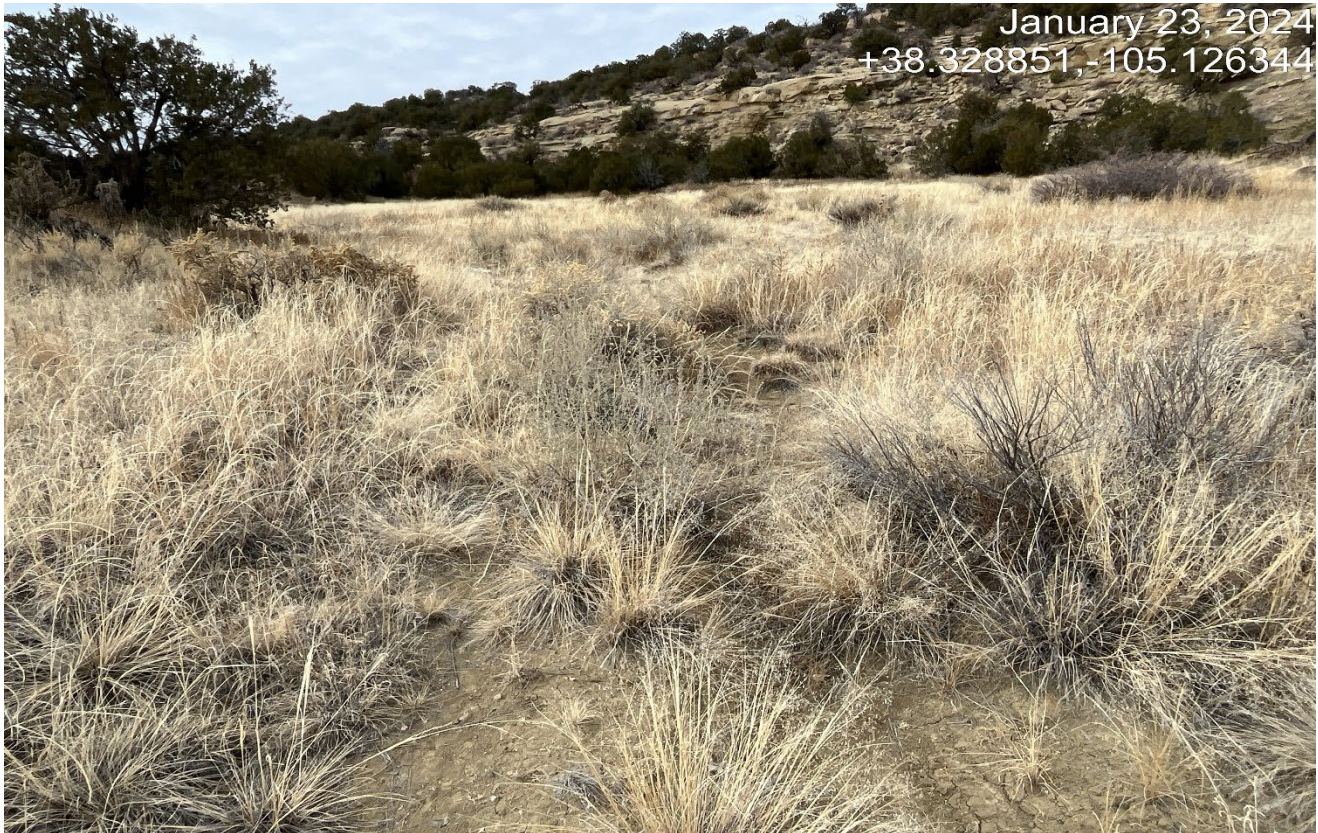
Photo 6. Facing west toward the location. Perennial native vegetation is progressing throughout the location.
