Inspection Photos

Location Name: CAERUS PICEANCE LLC N.PARACHUTE EF06D J27 595 Pad

Location #: 335787

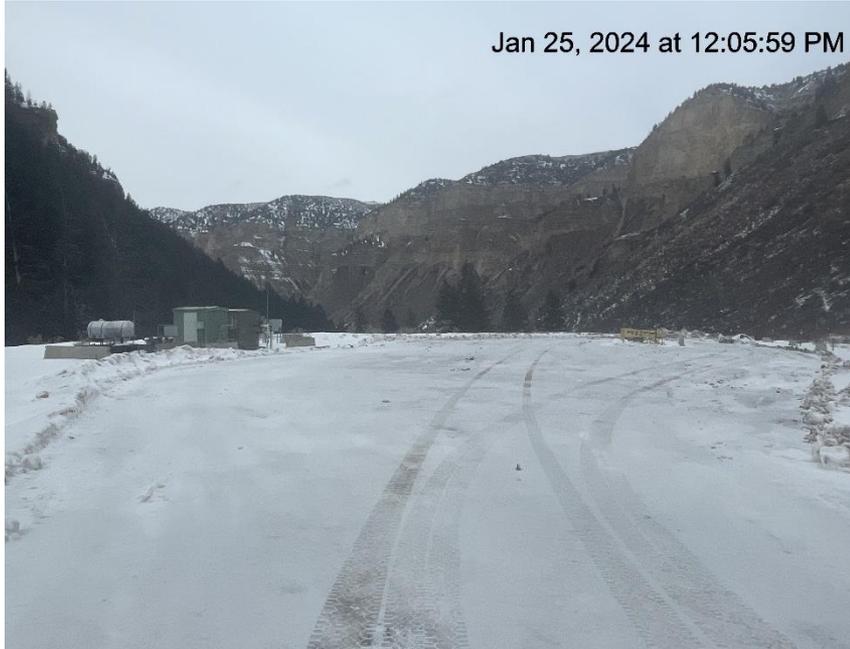
Photo # 3937 From entrance to location

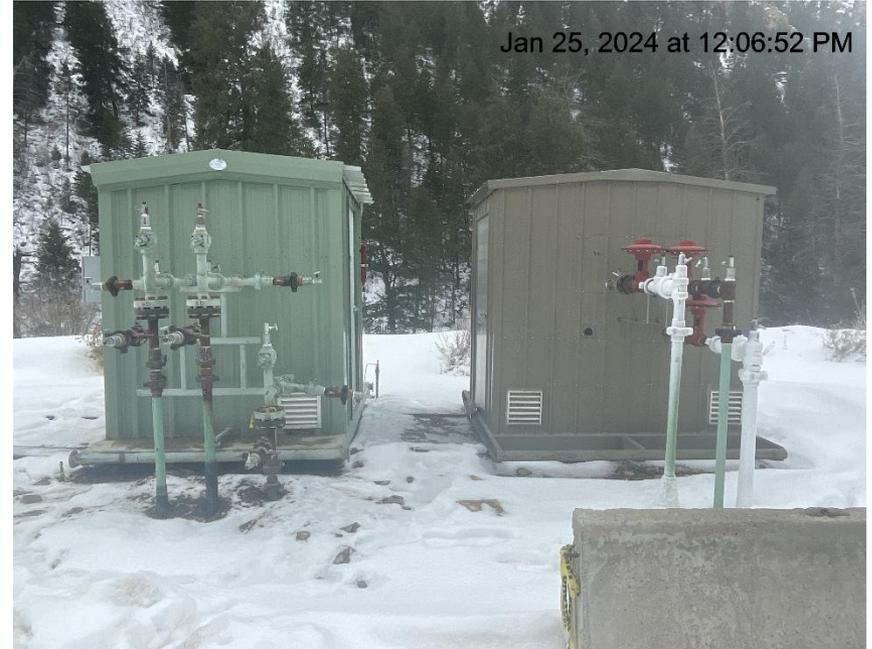
Photo # 3938 Location

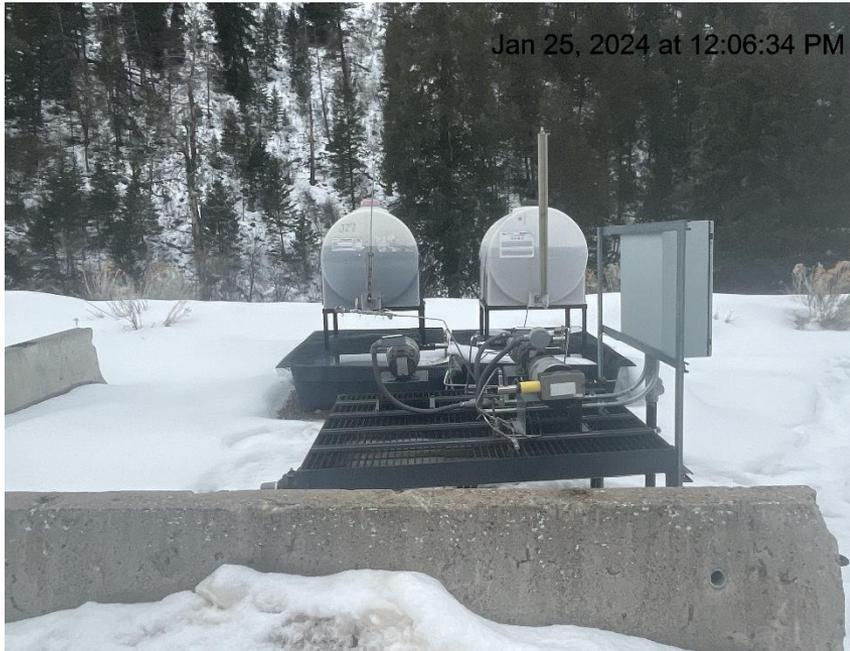
Photo # 3939 Location

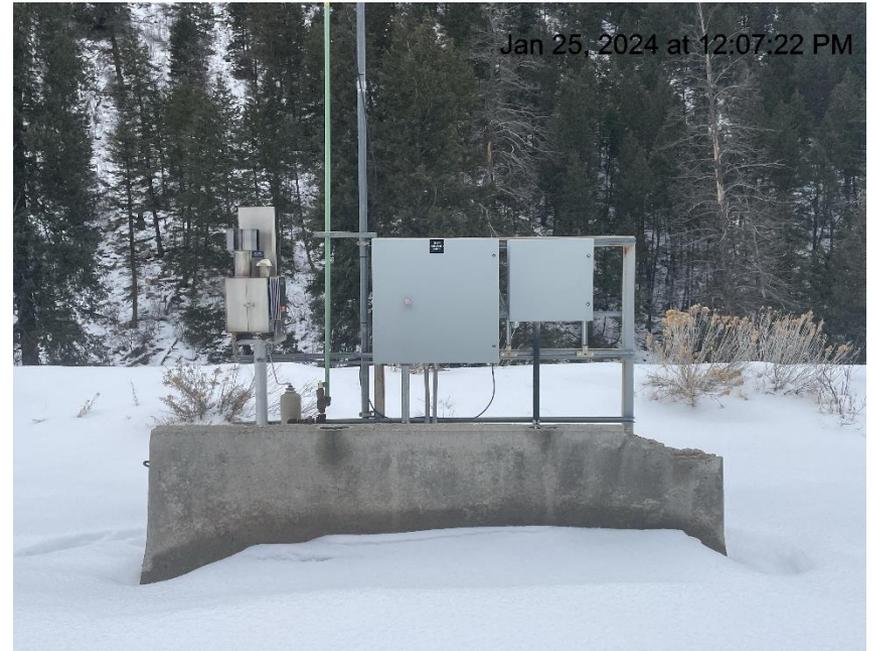
Photo # 3940 Location

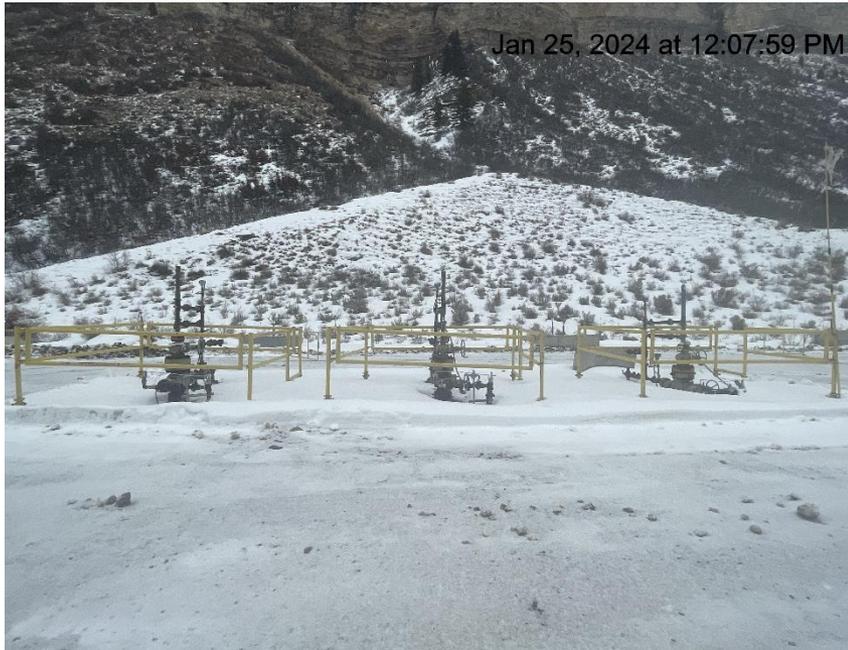
Photo # 3941 Location

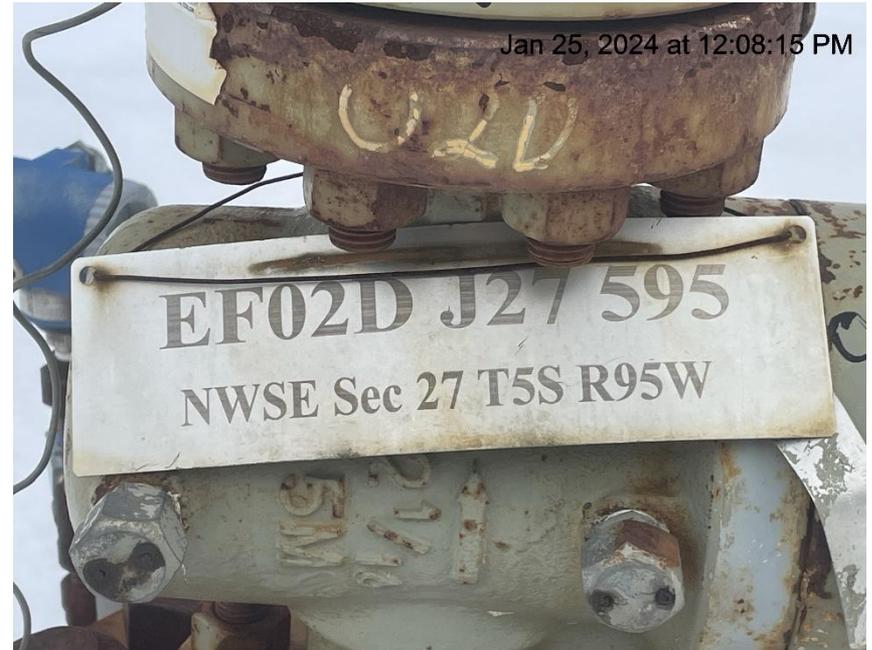
Photo # 3942 Wellhead signage insufficient/sign does not conform to CECMC rules

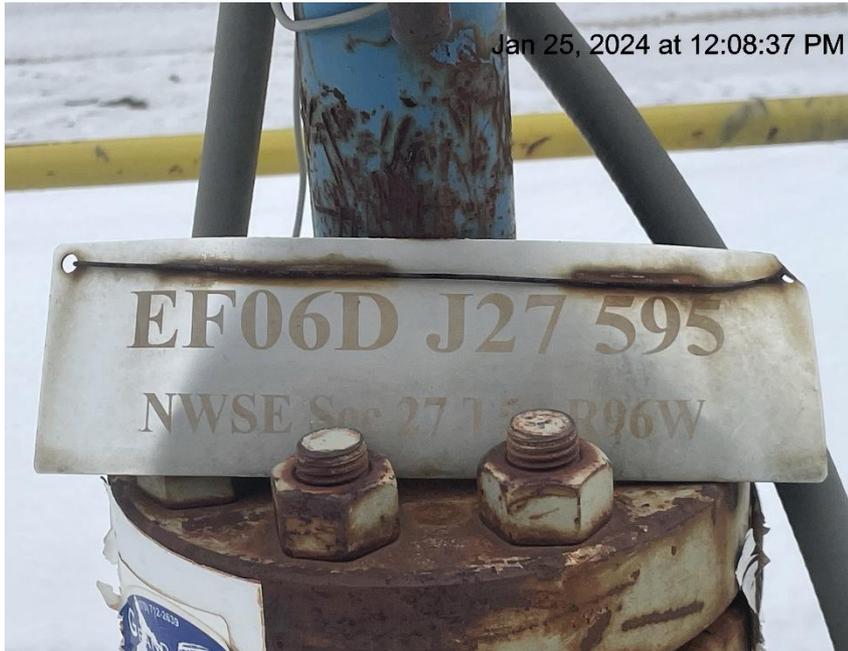
Photo # 3943 Wellhead signage insufficient/sign does not conform to CECMC rules

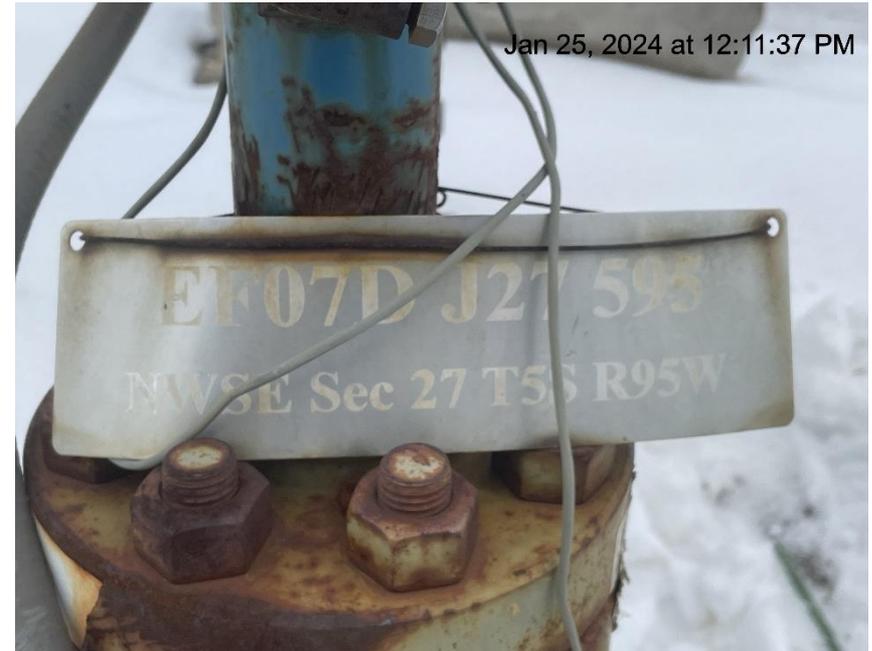
Photo # 3944 Wellhead signage insufficient/sign does not conform to CECMC rules
