Inspection Photos

Loc: 322227

Operator: **JAVERNICK OIL**

Inspection Date: 1/23/2024

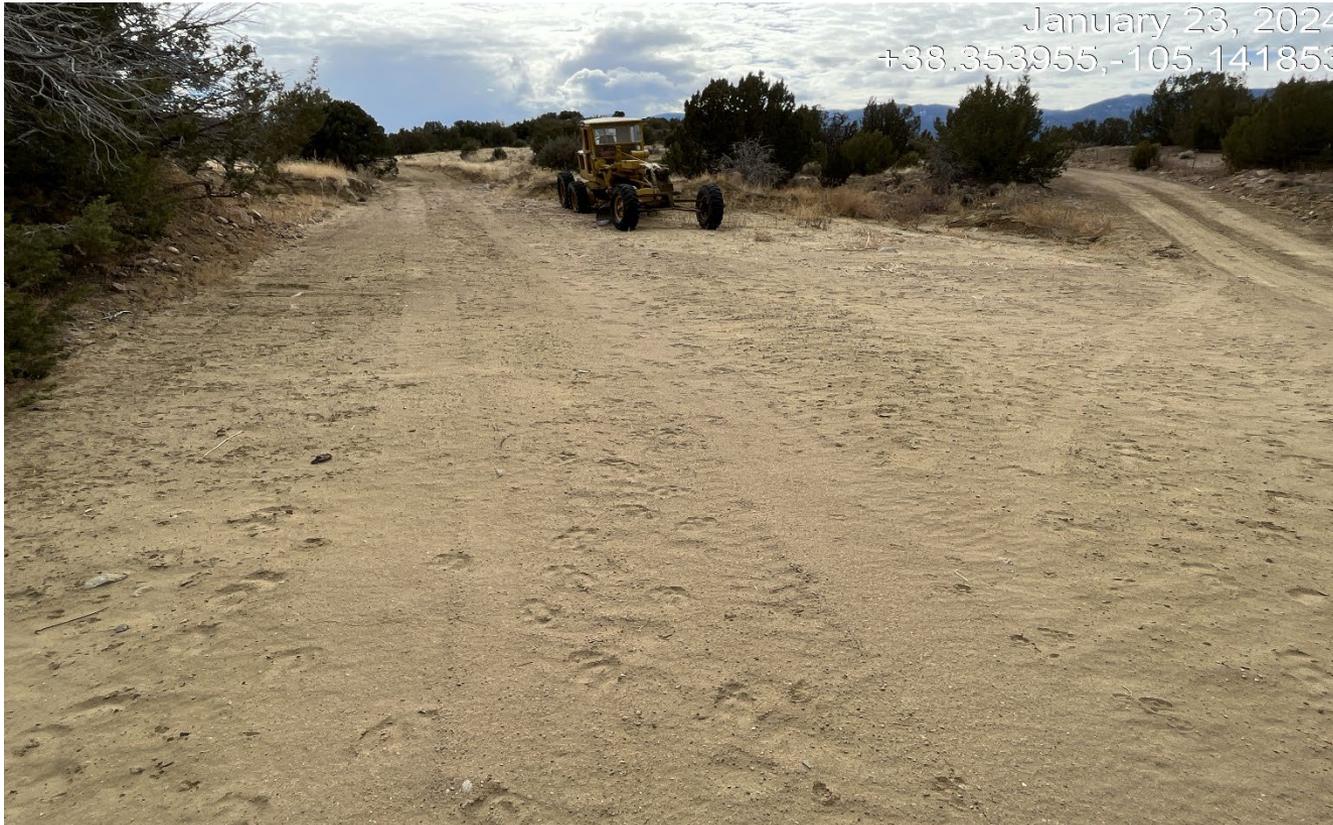
Photo 1. Facing southeast along the access road. This area has been regraded since the previous inspection. The sandy loose soils need to be stabilized.

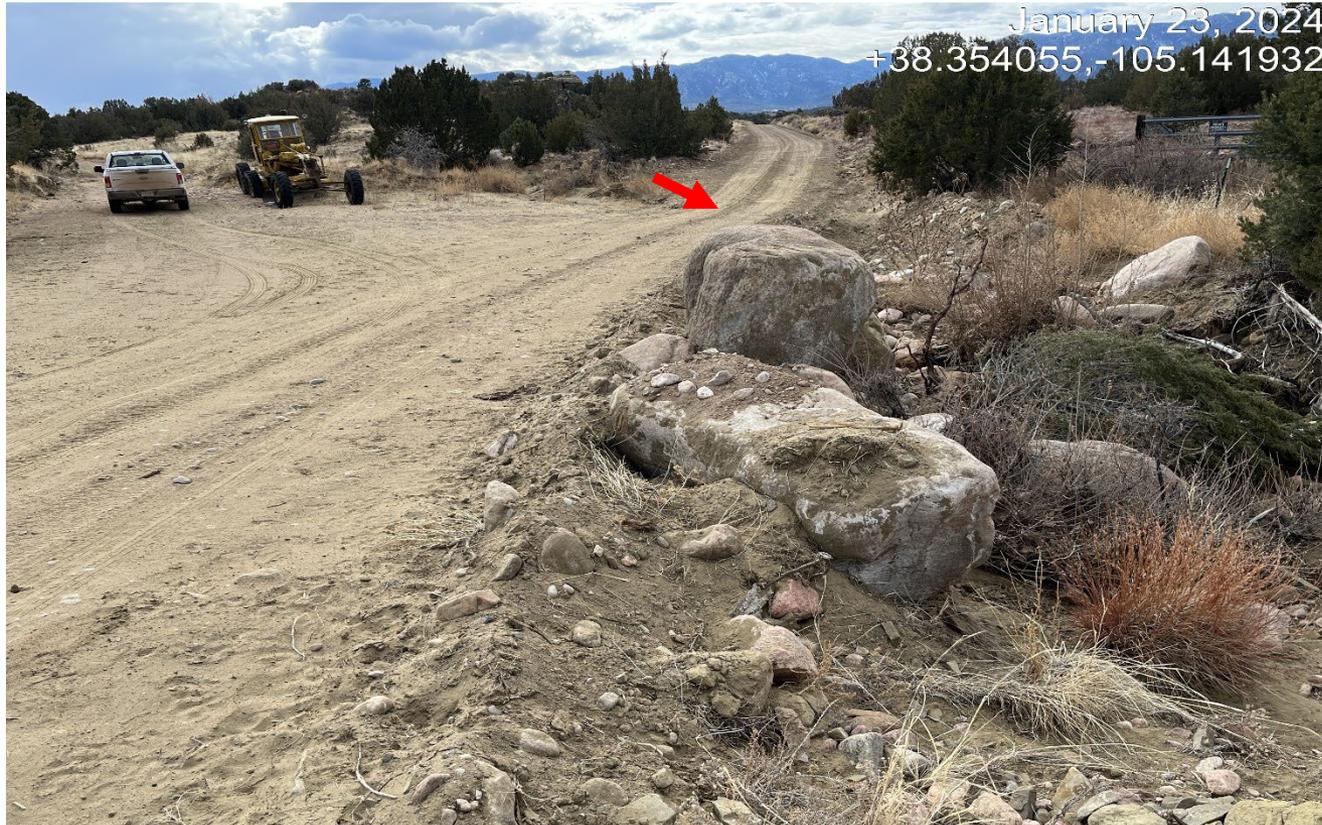
Photo 2. Facing south standing further back where the intermittent drainage crosses the road at red arrow. The rocks, sediment, and debris have been pushed out into the drainage at right side of the photo.

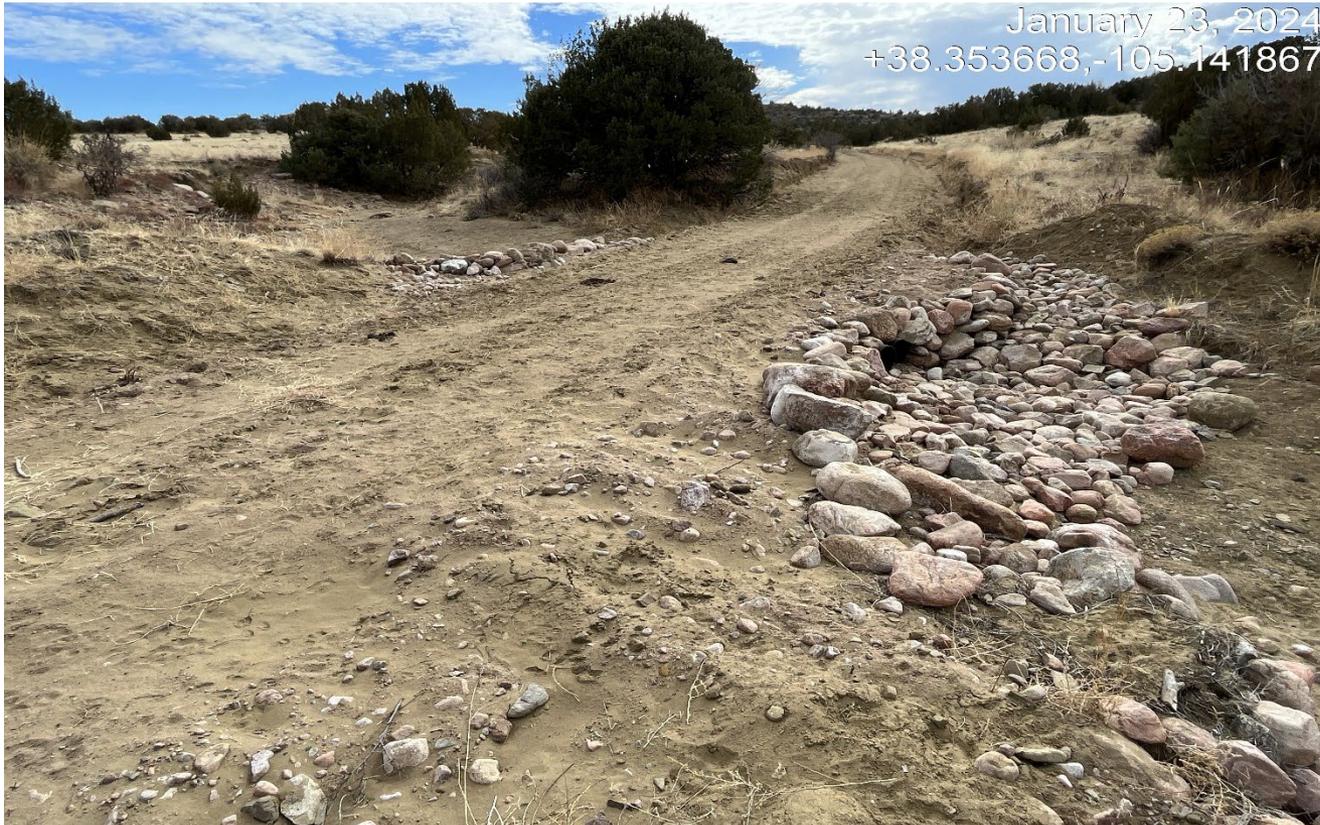
Photo 3. Facing toward the intermittent drainage that had washed out the road. There are two 1' culverts installed which may not be adequately sized for heavy storm events. The road rock used for outlet protection could become easily displaced.

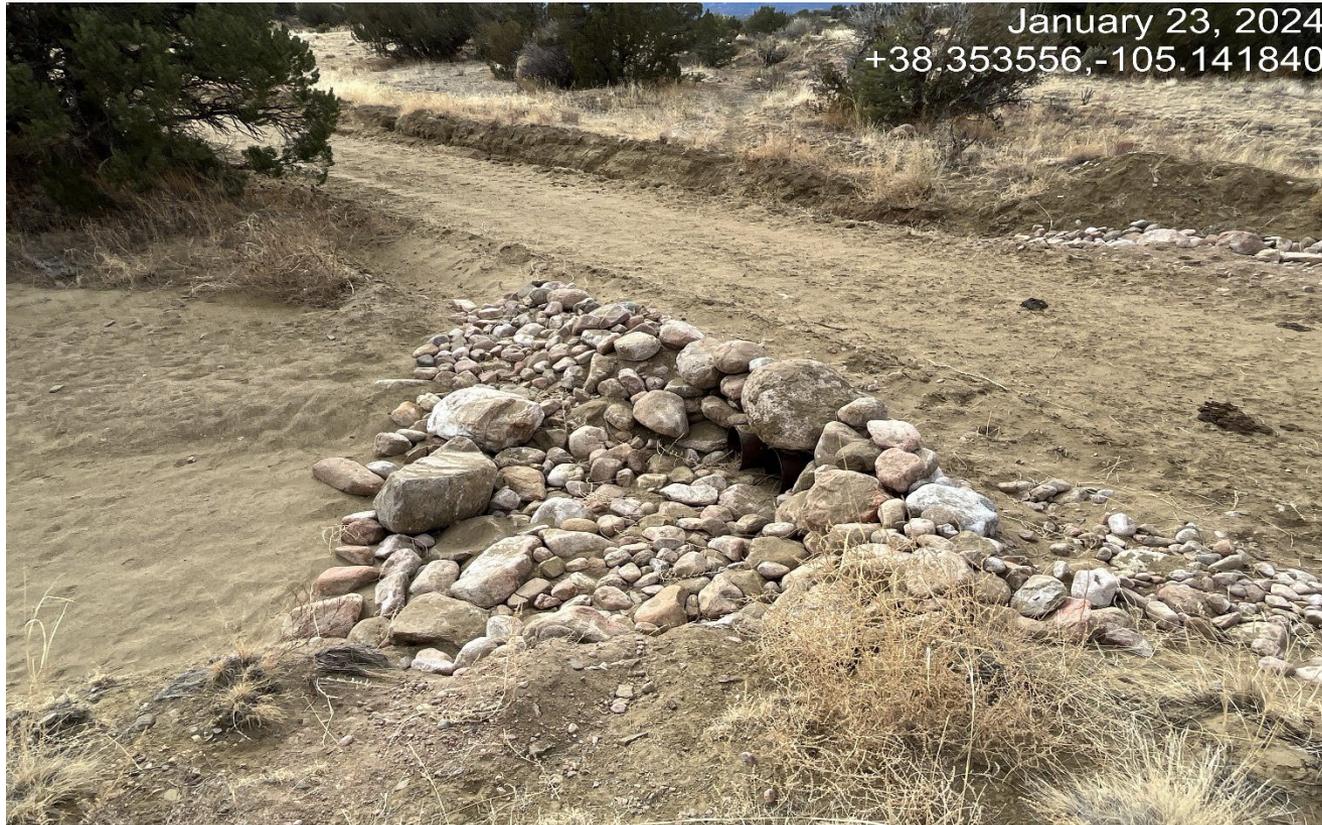
Photo 4. Facing toward the intermittent drainage that had washed out the road. There are two 1' culverts installed which may not be adequately sized for heavy storm events. The road rock used for outlet protection could become easily displaced.

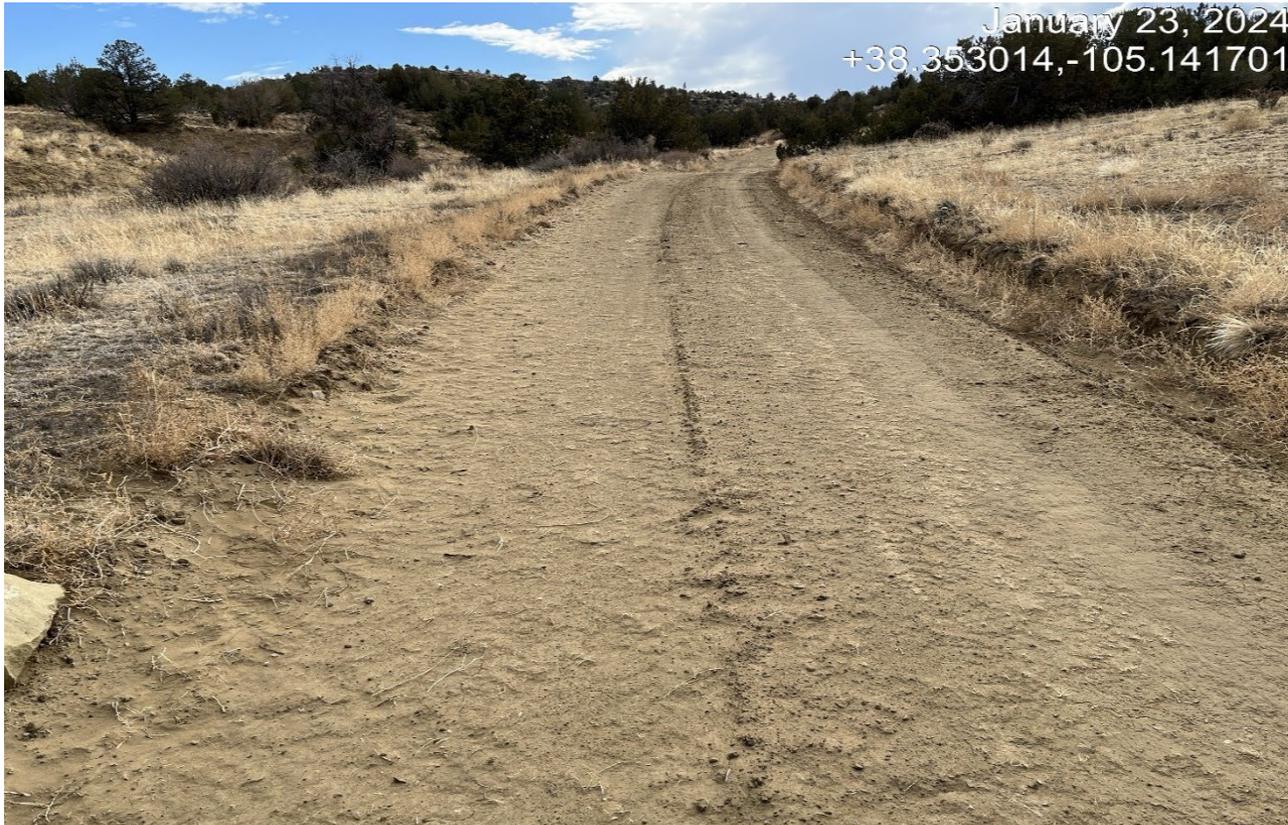
Photo 5. Further up along the access road facing southeast. The loose sandy soils are not stabilized and could easily erode.

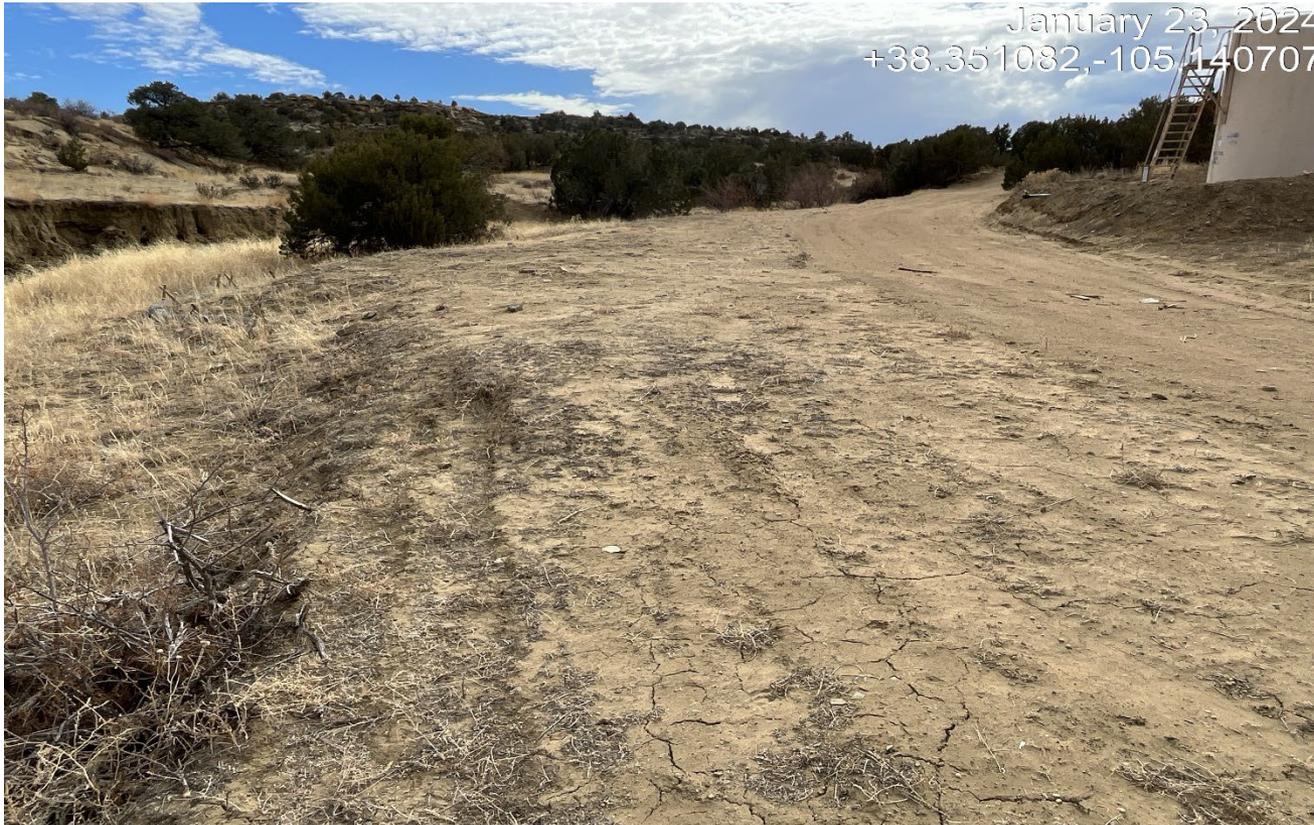
Photo 6. Facing southeast at the tank battery site. The disturbed area along the road side needs to be reclaimed and stabilized. Previous corrective action was not completed.

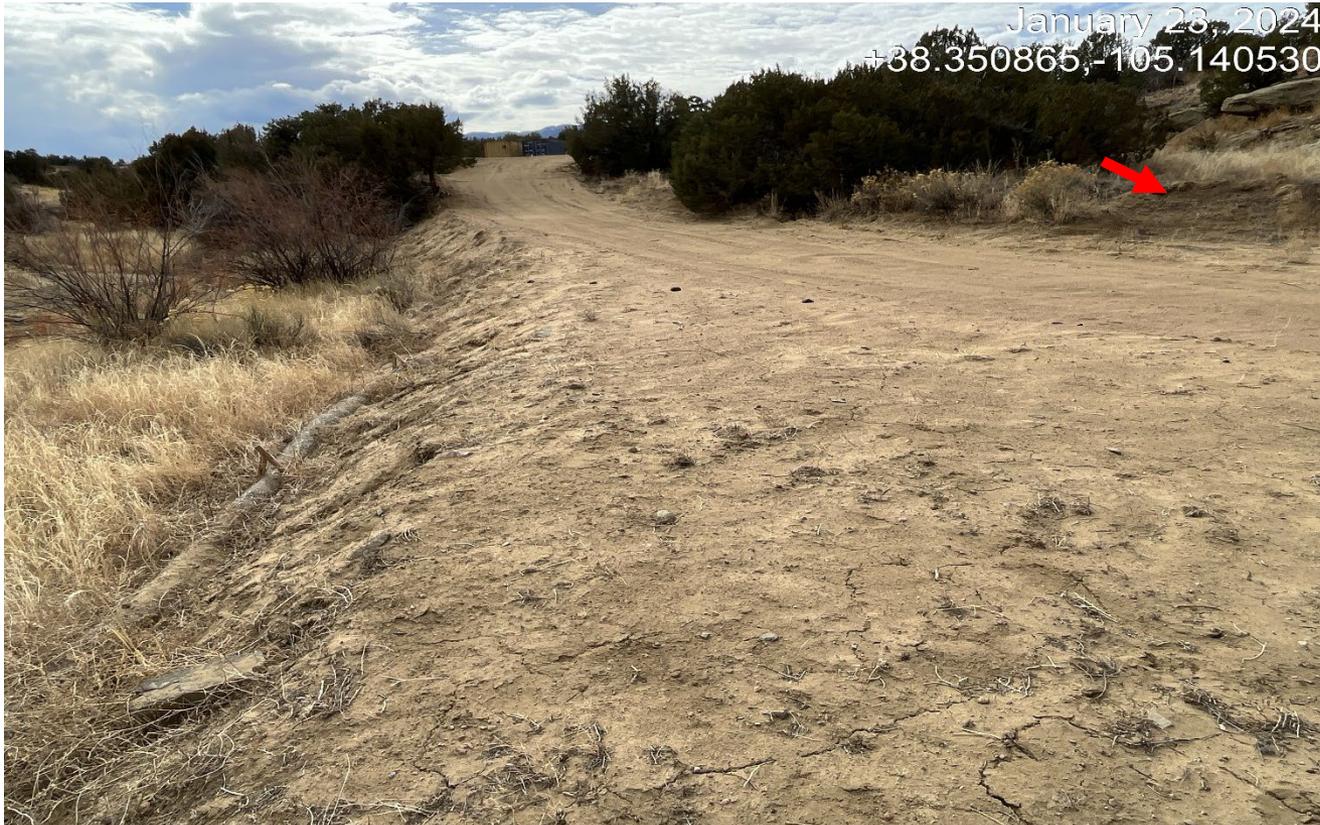
Photo 7. Facing south where soils were pushed out along the road side. Disturbed soils need to be replaced (at red arrow) and reclaimed.

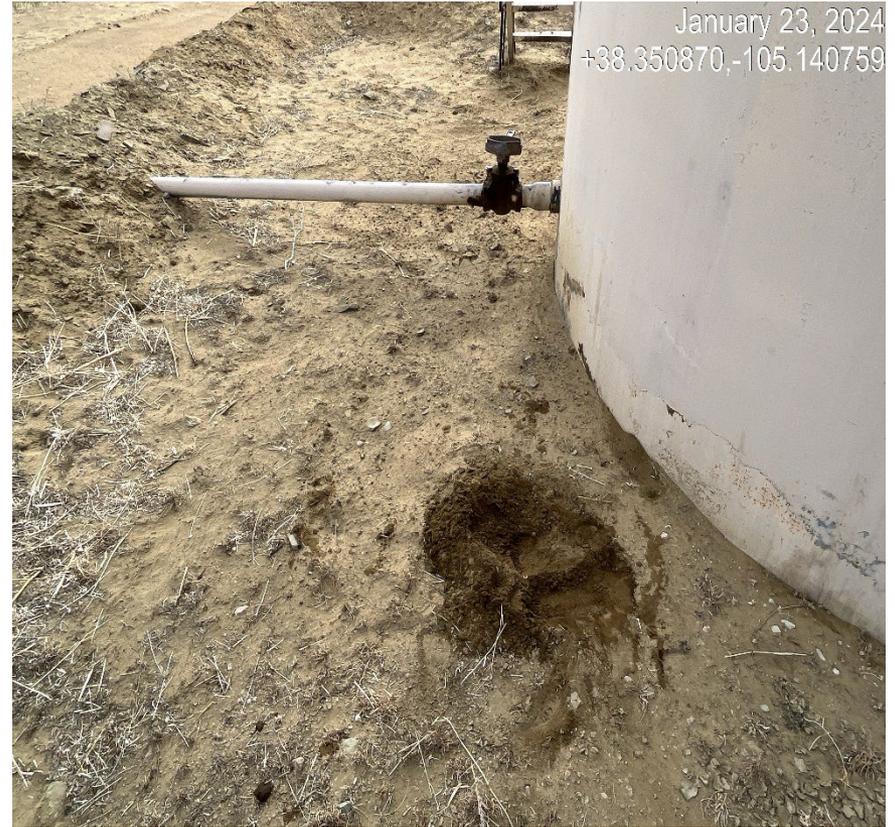
Photo 10. There appears to be oil stained soil at the from side of the tank.

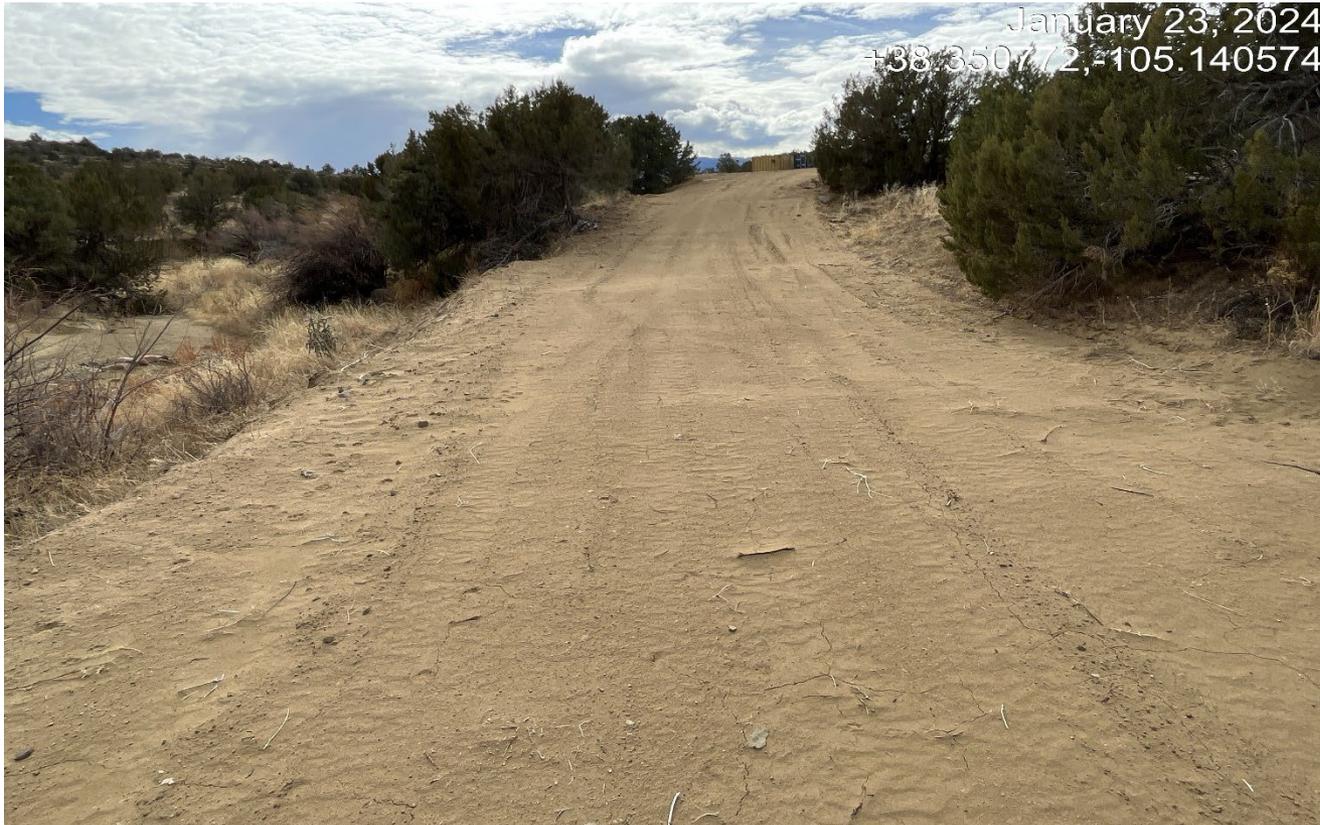
Photo 11. Facing south along the access road to the wellsite location. The erosion along this area was repaired however BMP's have not been installed and loose soils are susceptible to erosion.

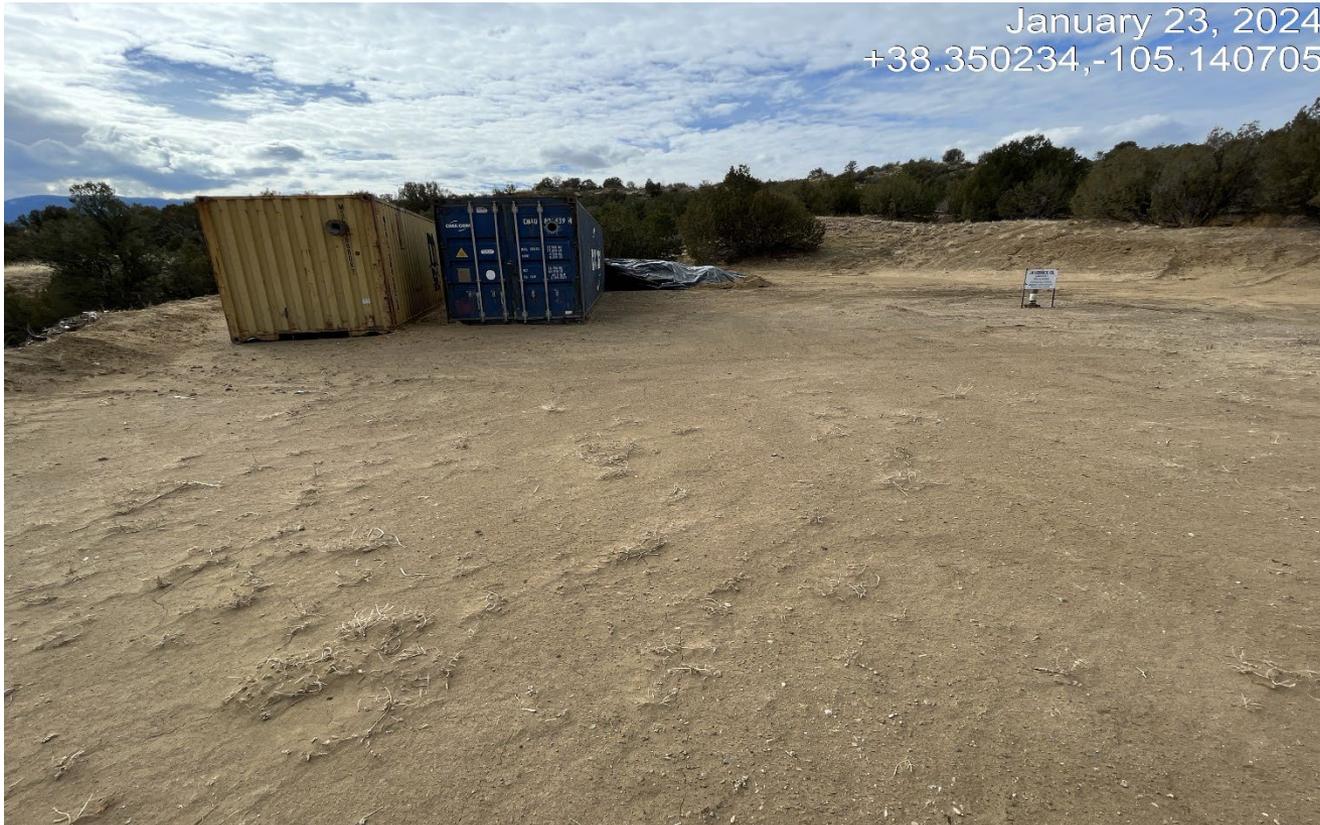
Photo 12. Facing southwest toward the well site. There are still equipment containers that need to be removed.

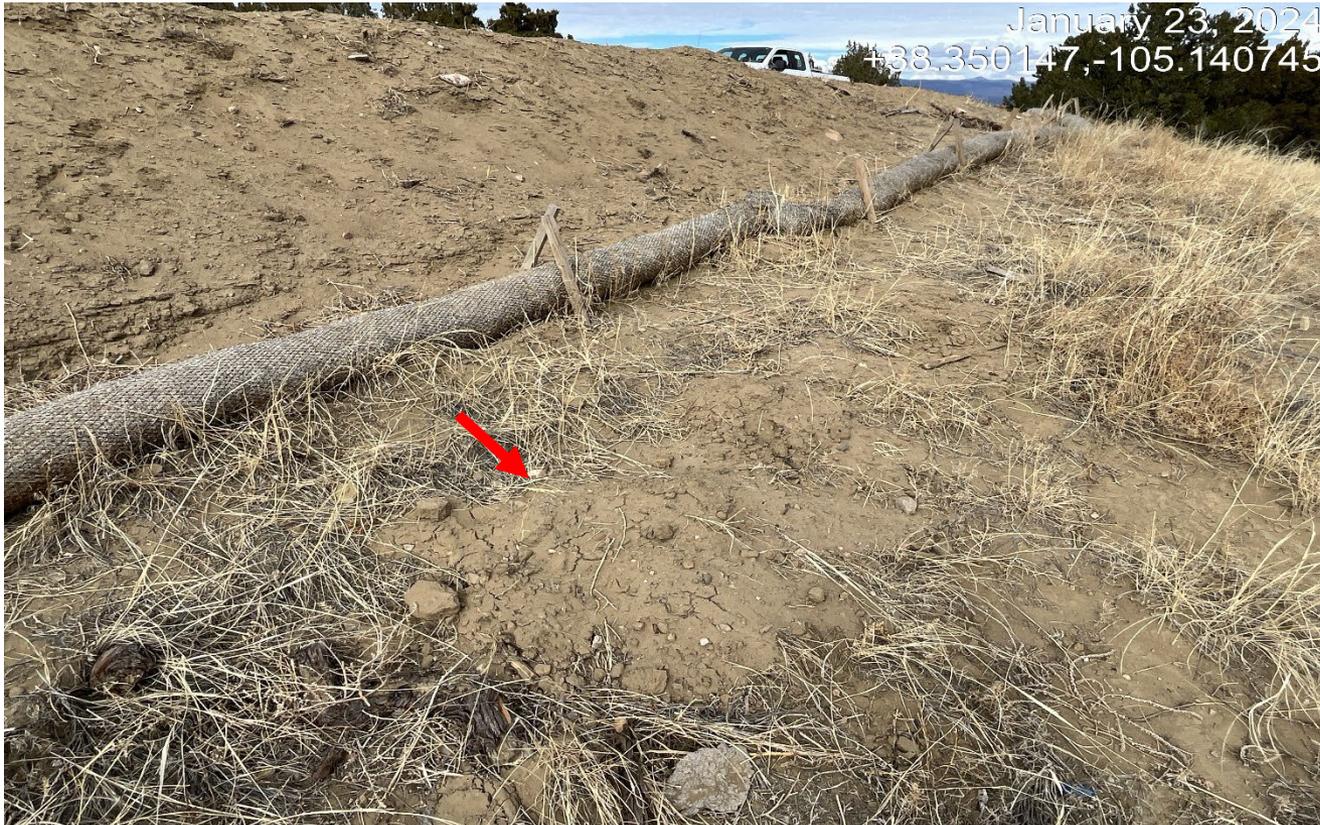
Photo 15. Facing along the east side of the location. It appears sediment along the wattles was cleaned out and shoveled toward the outside of the wattles shown at red arrow. The wattles are meant to contain sediment from leaving the site.

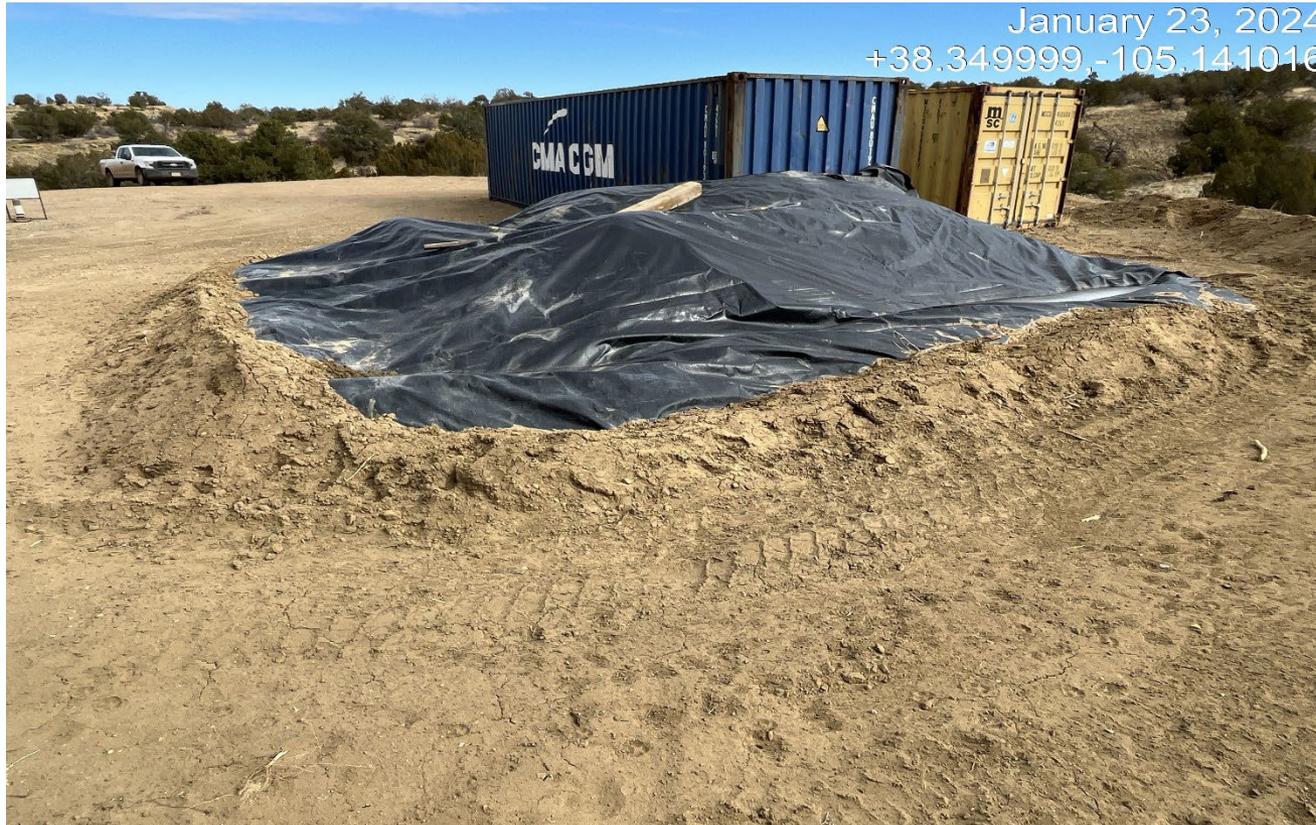
Photo 17. Facing toward the cuttings pile that still remains on location. The cuttings pile is covered with a plastic tarp.

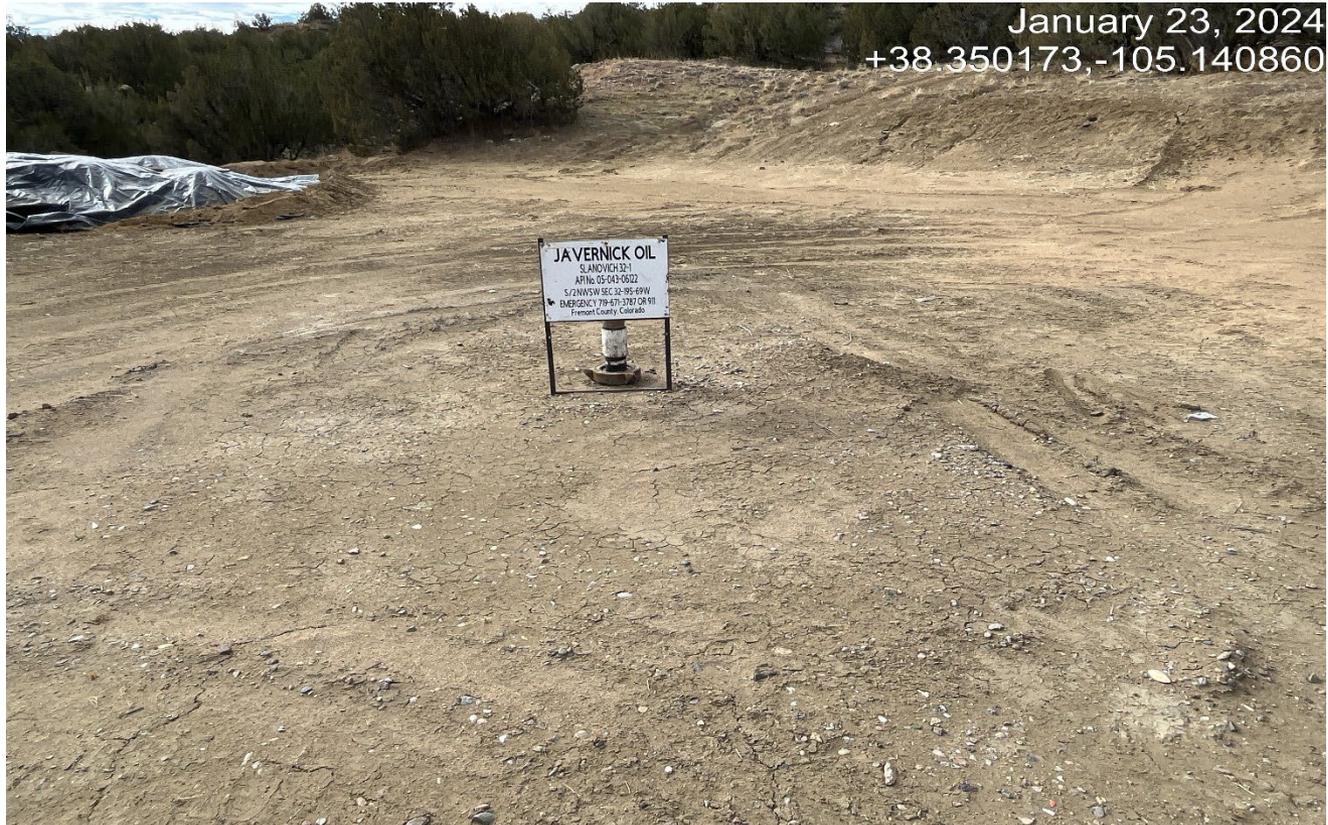
Photo 19. Facing southwest toward the wellsite. Sign is posted at the wellhead and well is temporarily abandoned.

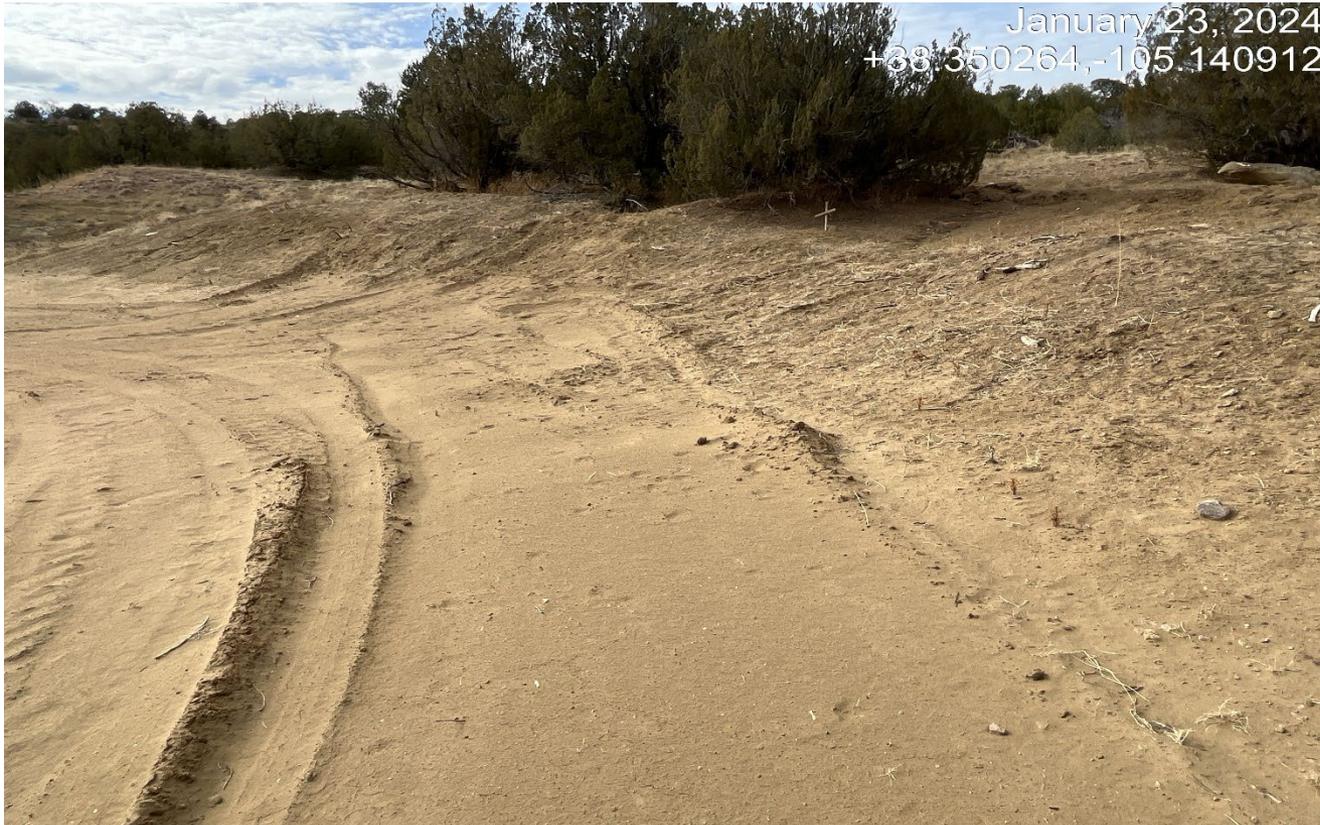
Photo 20. Facing southwest at the location. The cut slope of the location is not stabilized and there are insufficient stormwater run-on controls.

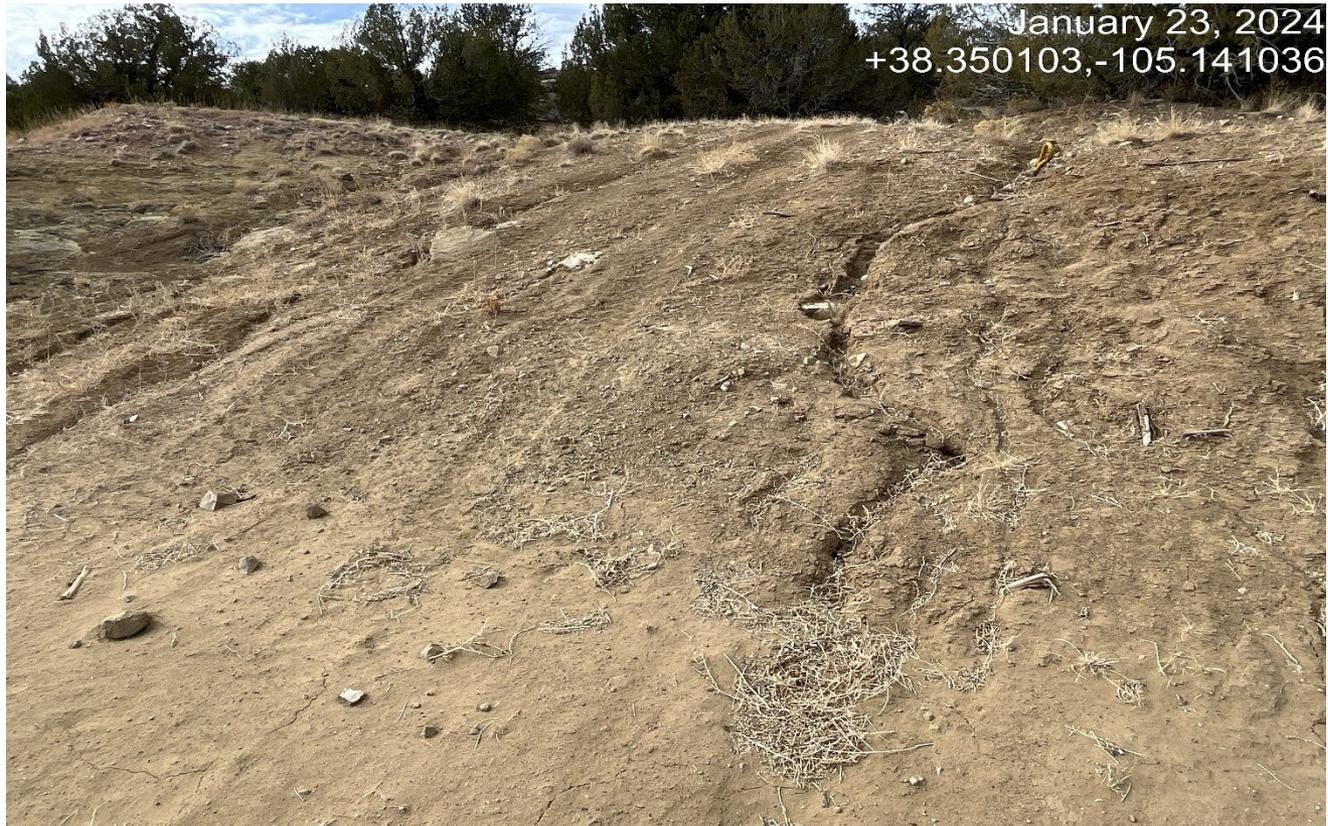
Photo 21. Facing toward the cut slope which still has signs of erosion rilling.

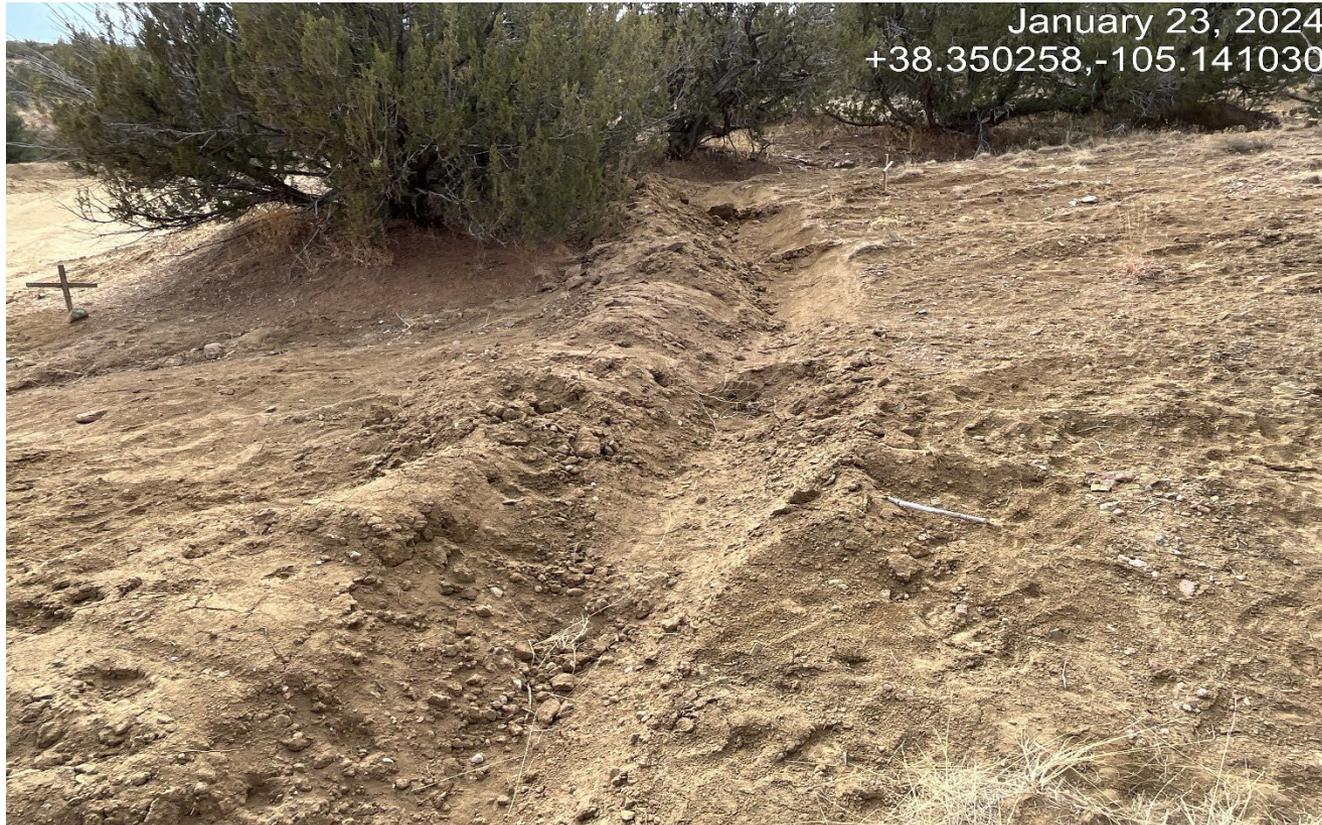
Photo 22. A small ditch was installed above the northwest side however, loose disturbed soils are susceptible to erosion.
