Inspection Photos

Location Name: CAERUS PICEANCE LLC N.PARACHUTE EF15D C27 595 Pad

Location #: 335828

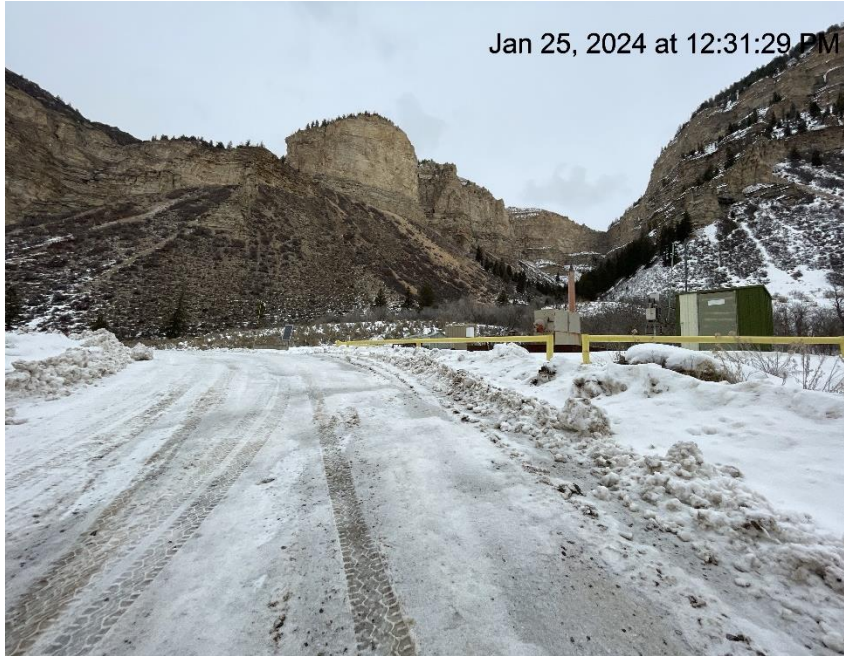
Photo # 3971 From entrance to location

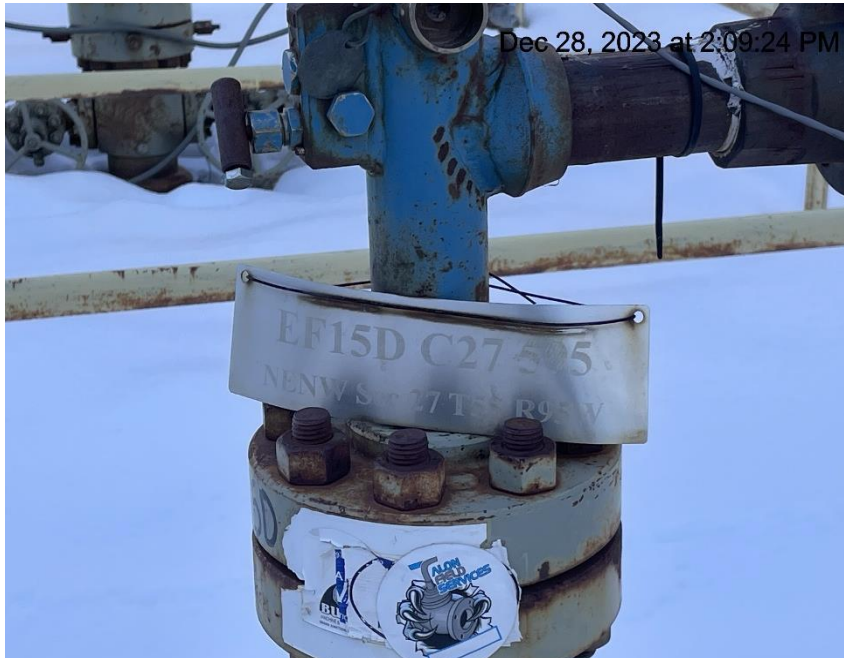
Photo # 1367 From inspection 708902651 conducted on 12/28/2023 Wellhead sign lacks required info/sign in not in compliance with CECMC rules

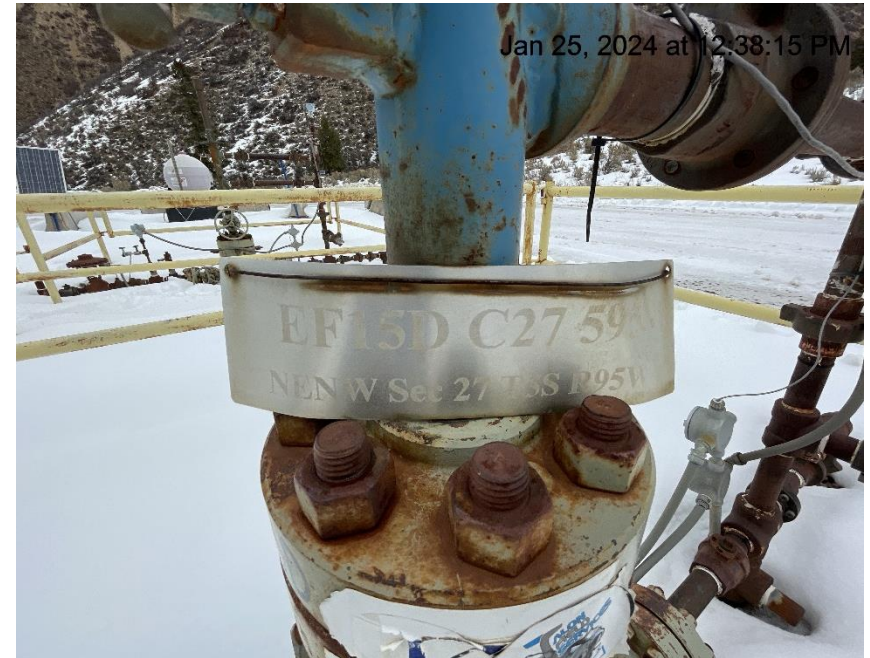
Photo # 3979 Wellhead sign lacks required info/sign in not in compliance with CECMC rules

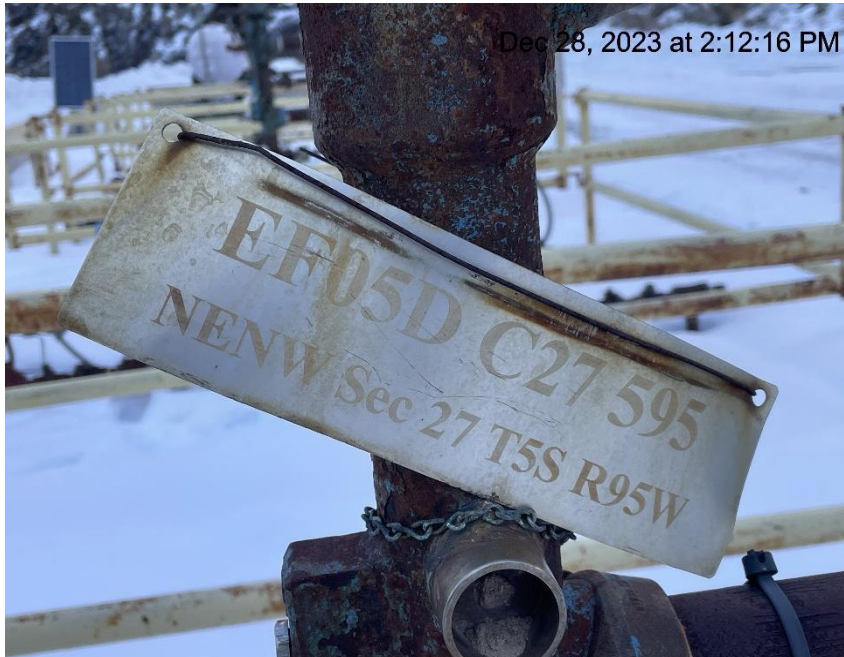
Photo # 1368 From inspection 708902651 conducted on 12/28/2023 Wellhead sign lacks required info/sign in not in compliance with CECMC rules

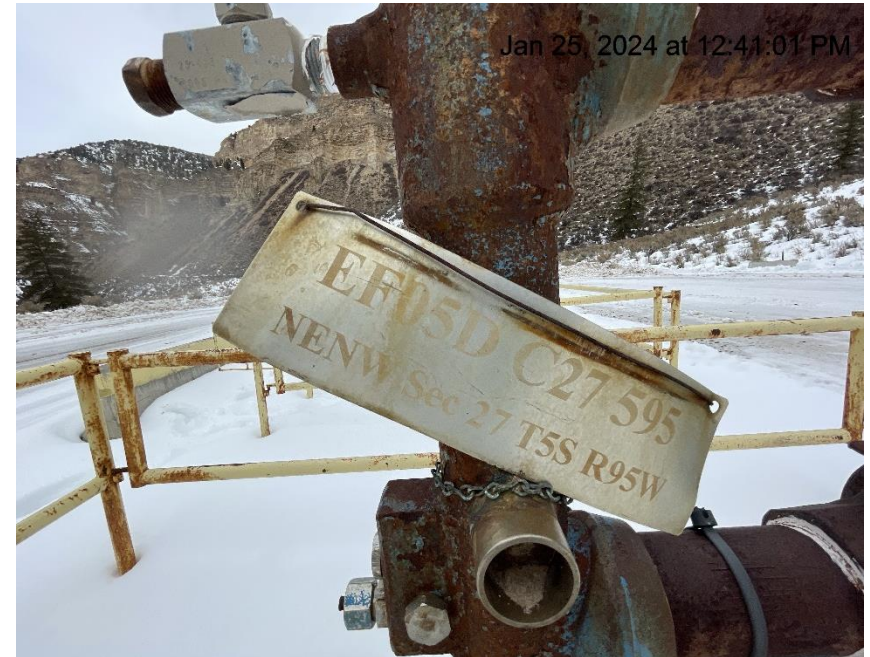
Photo # 3980 Wellhead sign lacks required info/sign in not in compliance with CECMC rules

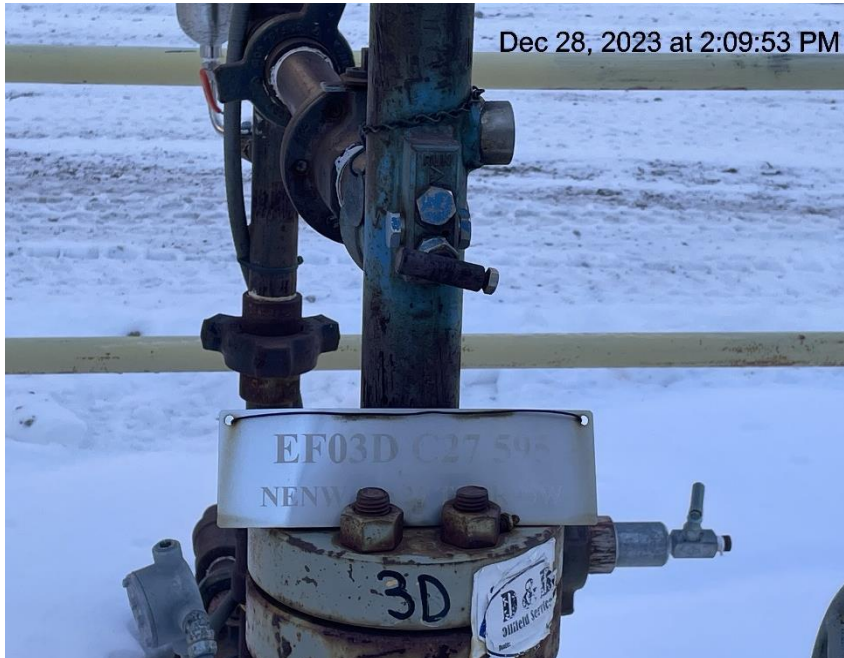
Photo # 1369 From inspection 708902651 conducted on 12/28/2023 Wellhead sign lacks required info/sign in not in compliance with CECMC rules

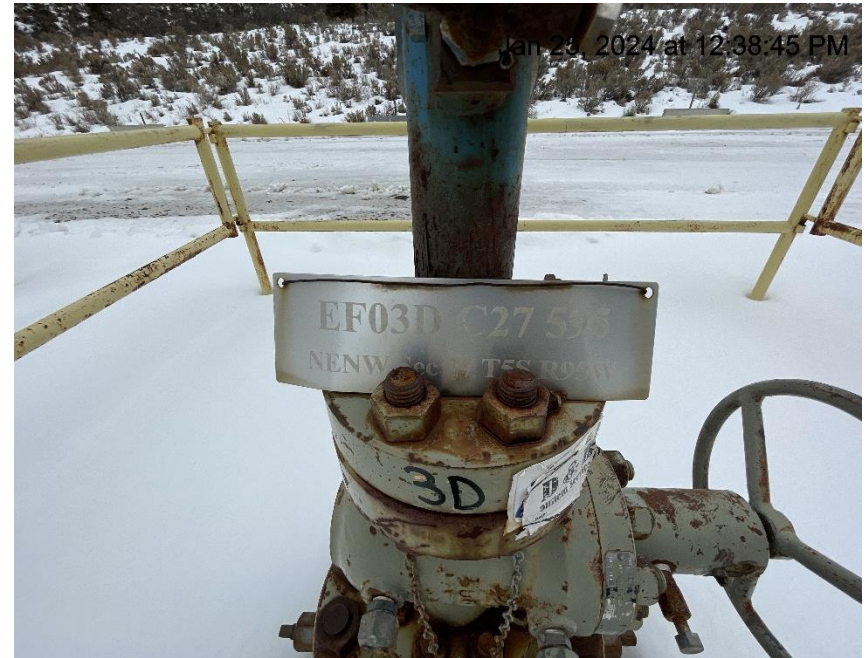
Photo # 3981 Wellhead sign lacks required info/sign in not in compliance with CECMC rules

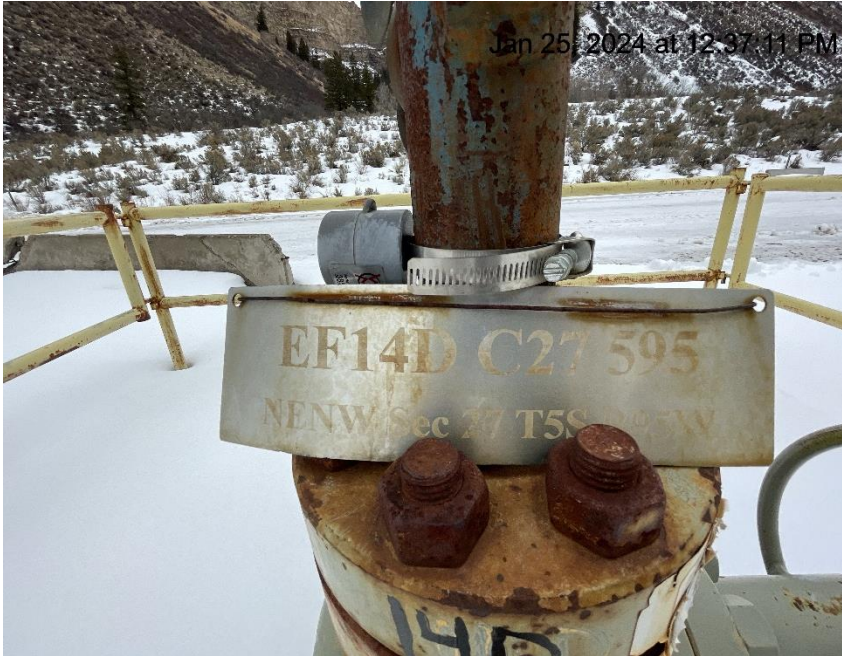
Photo # 3982 Wellhead sign lacks required info/sign in not in compliance with CECMC rules
