Inspection Photos

Location Name: CAERUS PICEANCE LLC N. PARACHUTE H29A 595 Pad

Location #: 335594

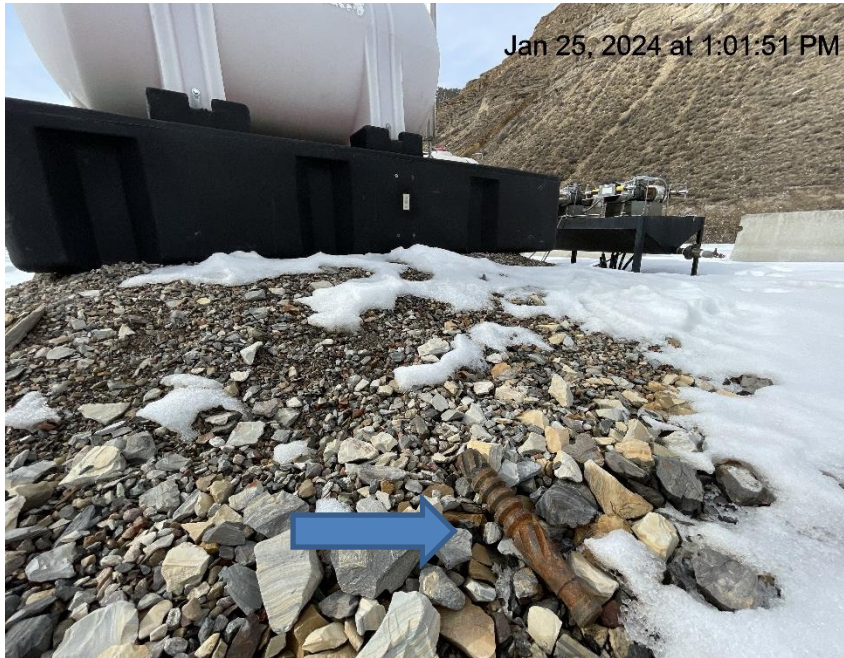
Photo # 4015 Debris

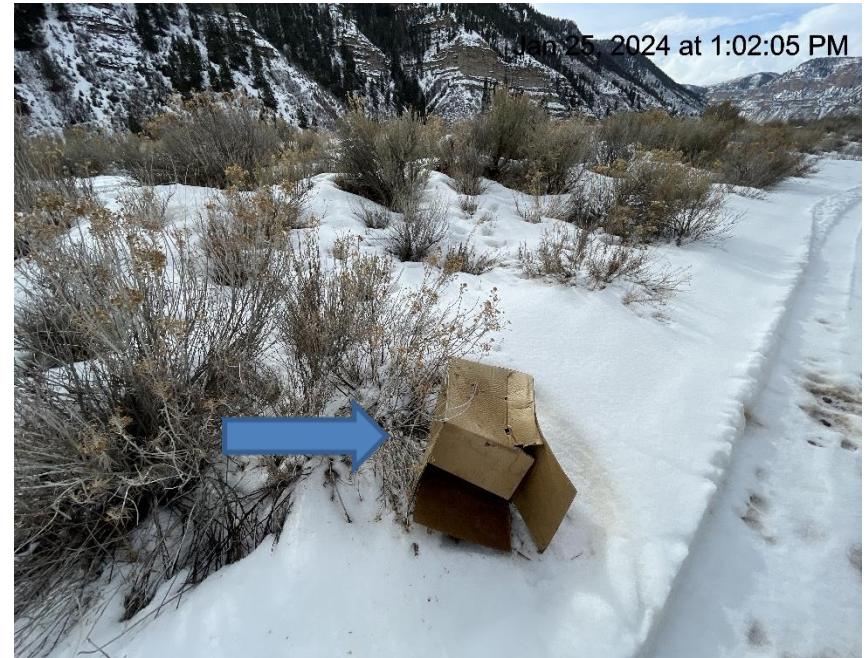
Photo # 4016 Debris

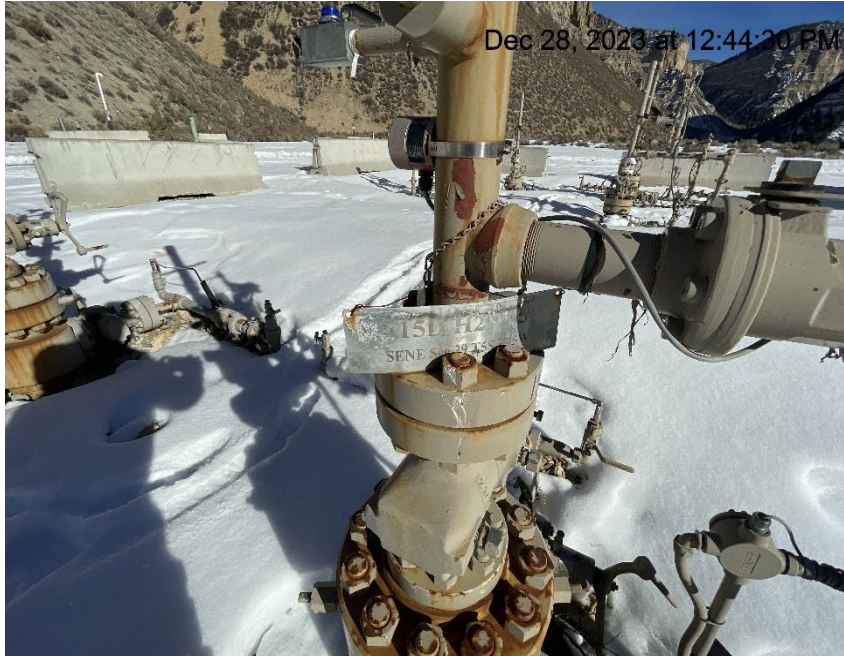
Photo # 1207 From inspection 708902630 conducted on 12/28/2023 All wellhead signs on location lack required information/wellhead signage insufficient/signs are not in compliance with CECMC rules

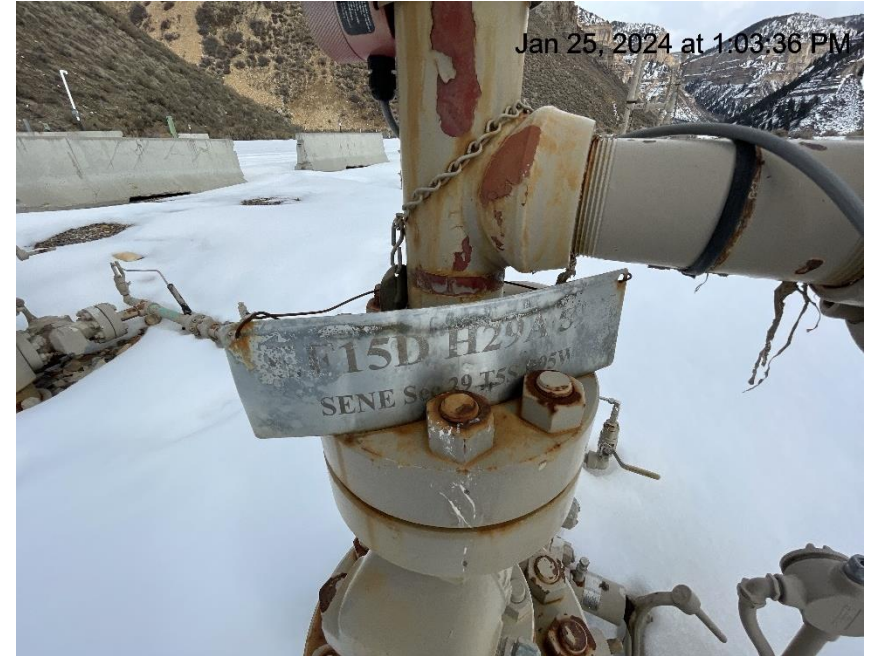
Photo # 4017 All wellhead signs on location lack required information/wellhead signage insufficient/signs are not in compliance with CECMC rules

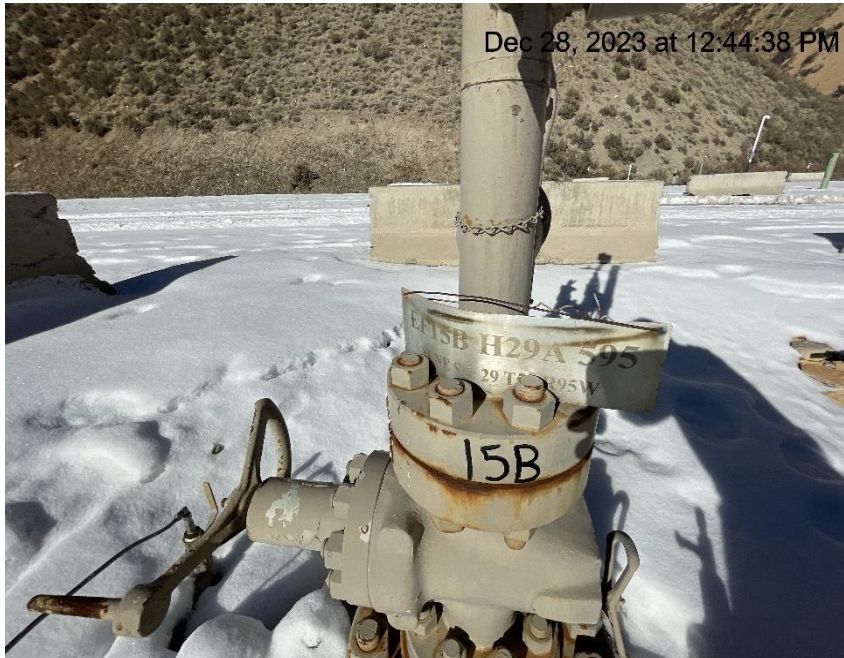
Photo # 1208 From inspection 708902630 conducted on 12/28/2023 All wellhead signs on location lack required information/wellhead signage insufficient/signs are not in compliance with CECMC rules

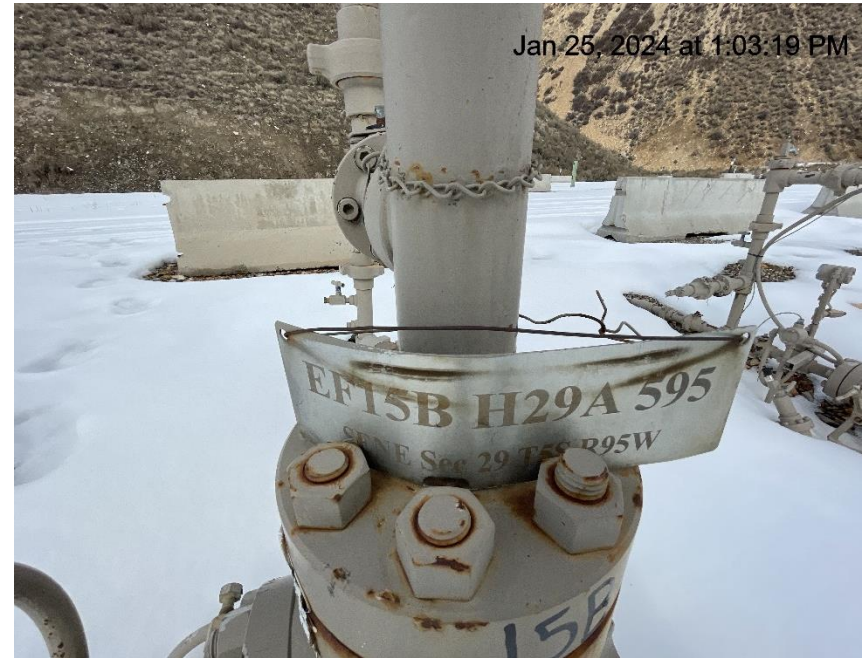
Photo # 4018 All wellhead signs on location lack required information/wellhead signage insufficient/signs are not in compliance with CECMC rules

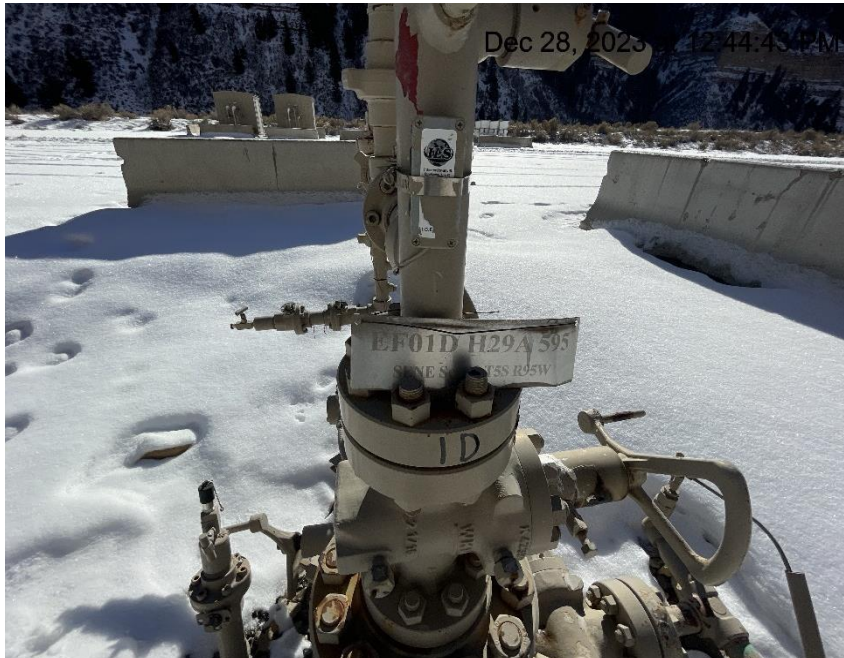
Photo # 1209 From inspection 708902630 conducted on 12/28/2023 All wellhead signs on location lack required information/wellhead signage insufficient/signs are not in compliance with CECMC rules

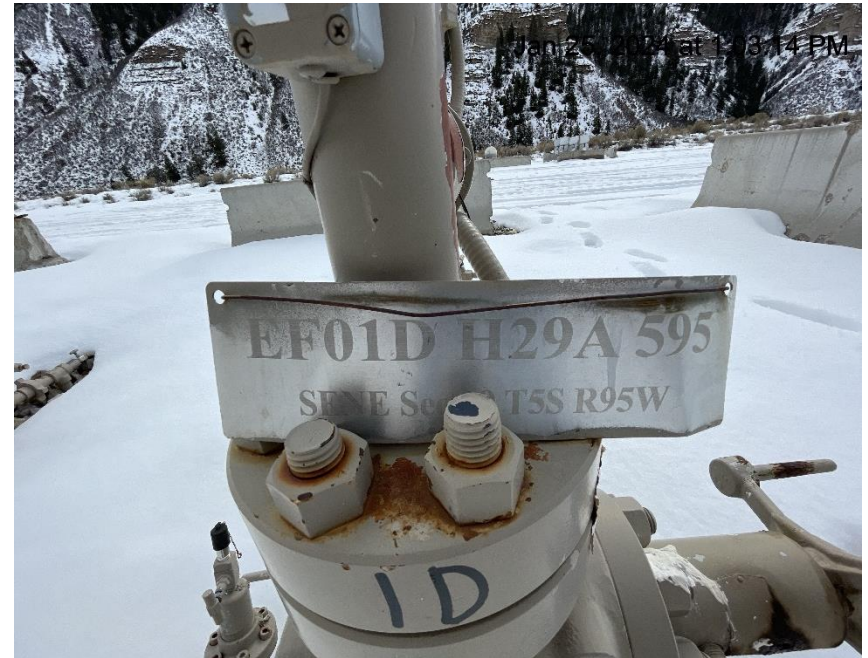
Photo # 4019 All wellhead signs on location lack required information/wellhead signage insufficient/signs are not in compliance with CECMC rules
