Inspection Photos

Location Name: CAERUS PICEANCE LLC Federal 29-6BB (PF-29) Pad

Location #: 334681

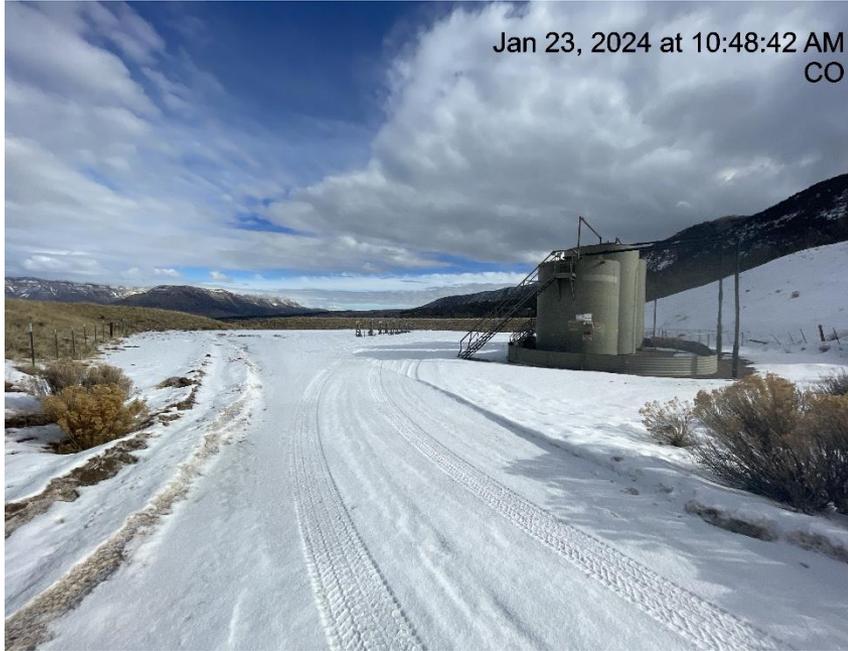
Photo # 3488 From entrance to location

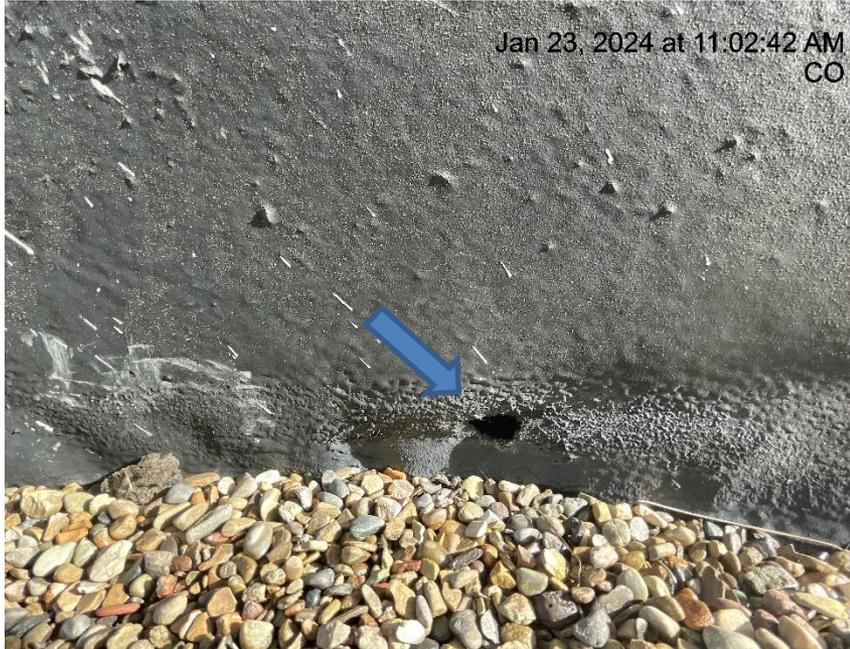
Photo # 3496 Hole in secondary containment liner
