Inspection Photos

Location Name: CAERUS PICEANCE LLC S. PARACHUTE FEDERAL PA-30 Pad

Location #: 334663

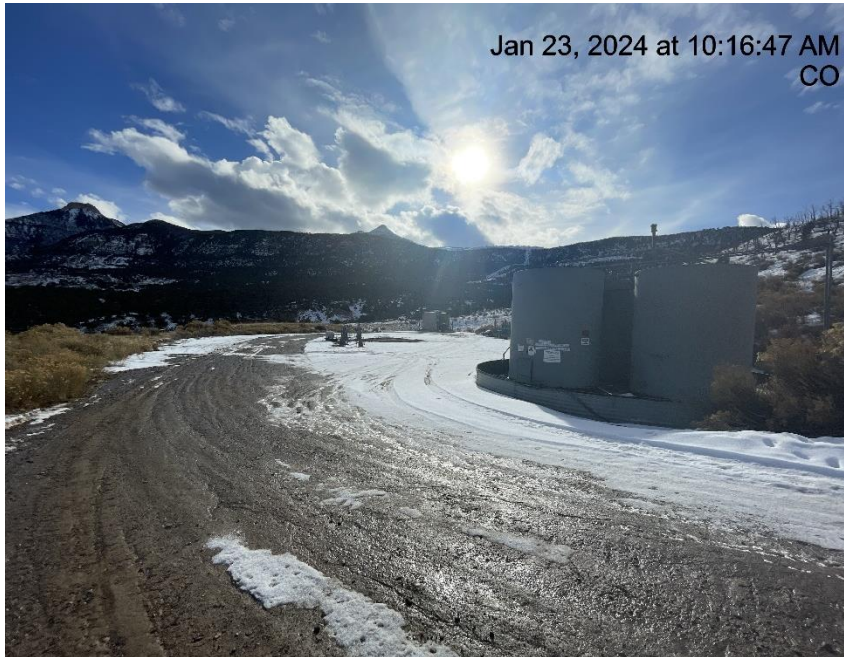
Photo # 3433 From entrance to location

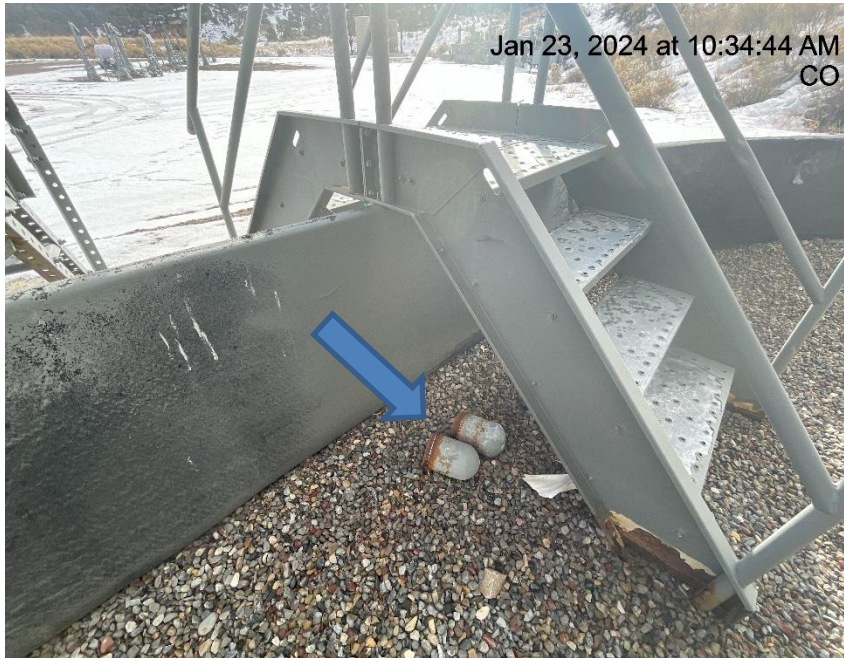
Photo # 3441 Debris

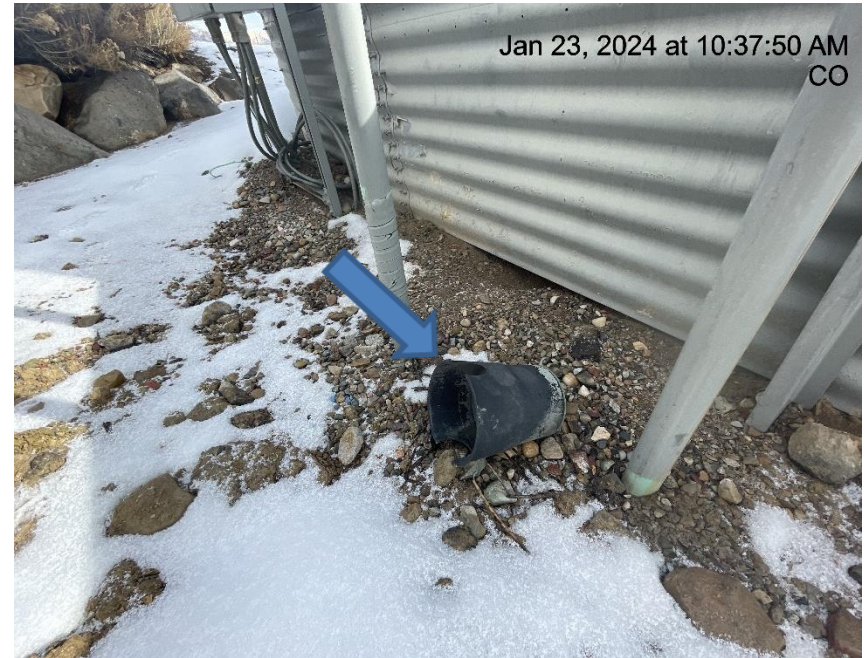
Photo # 3442 Debris

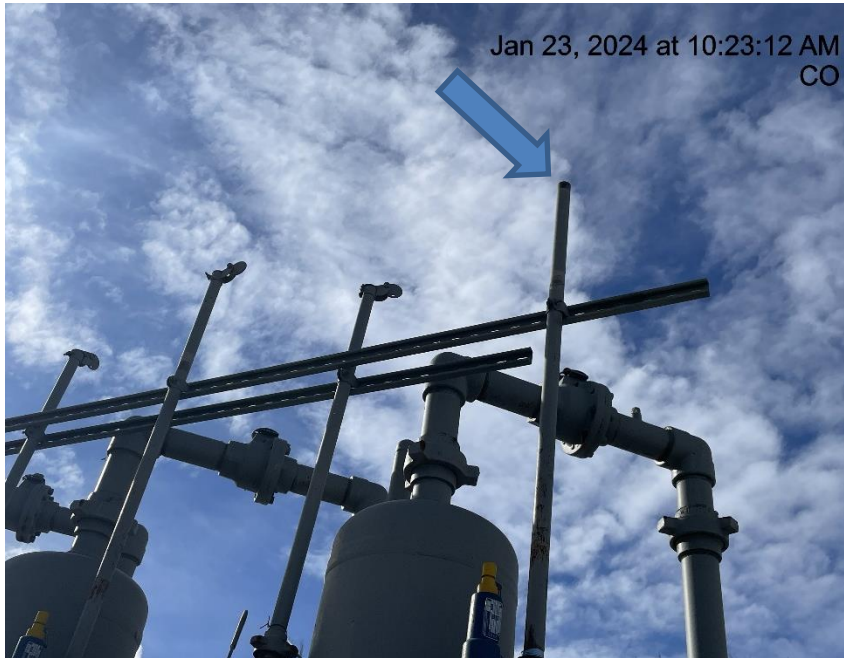
Photo # 3443 PRV vent line lacks cap

Photo # 3445 Cap installed on PRV vent line by Caerus employee

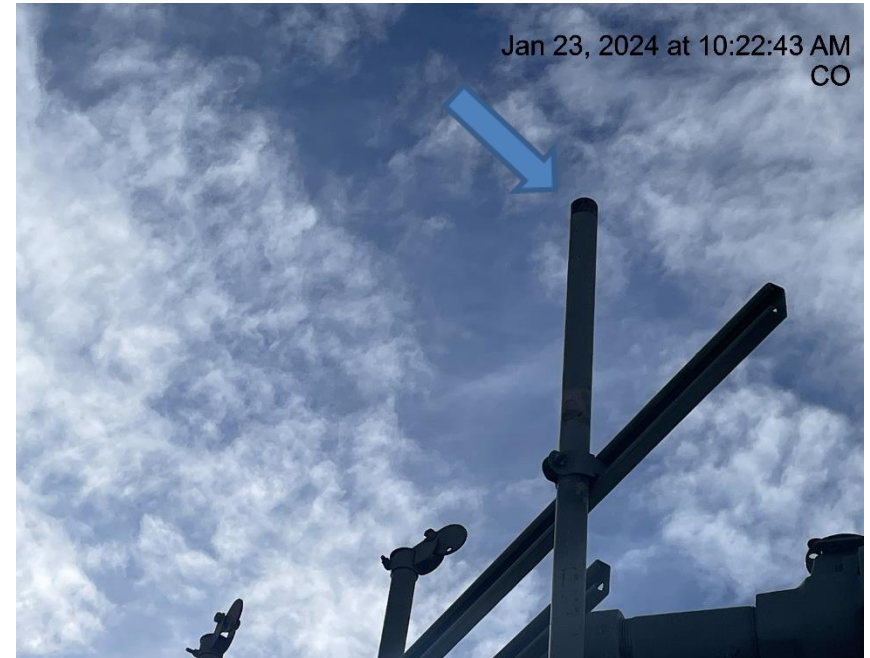
Photo # 3444 PRV vent line lacks cap

Photo # 3446 Cap installed on PRV vent line by Caerus employee
