Inspection Photos

Loc: 309022

Operator: EVERGREEN NATURAL
RESOURCES LLC

Inspection Date: 1/25/2024

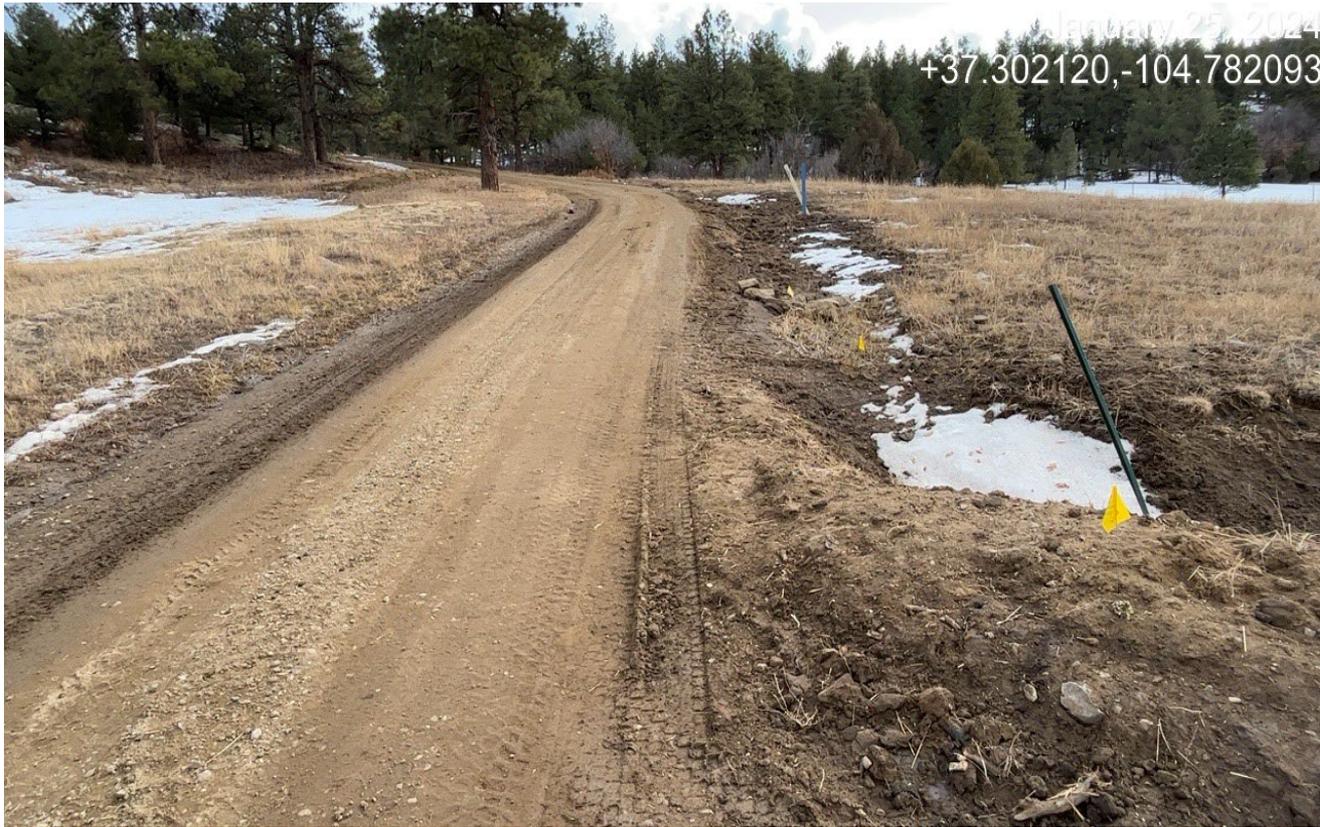
Photo 1. This culvert has been cleaned out and maintained at Lat/Long:37.302109, -104.78223 .

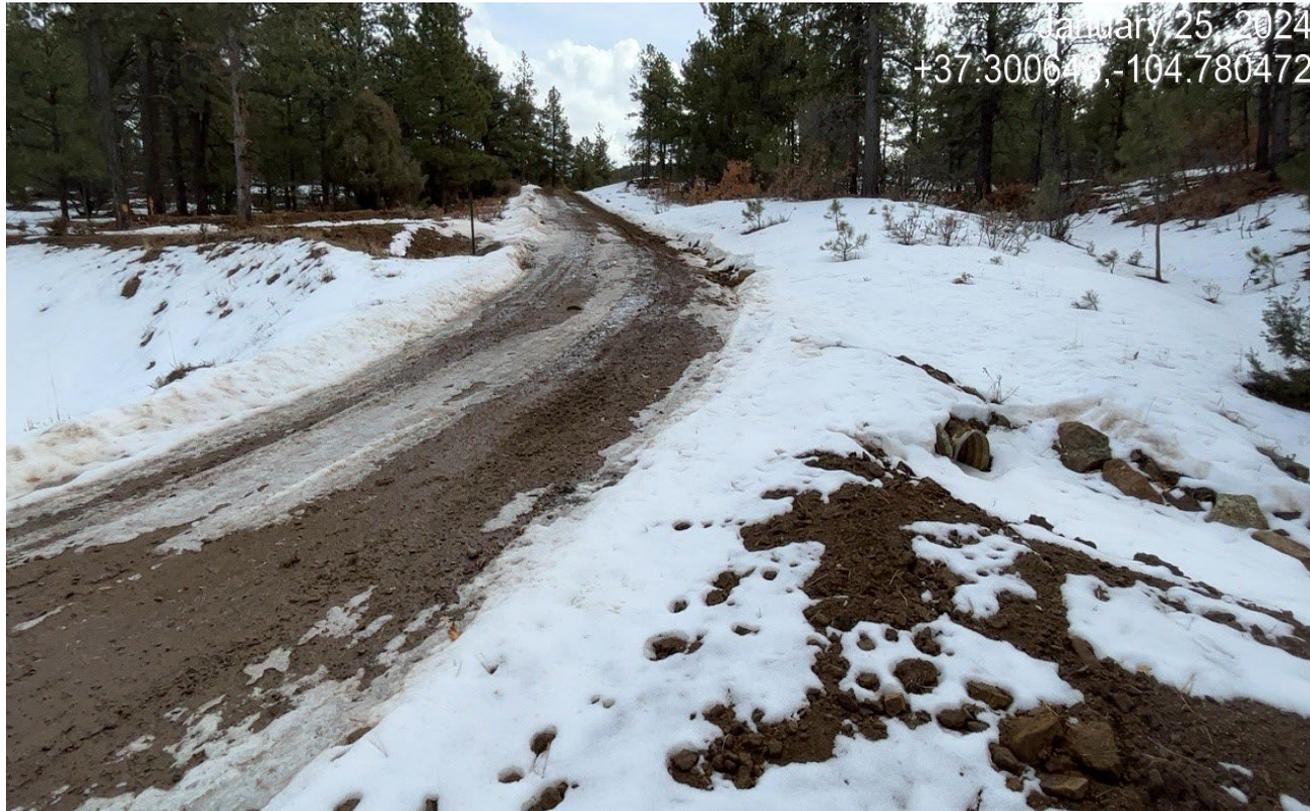
Photo 2. It appears erosion was repaired by the Rampart 43-33 well site.

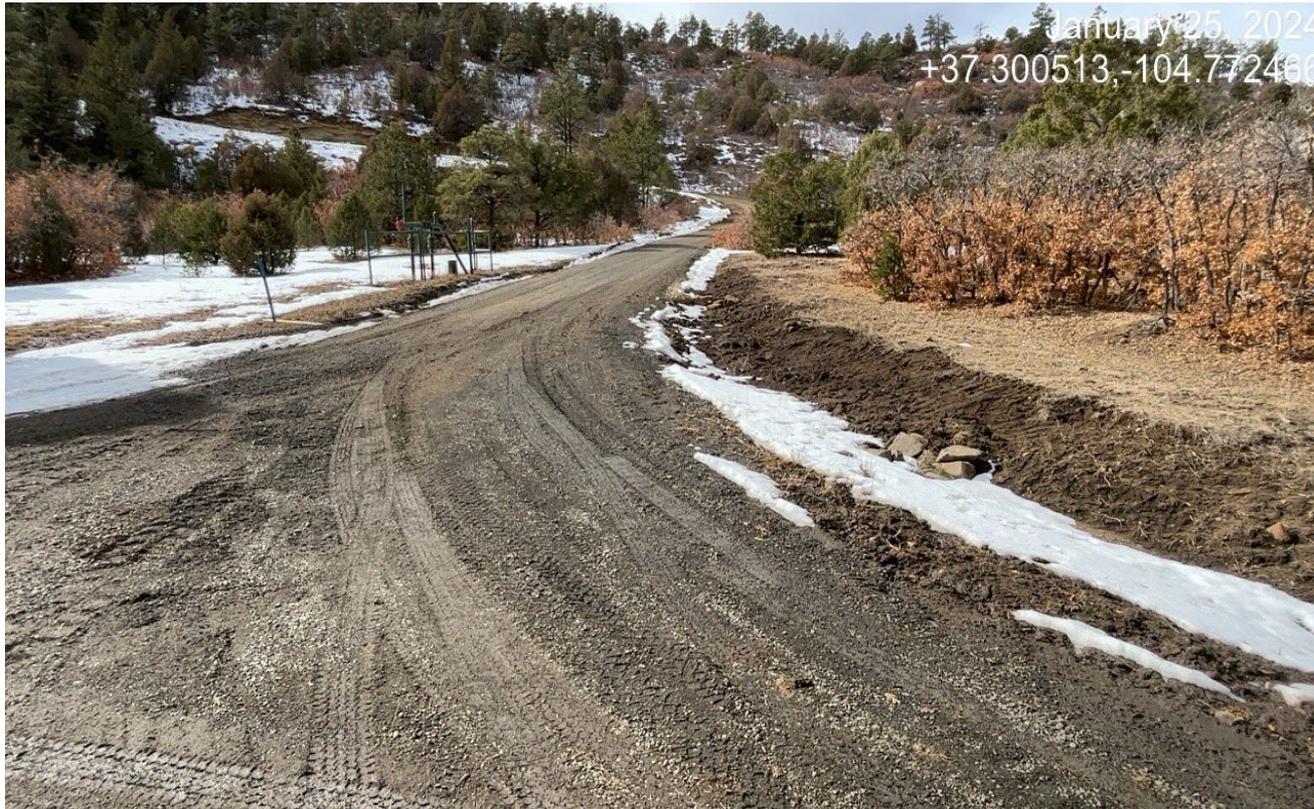
Photo 3. Facing southwest along. There has been repairs performed along the road and disturbed areas were seeded.

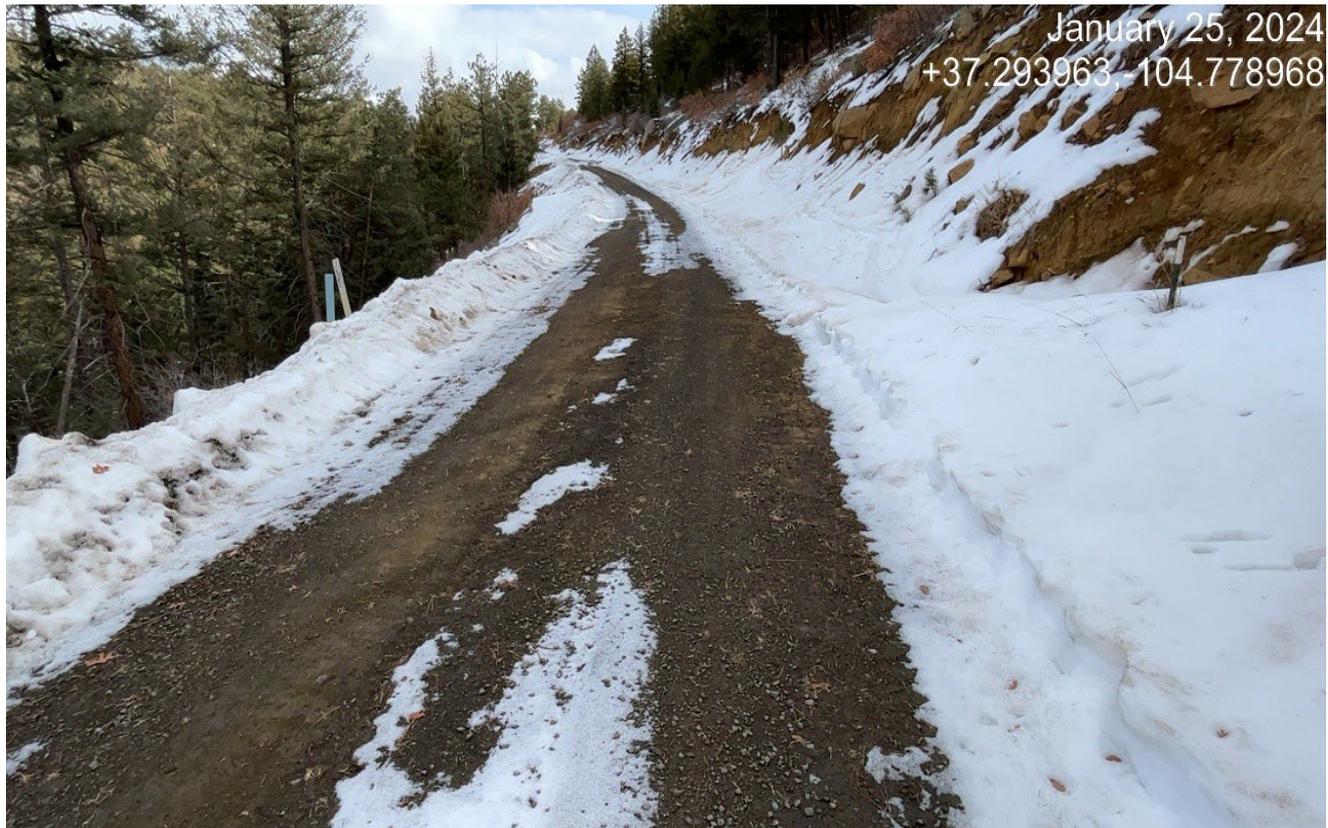
Photo 4. Facing southeast along the access road. It appears erosion has been repaired and snow was plowed off the road for access.
