Inspection Photos

Location Name: TEP ROCKY MOUNTAIN LLC Federal DOE 2-W-29 Pad

Location ID: 335255

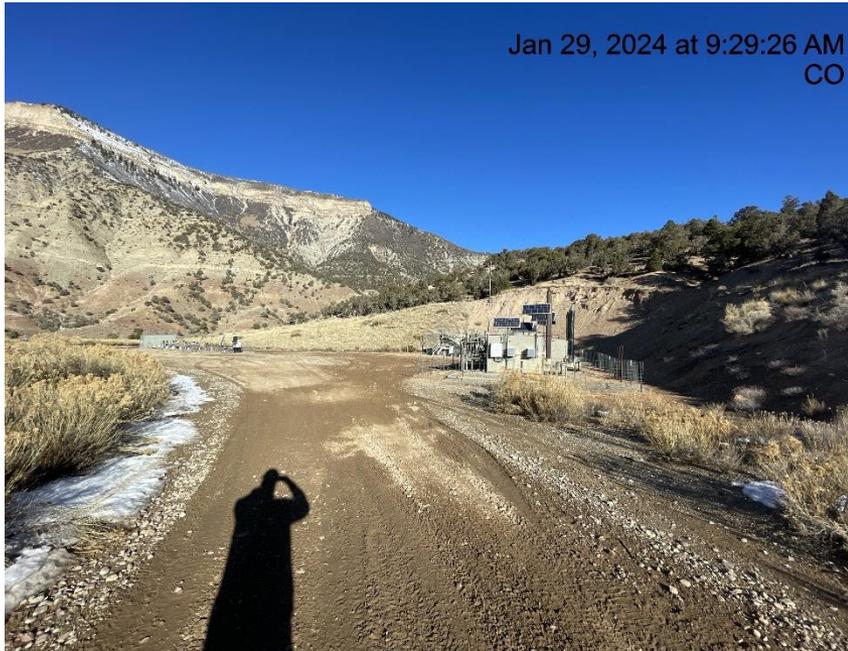
Photo # 4220 From entrance to location

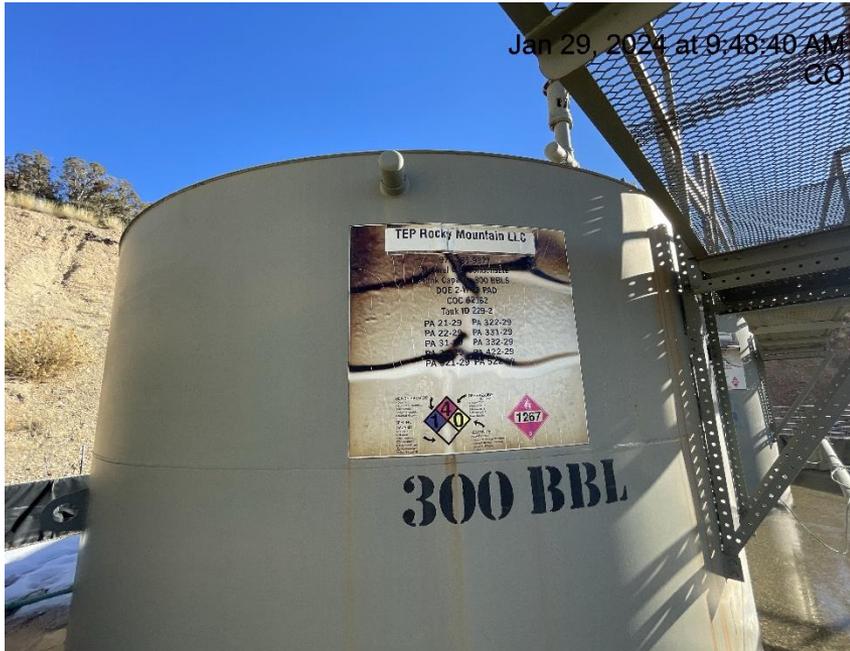
Photo # 4226 Tank label weathered & some required info is illegible

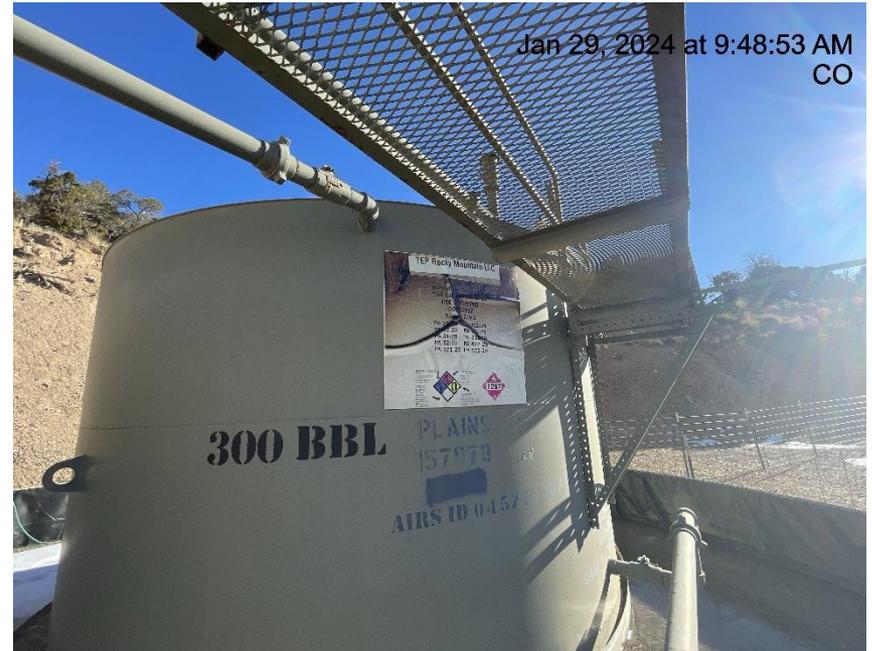
Photo # 4227 Tank label weathered & some required info is illegible

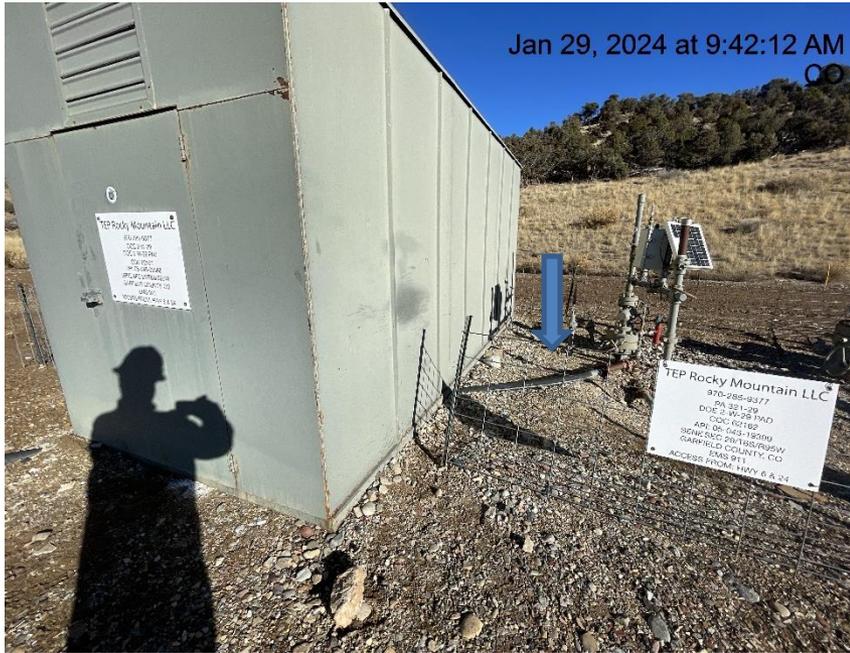
Photo # 4228 Line going from PA 321-29 well flowline to DOE 2-W-29 injection well

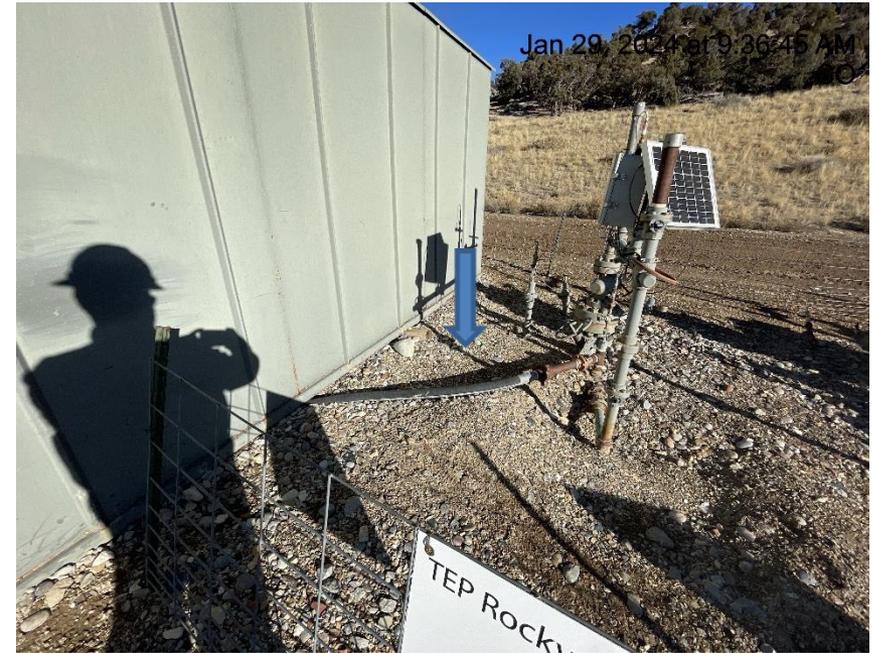
Photo # 4229 Line going from PA 321-29 well flowline to DOE 2-W-29 injection well

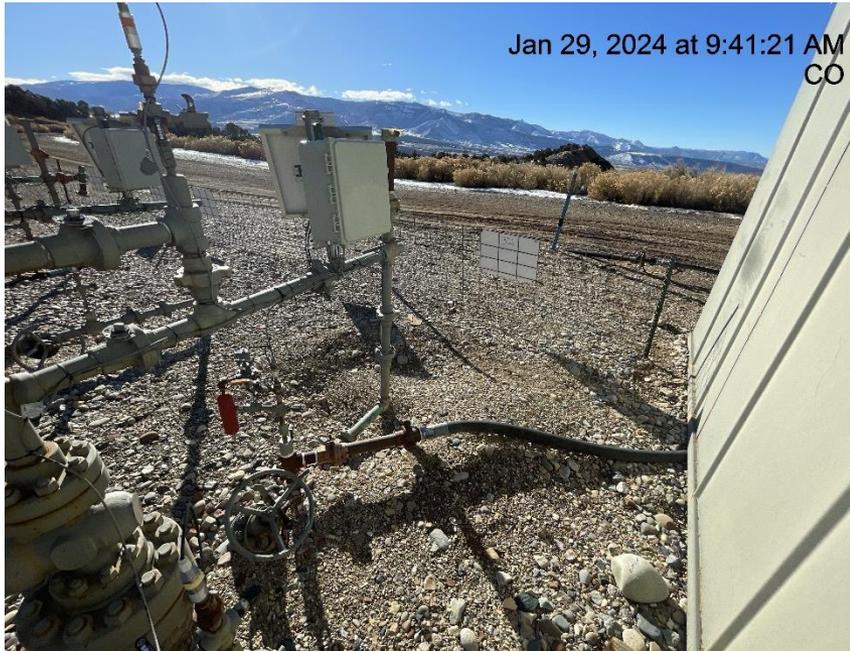
Photo # 4230 Line going from PA 321-29 well flowline to DOE 2-W-29 injection well

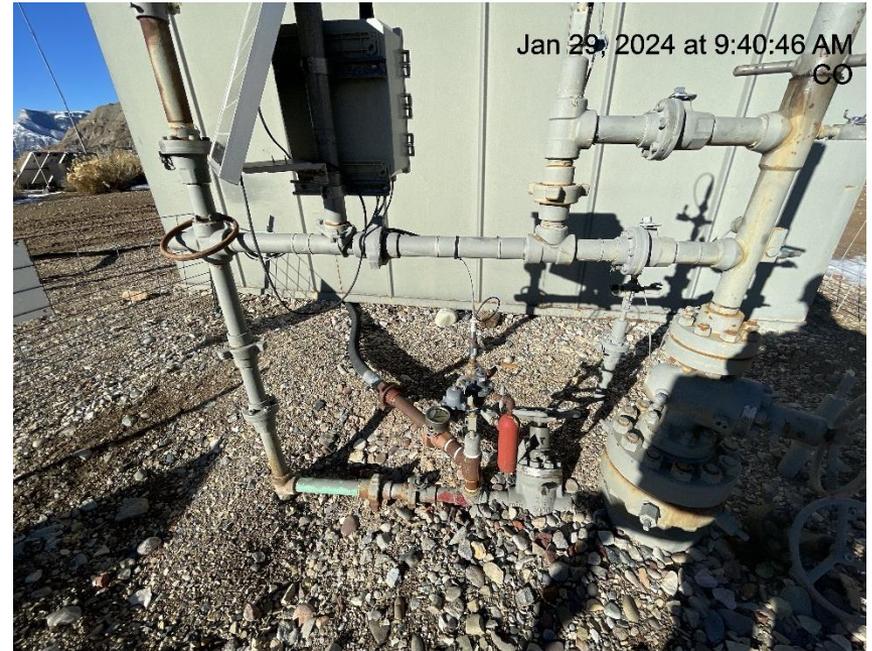
Photo # 4231 Line going from PA 321-29 well flowline to DOE 2-W-29 injection well

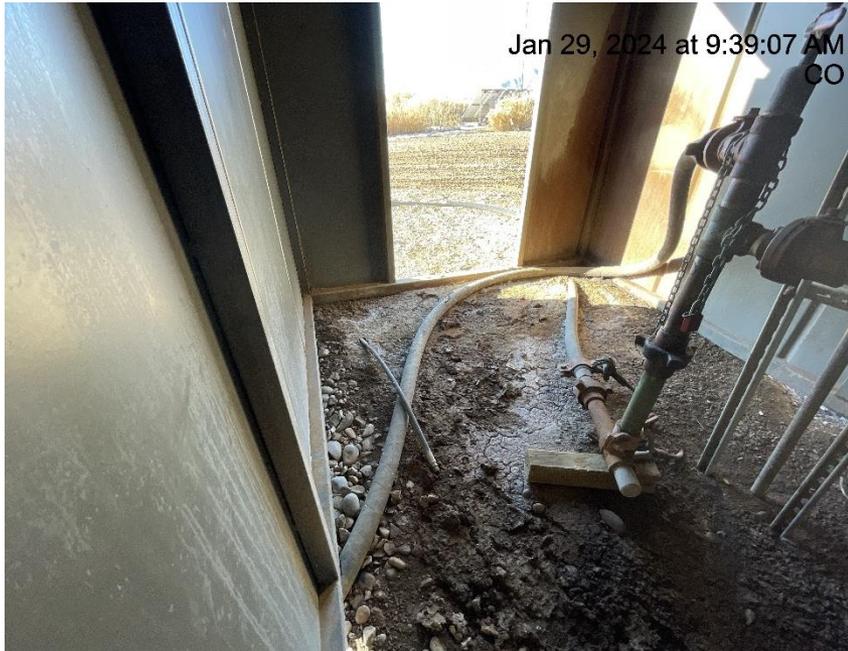
Photo # 4232 Line from PA 321-29 well flowline connected to line on DOE 2-W-29 injection well

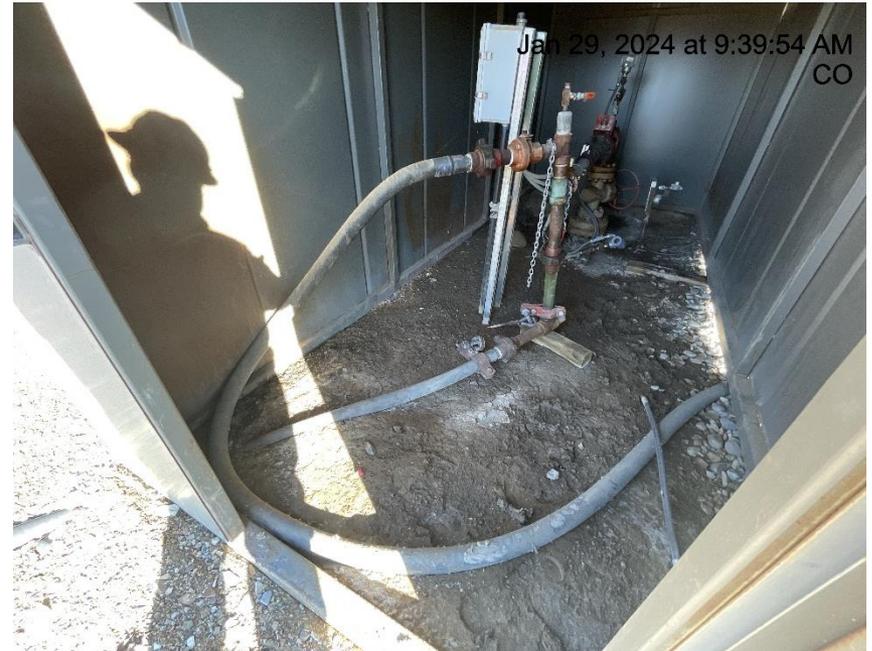
Photo # 4233 Line from PA 321-29 well flowline connected to line on DOE 2-W-29 injection well

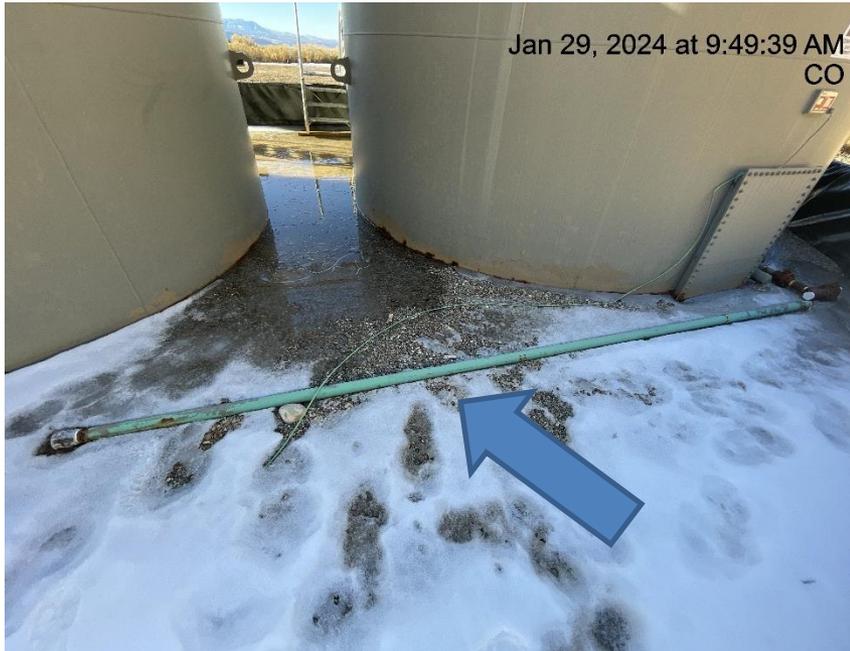
Photo # 4234 Debris
