Caerus Piceance LLC  
Piceance creek Unit-62S97W 11NESW  
Loc ID: 335712

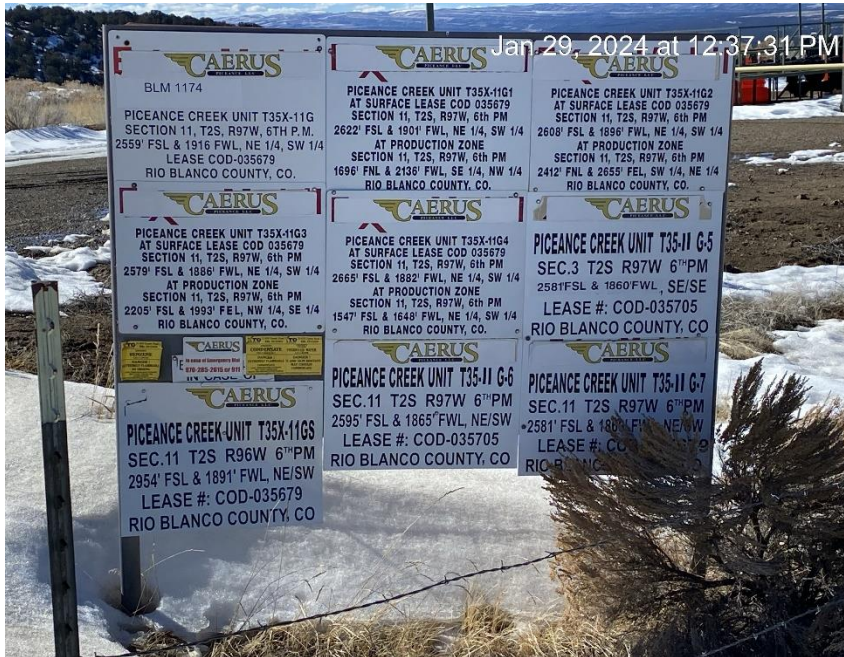
As signs are replaced additional information will be required

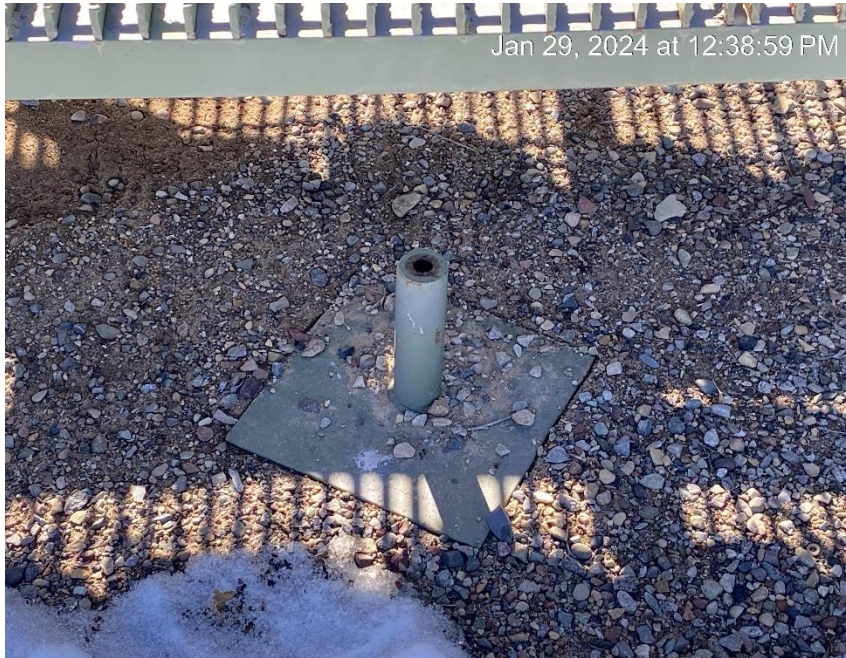
Debris

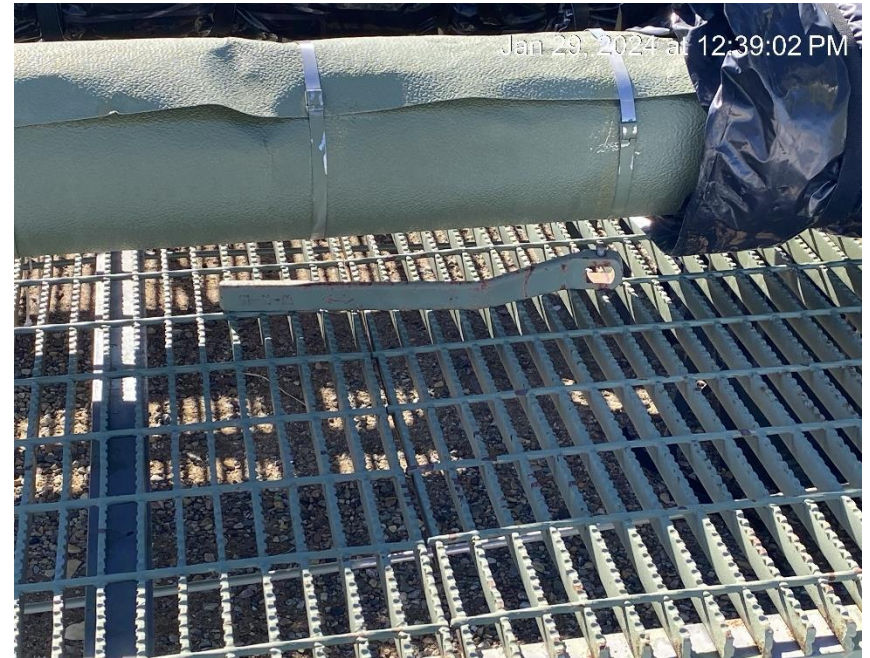
Debris

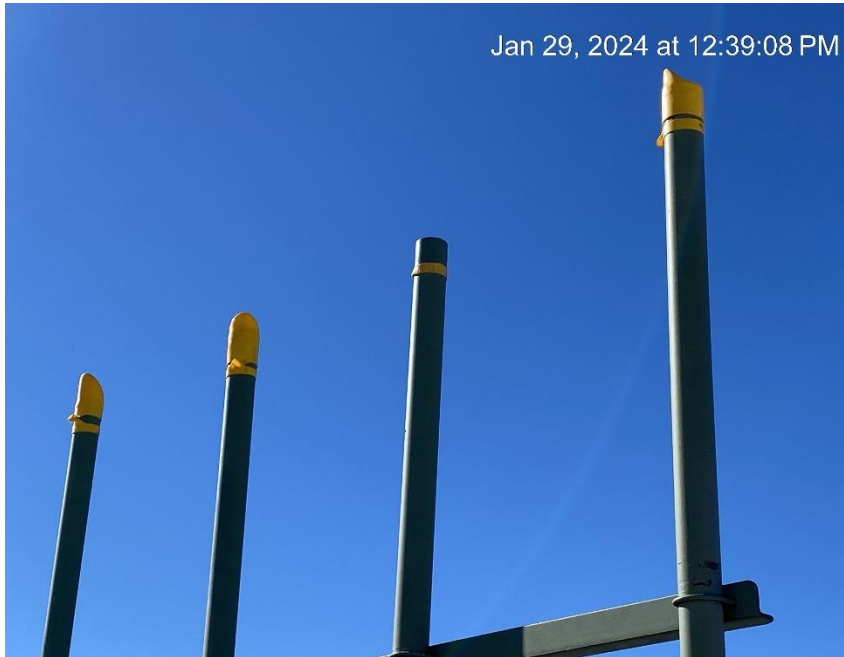
**Rain cap missing**

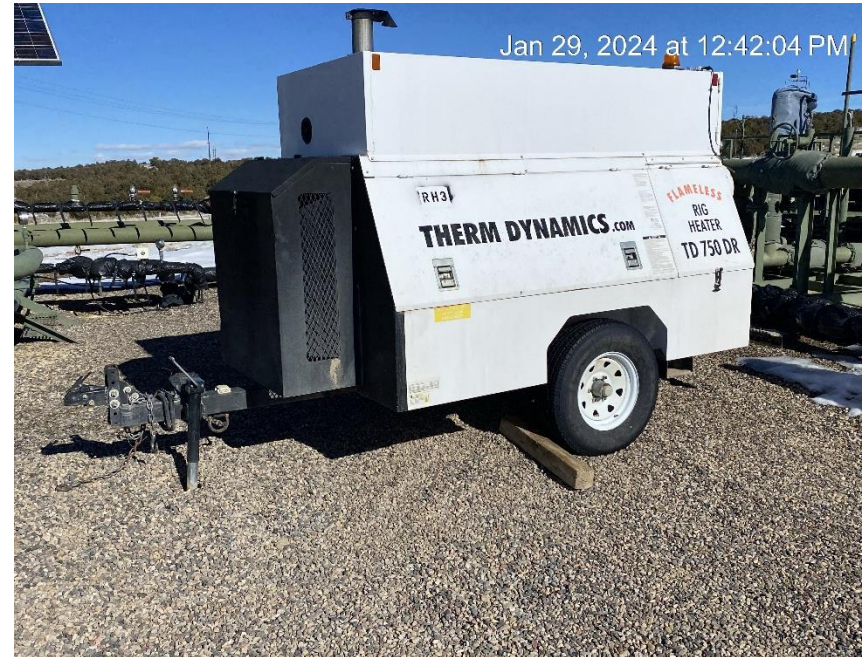
**Unused equipment storage**

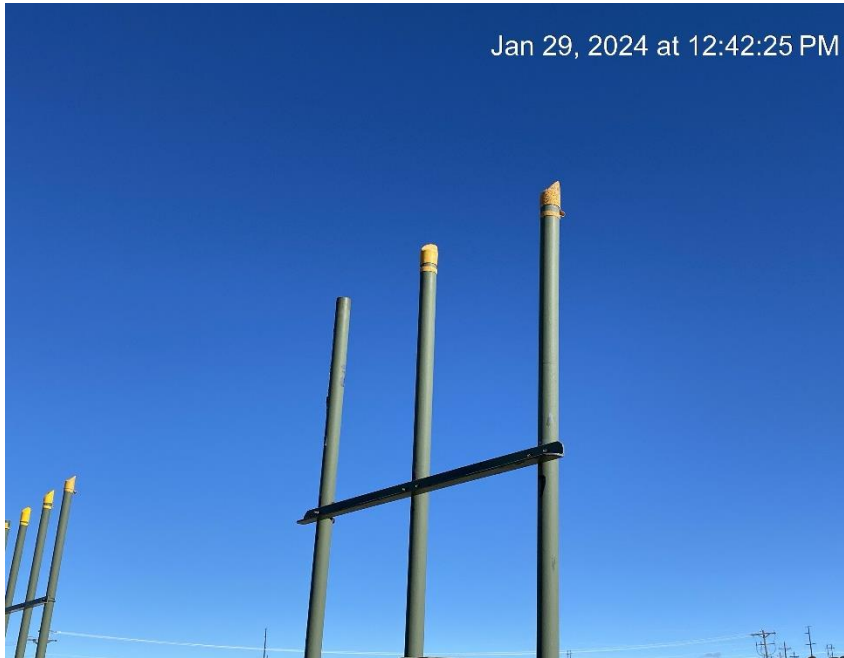
Rain cap missing

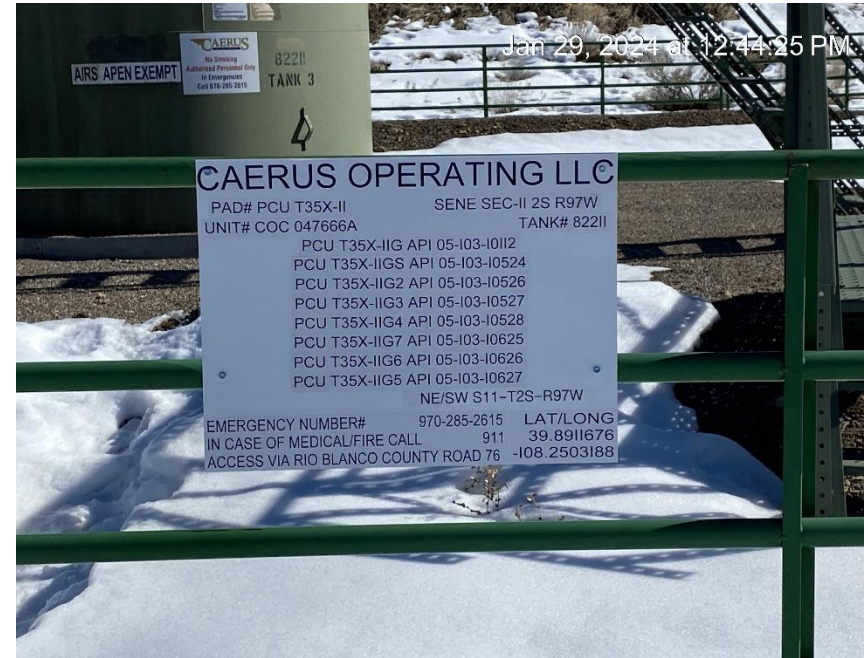
SENE or NESW?

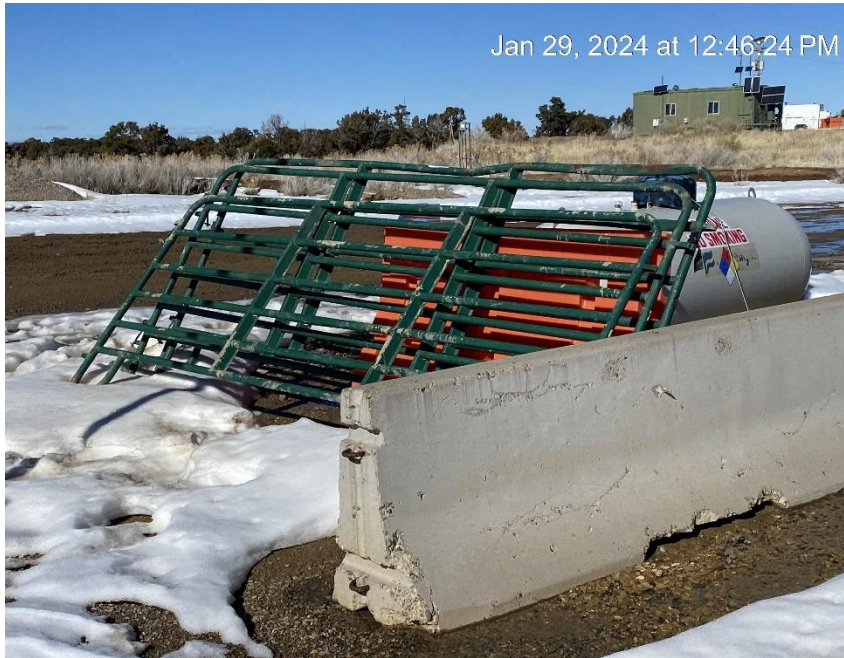
Debris

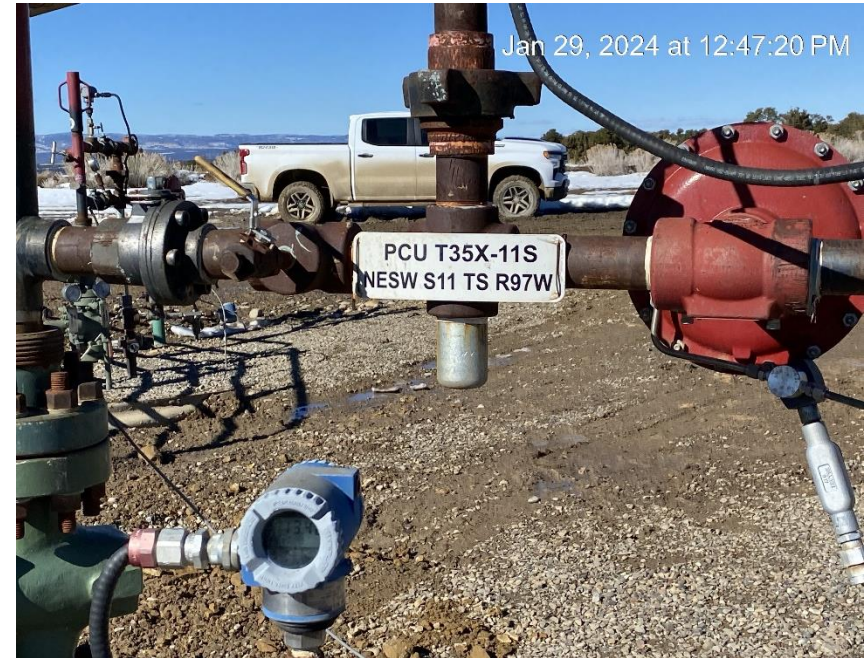
Inaccurate well sign

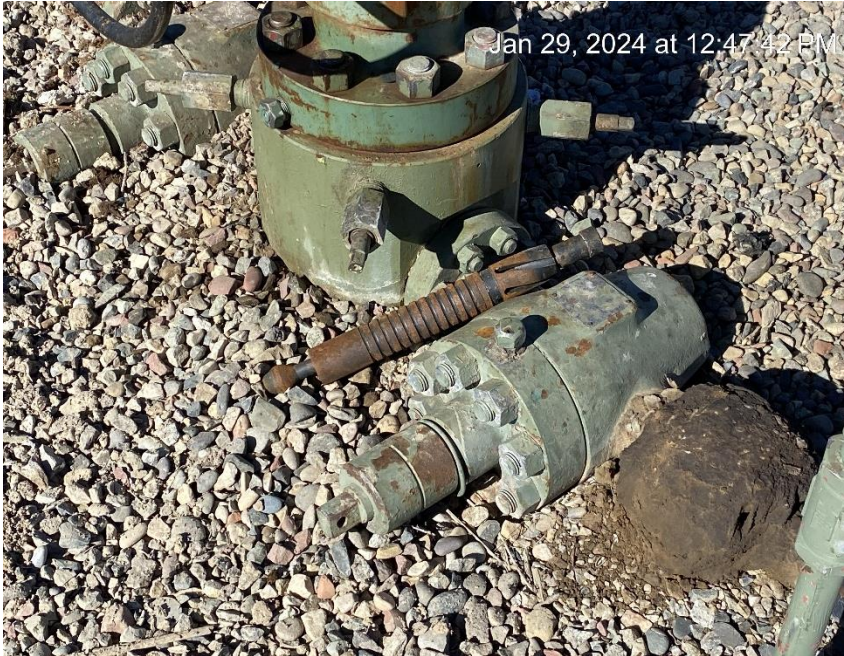
Debris

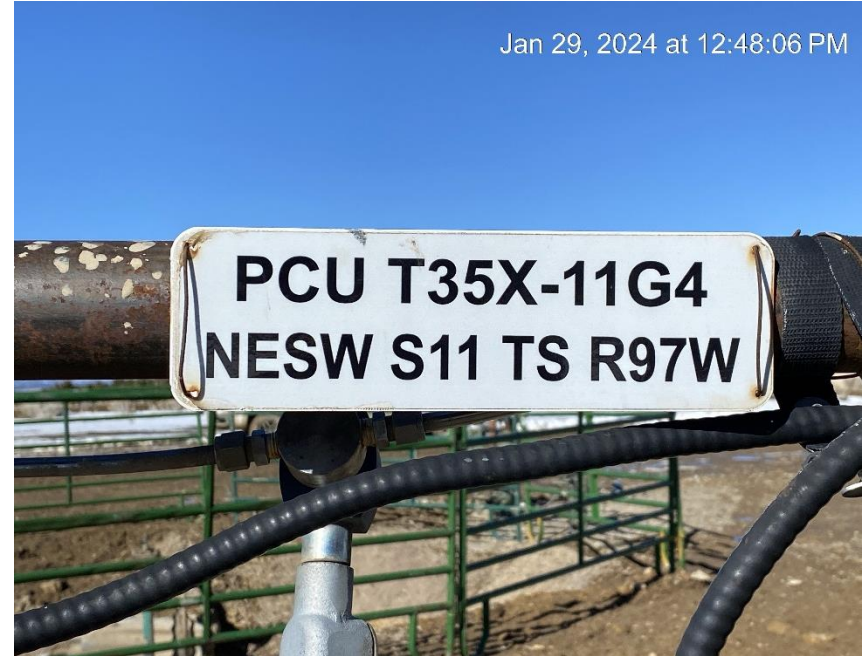
As signs are replaced additional information will be required

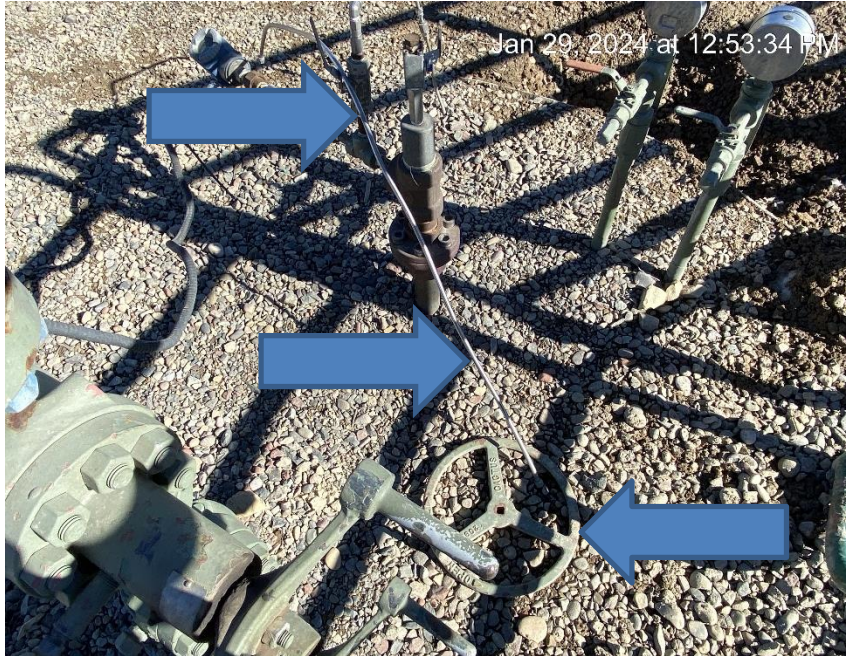
Debris

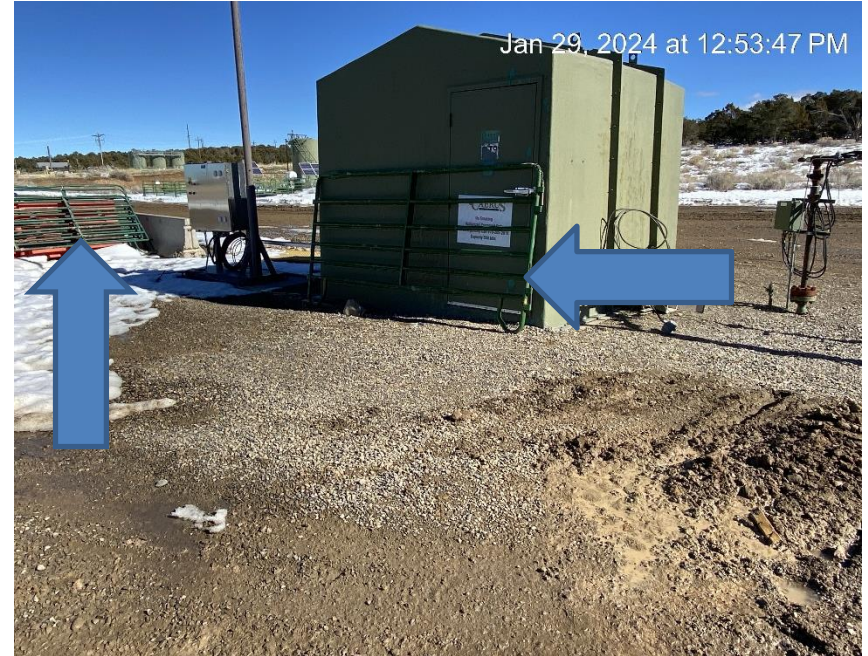
Debris
