© 26-Jan-24 08:04:47 AM
ECMC Environmental Inspection Jillson

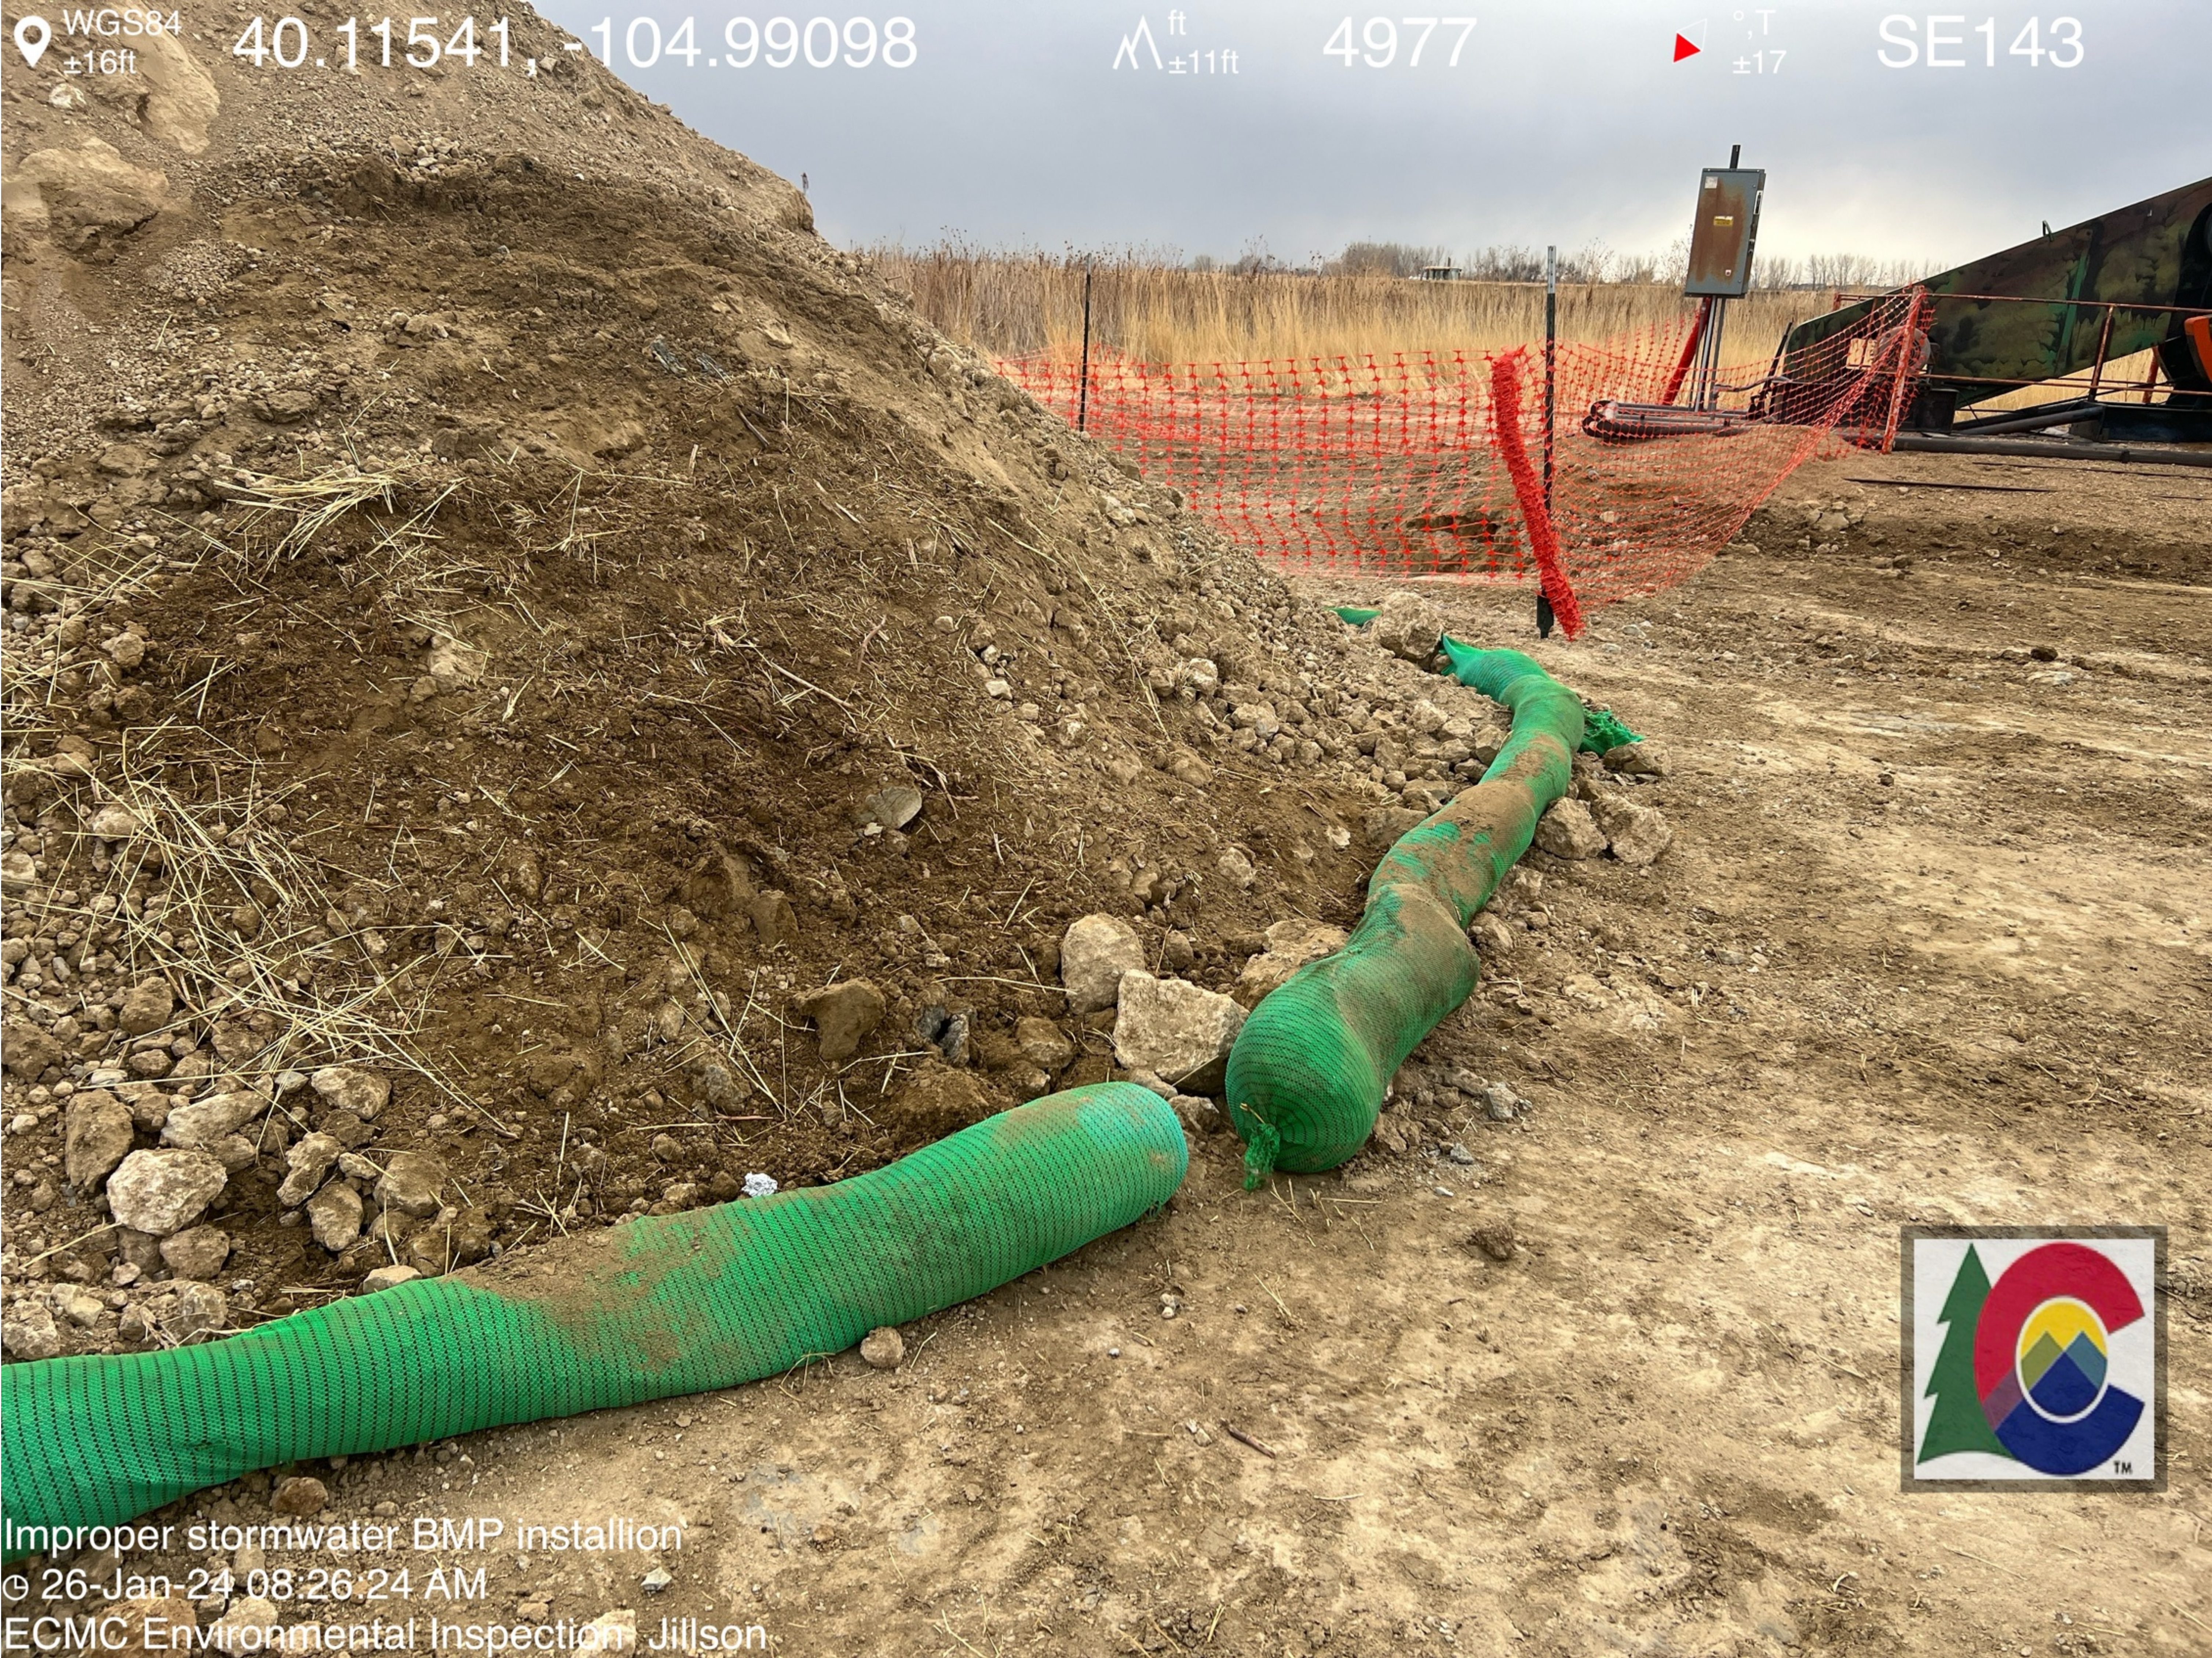
Improper stormwater BMP installation
© 26-Jan-24 08:26:24 AM
ECMC Environmental Inspection Jillson
