Inspection Photos

Loc: 321179

Operator: INVESTMENT EQUIPMENT LLC

Inspection Date: 1/30/2024

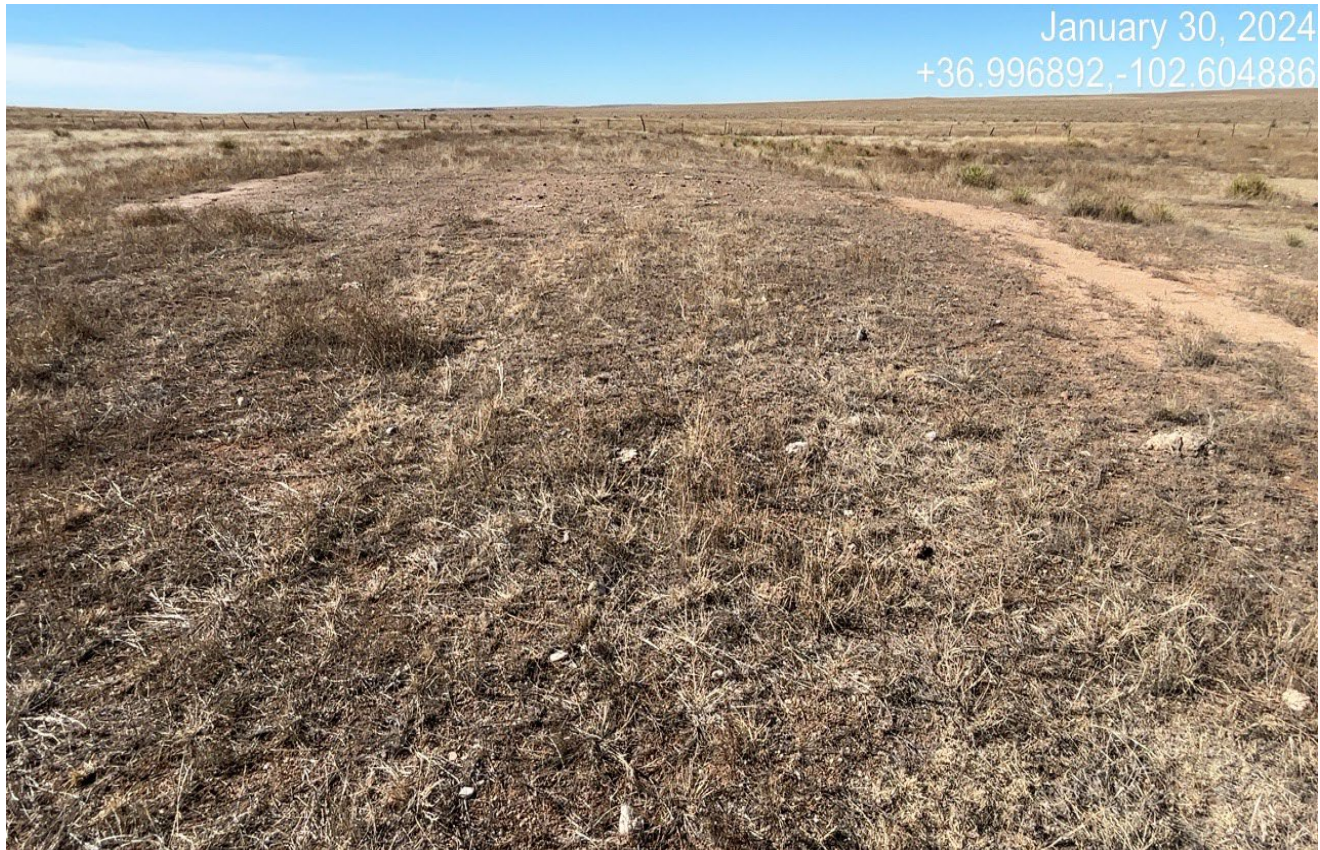
Photo 1. Northeast corner of the location facing west. The fill slope has not been regraded and perennial vegetation has not established. This area westward consists mostly of undesirable weeds.

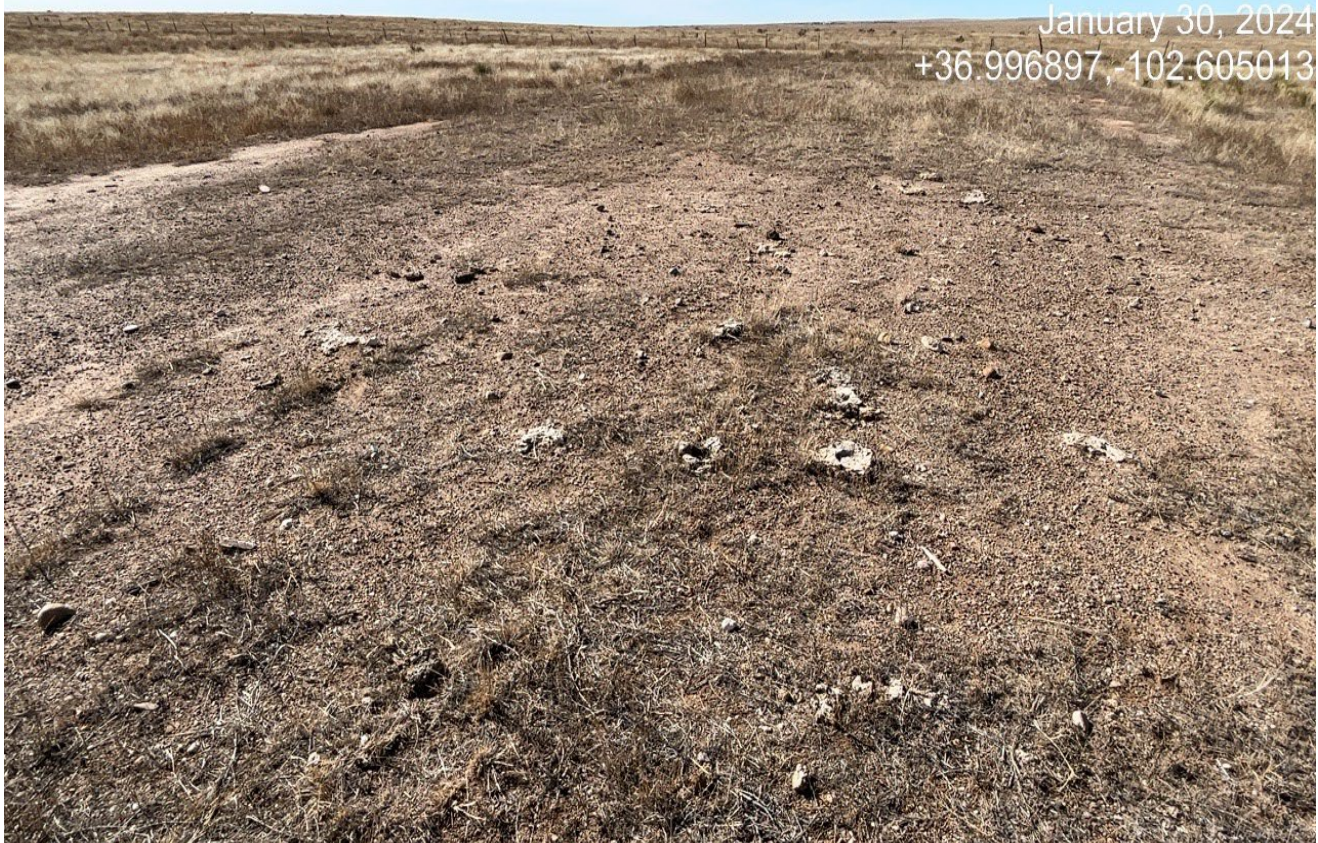
Photo 2. Facing at the north center side of the location. This area approximately 40'x40' has minimal vegetation growth.

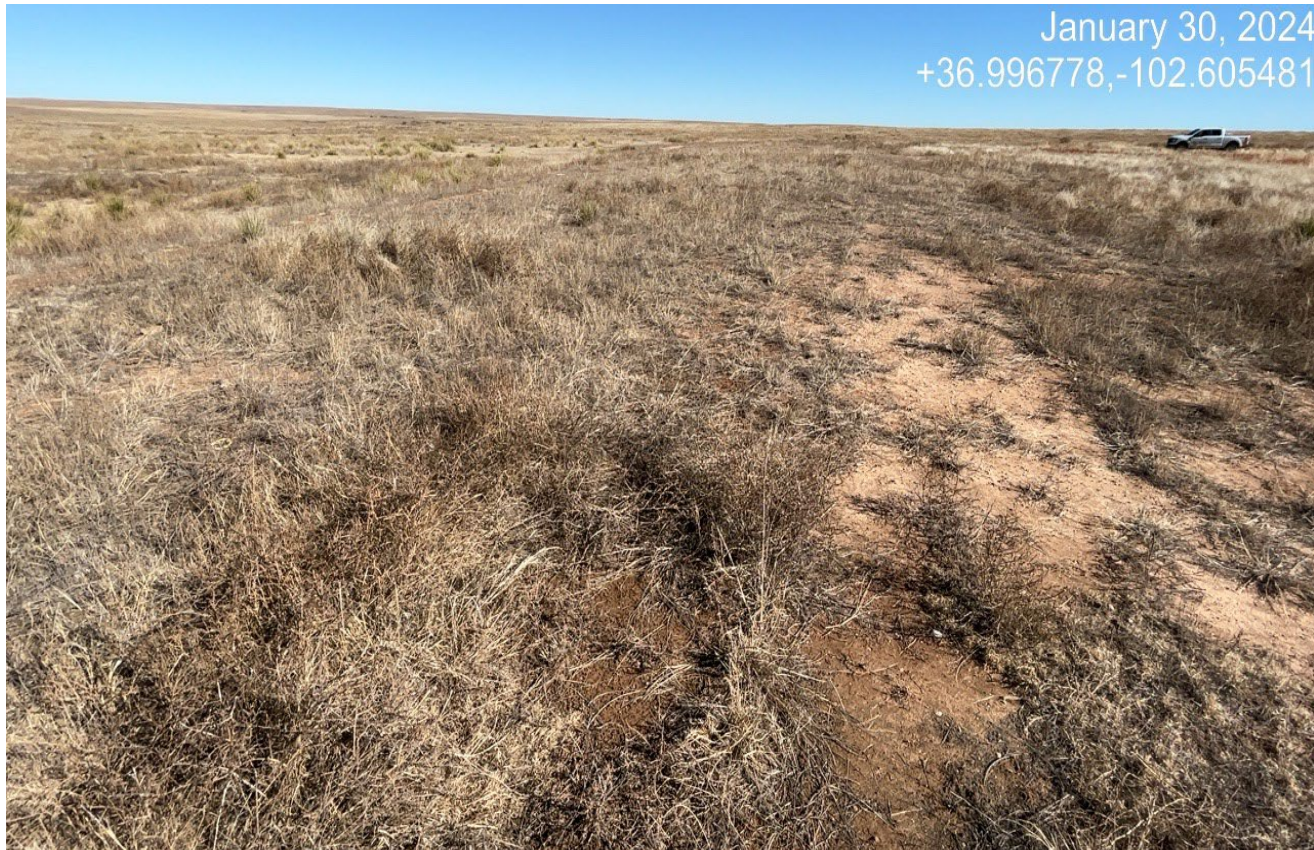
Photo 3. Northwest corner of the location facing east. The fill slope has not been regraded and perennial vegetation has not established. This area eastward consists mostly of undesirable weeds.

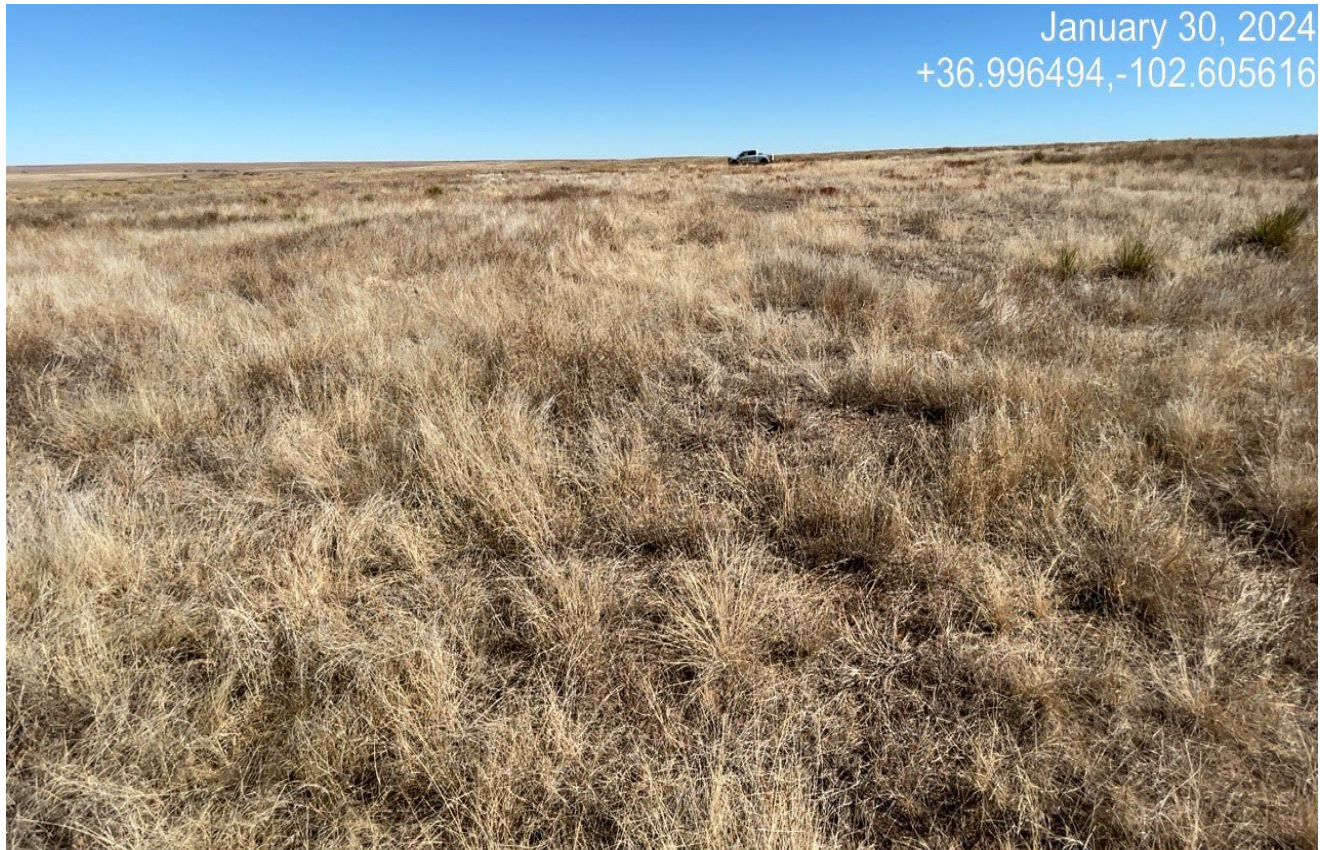
Photo 4. Southwest side of the location facing west. The southern portion of the location has a good stand perennial vegetation.

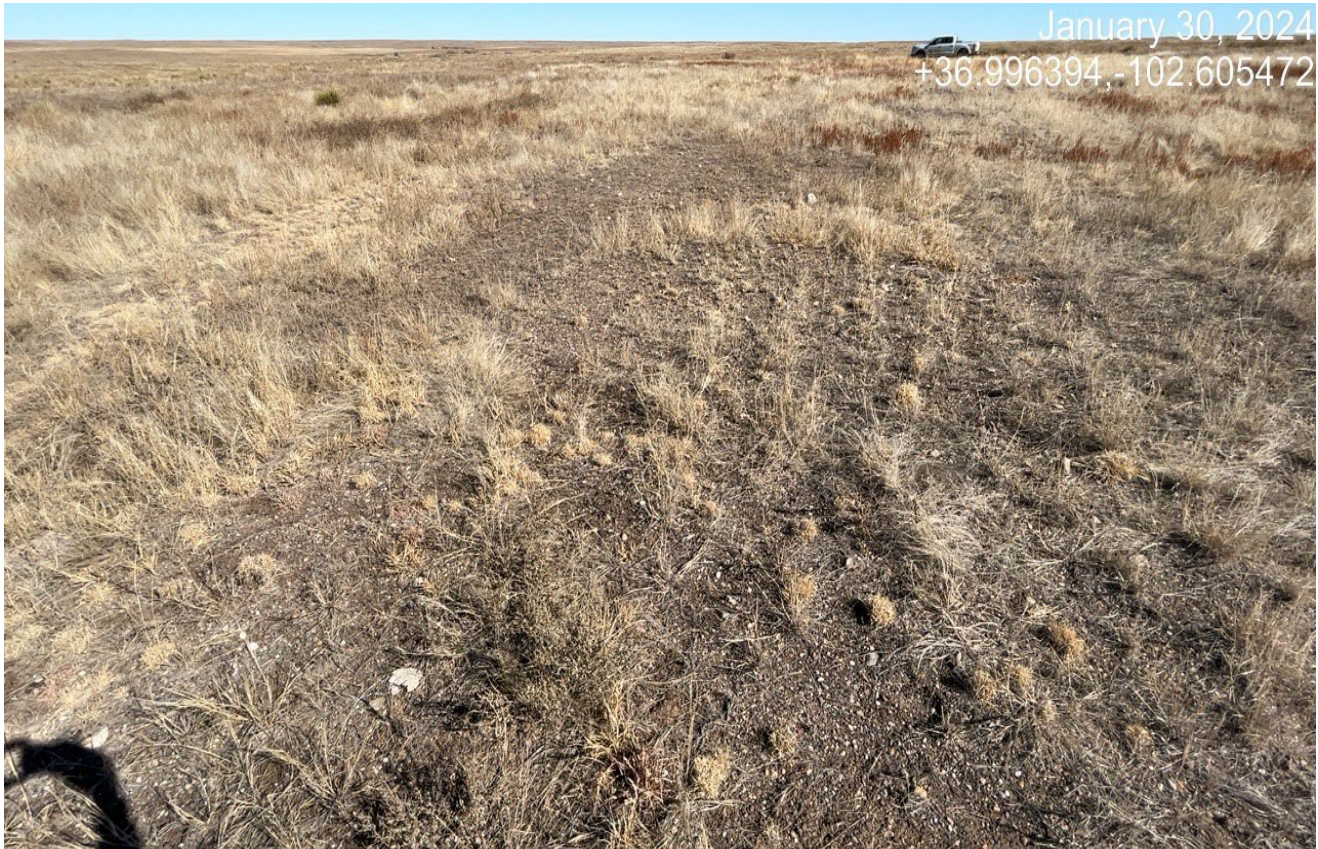
Photo 5. The southern center of the location has this area of sparse vegetation with some gravel that remains..
