Inspection Photos

Loc: 321186

Operator: INVESTMENT EQUIPMENT LLC

Inspection Date: 1/30/2024

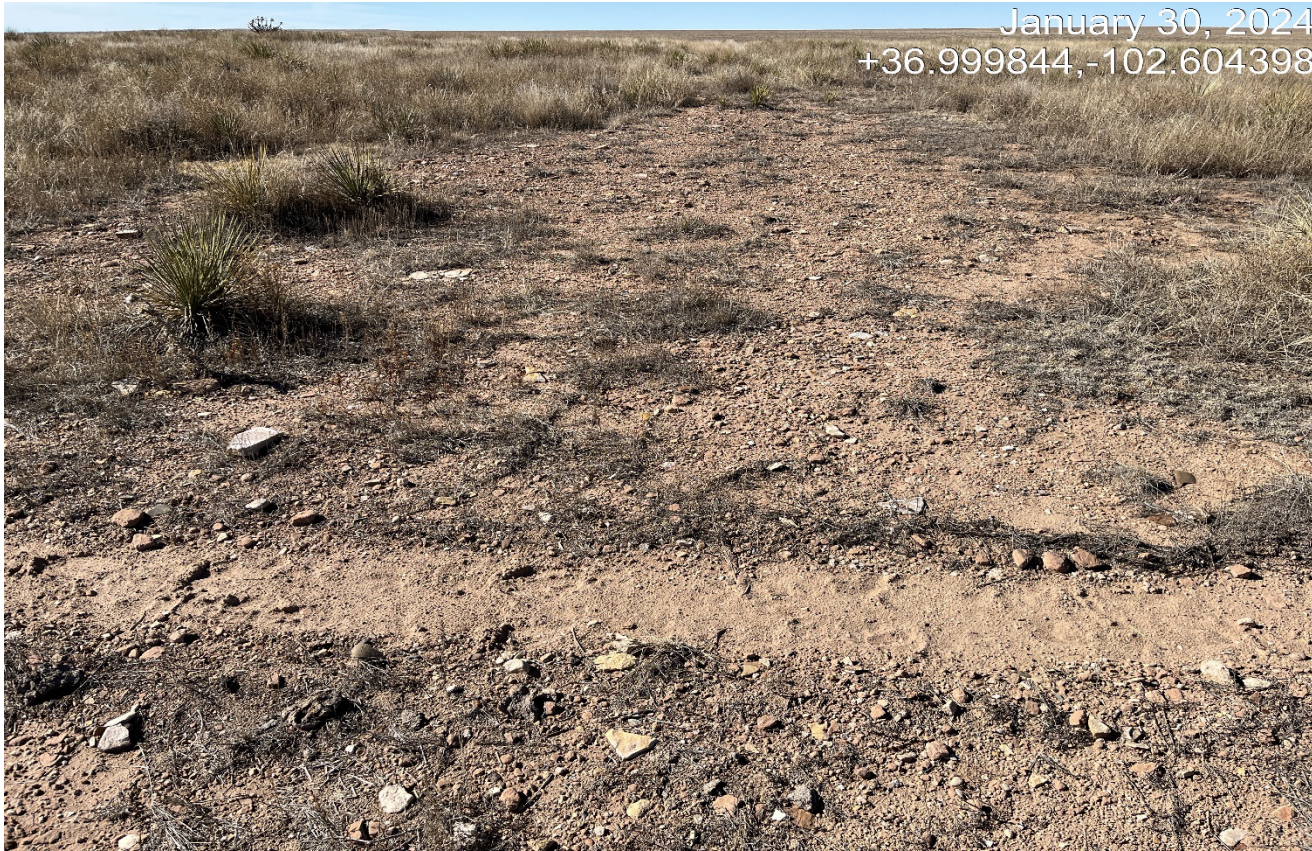
Photo 1. Facing west at the beginning of the access road. Vegetation has not reestablished in this area.

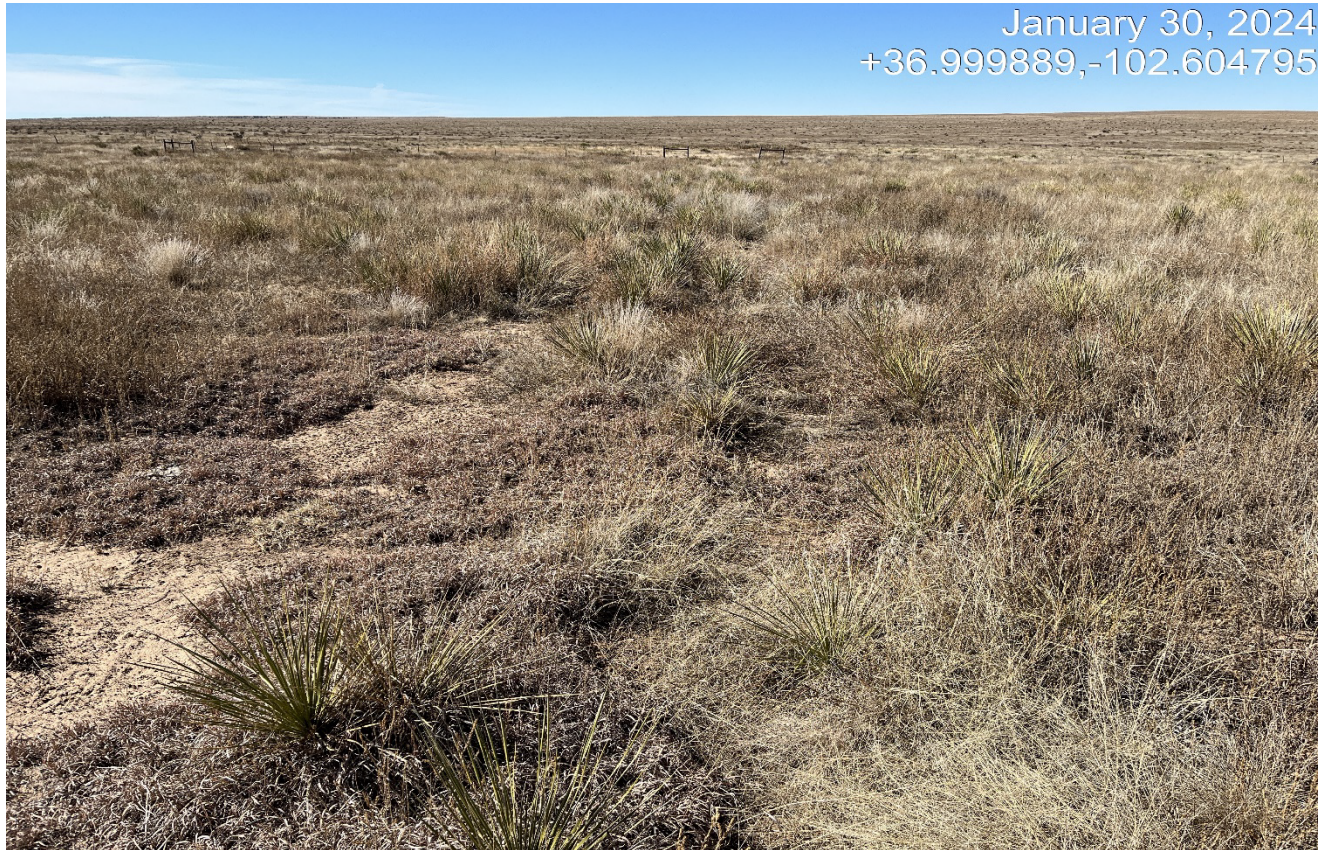
Photo 2. Facing west along the access road. Vegetation has established along this portion of the road.

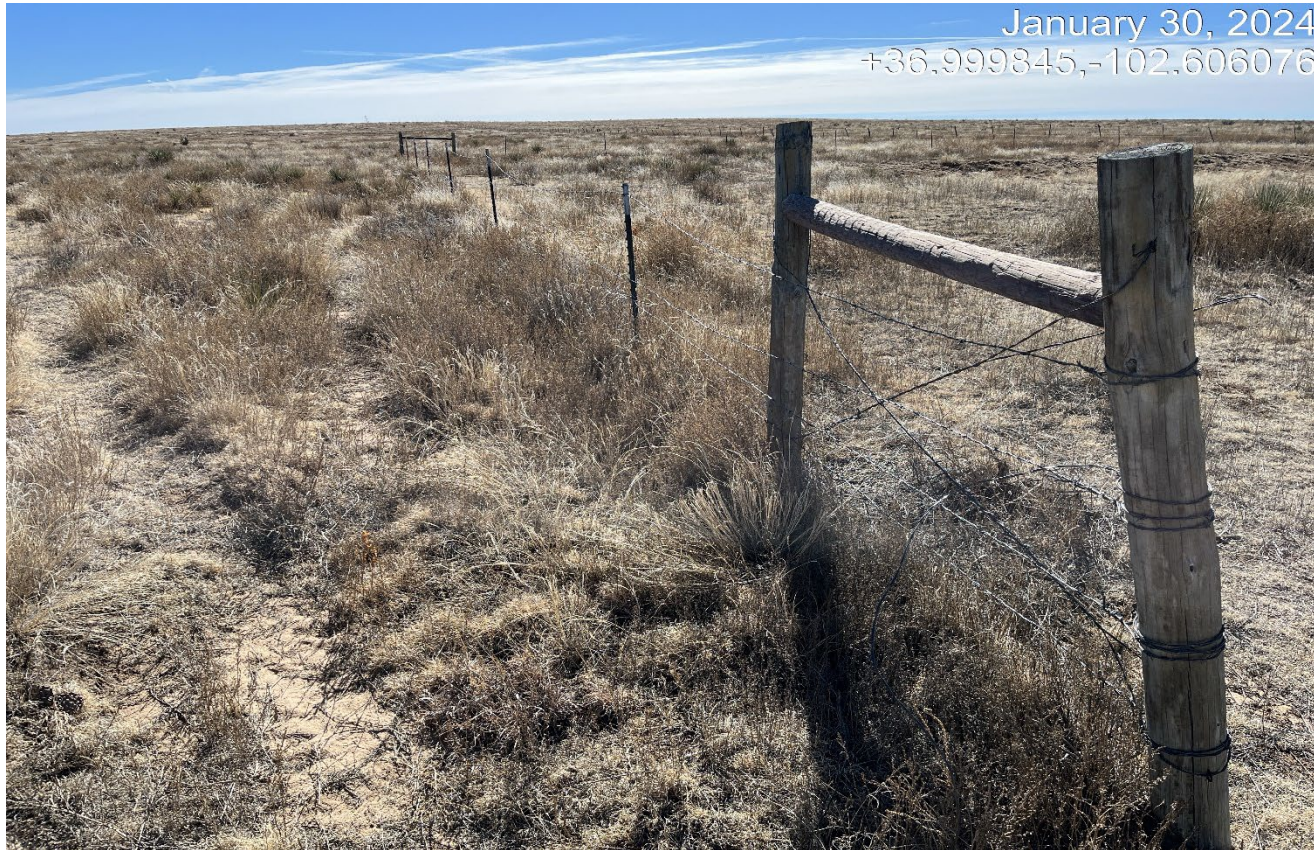
Photo 3. There is a perimeter fence that remains in disrepair around the location.

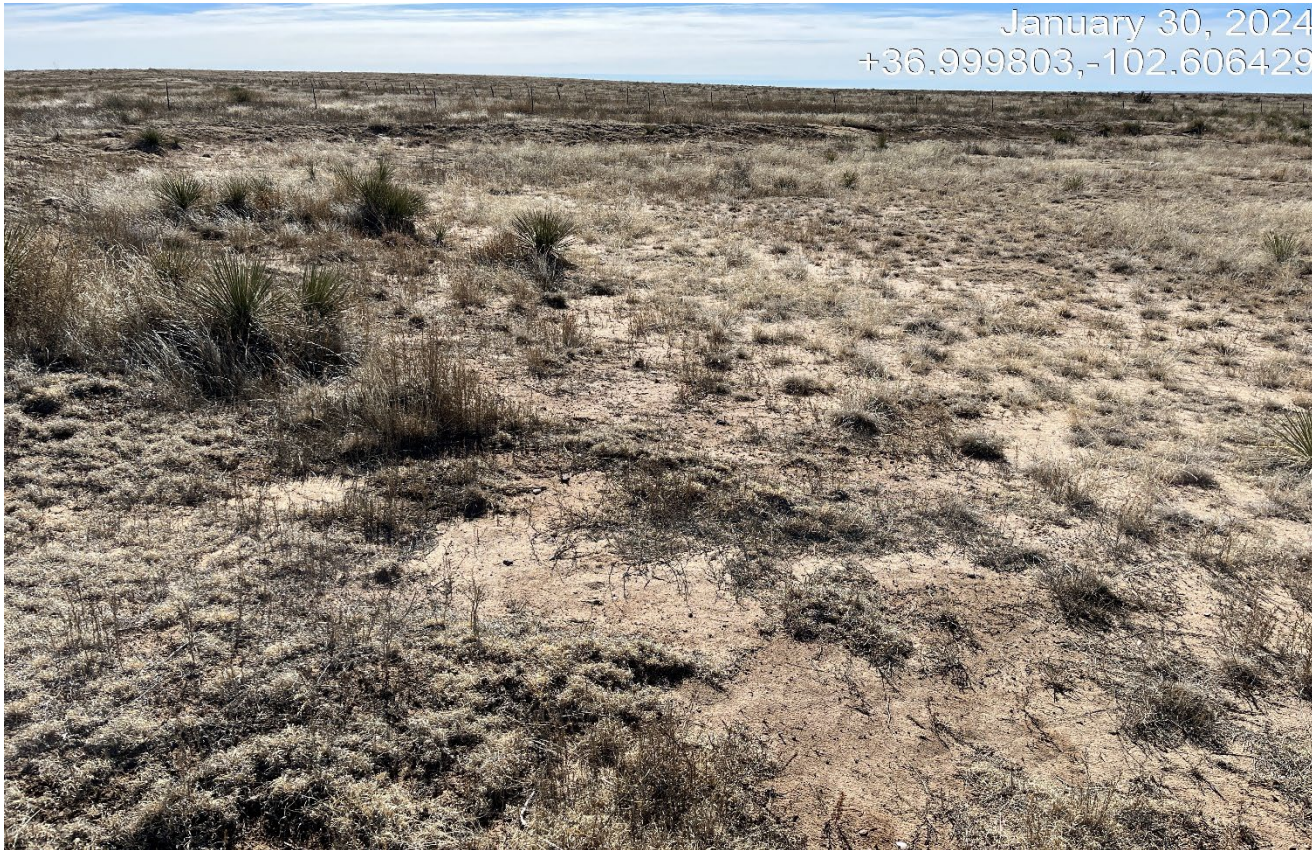
Photo 4. Facing southwest toward the location cut slope. The cut slope needs to be recontoured with fill slope material to match pre-existing grade.

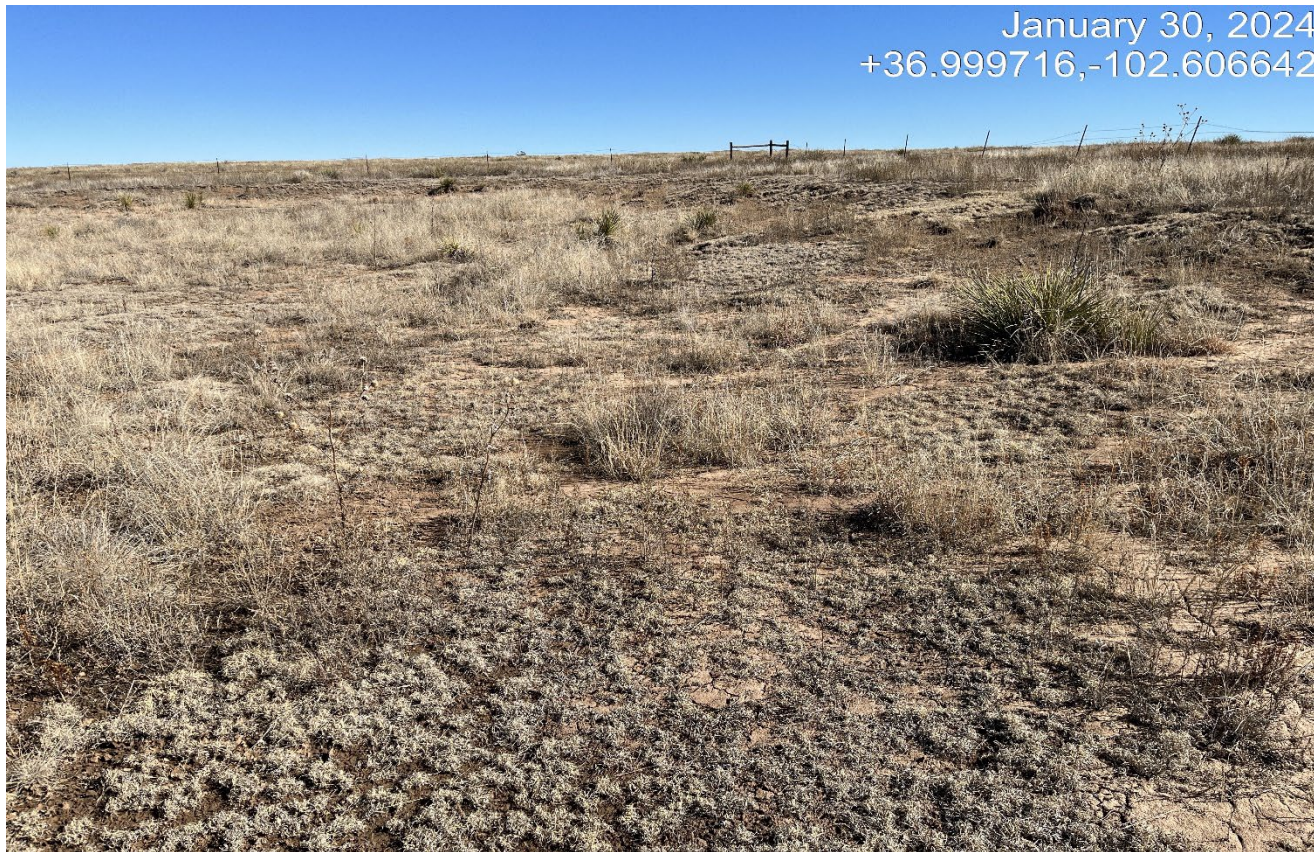
Photo 5. Facing east toward the location cut slope. The cut slope needs to be recontoured with fill slope material to match pre-existing grade..

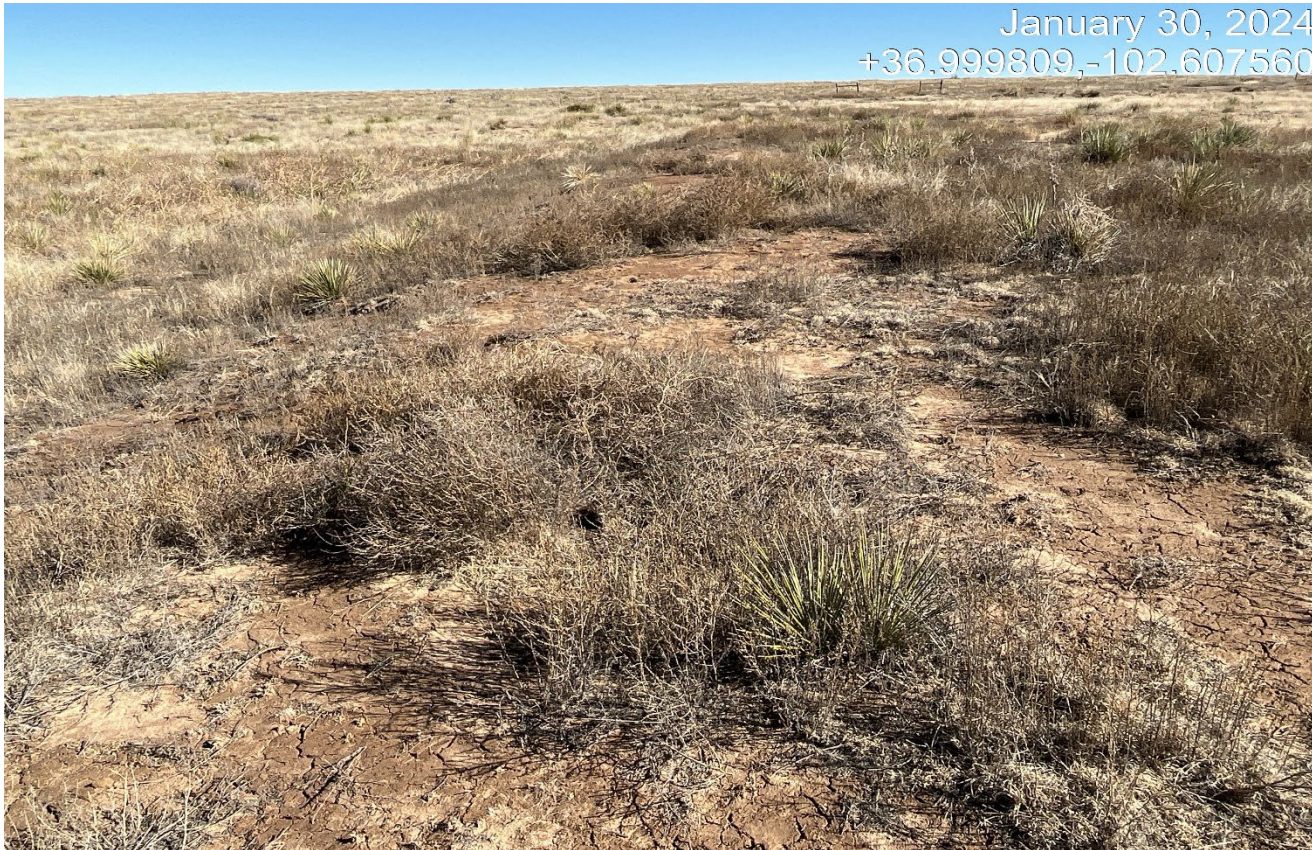
Photo 6. Northwest corner of the location facing east. The ill slope has not been recontoured to match the surrounding grade. The perennial vegetation has not established along the fill slope area.

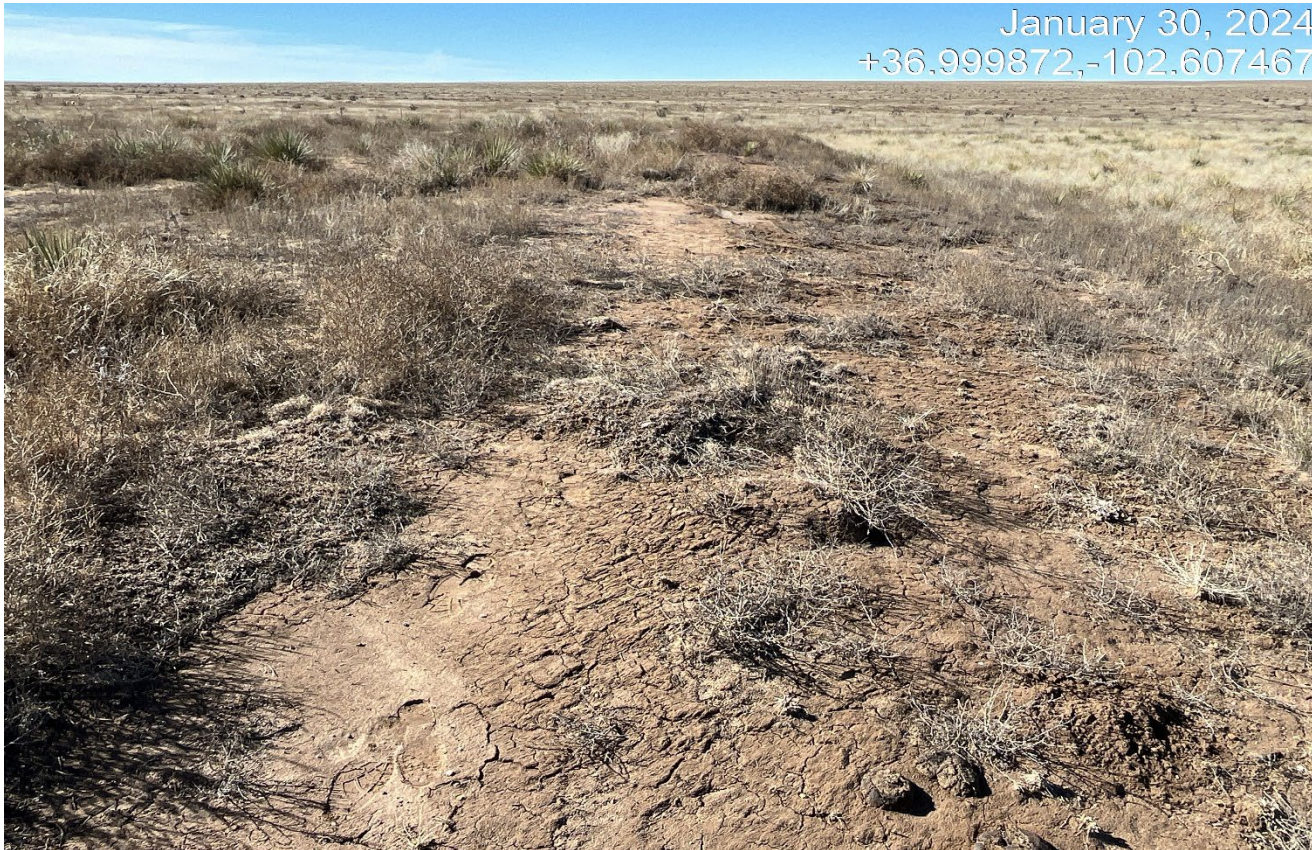
Photo 7. Facing east along the fill slope which is approximately 10 ft from the existing grade. The perennial vegetation has not established along the fill slope area.
