# 01/30/24 INSPECTION PHOTOS

## SOMCOE, LLC TIFFANY 5 LOCATION

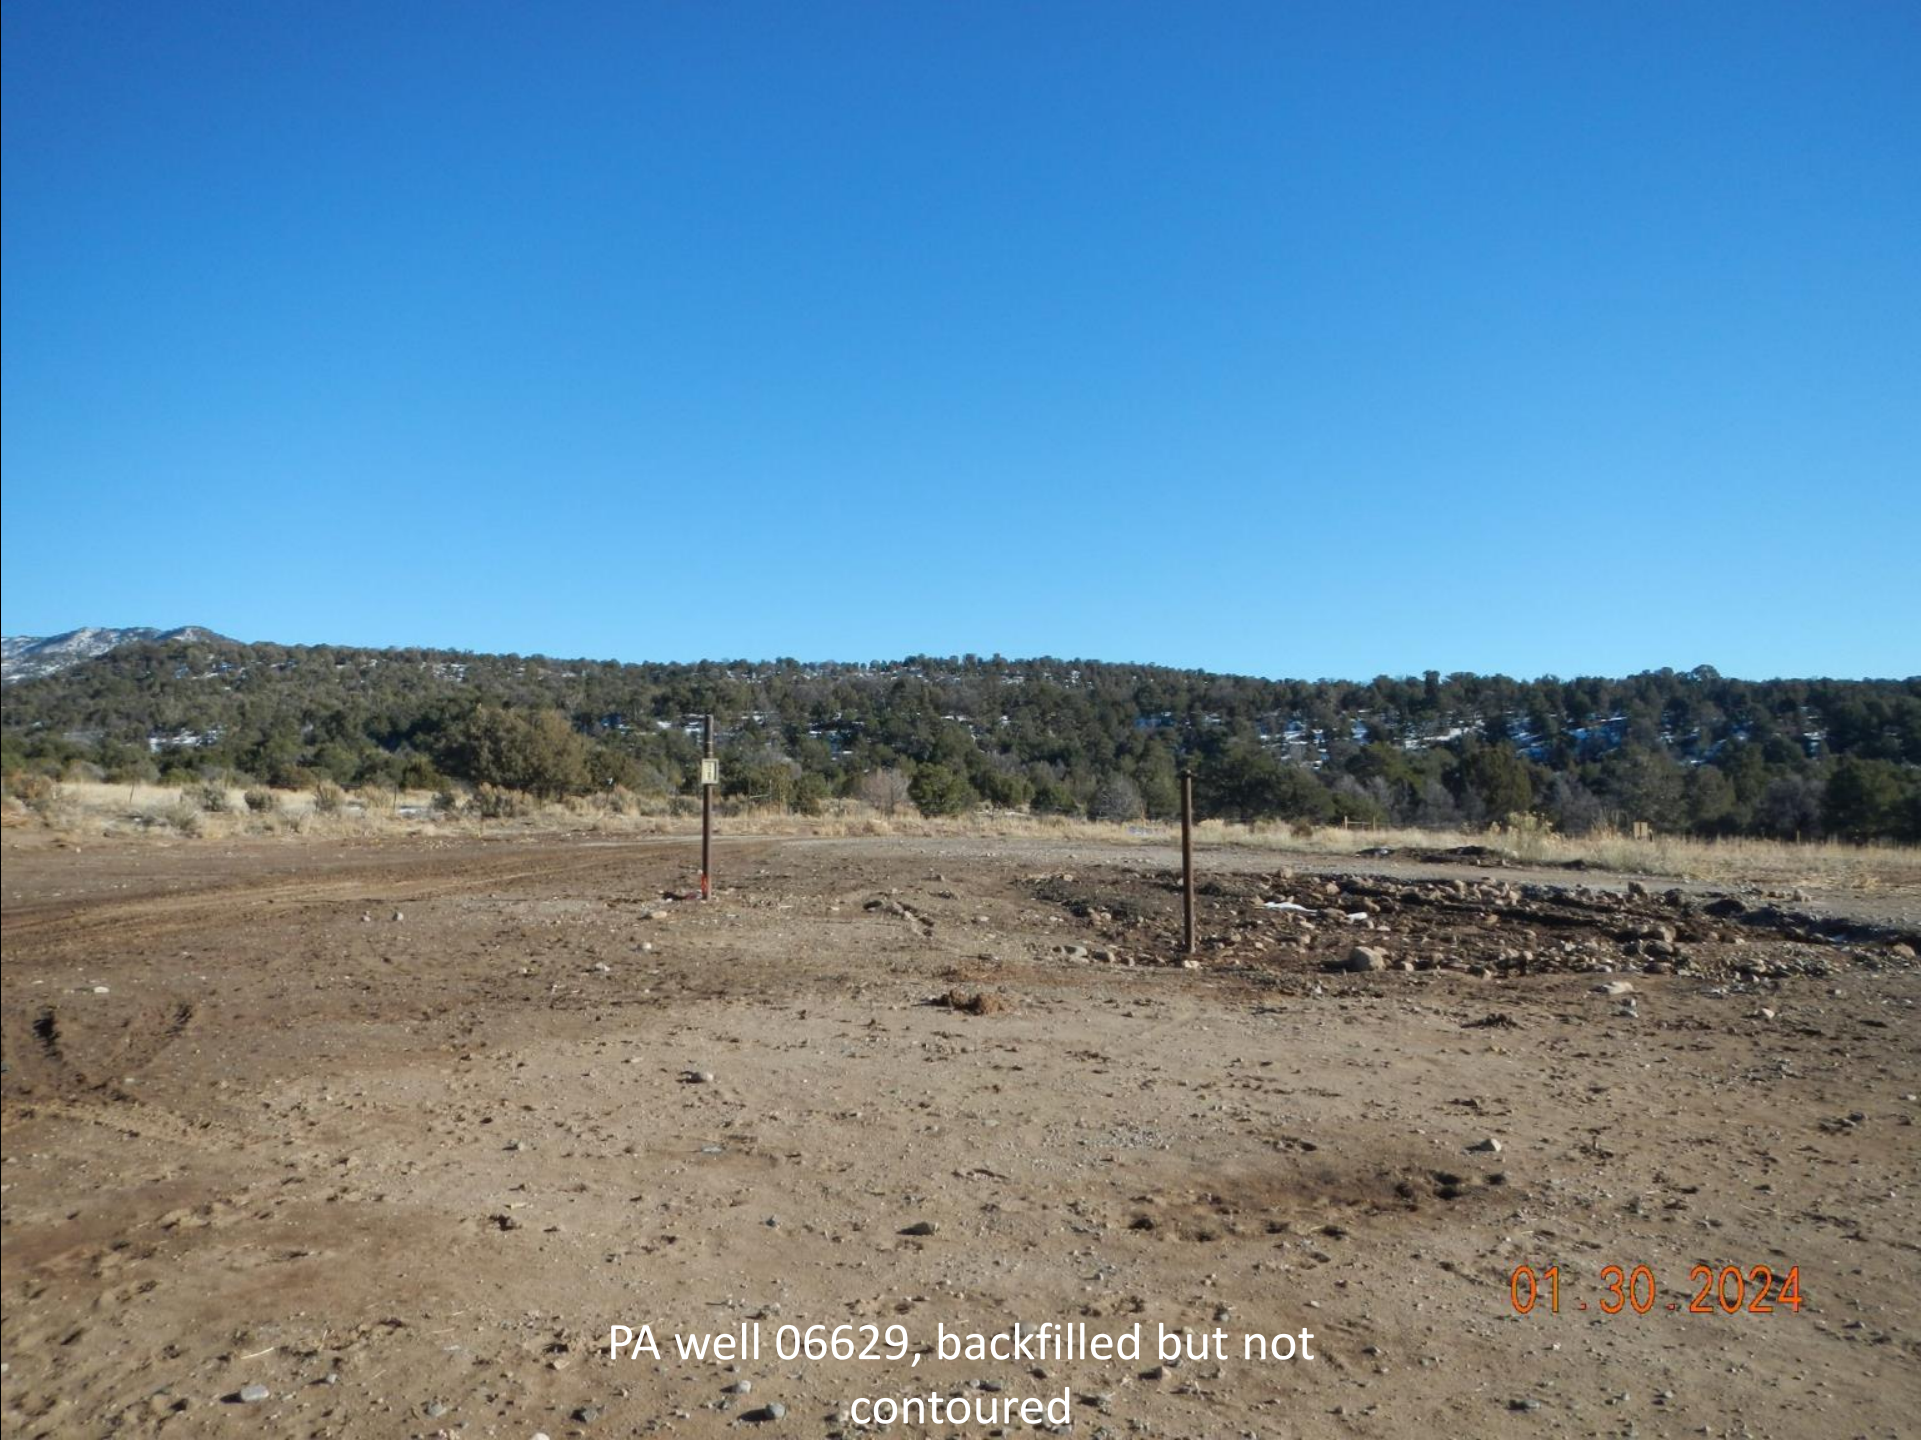
PA well 06629, backfilled but not  
contoured

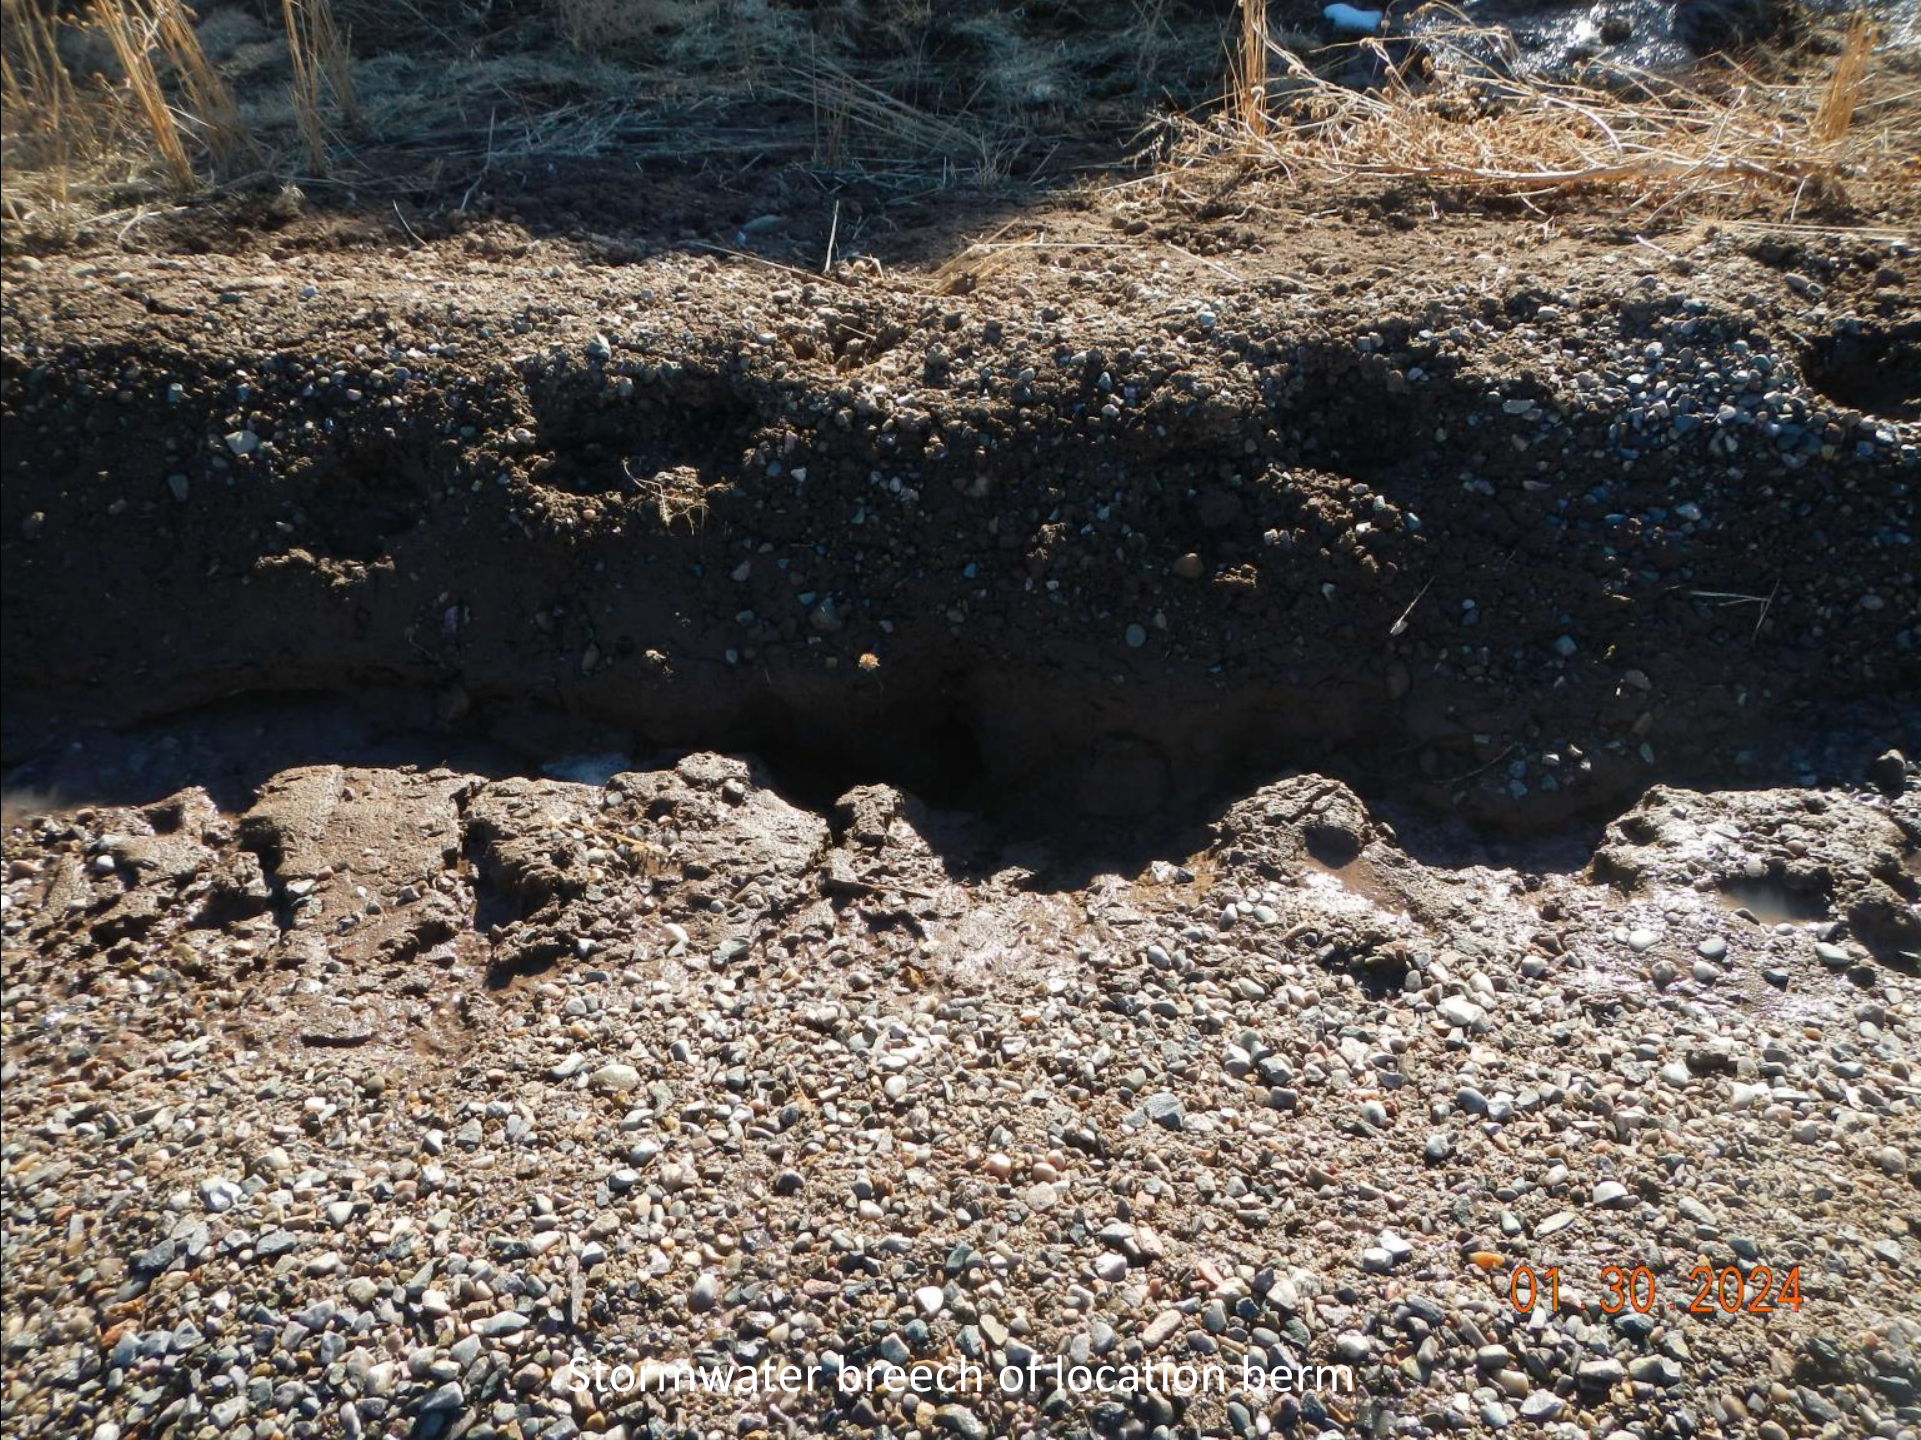
Stormwater erosion south edge  
middle

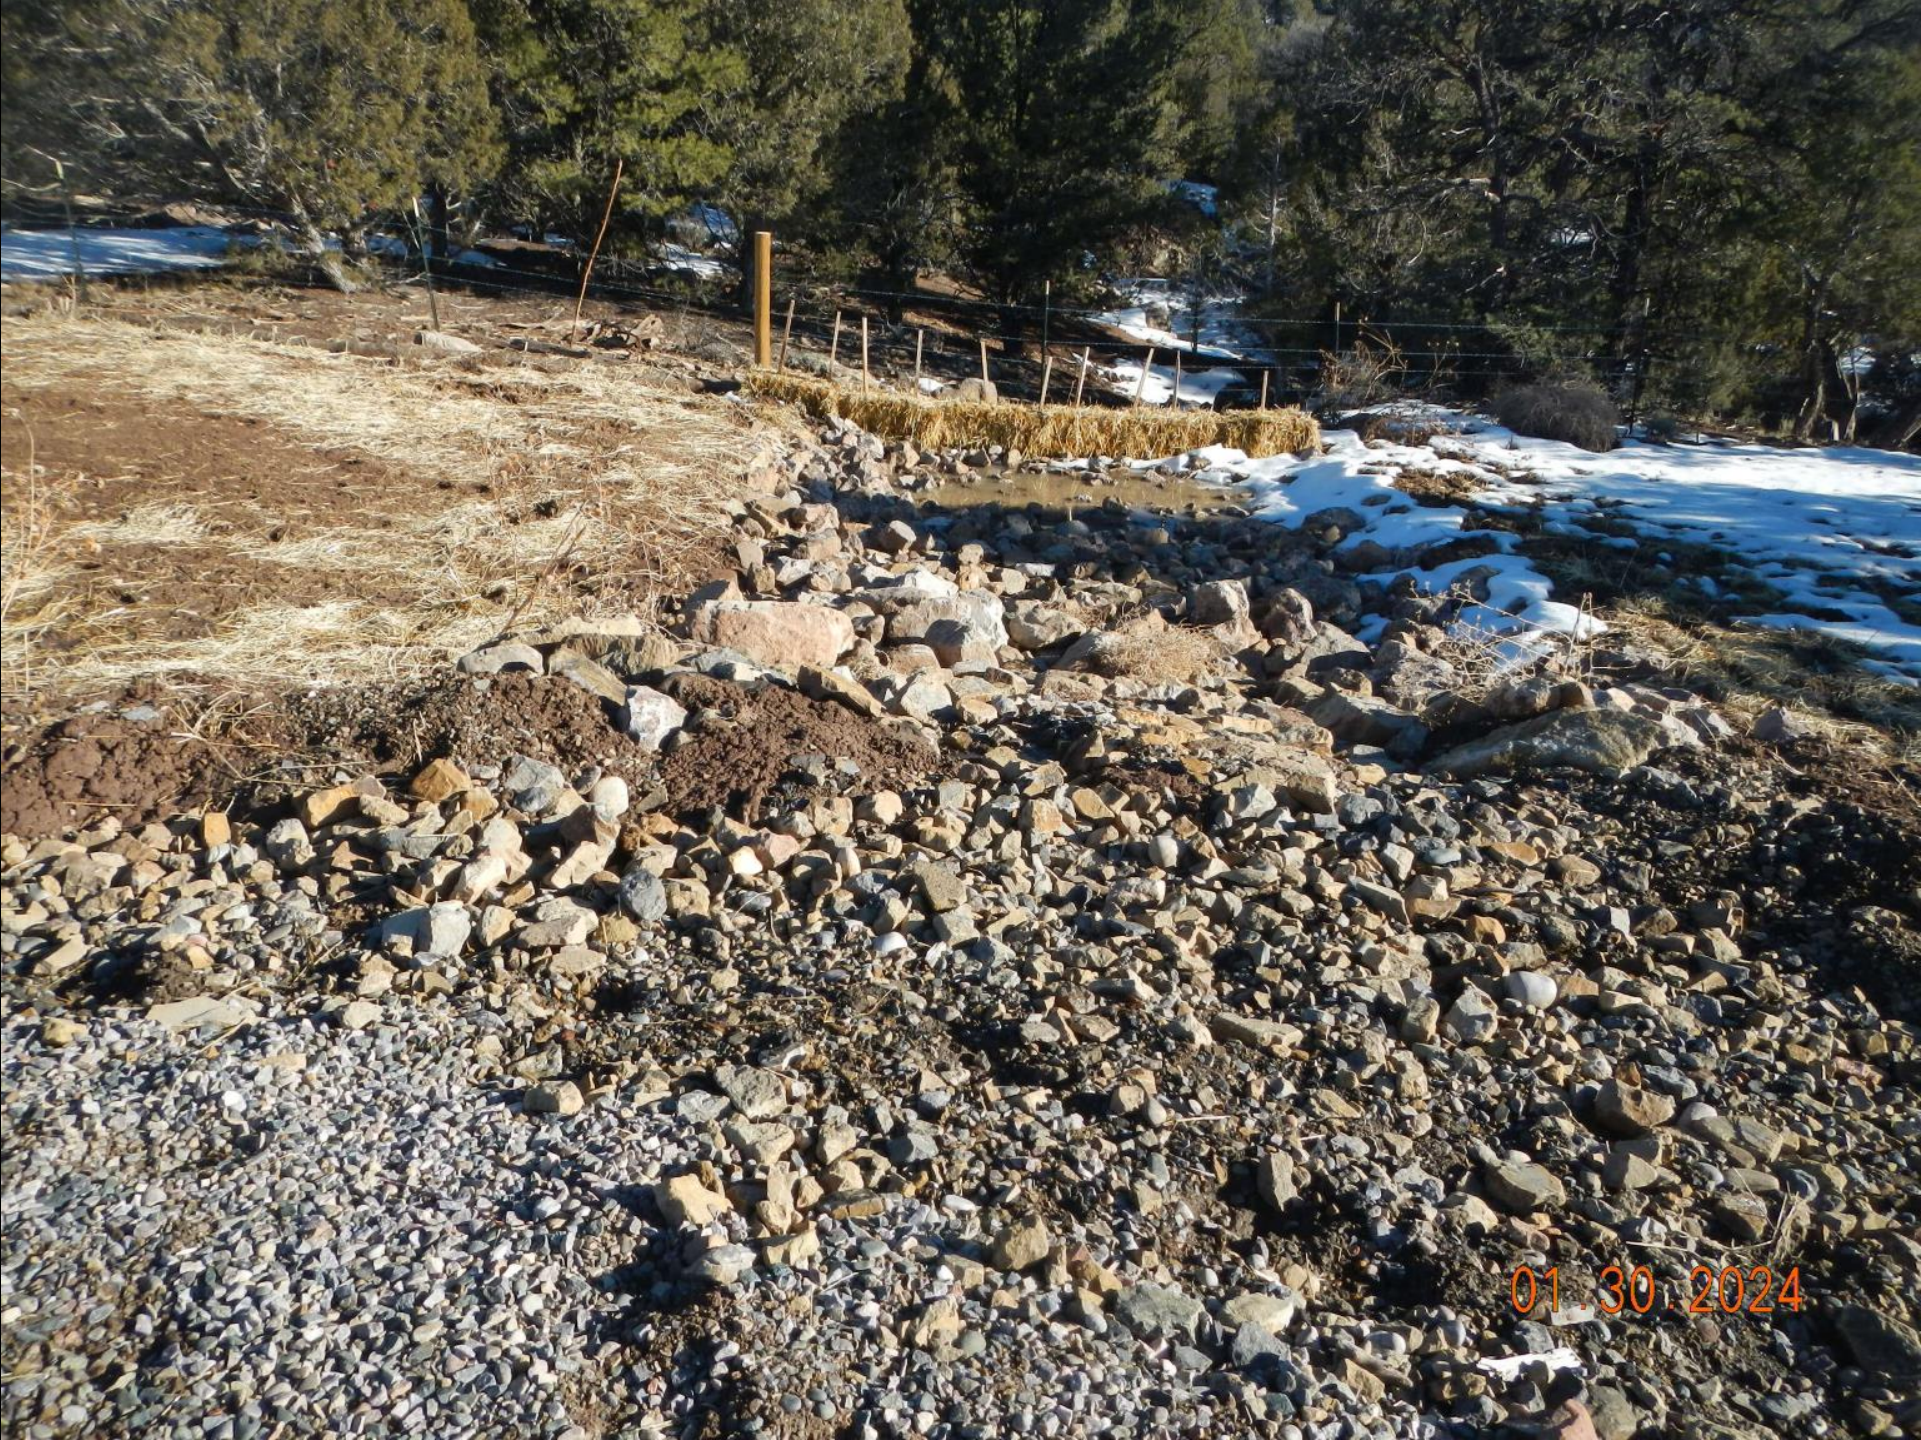
Stormwater breach of location berm

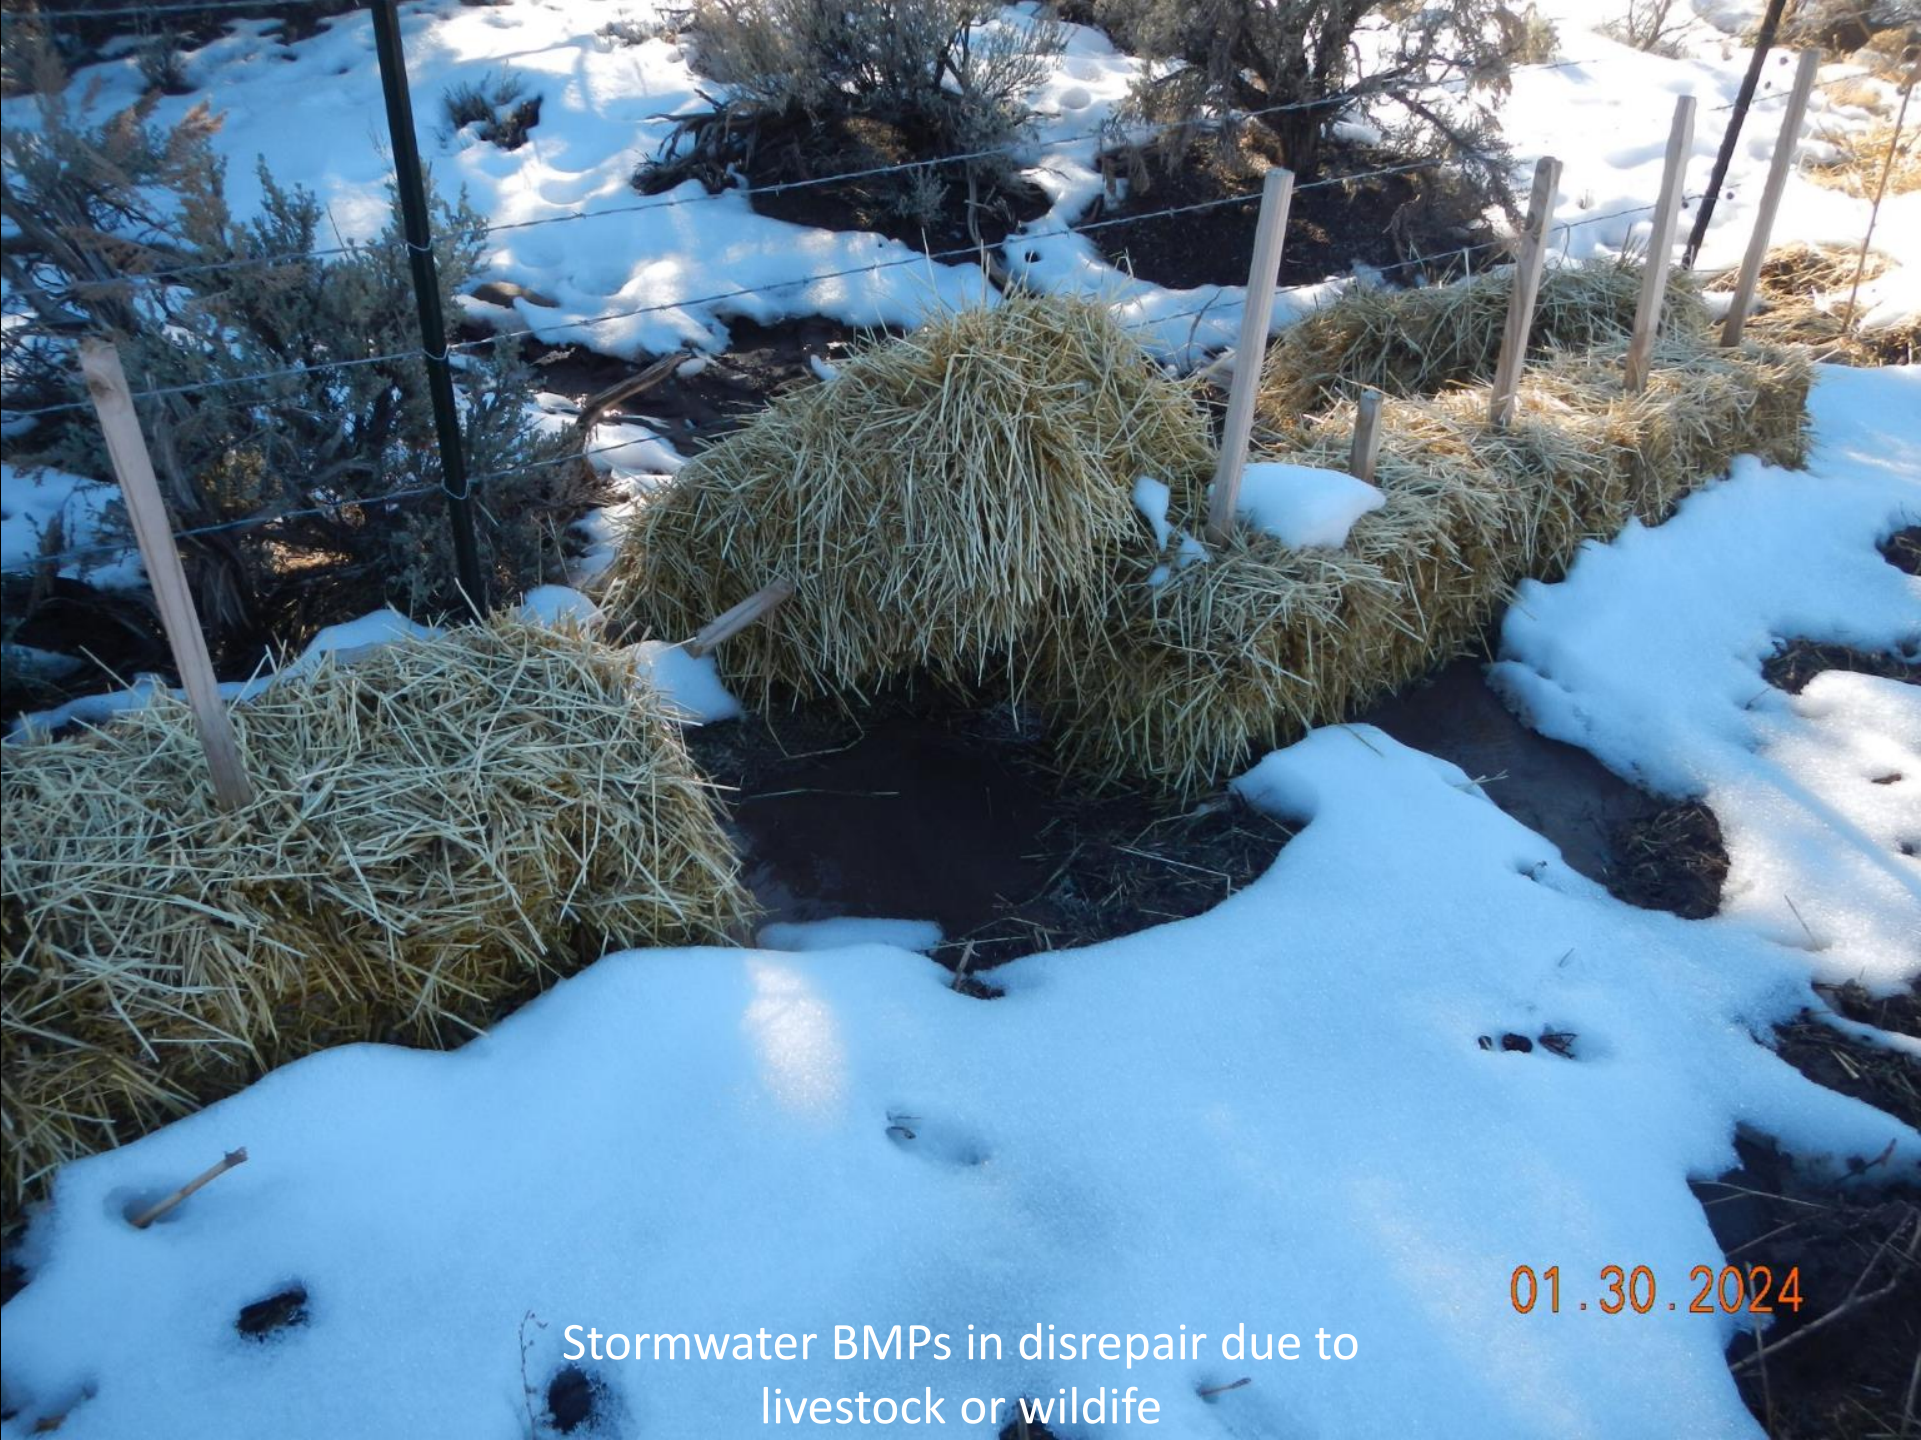
Stormwater run off going  
through/under wattles

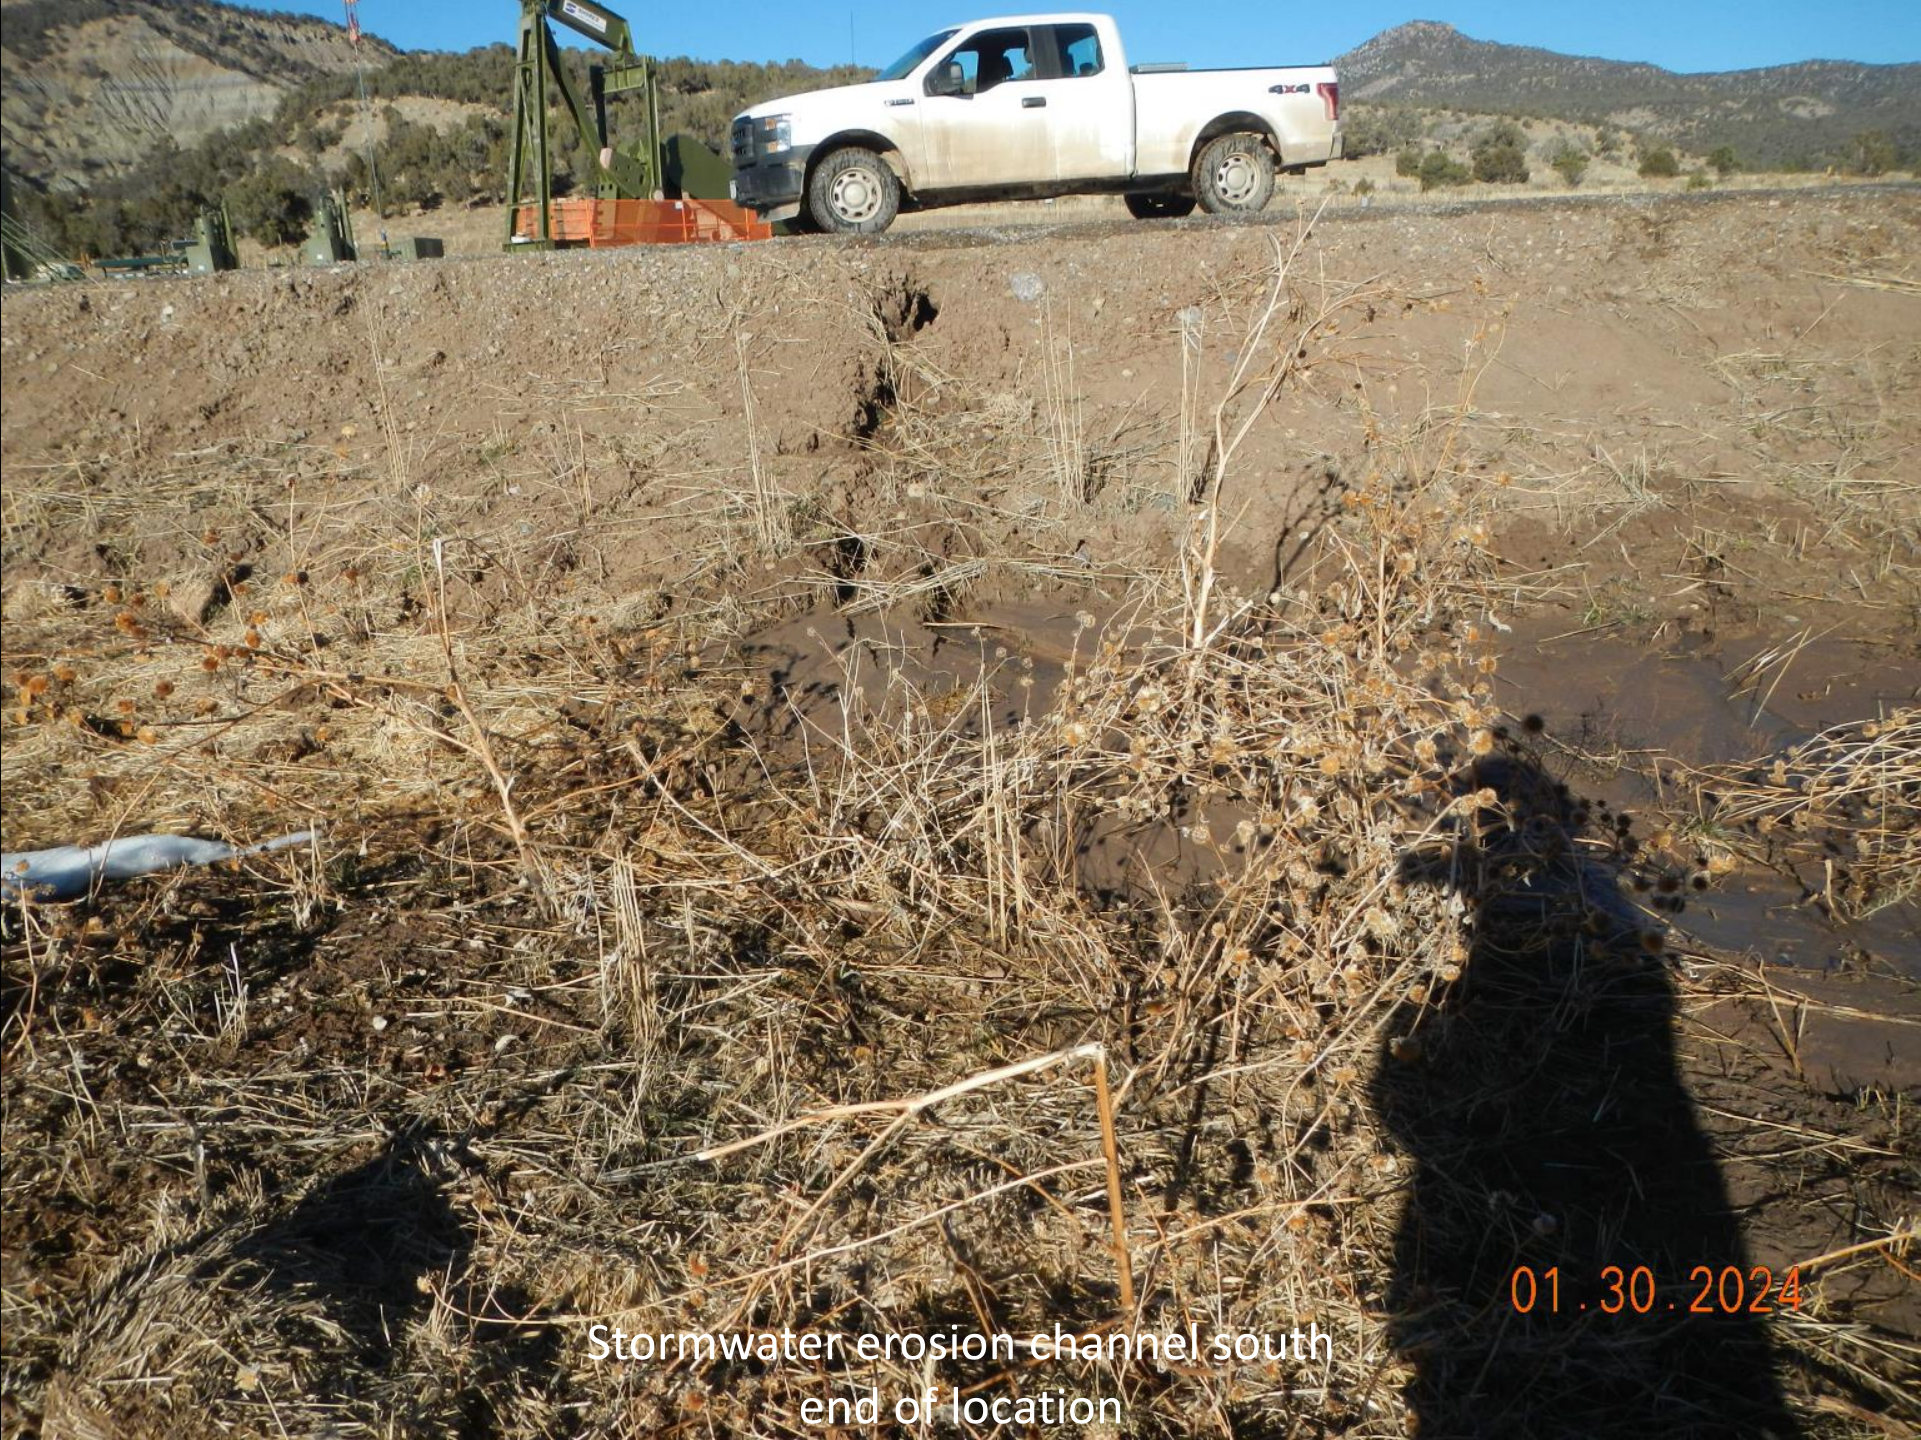
Stormwater BMPs in disrepair due to  
livestock or wildlife

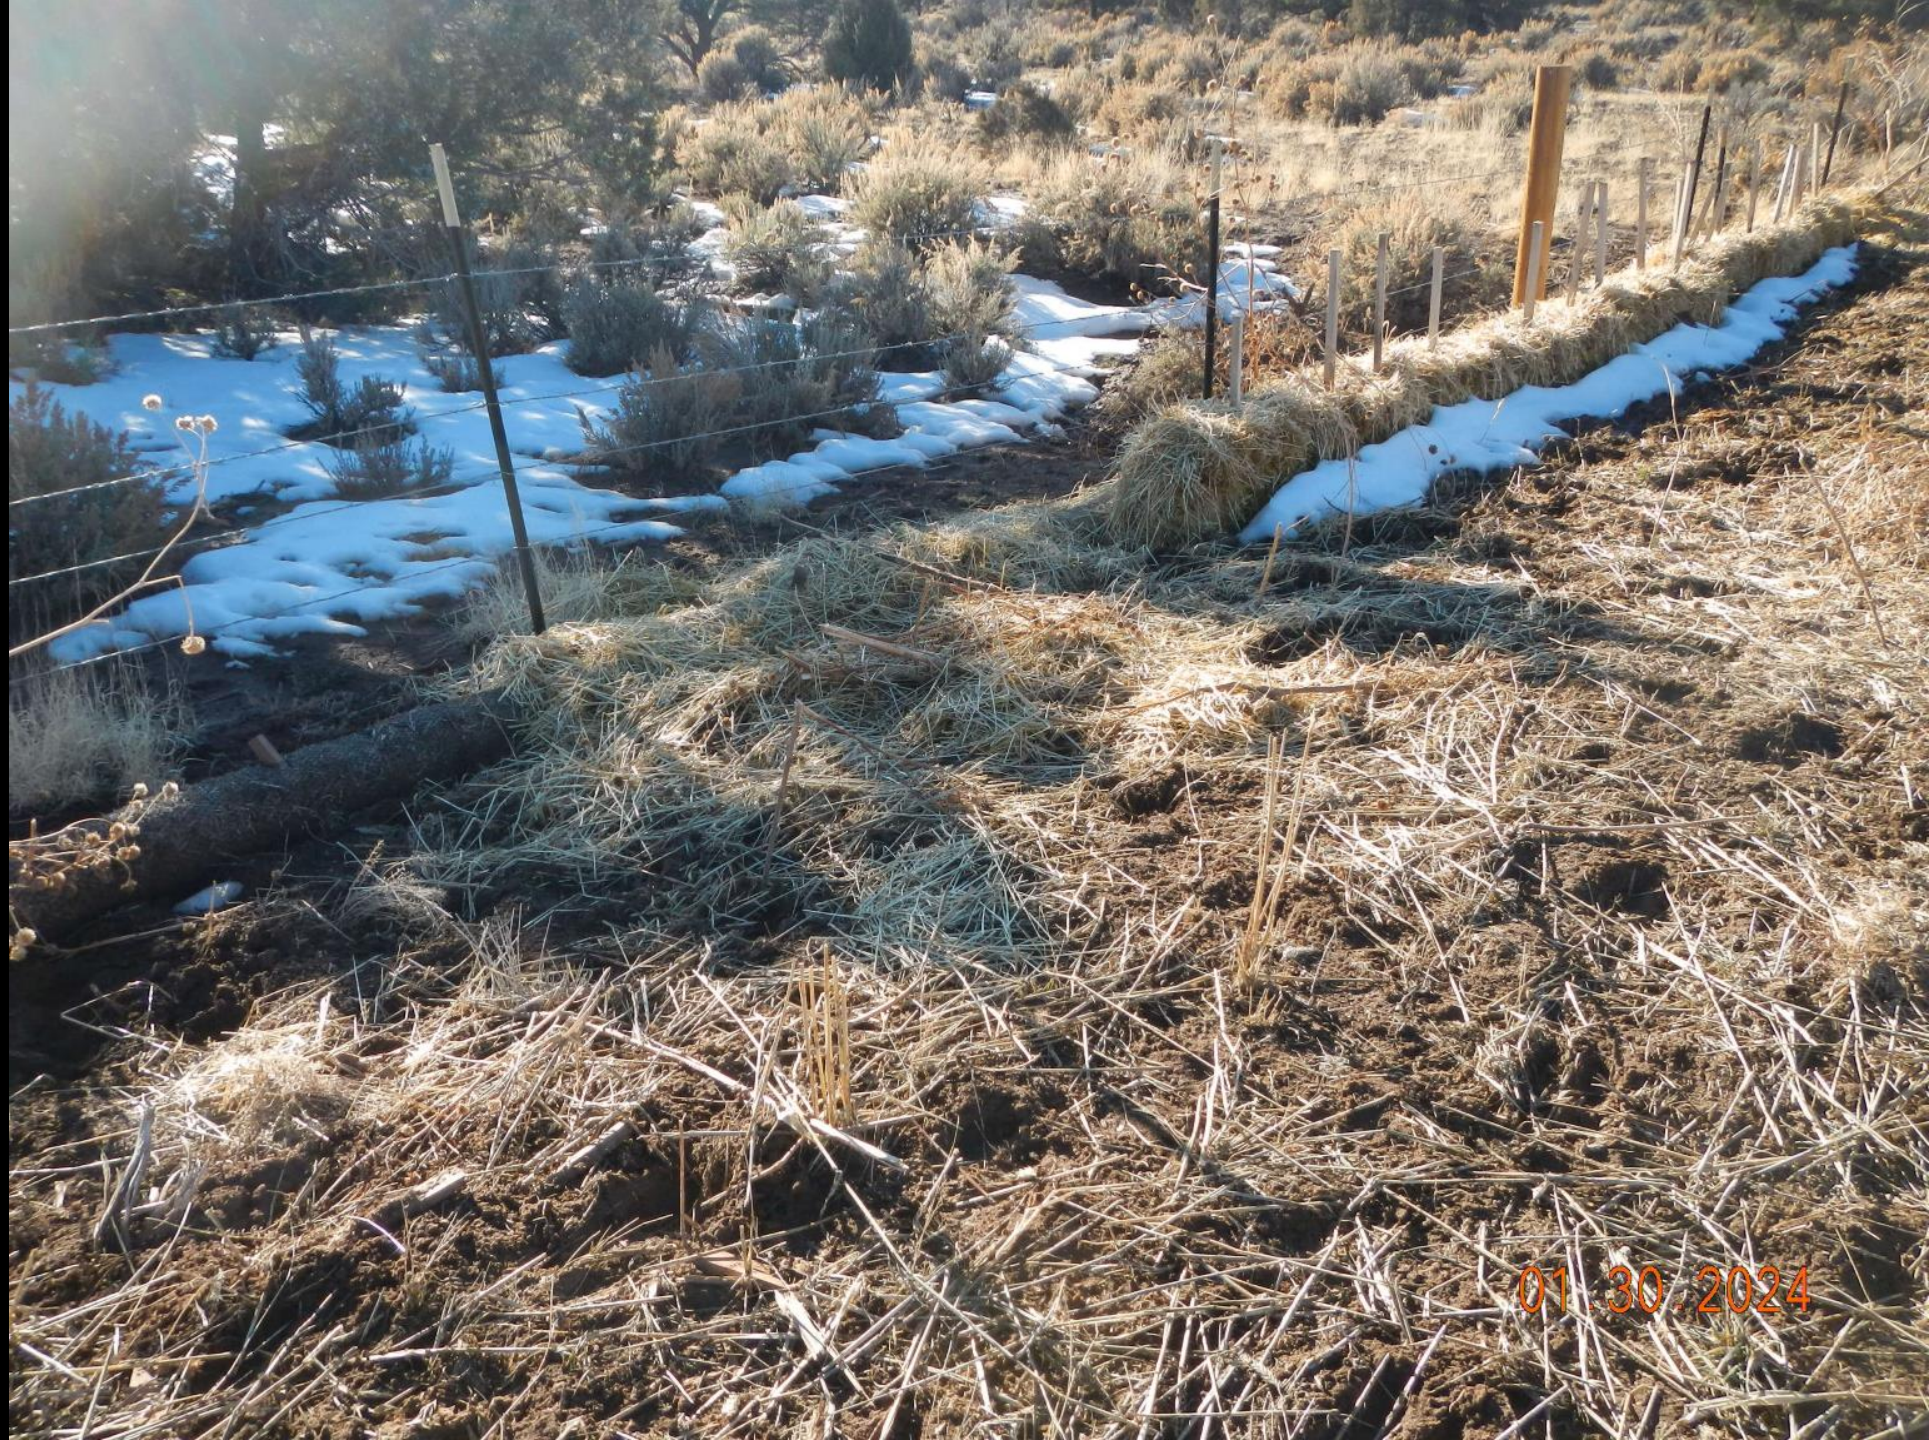
Stormwater erosion channel south  
end of location

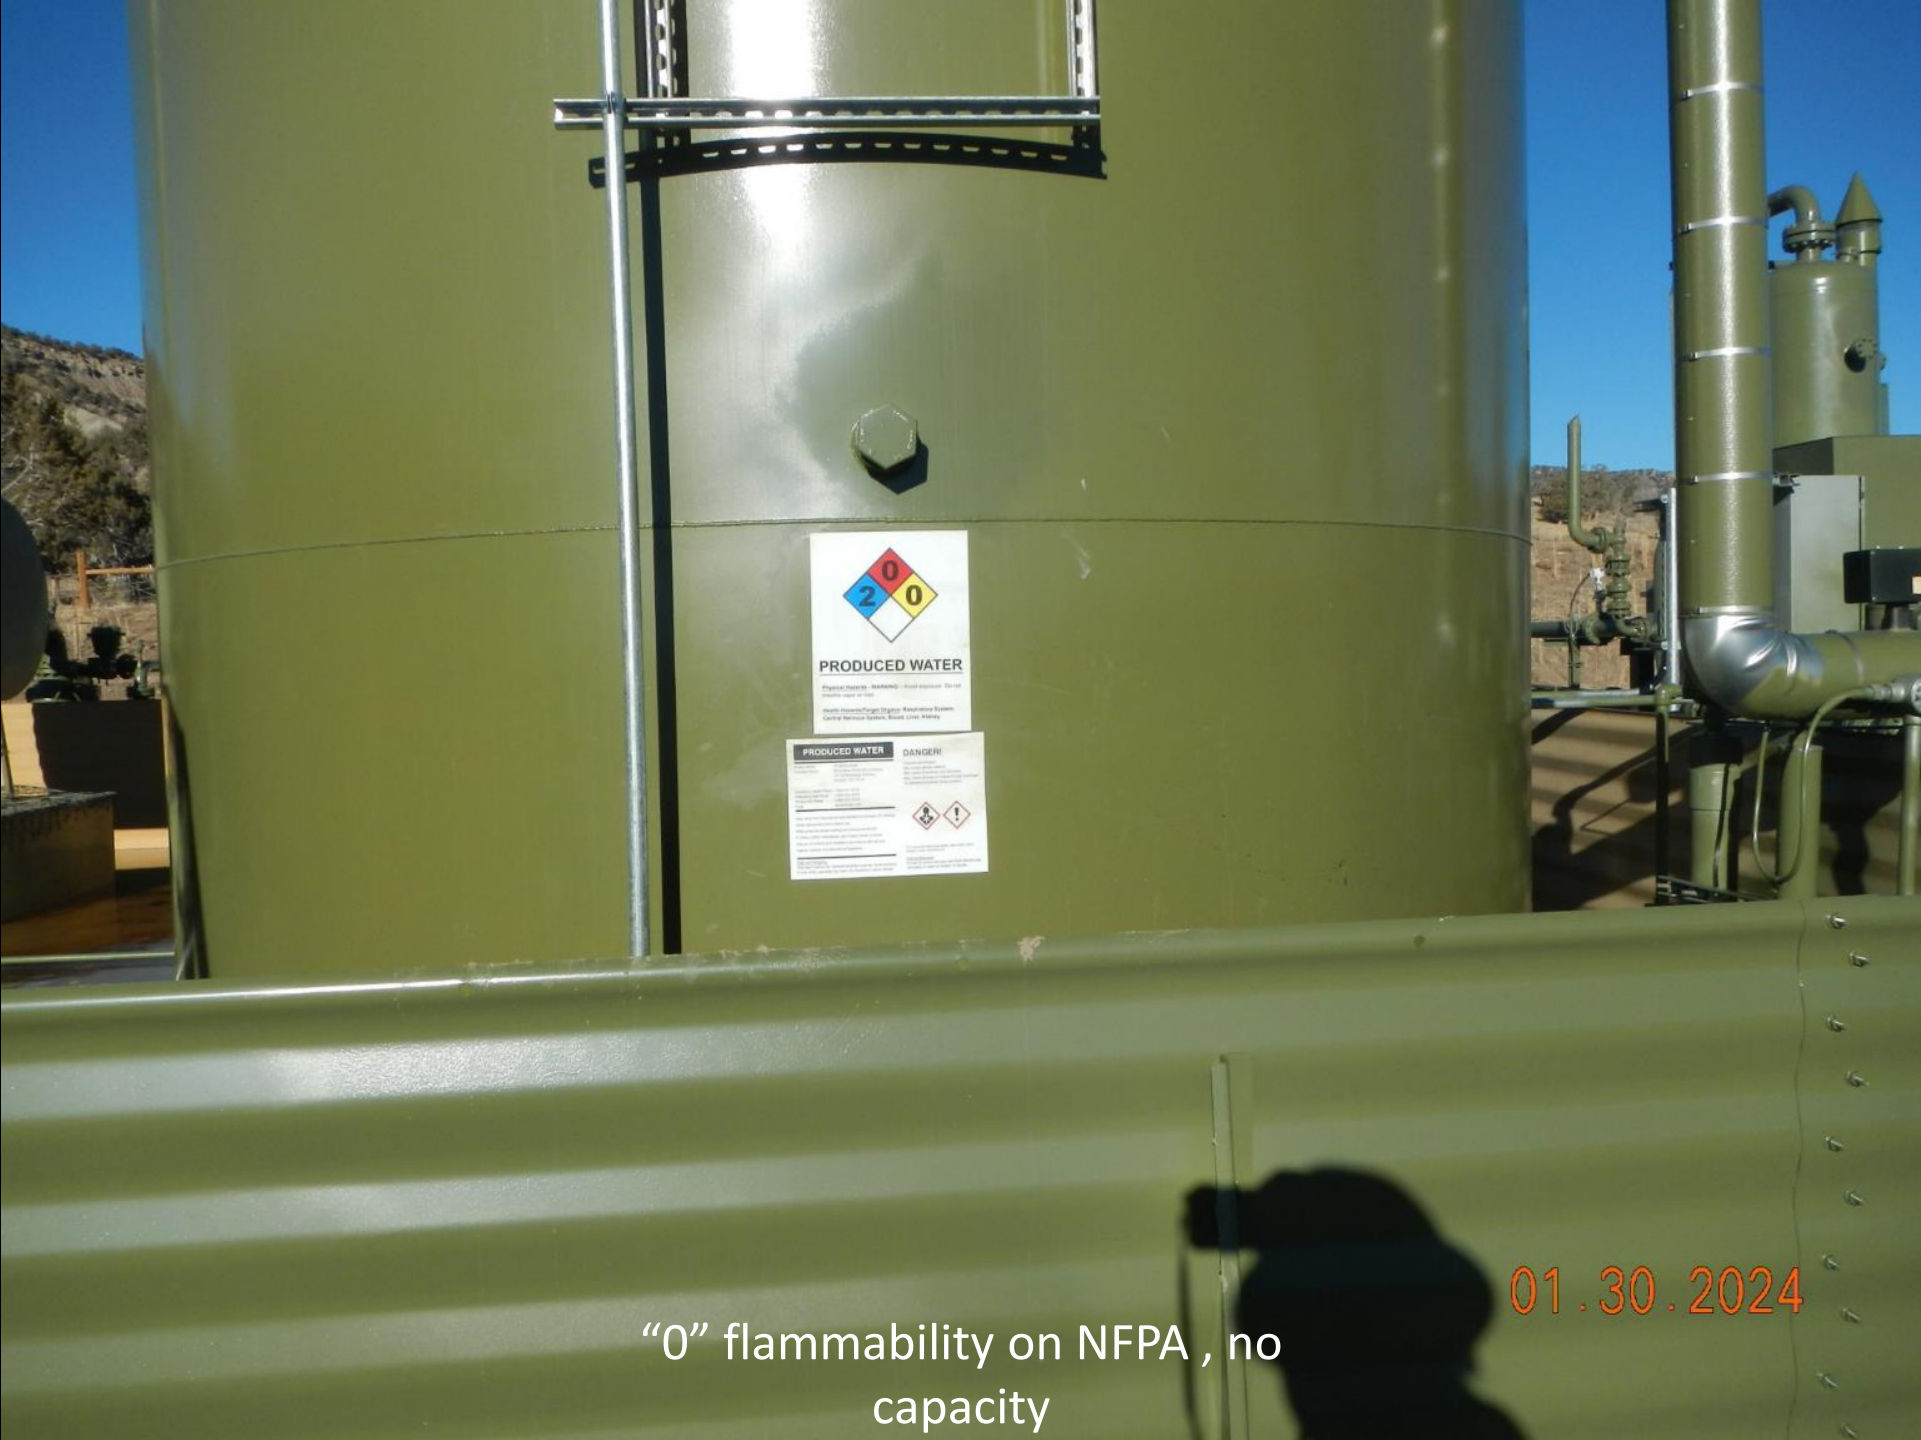
“0” flammability on NFPA , no  
capacity

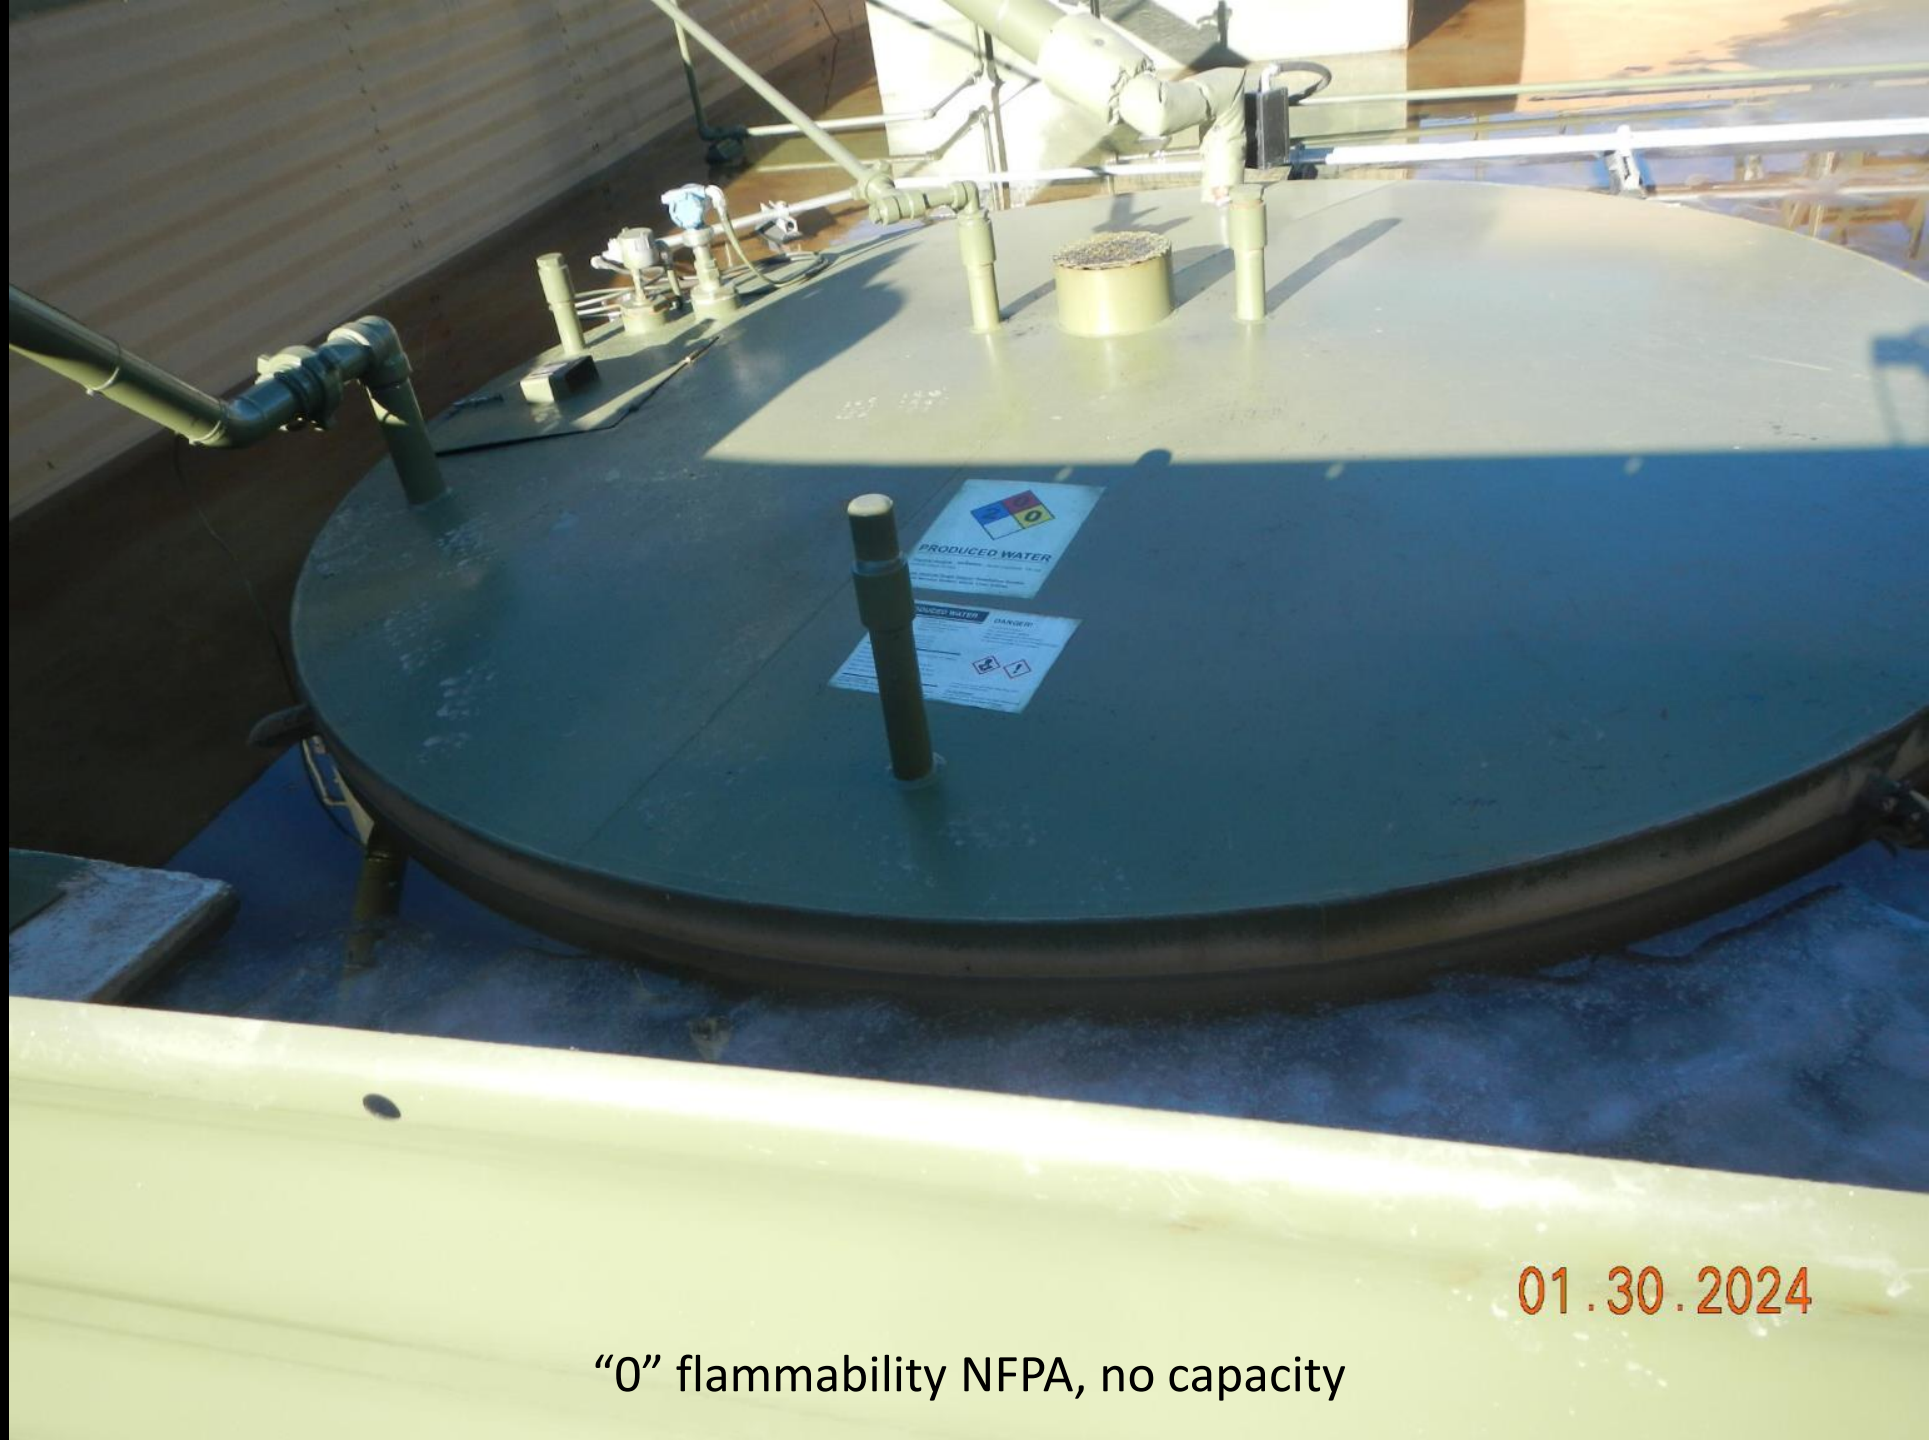
"0" flammability NFPA, no capacity
