# 01/30/24 INSPECTION PHOTOS

## SOMCOE, LLC TIFFANY 5 LOCATION

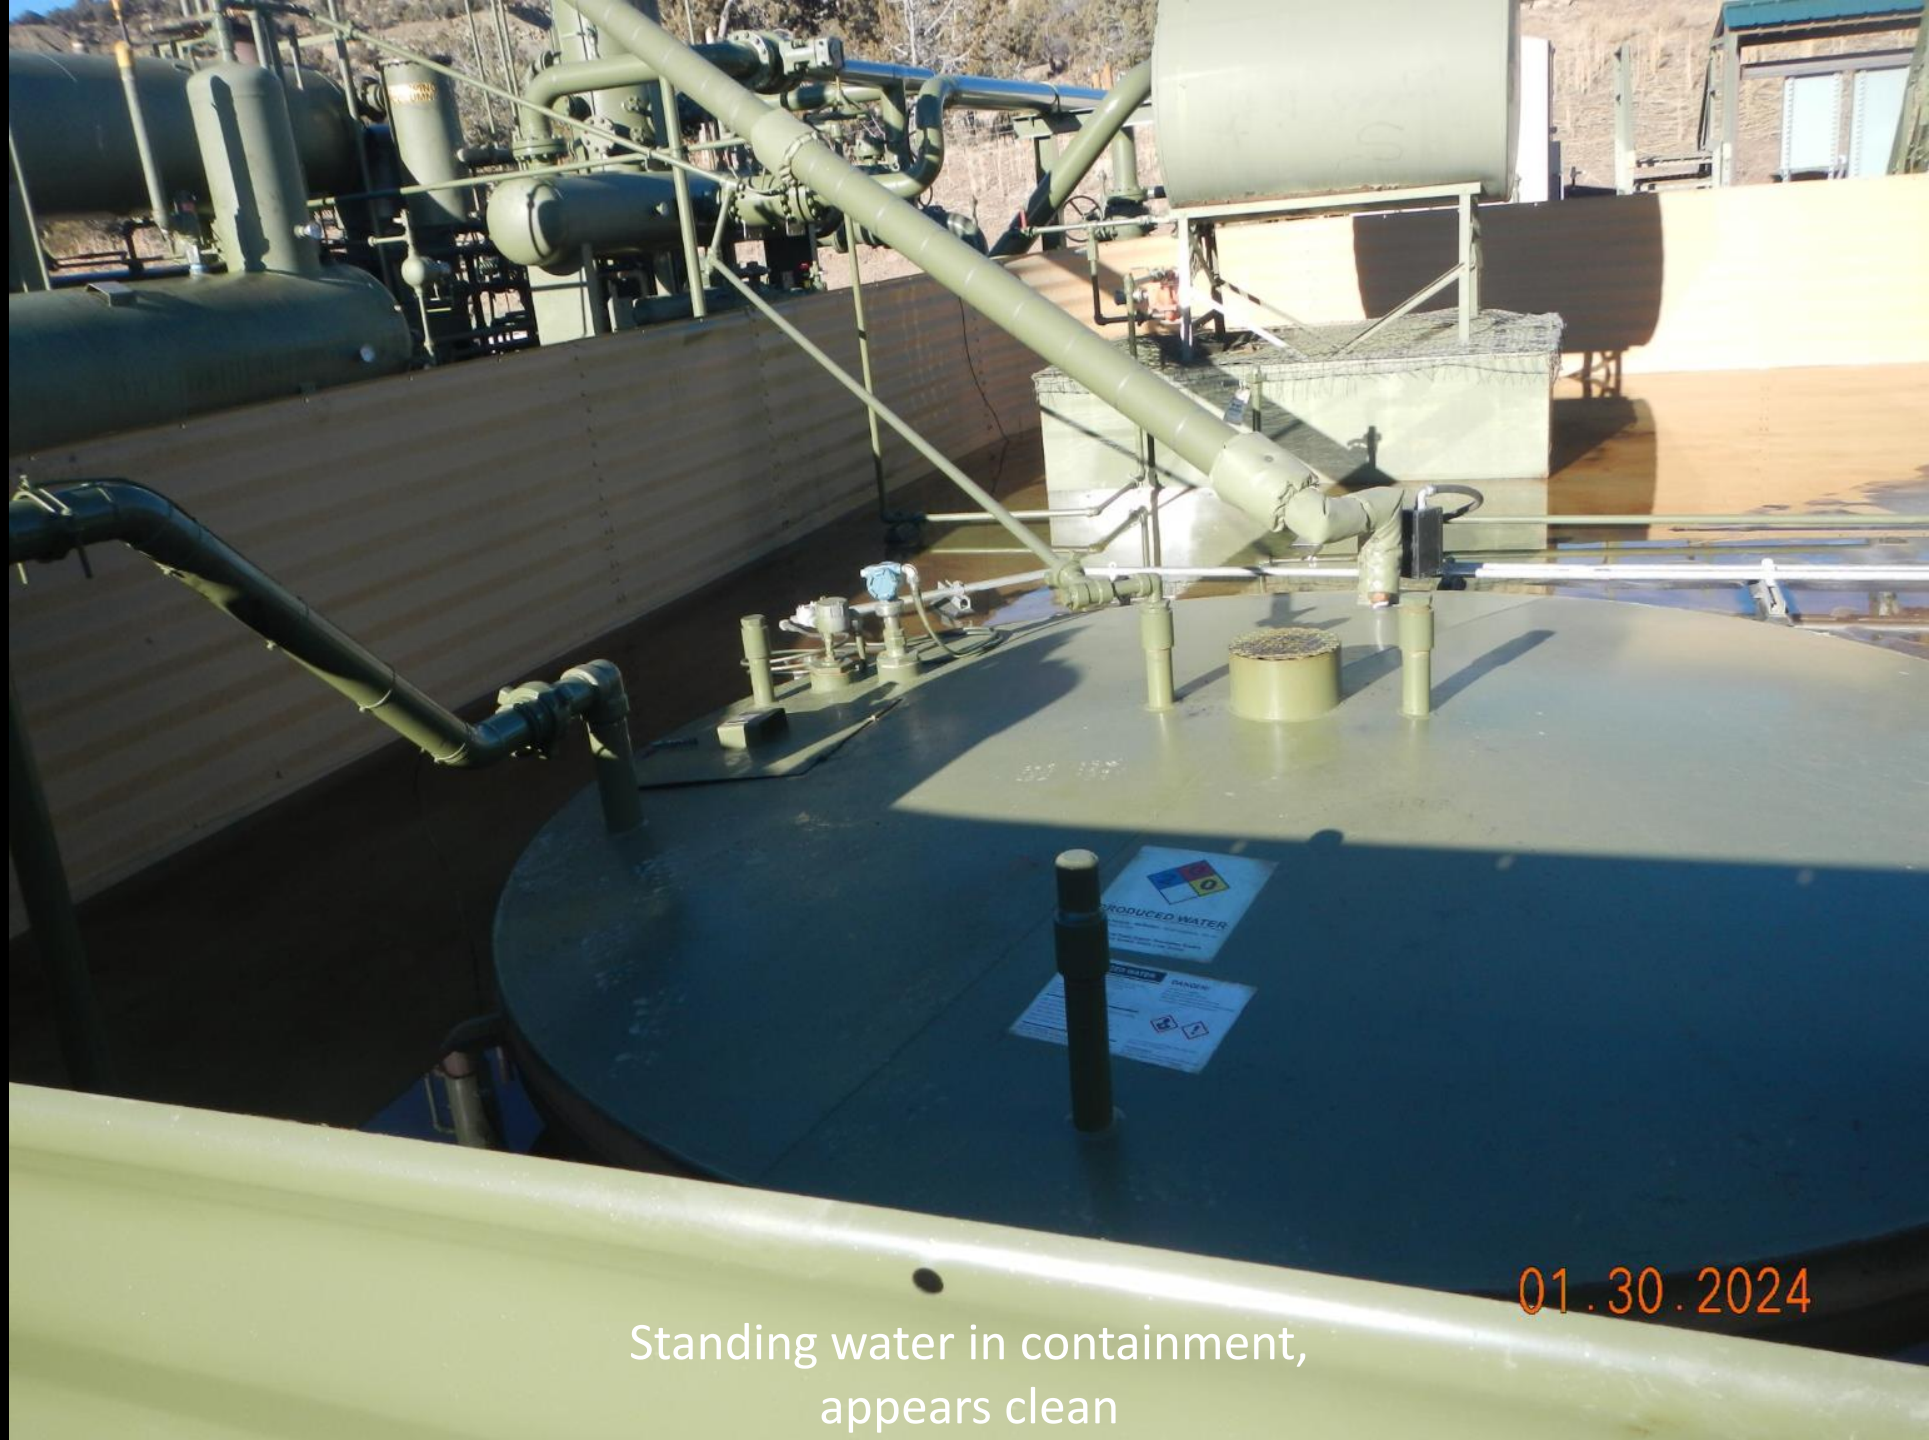
Standing water in containment,  
appears clean

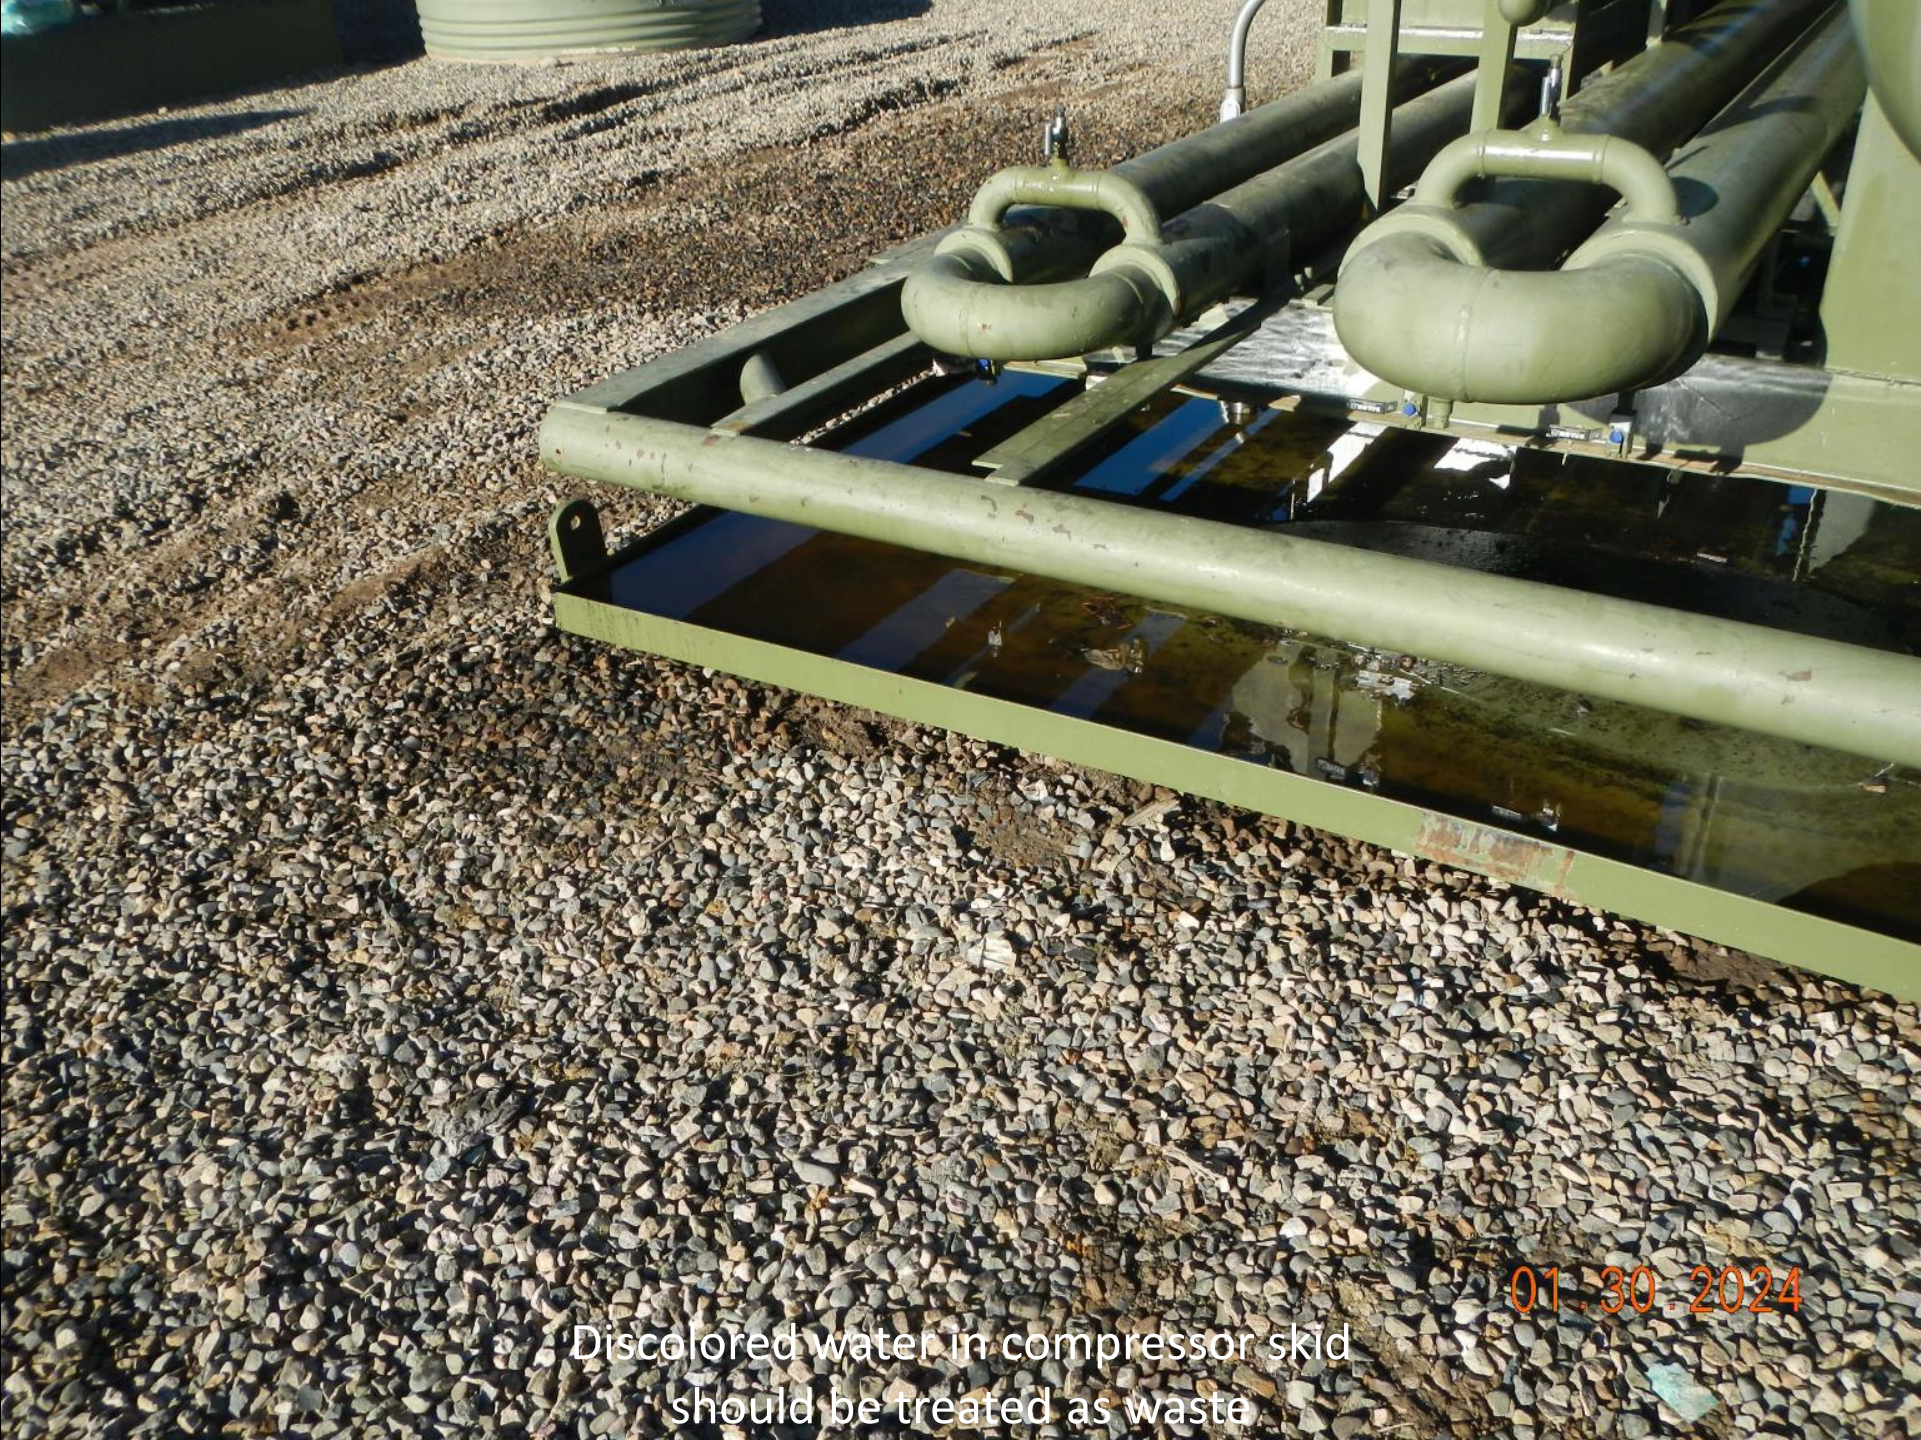
Discolored water in compressor skid  
should be treated as waste

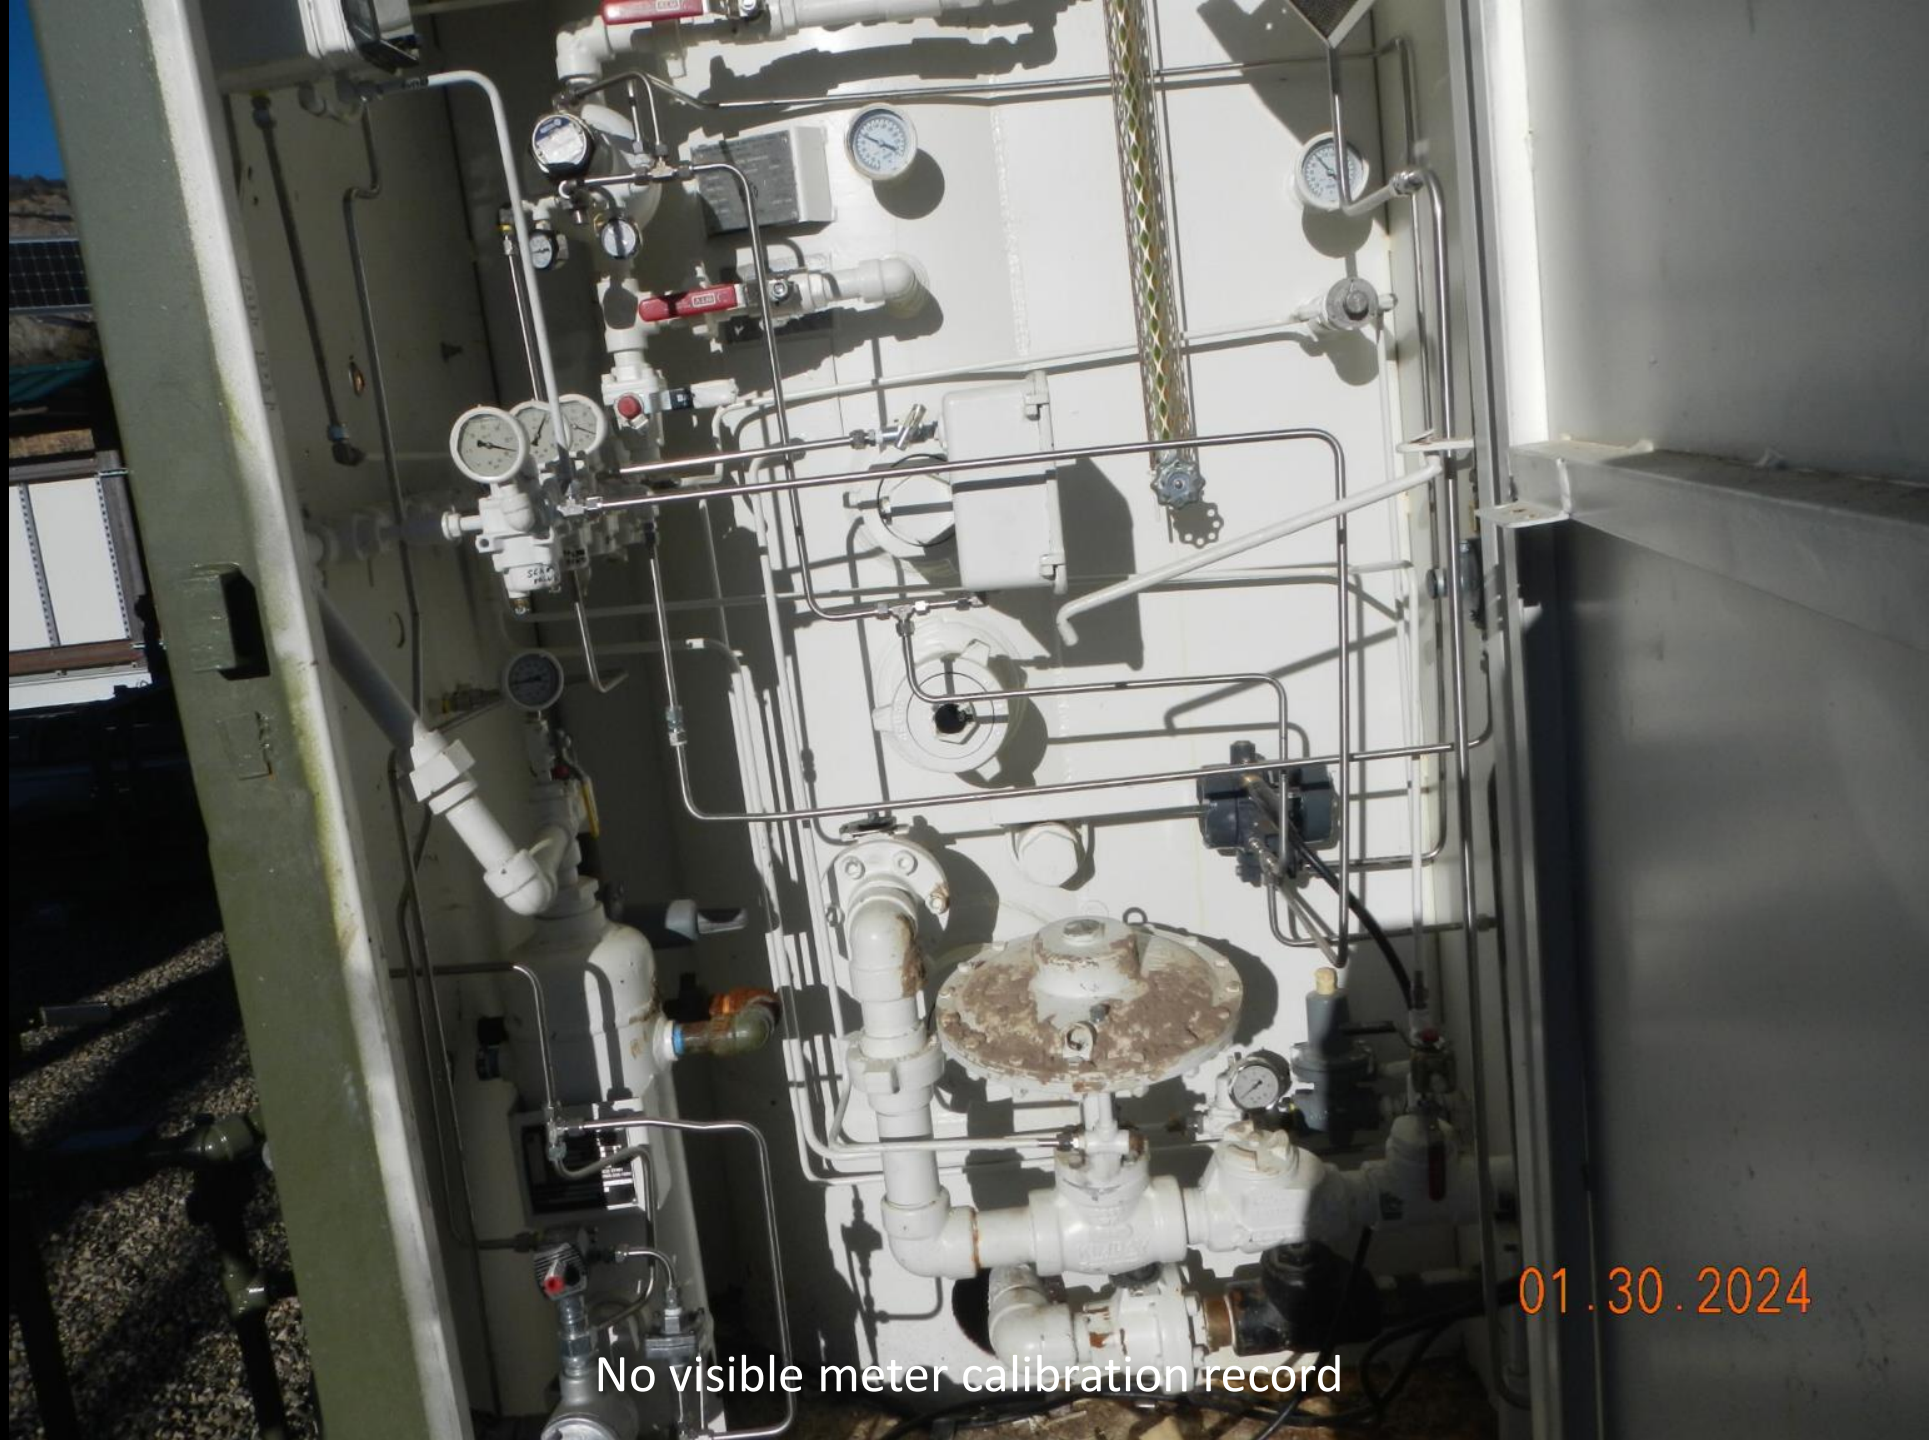
No visible meter calibration record

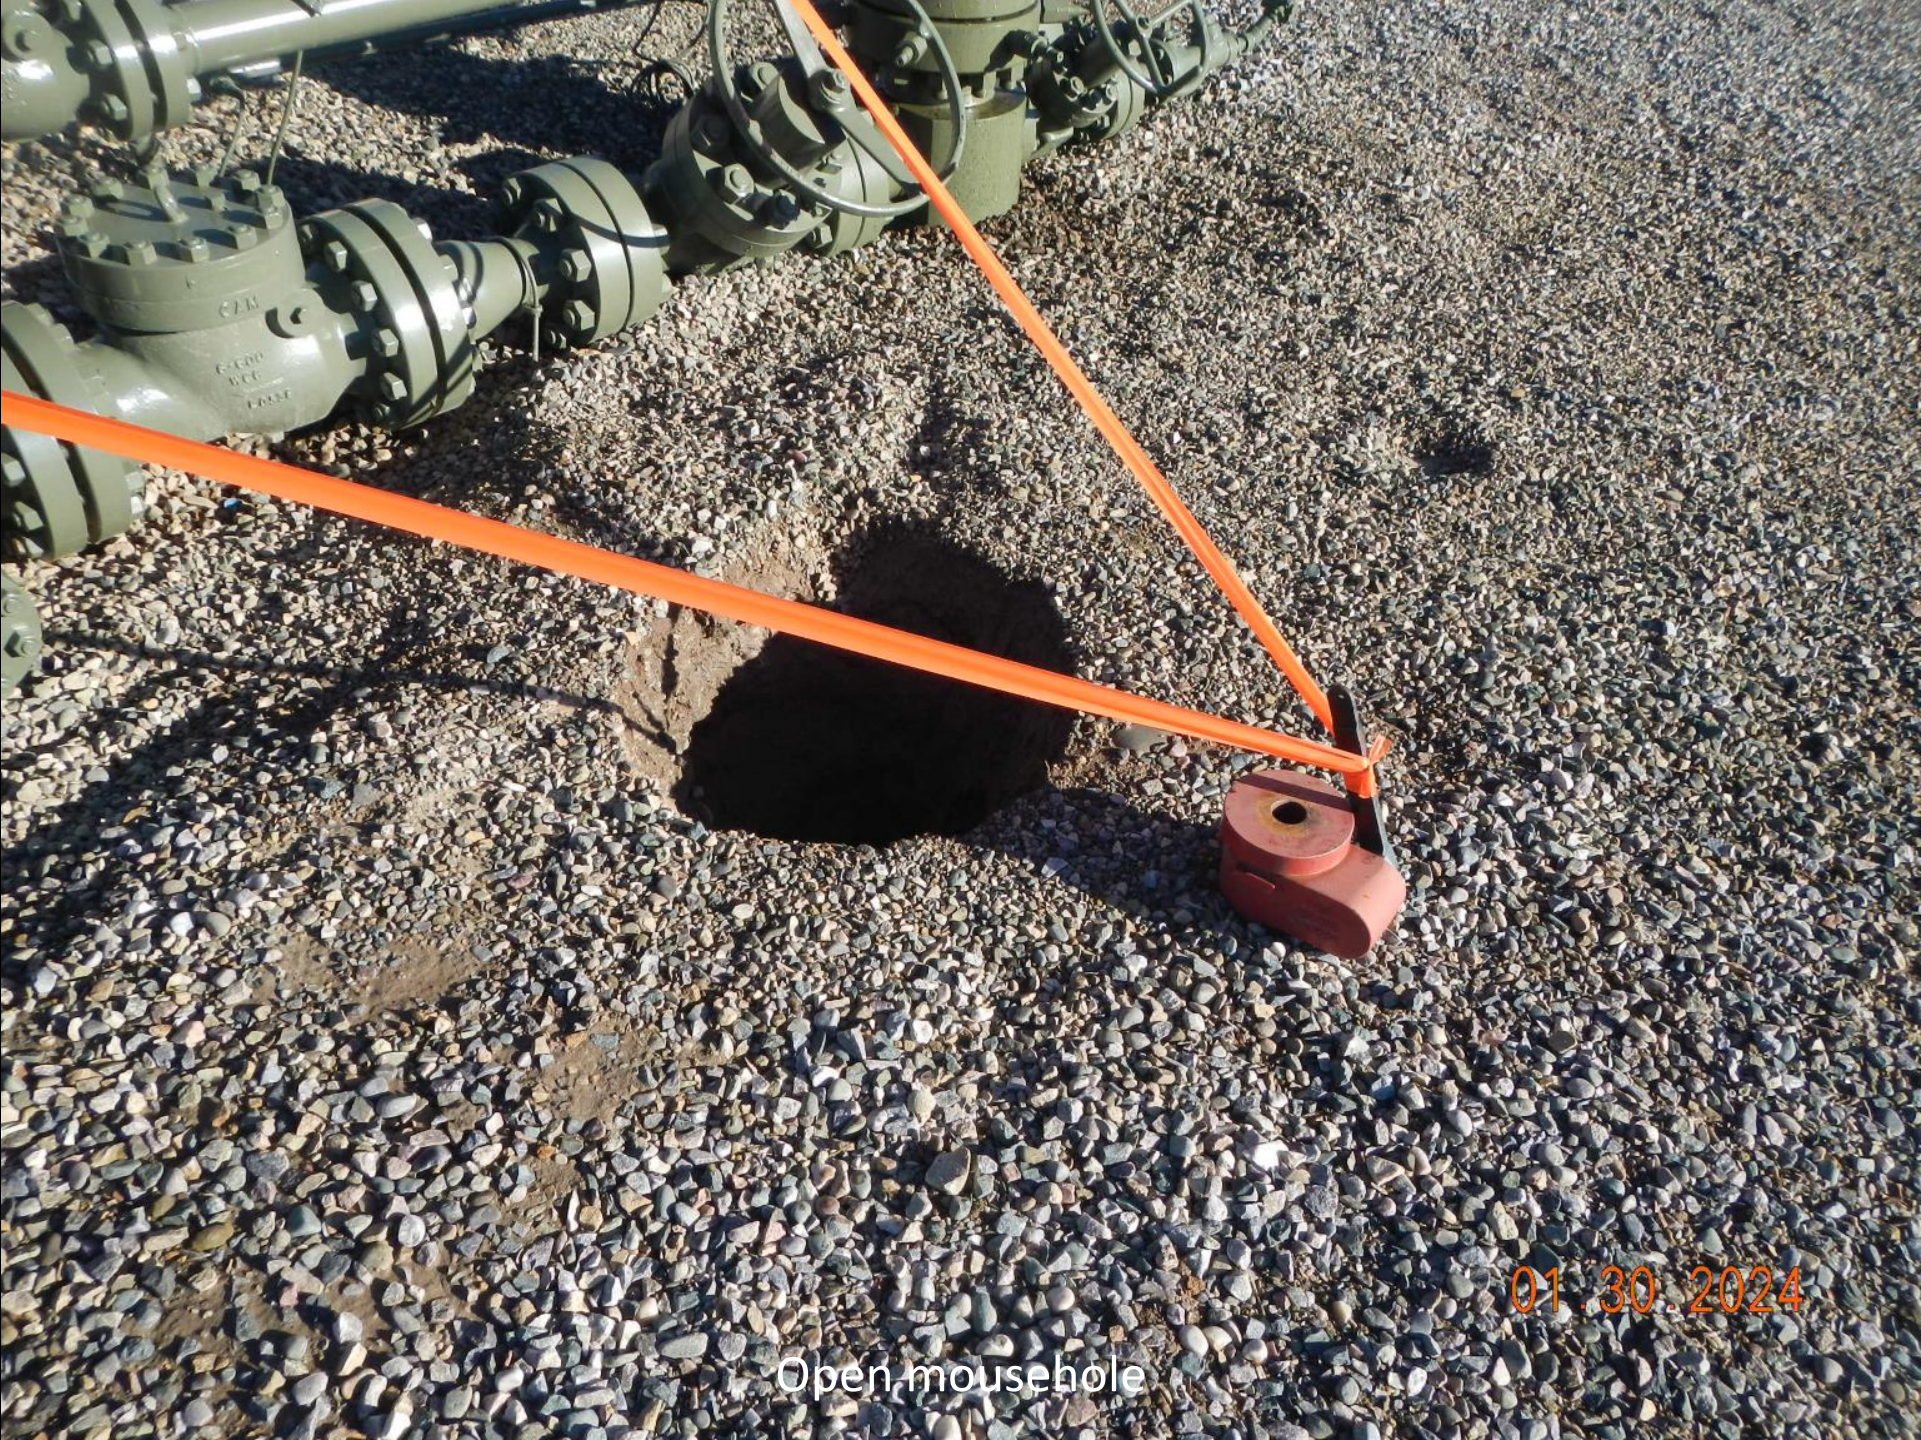
Open mousehole

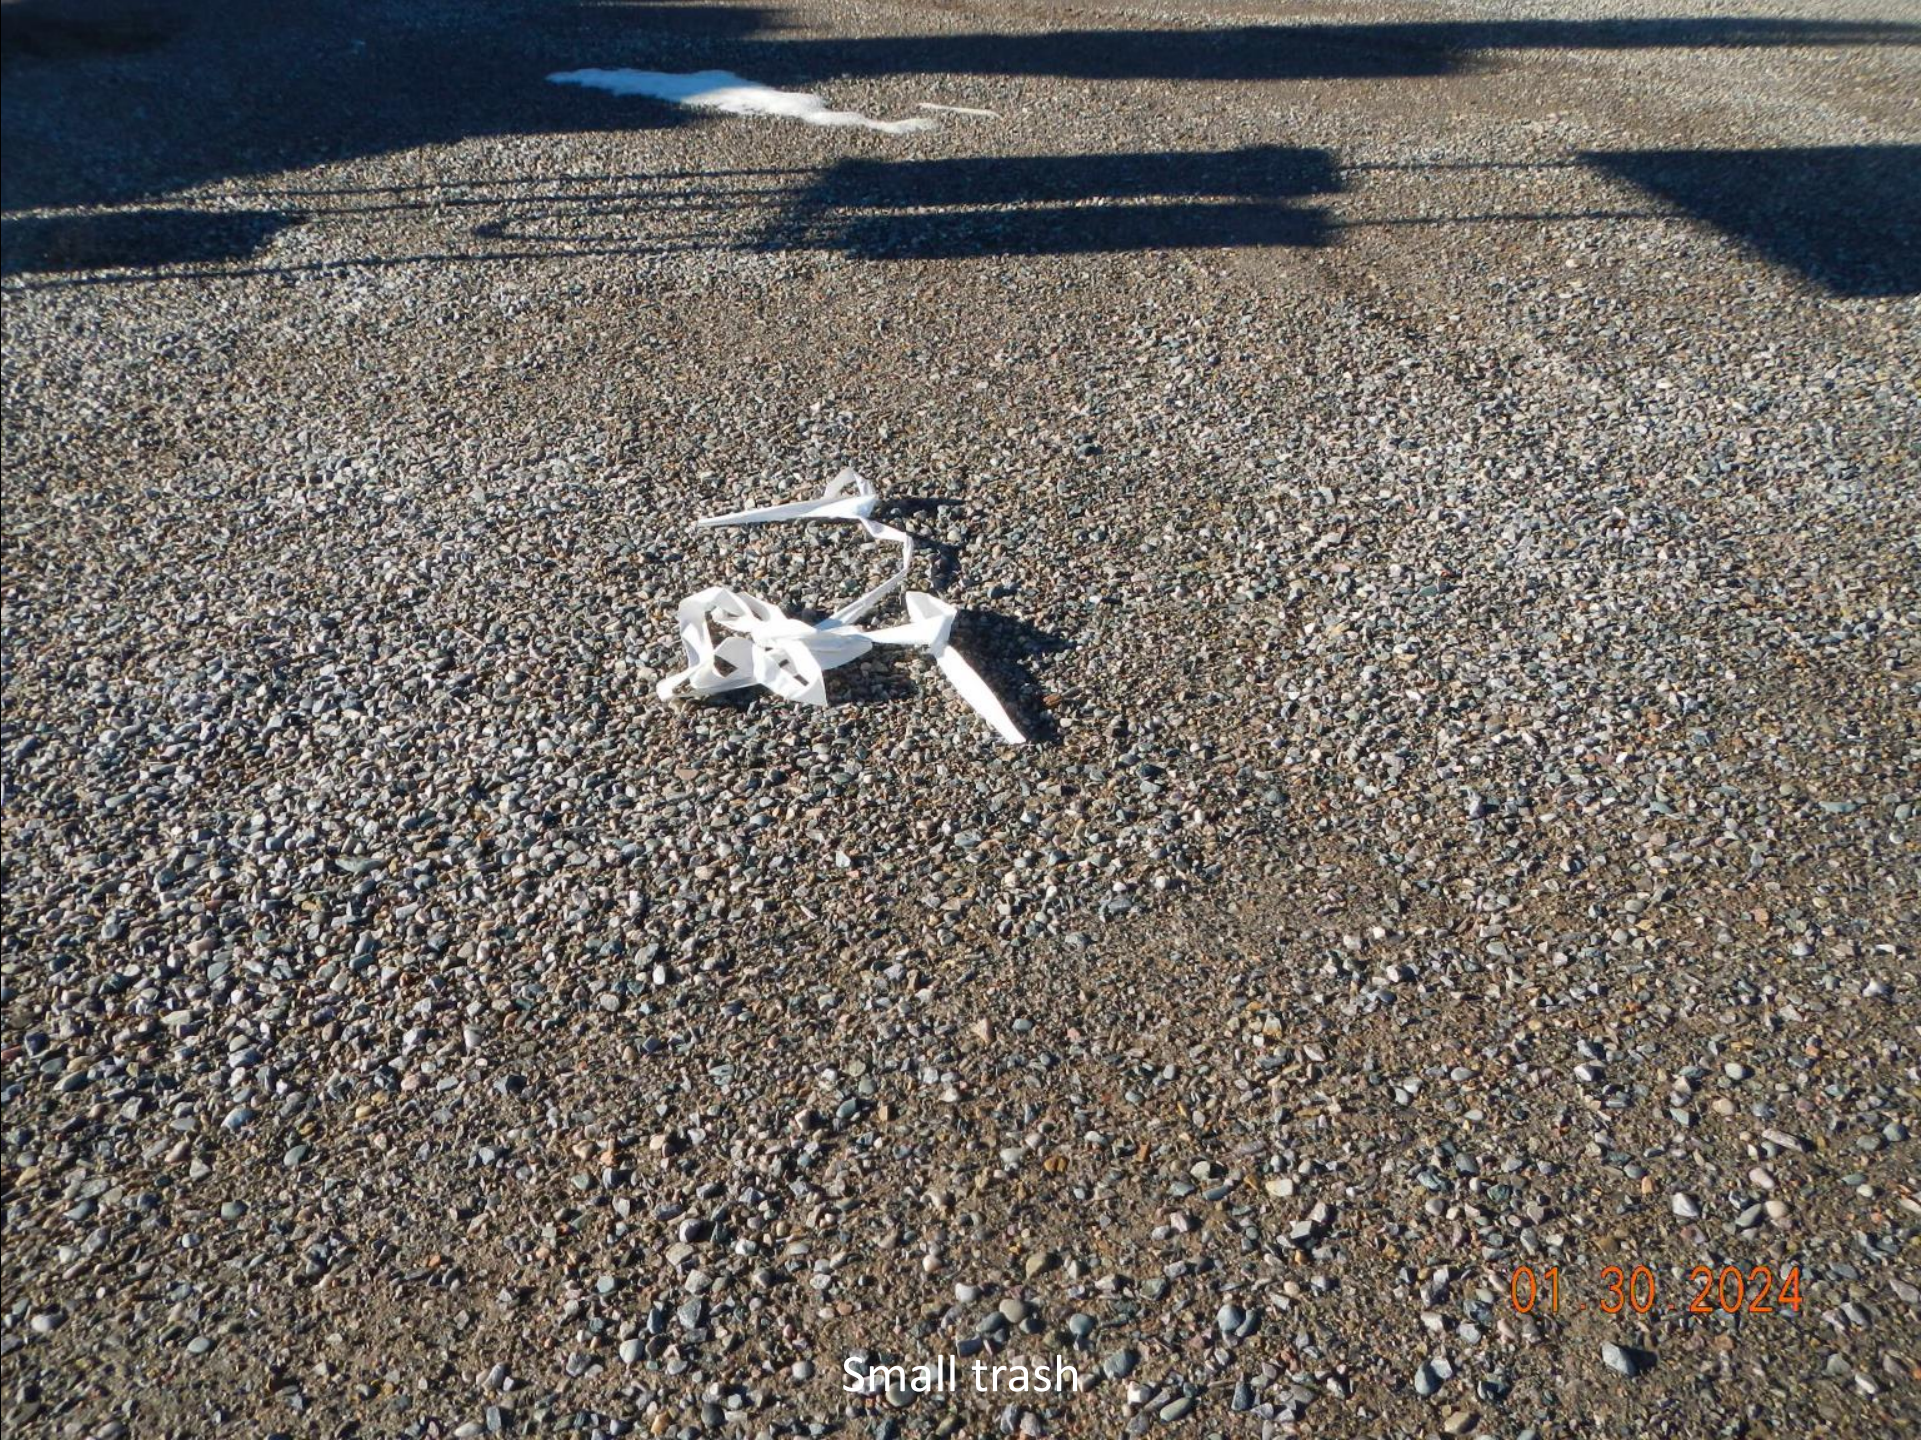
Small trash

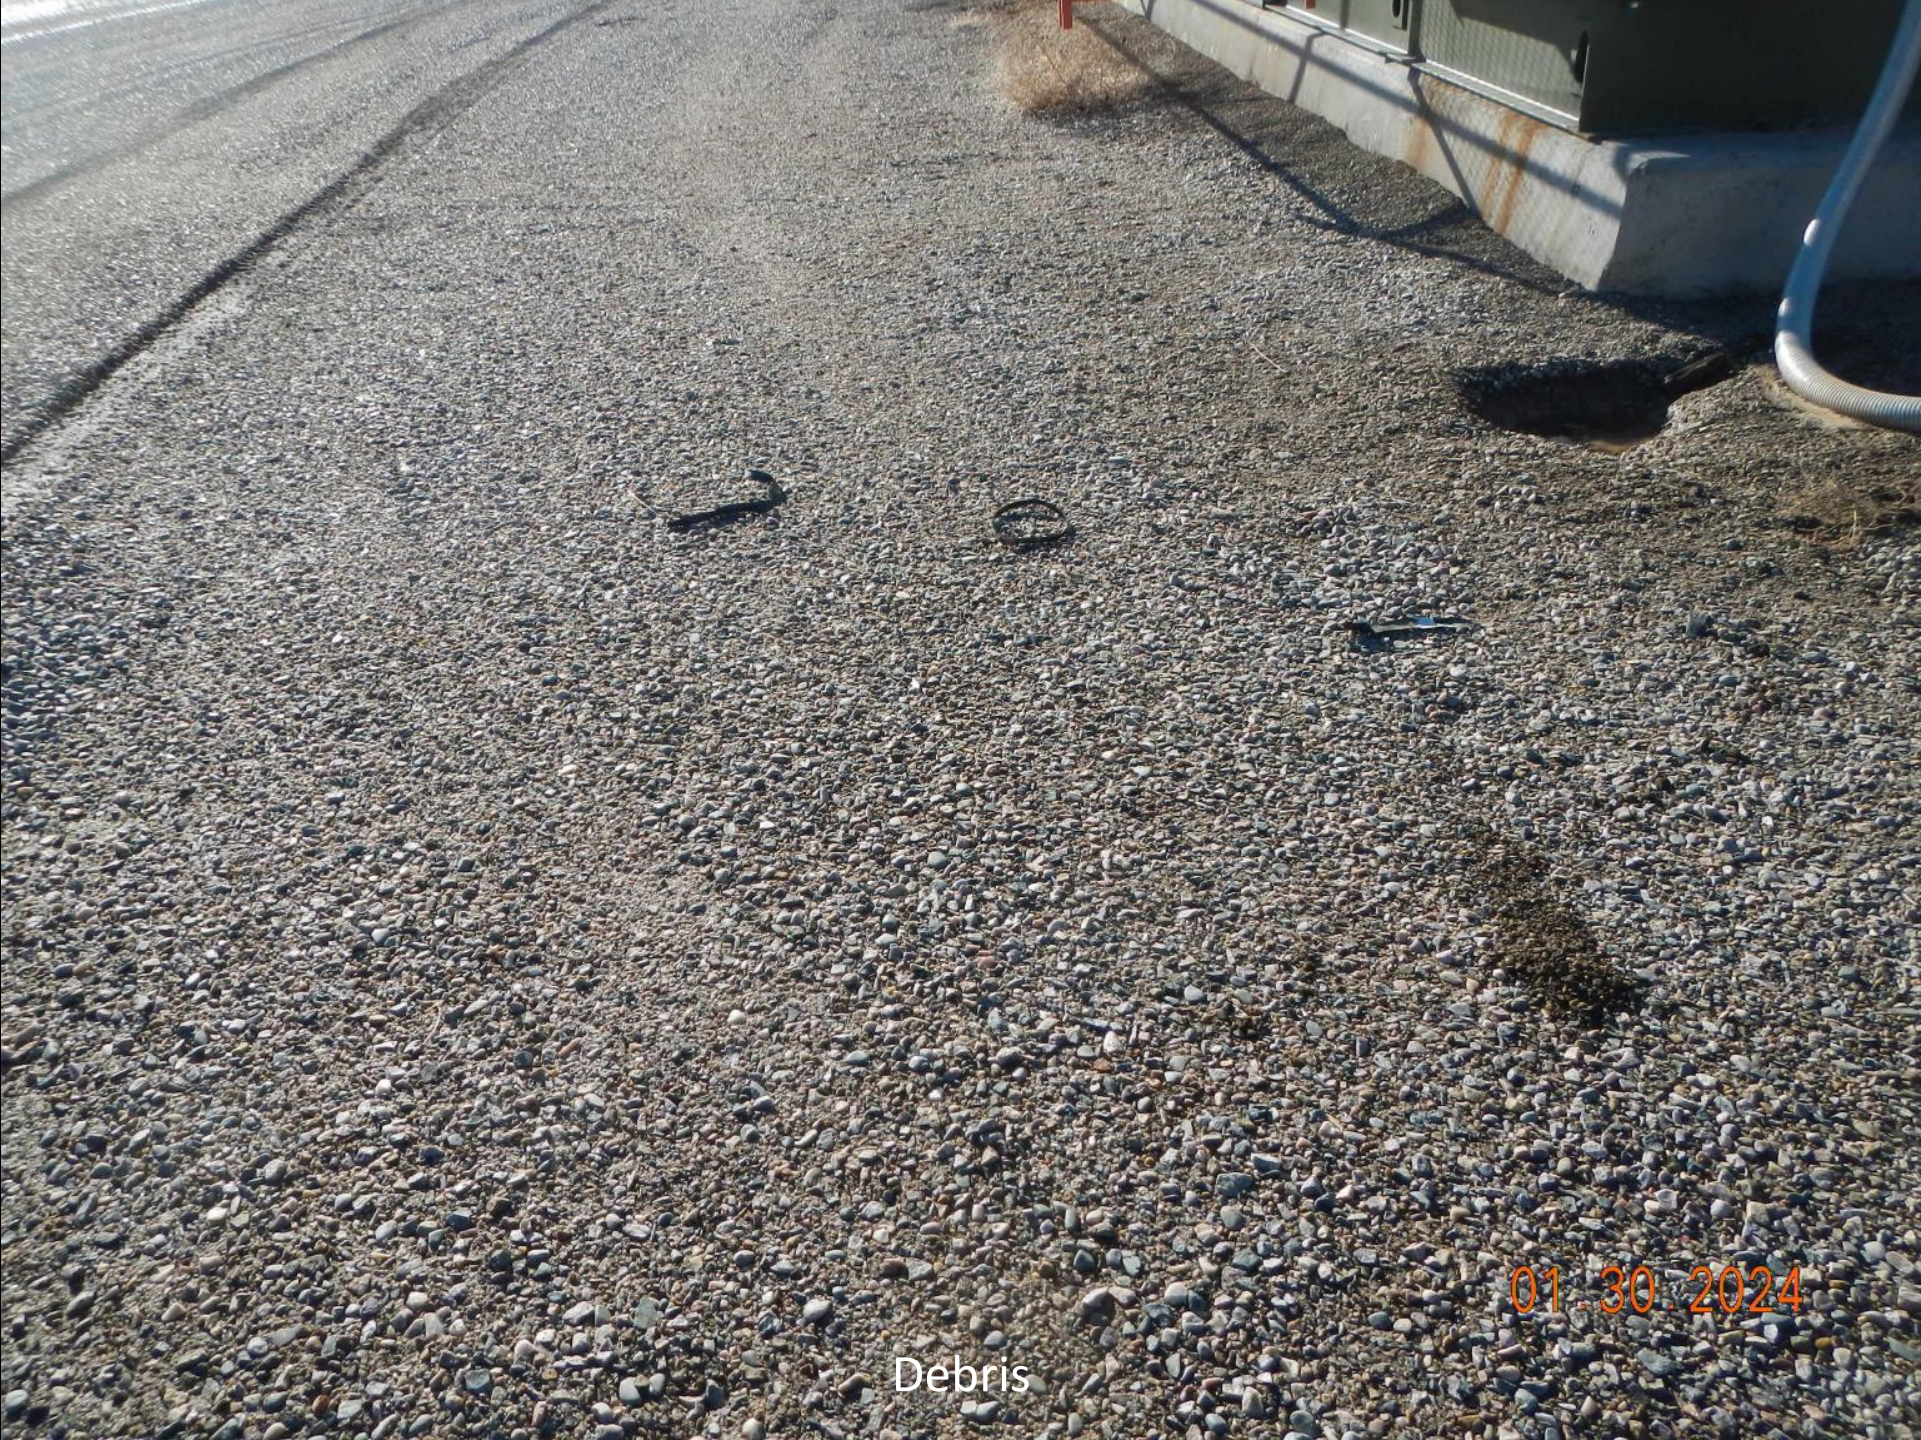
Debris

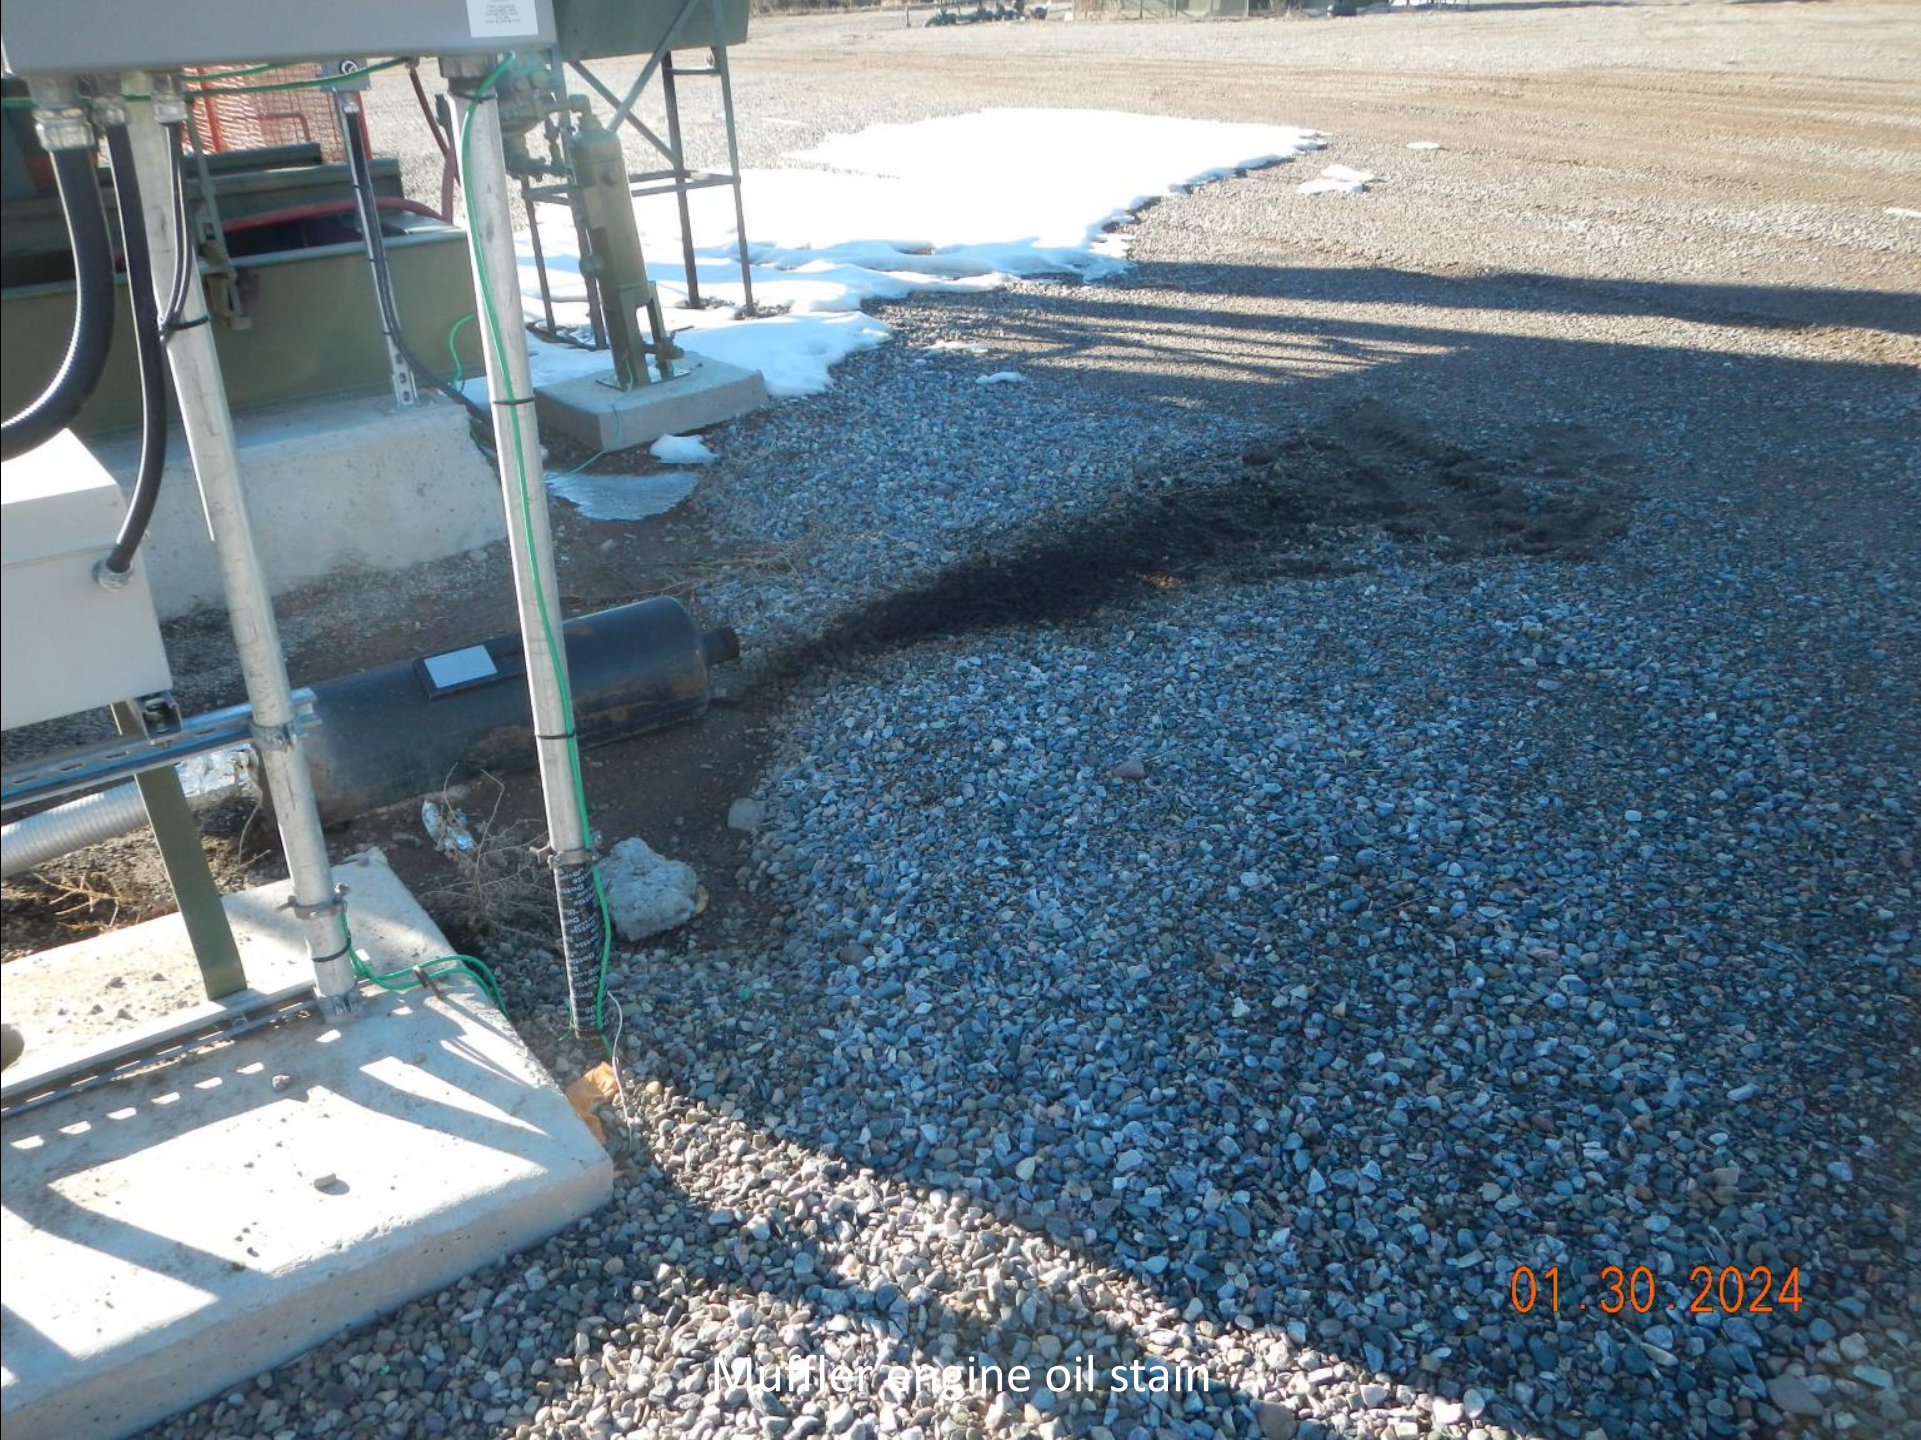
Muffler engine oil stain
