Final Reclamation and Stormwater Inspection

Operator: Vista Operating Inc - 100128

Location ID: 317407

Location Name: Scottie-Hickert 42-33

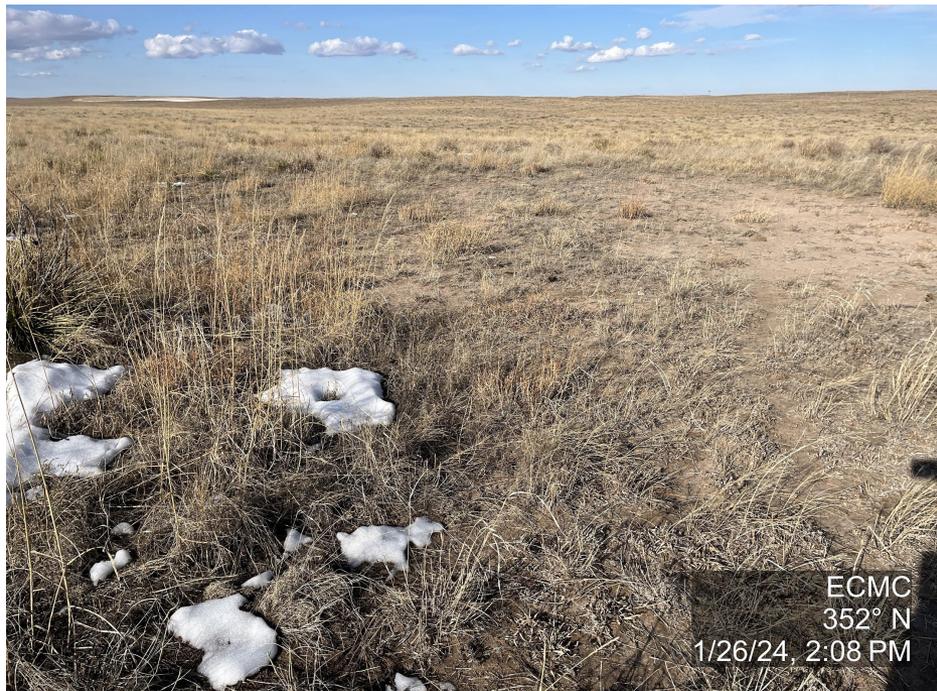
Photo 1. The photo was taken at the well location facing North. The photo illustrates a large area of bare soil where the well was located, though a large portion of the well location has good vegetative cover.

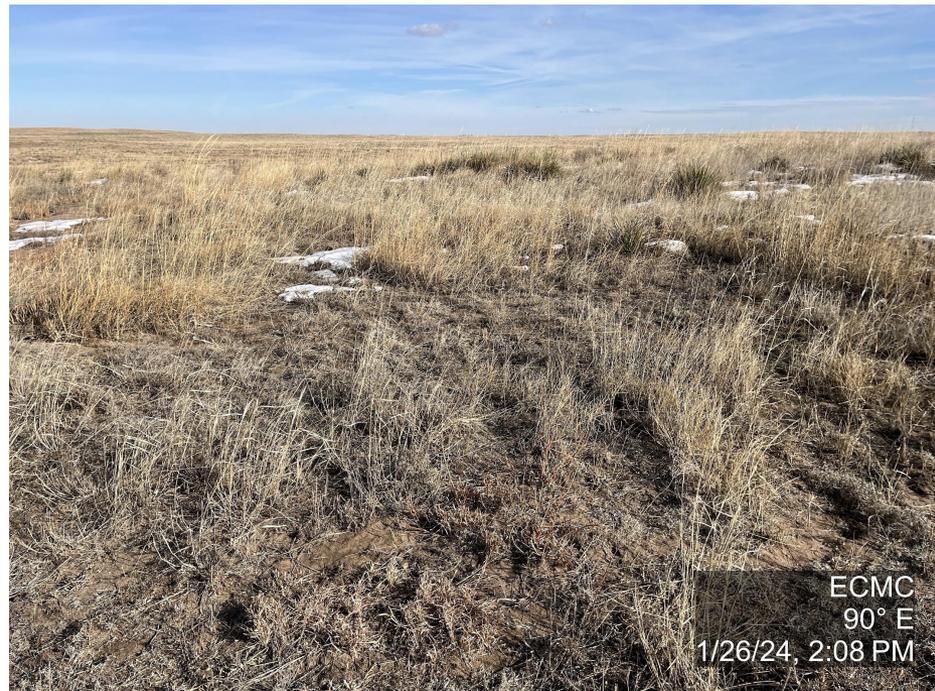
Photo 2. The photo was taken at the well location facing East. The photo illustrates good vegetative cover on the eastern portion of the well location.

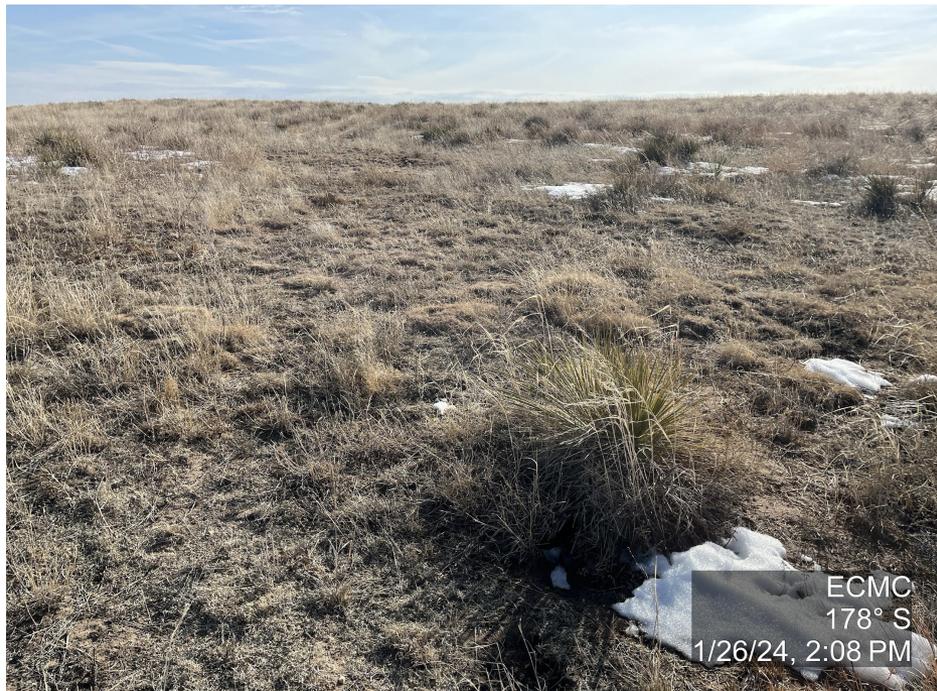
Photo 3. The photo was taken at the well location facing South. The photo illustrates good vegetative cover on the southern portion of the well location.

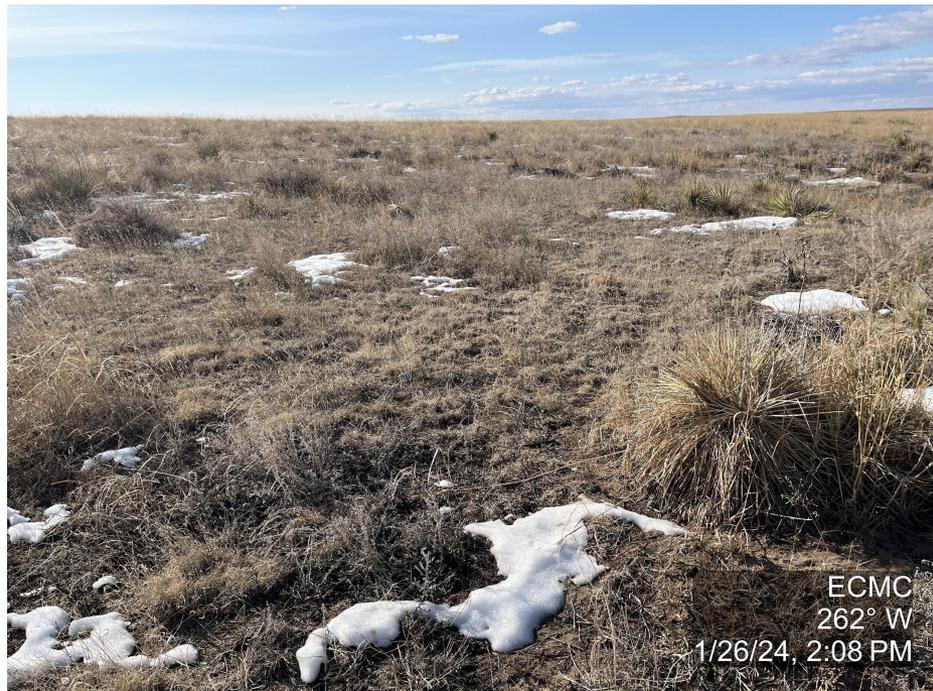
Photo 4. The photo was taken at the well location facing West. The photo illustrates good vegetative cover on the western portion of the well location.

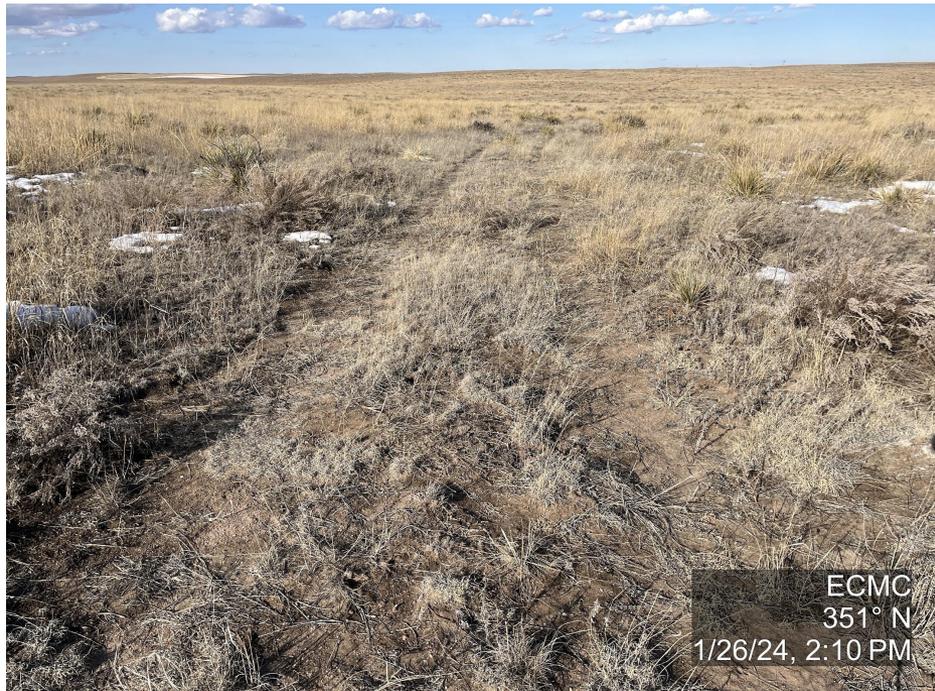
Photo 5. The photo was taken at the well location facing North. The photo illustrates a point along the access road that is not vegetated that demonstrates several areas on the access road do not meet reclamation standards.

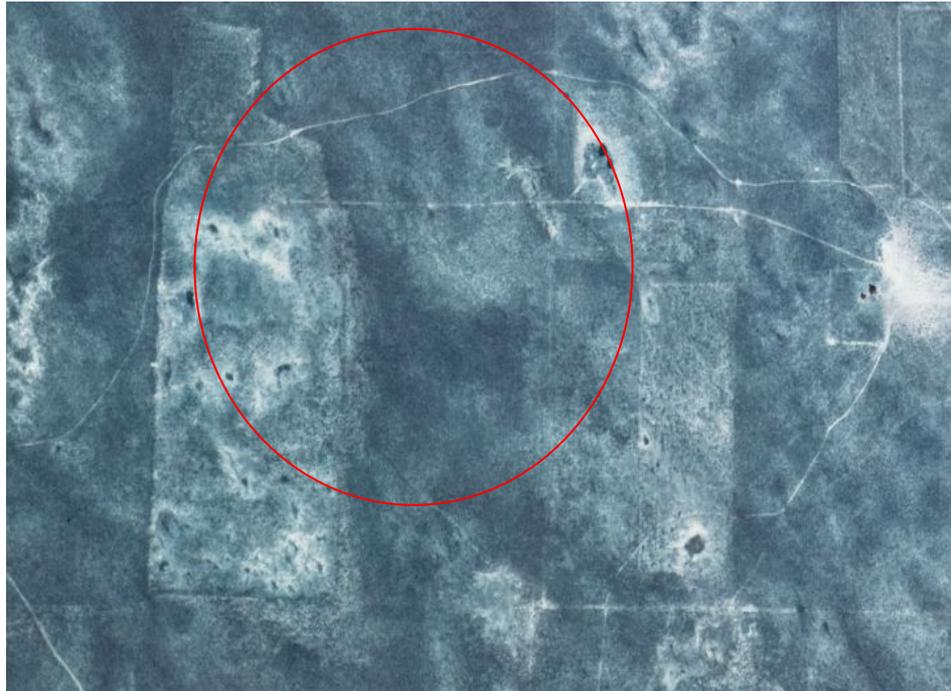
Photo 7. The photo is USGS imagery from 09/02/1980. The photo illustrates there were no access roads prior to O&G activities where Well API #121-10874 and #121-10873 were spud.

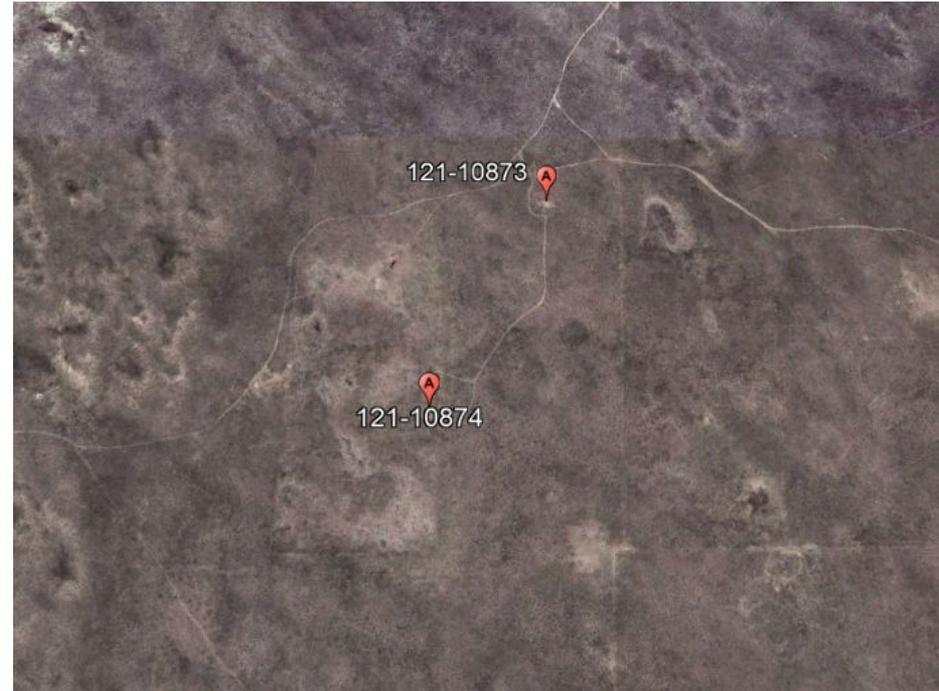
Photo 8. The photo is from Google Earth imagery from September of 2023 and illustrates the access roads still visible between the two wells.
