Inspection Photos

Loc: 321180

Operator: INVESTMENT EQUIPMENT LLC

Inspection Date: 1/30/2024

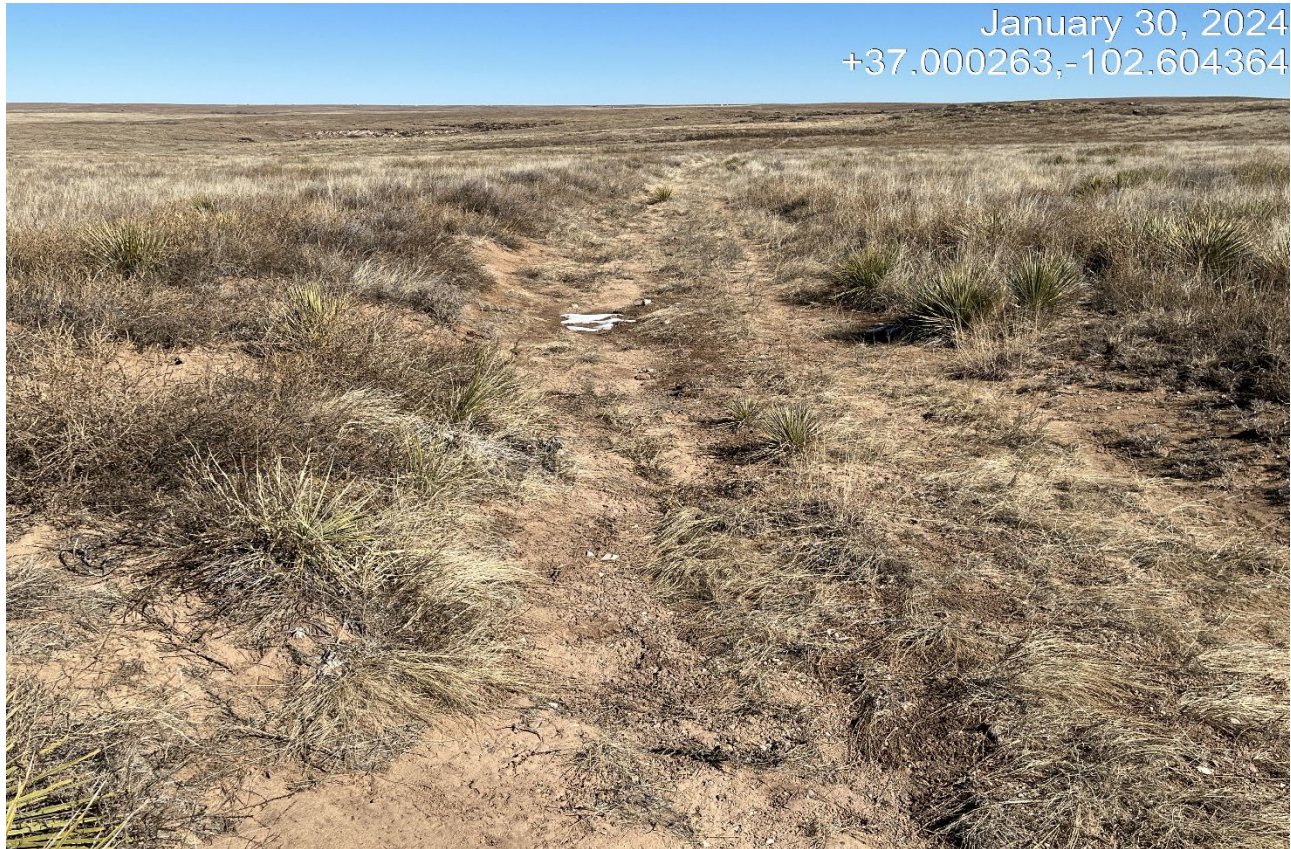
Photo 1. Facing east toward the access road. This area of the road remains swaled and was not recontoured.

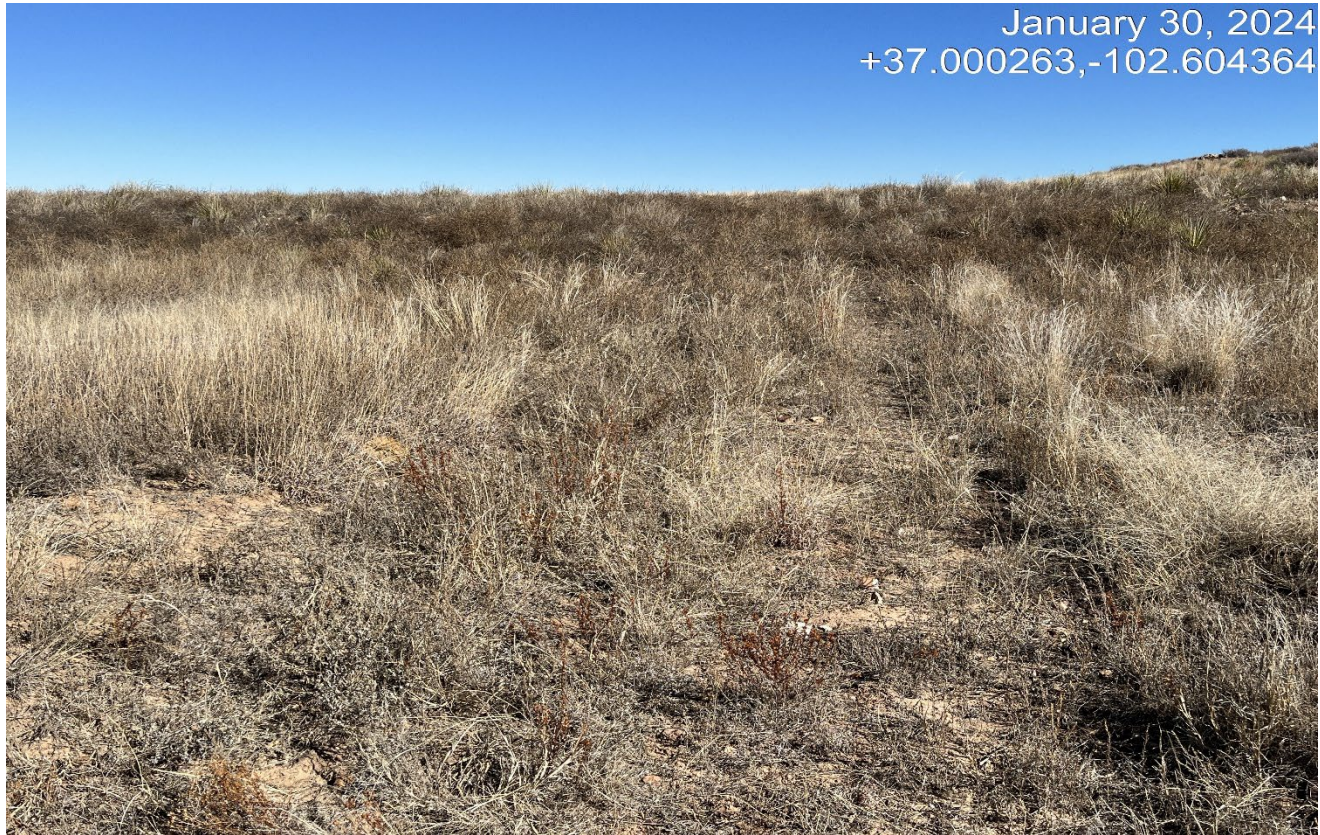
Photo 2. Facing east toward the location. The well pad was never recontoured.

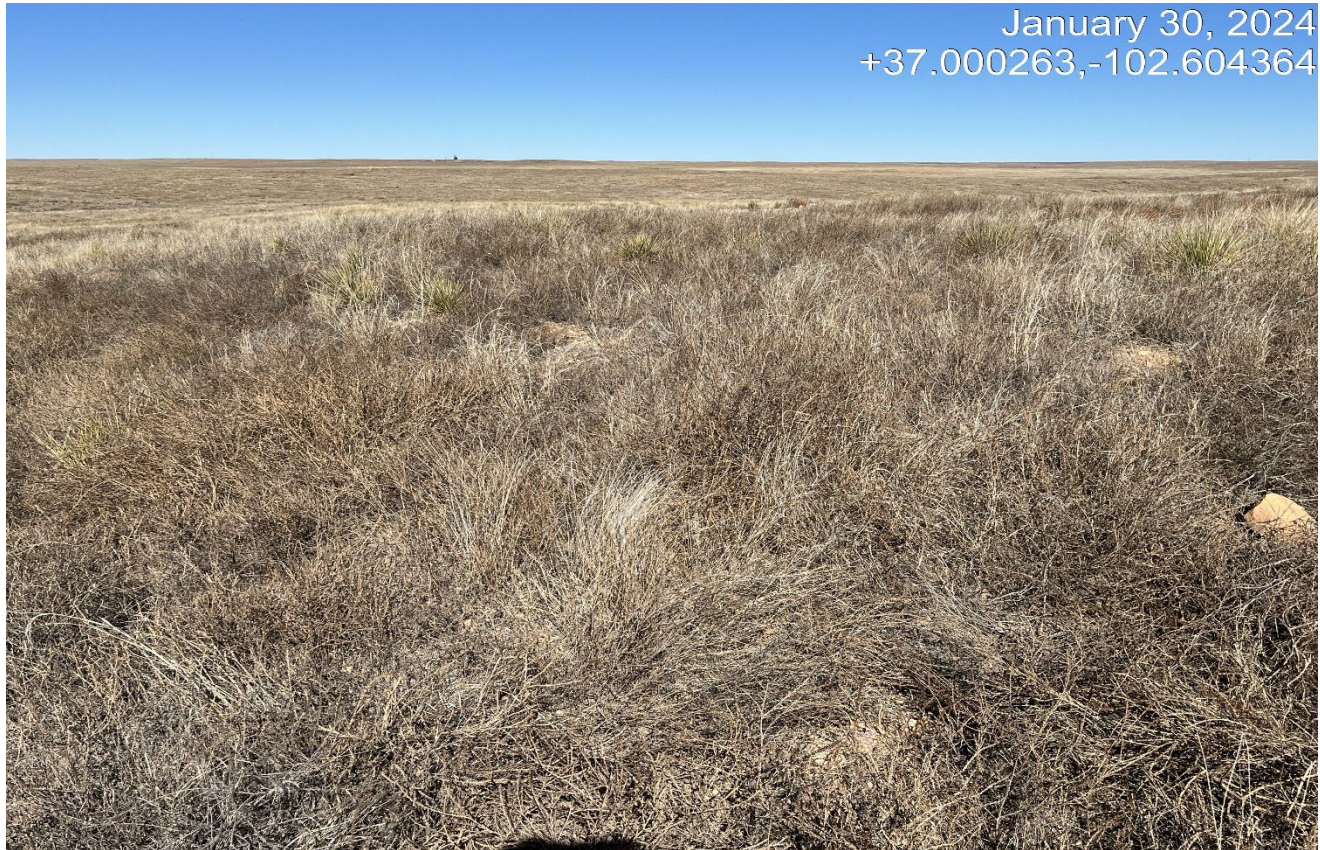
Photo 3. West side of the location consists mostly of undesirable weeds (Russian thistle).

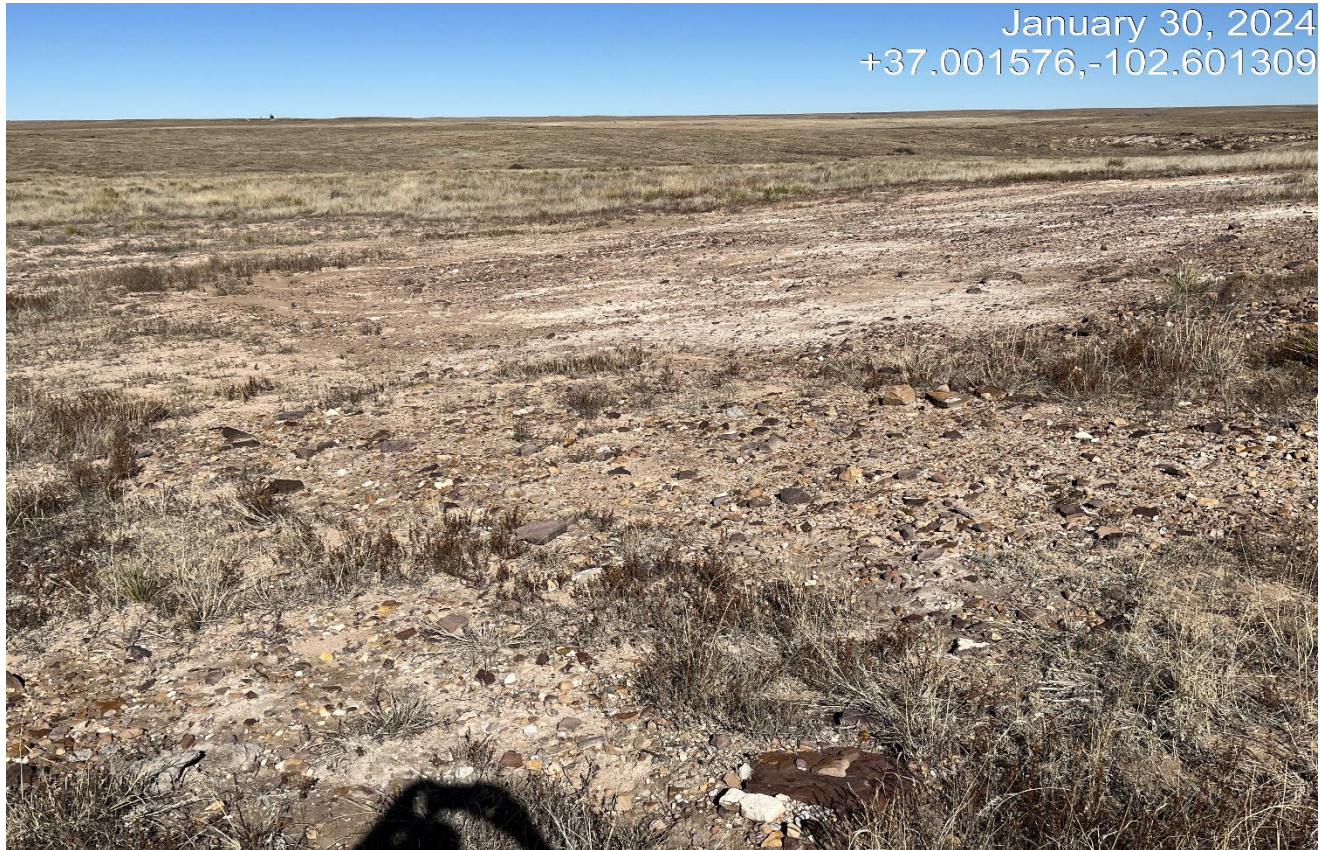
Photo 5. Facing northeast at the north side of the location. The soil appears to be impacted and vegetation is not establishing.

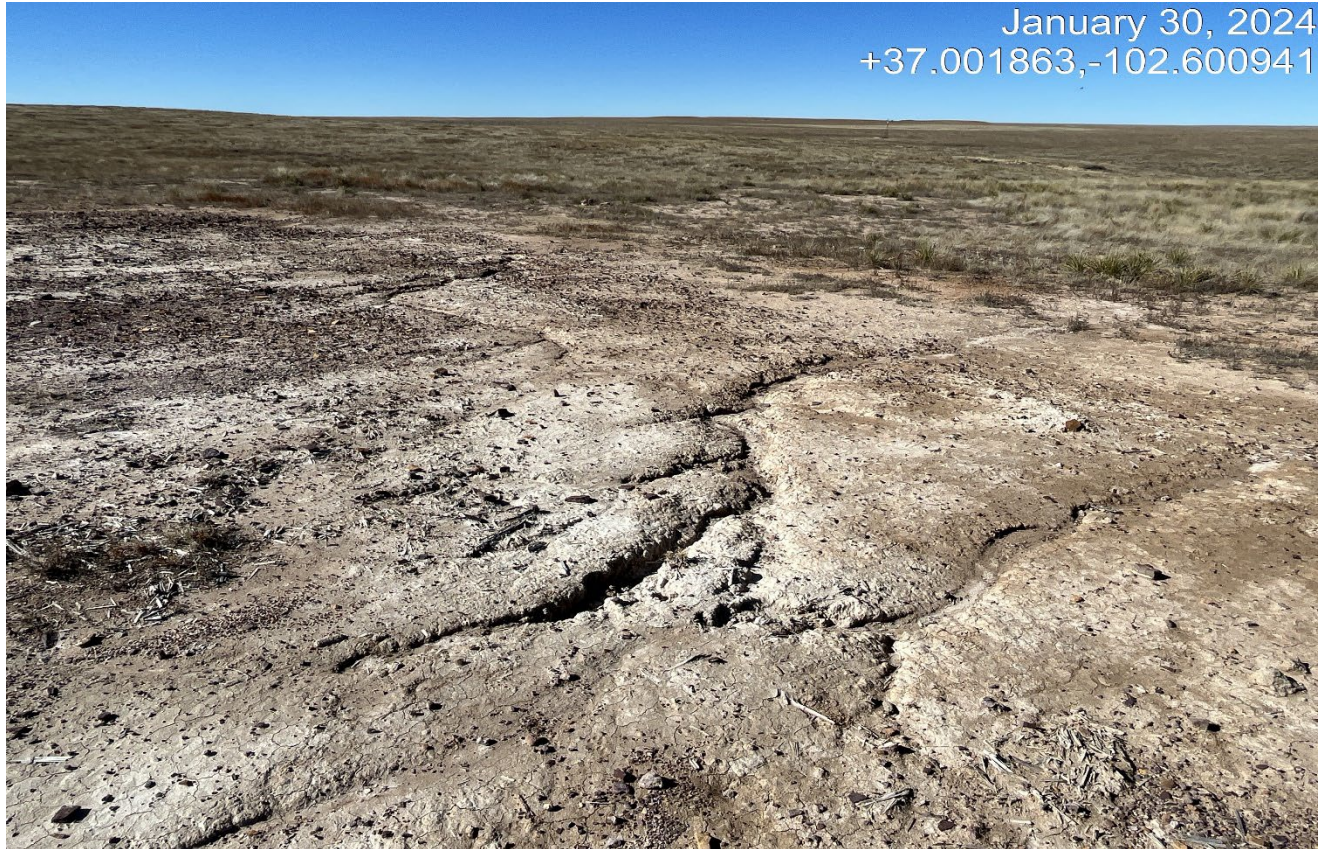
Photo 6. Facing northwest at the north side of the location. The soil appears to be impacted and erosion is occurring along this area.
