# Inspection Photos

Location Name: CAERUS PICEANCE LLC BATTLEMENT MESA 35L-795 Pad

Location ID: 416986

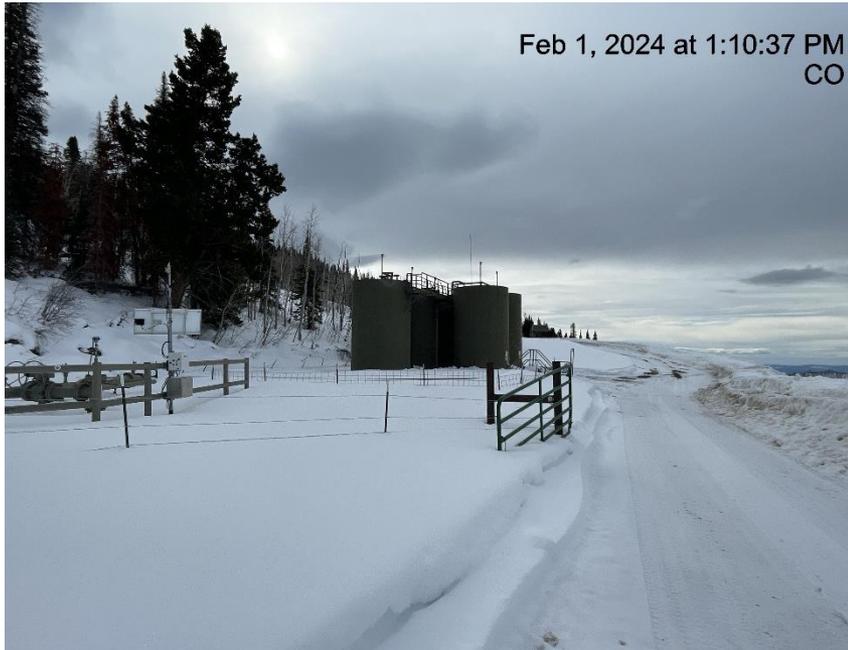
Photo # 5248 From entrance to location

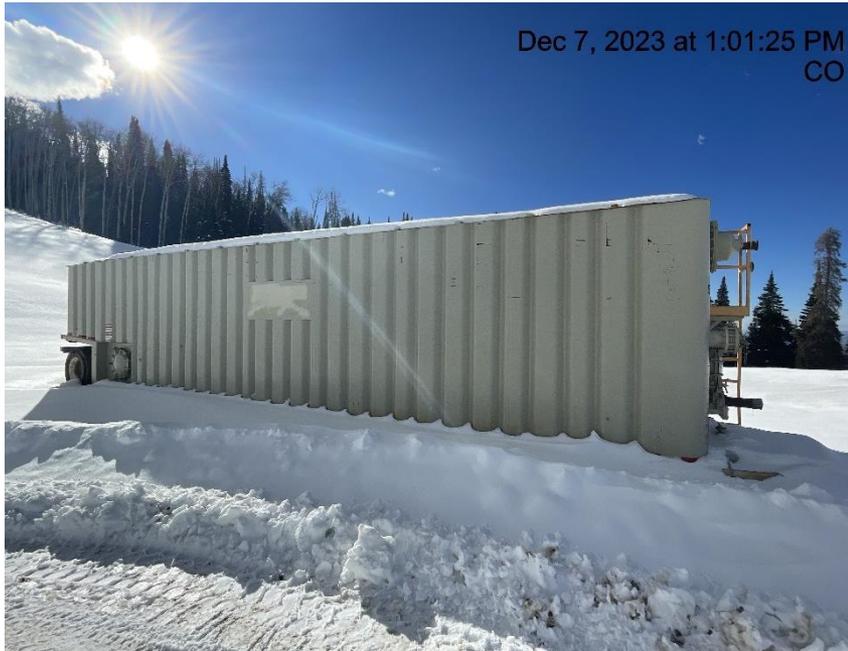
**Photo # 8840 From inspection 708902470 conducted on 12/07/2023 Unused equipment**

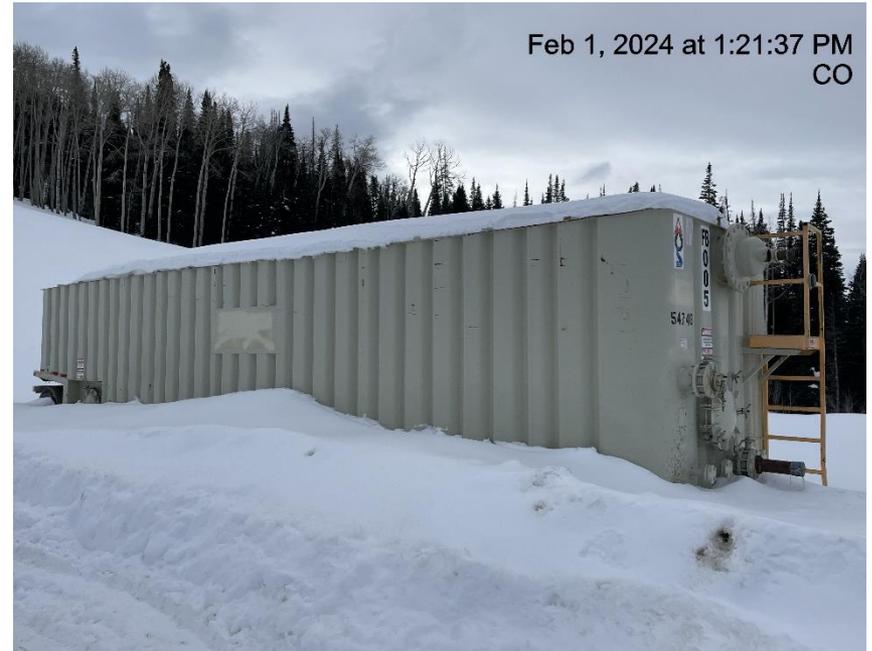
**Photo # 5256 Unused equipment**

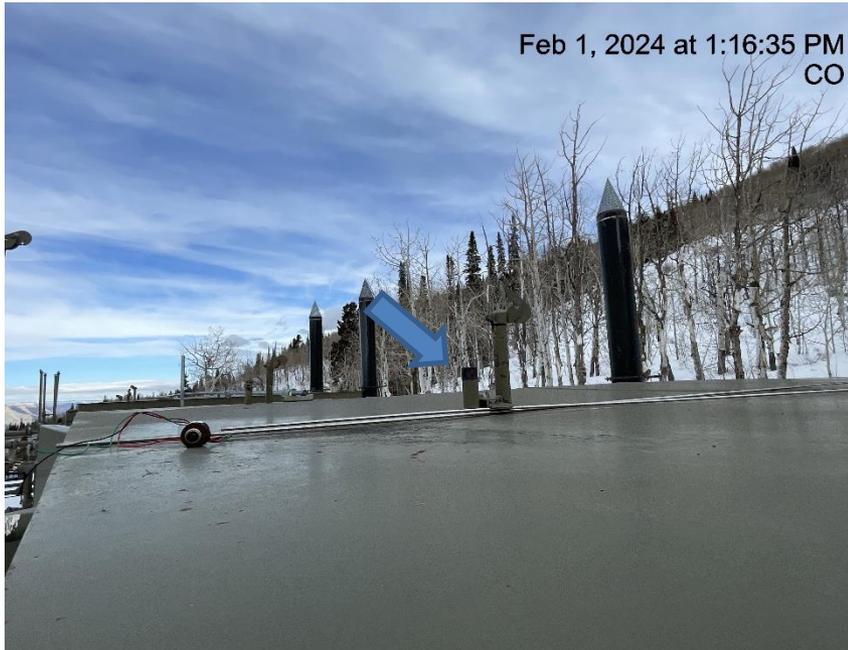
Photo # 5257 Rupture disc vent line lacks cap

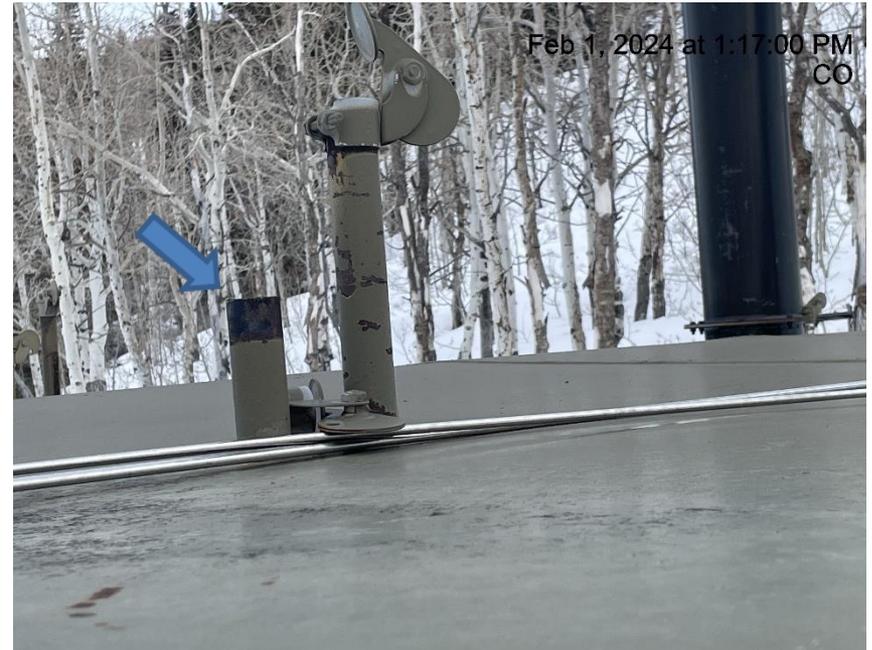
Photo # 5258 Rupture disc vent line lacks cap

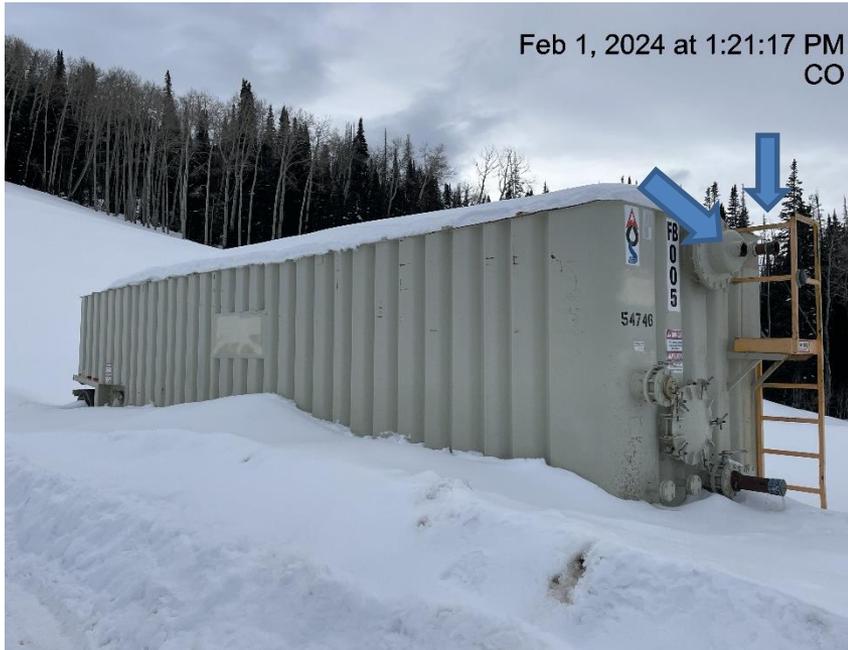
**Photo # 5259 Open ended piping/wildlife hazards/available for entry by wildlife**
