Inspection Photos

Location Name: CAERUS PICEANCE LLC Battlement Mesa 36L-795 Pad

Location ID: 334180

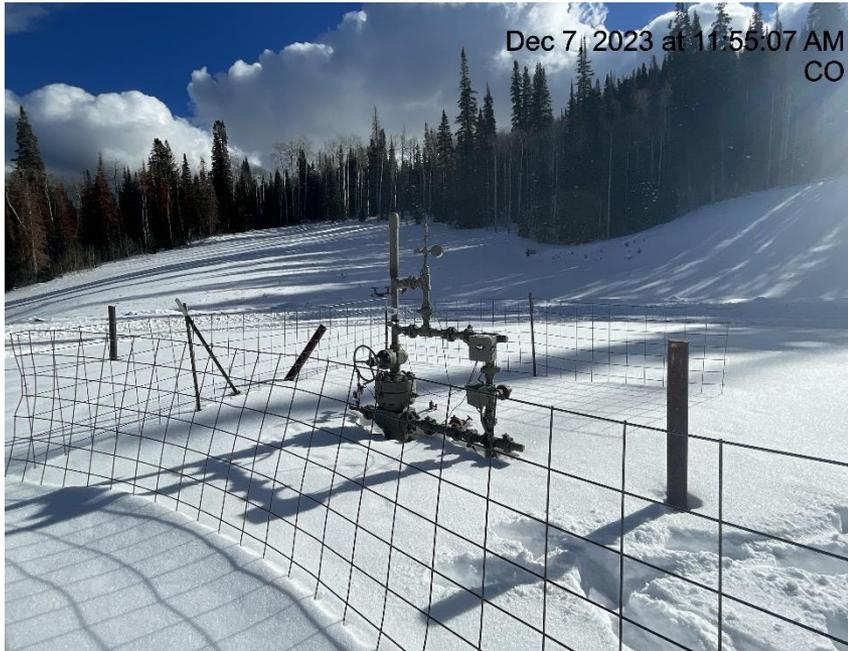
Photo # 8782 From inspection 708902455 conducted on 12/07/2023 Wellhead lacks required signage

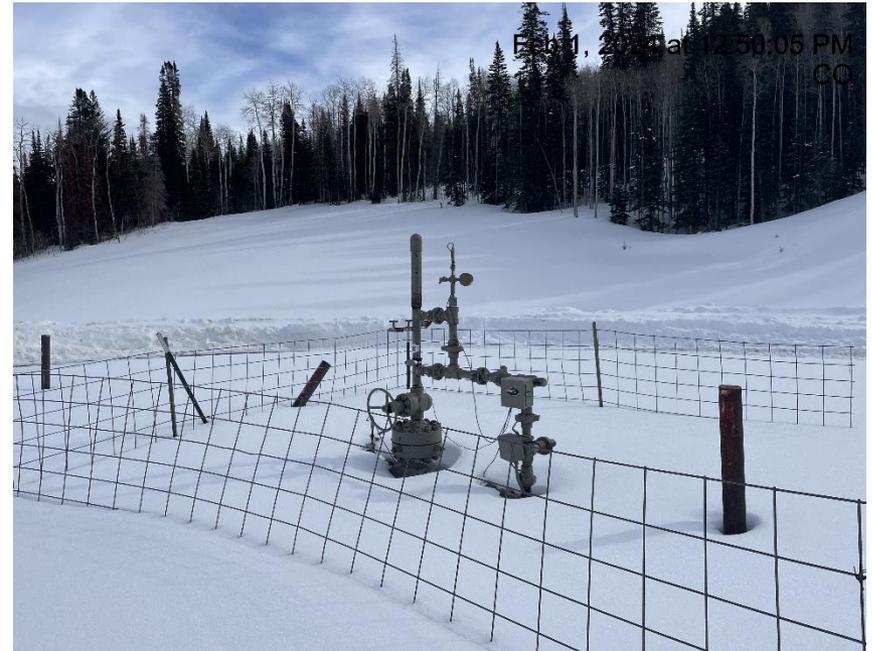
Photo # 5211 Wellhead lacks required signage

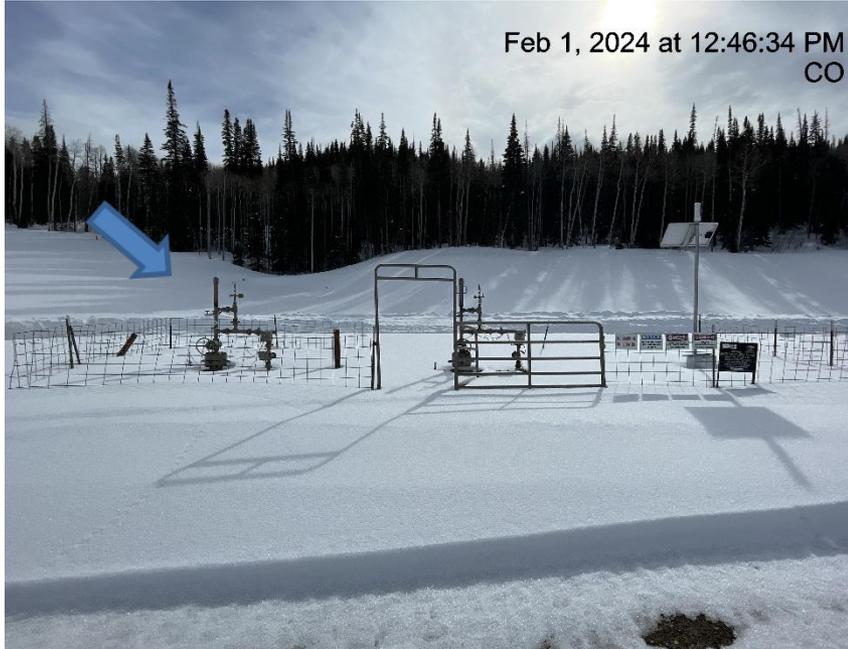
Photo # 5212 Wellhead lacks required signage

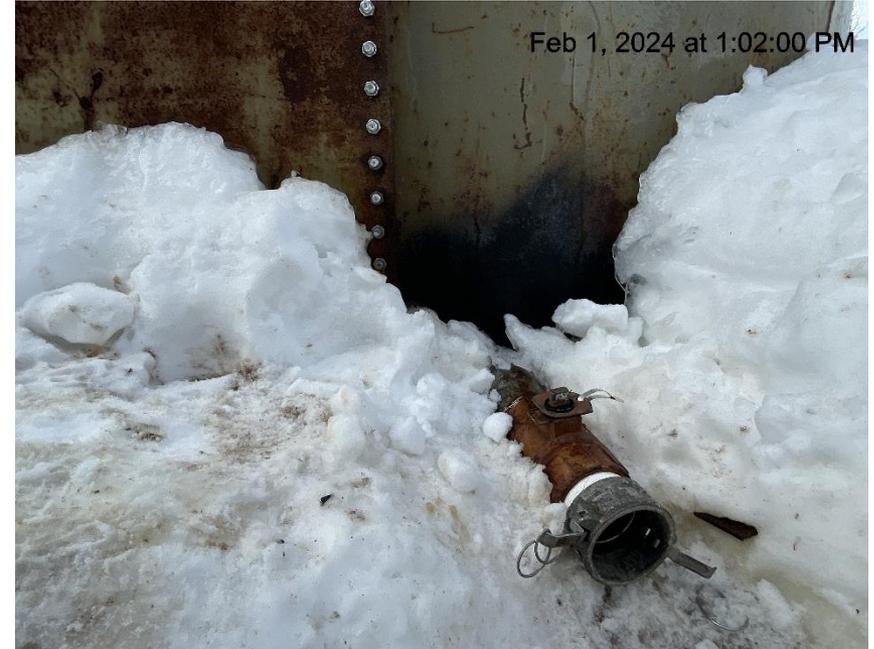
Photo # 5213 Open ended load line

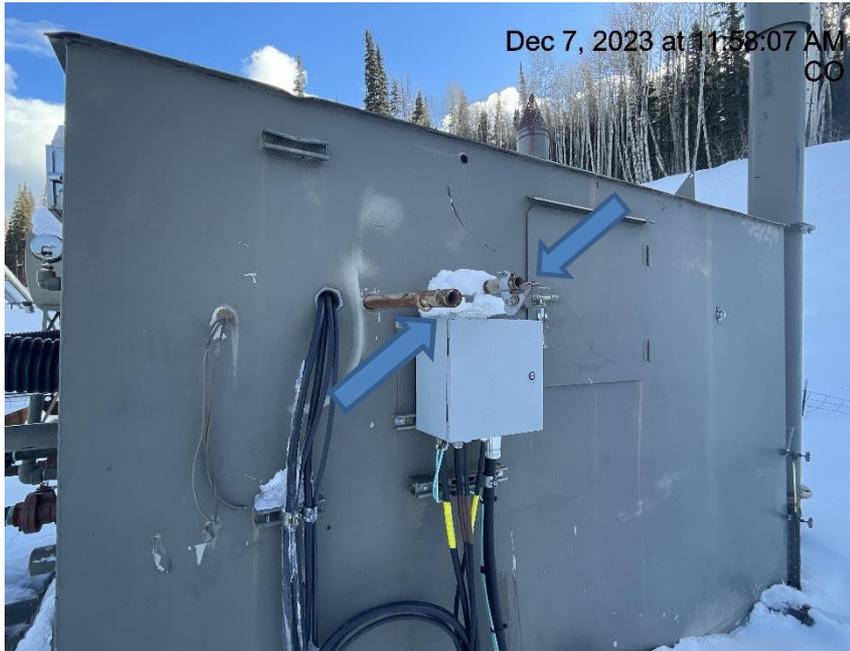
Photo # 8783 From inspection 708902455 conducted on 12/07/2023 PRV & rupture disc vent lines terminate in an unsafe manner

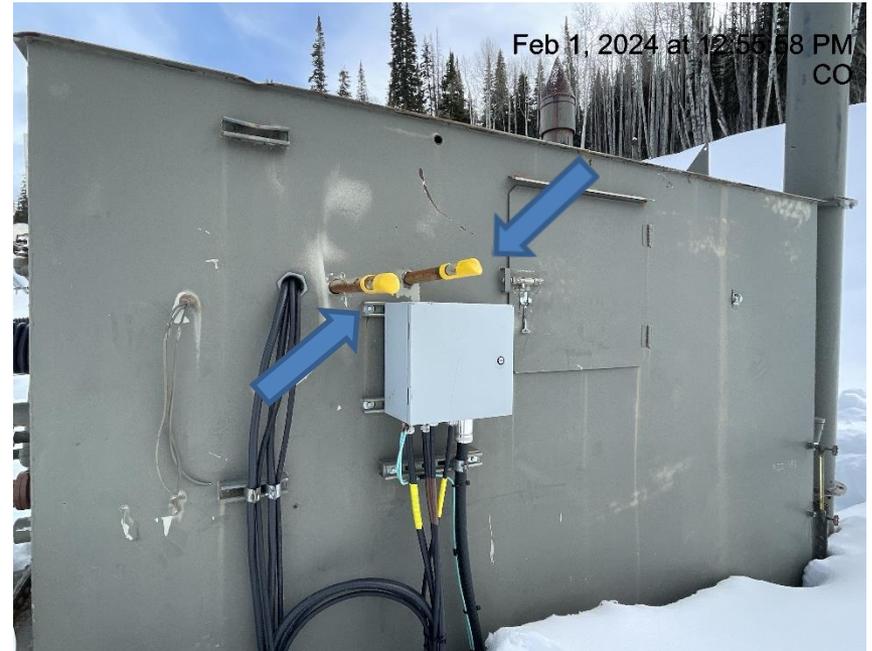
Photo # 5214 PRV & rupture disc vent lines terminate in an unsafe manner

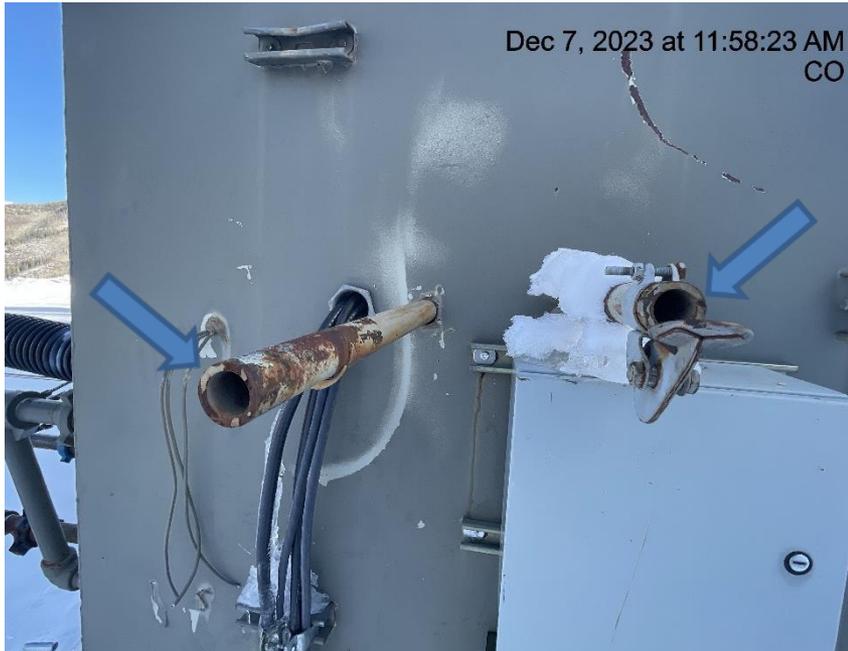
Photo # 8784 From inspection 708902455 conducted on 12/07/2023 PRV & rupture disc vent lines terminate in an unsafe manner

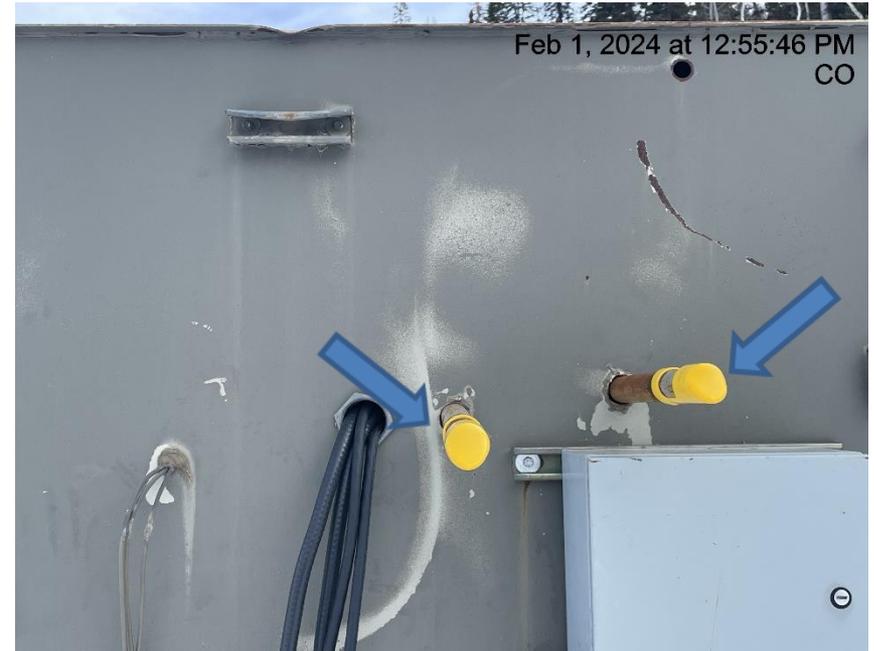
Photo # 5215 PRV & rupture disc vent lines terminate in an unsafe manner

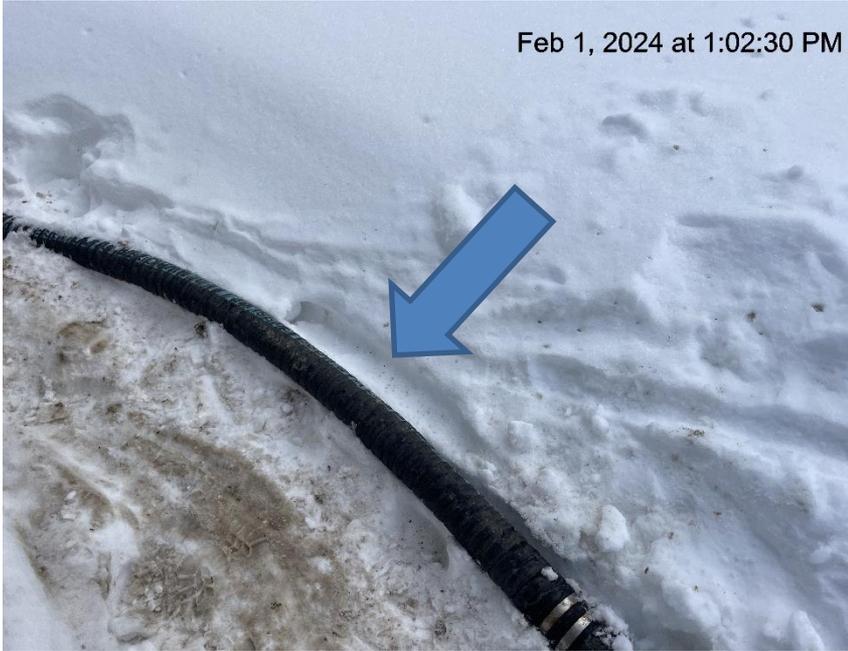
Photo # 5216 Debris
