Inspection Photos Johnson 1 Flowline Spill ID 485936

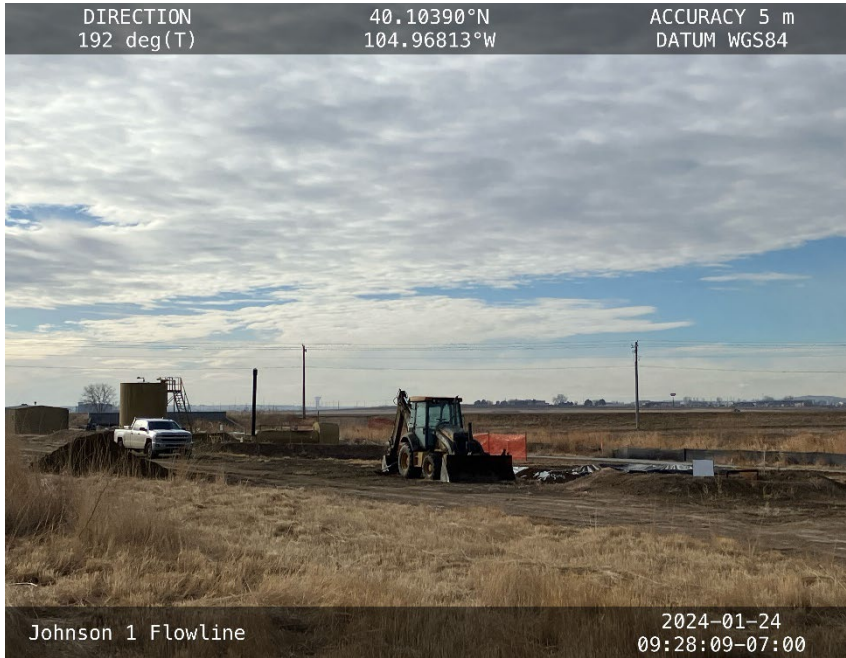
Photo 1 – Site photo 1/24/2024

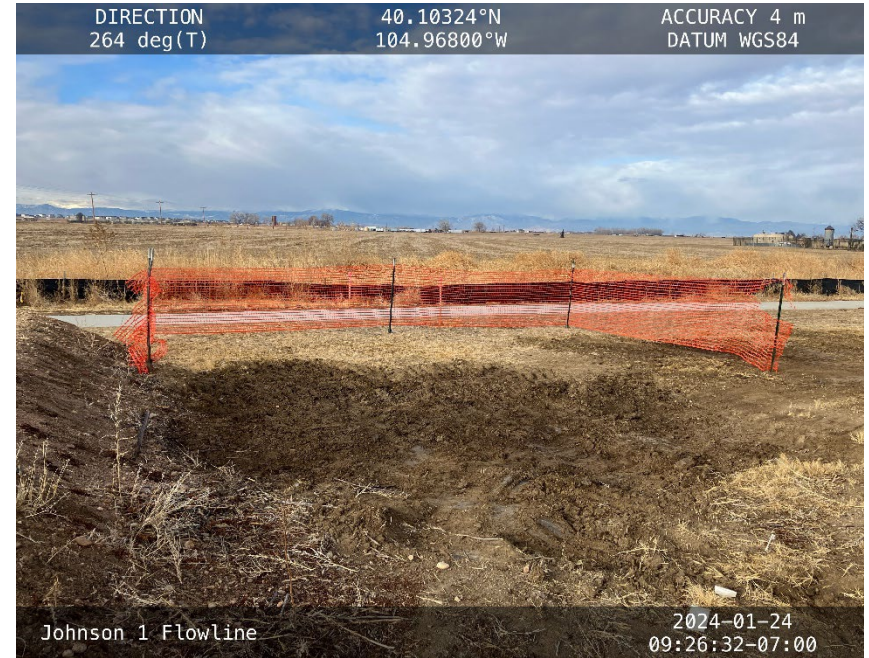
Photo 2 - Spill area 1/24/2024

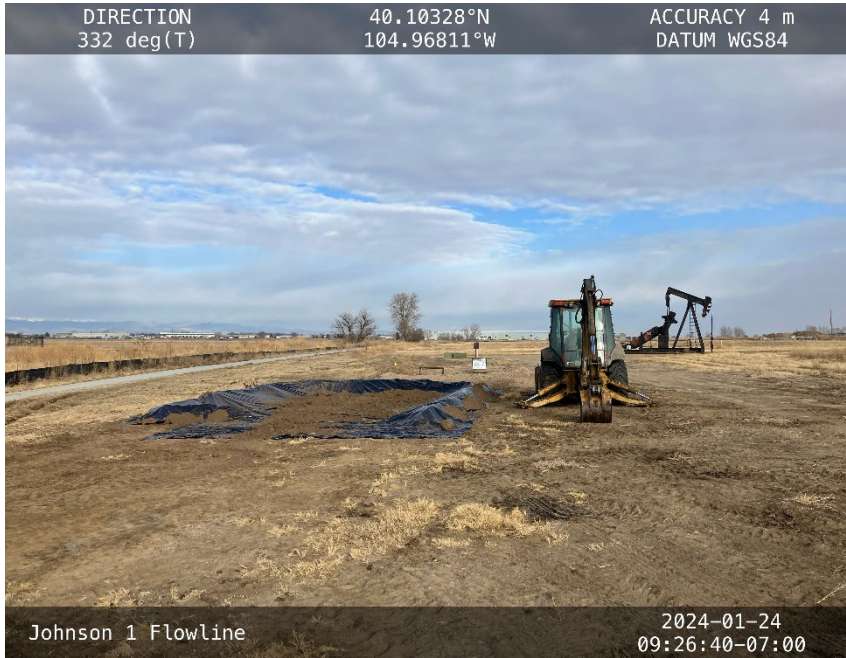
Photo 3 – Stockpile area 1/24/2024

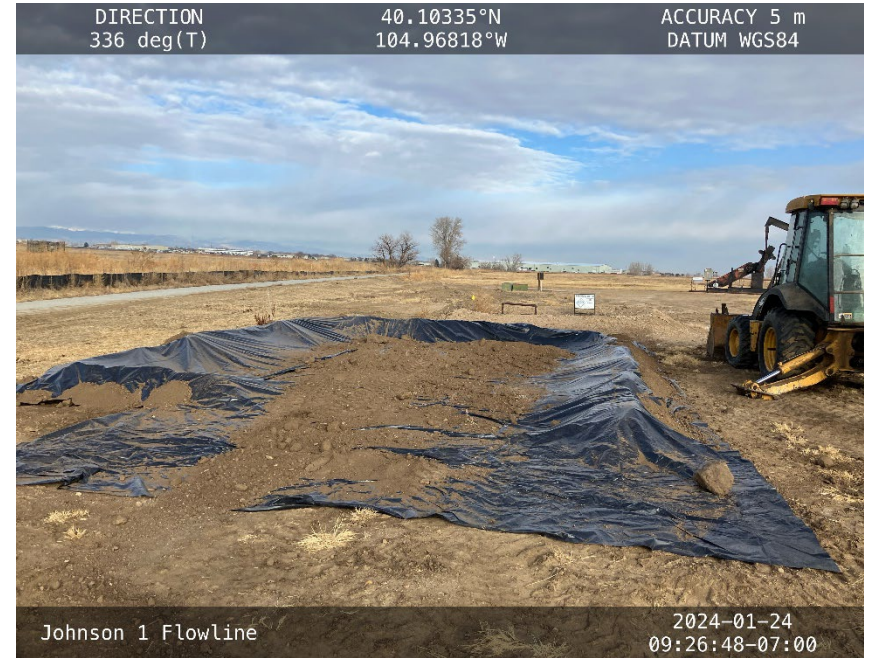
Photo 4 - Stockpile area 1/24/2024

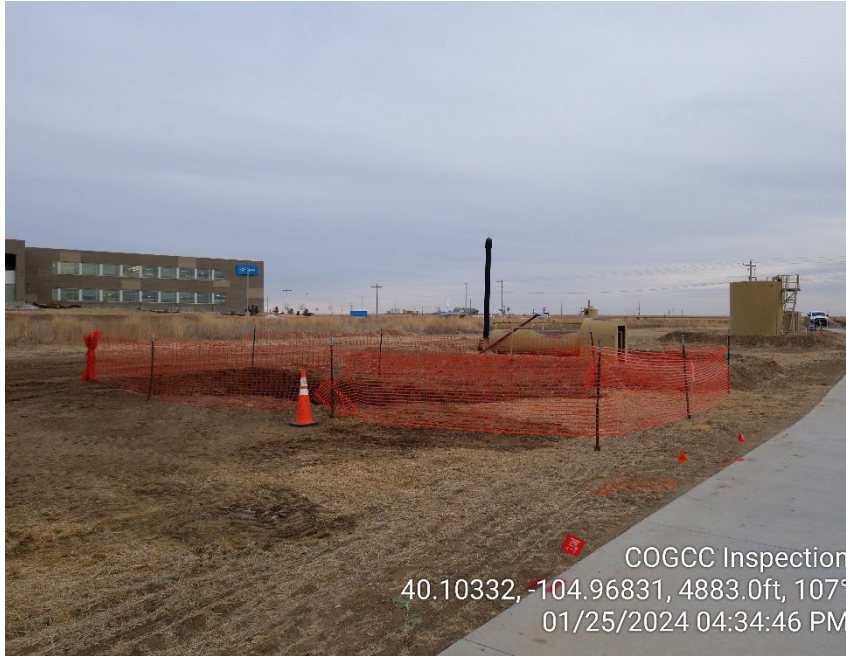
Photo 5 – Spill area 1/25/2024

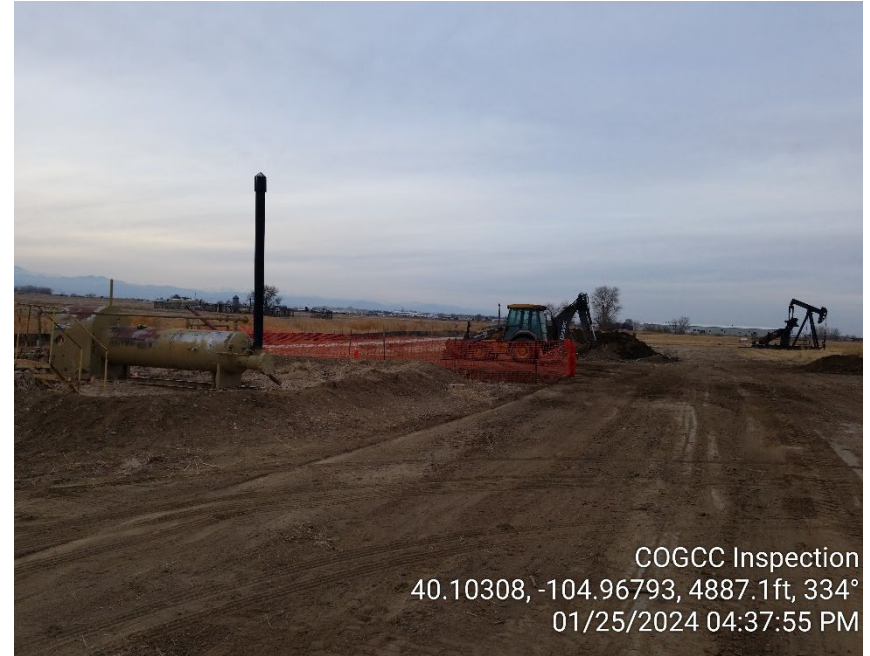
Photo 6 - Spill area 1/25/2024

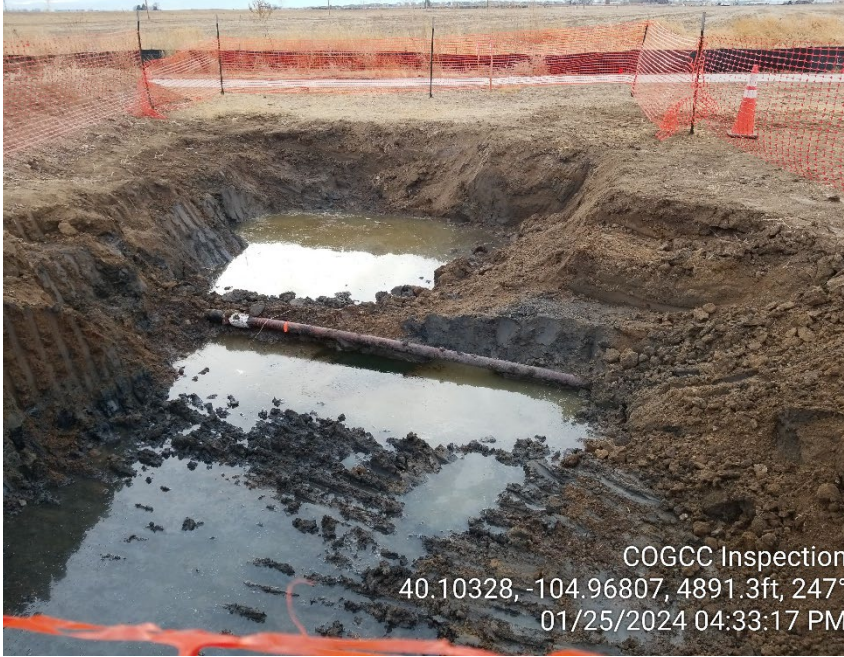
Photo 7 – Open excavation 1/25/2024

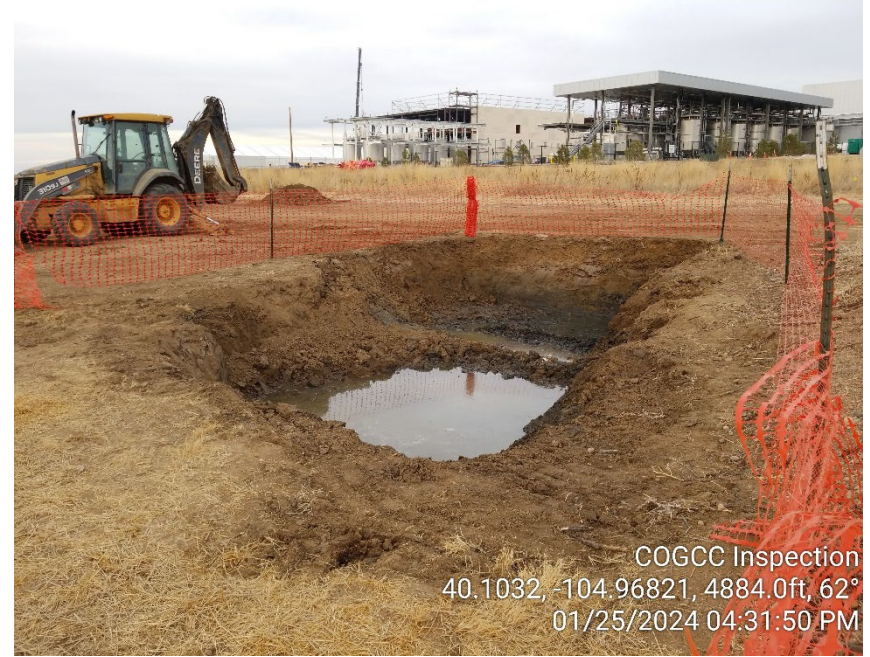
Photo 8 - Open excavation 1/25/2024

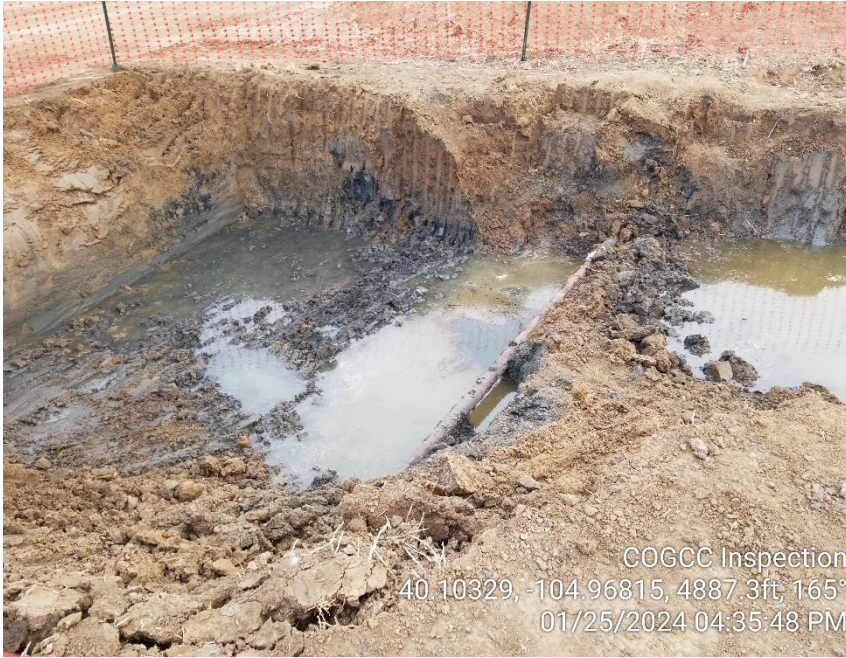
Photo 9 – Spill area 1/25/2024

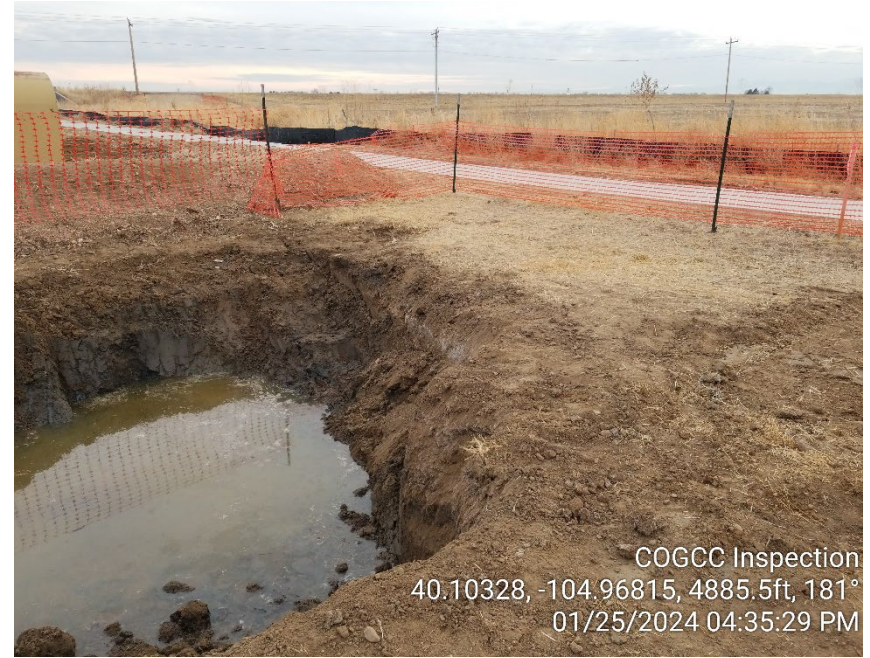
Photo 10 - Open excavation 1/25/2024

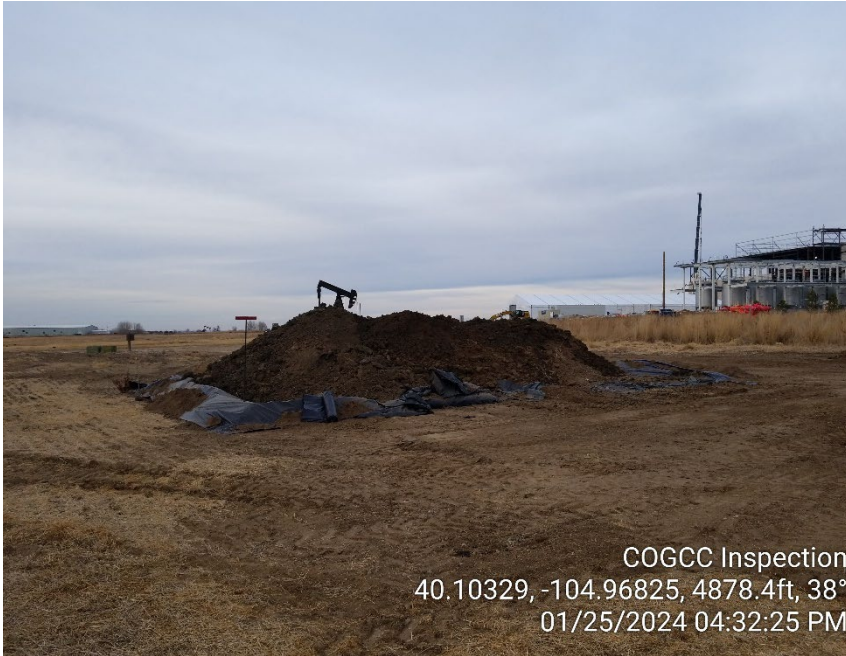
Photo 11 – Soil stockpile 1/25/2024

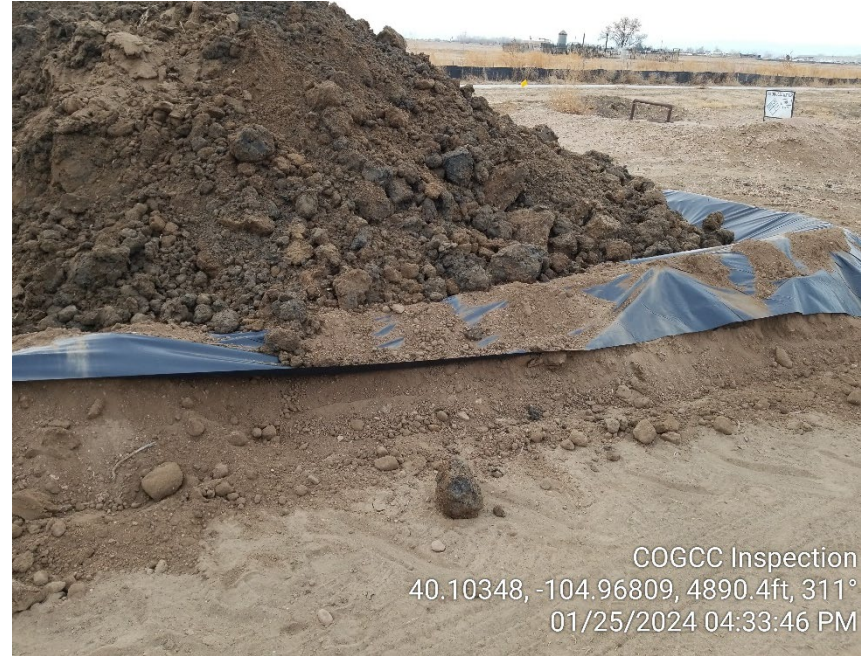
Photo 12 - Soil stockpile 1/25/2024

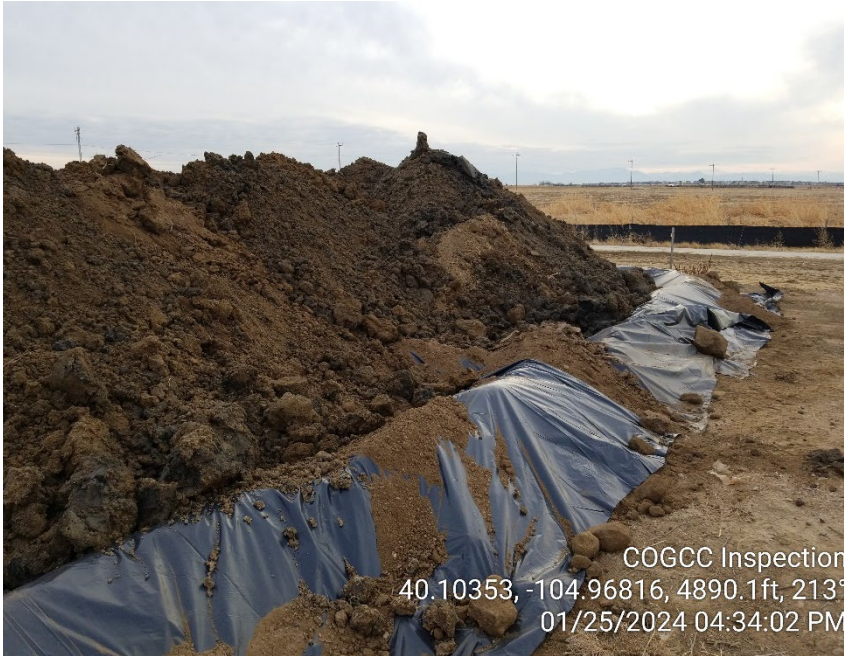
Photo 13 – Soil stockpile 1/25/2024

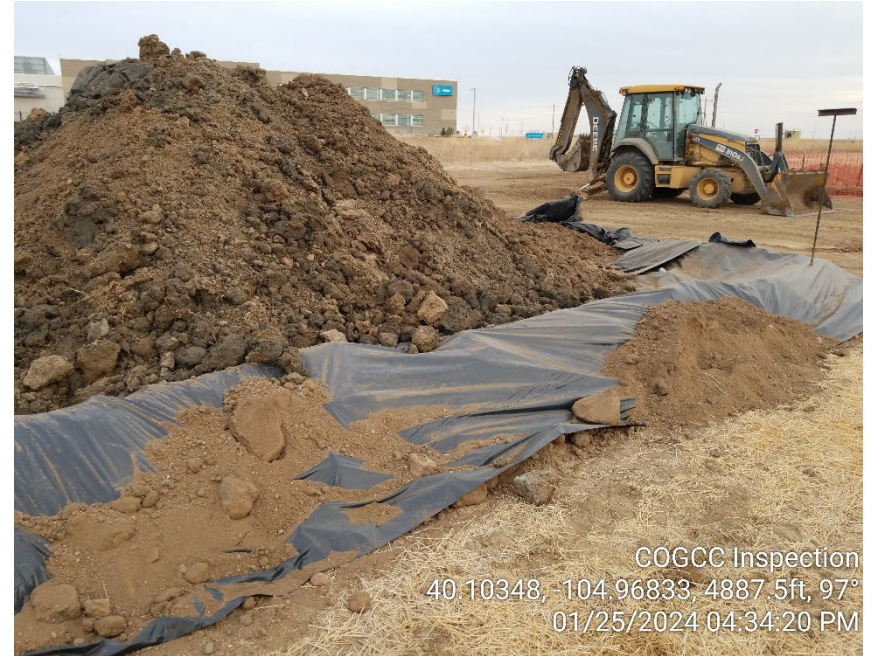
Photo 14 - Soil stockpile 1/25/2024

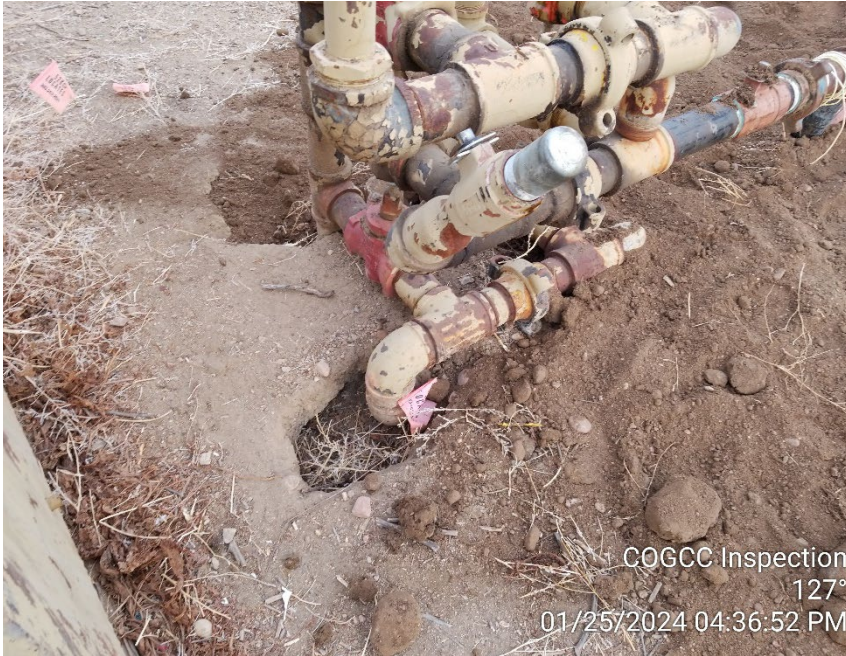
Photo 15 – Separator 1/25/2024

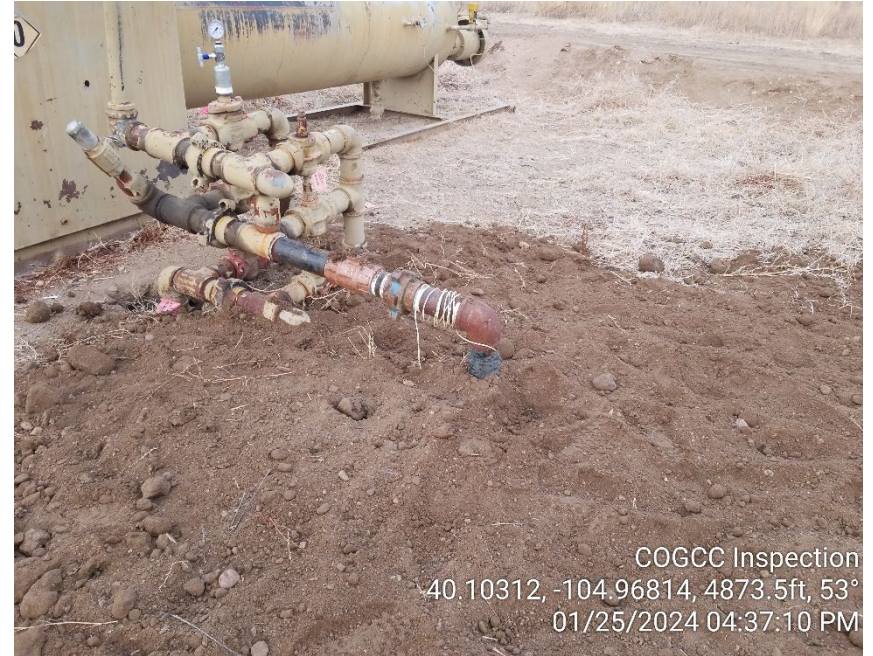
Photo 16 - Separator 1/25/2024

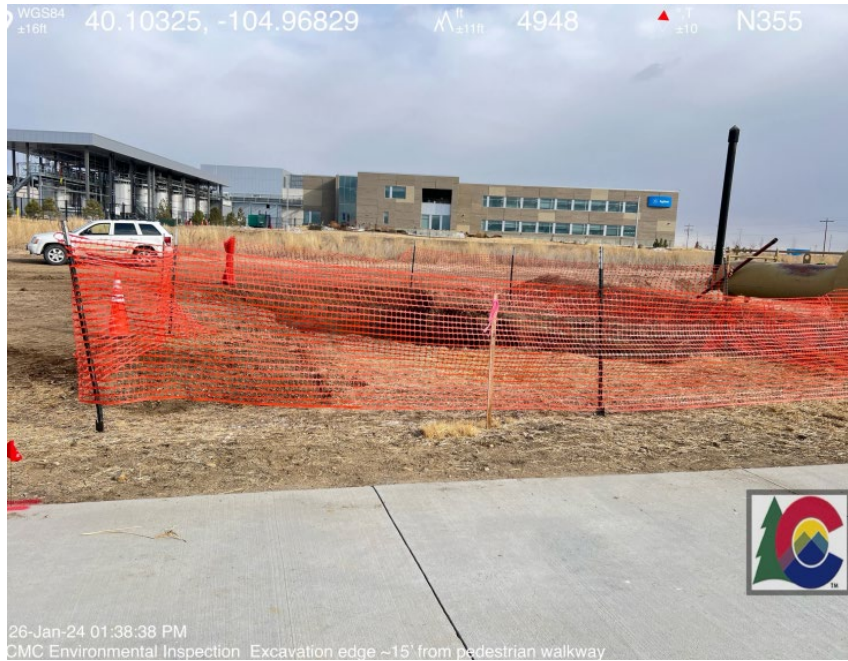
Photo 17– Spill area 1/26/2024

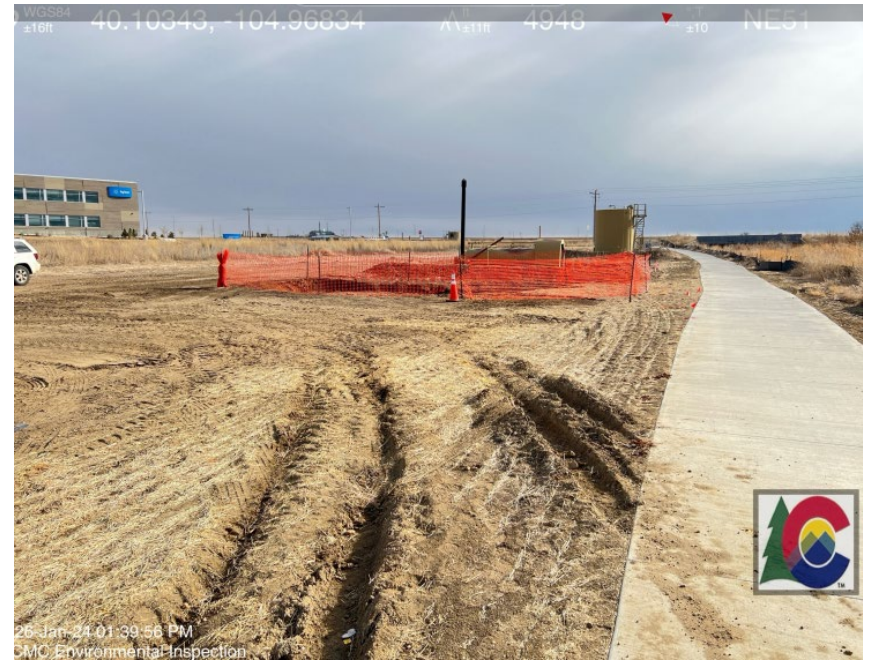
Photo 18 - Spill area 1/26/2024

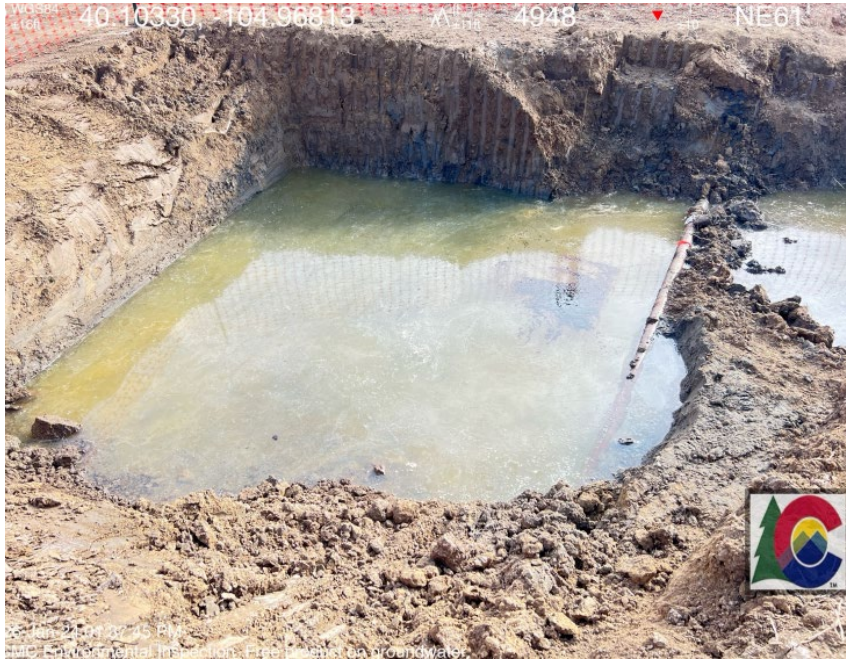
Photo 19 – Open excavation 1/26/2024

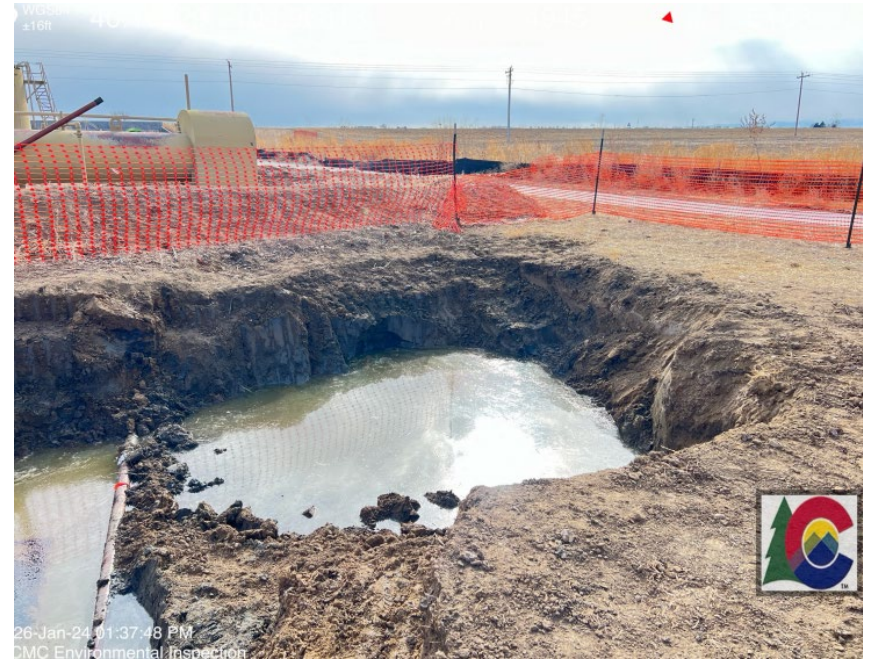
Photo 20 - Open excavation 1/26/2024

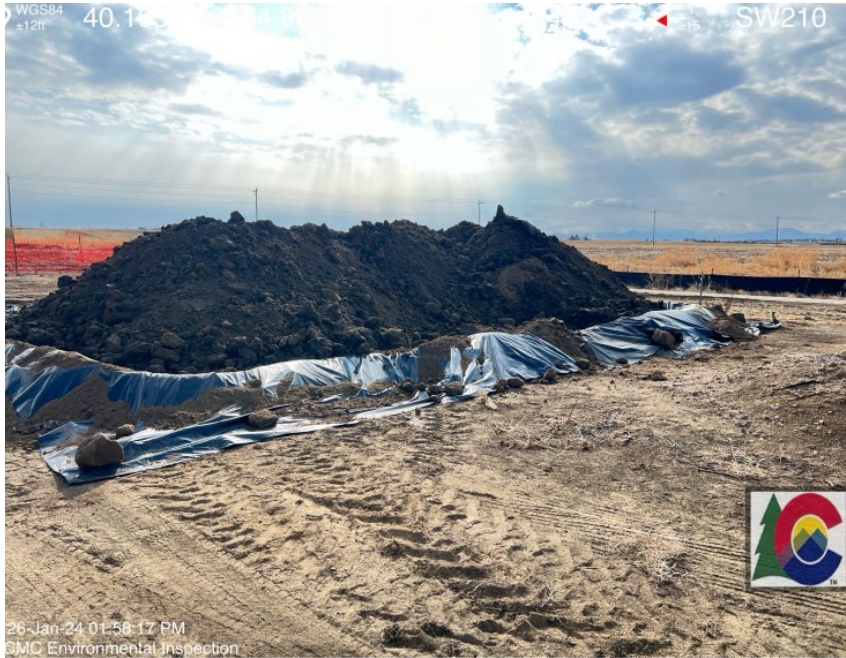
Photo 21 – Soil stockpile 1/26/2024

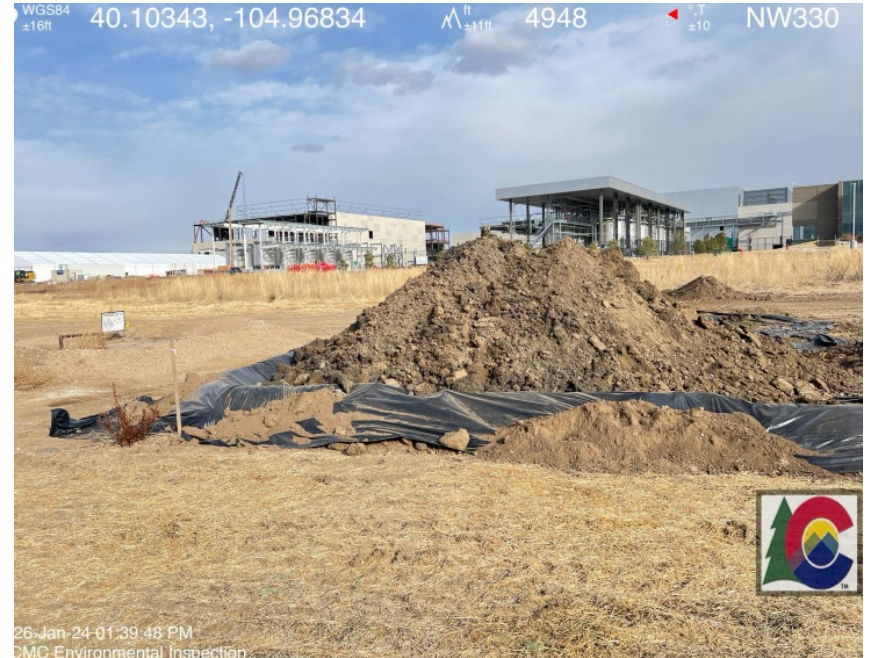
Photo 22 - Soil stockpile 1/26/2024

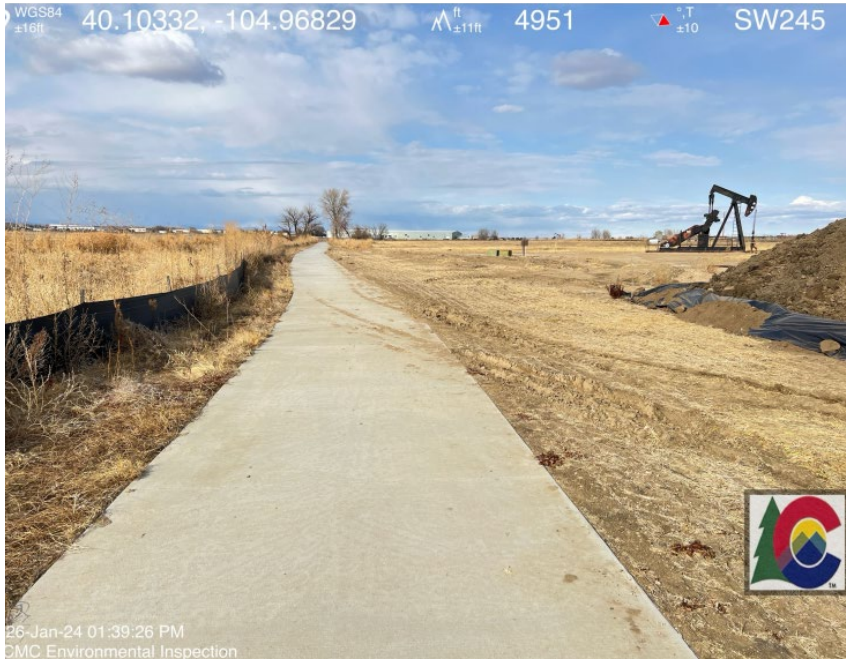
Photo 23 – Tracking

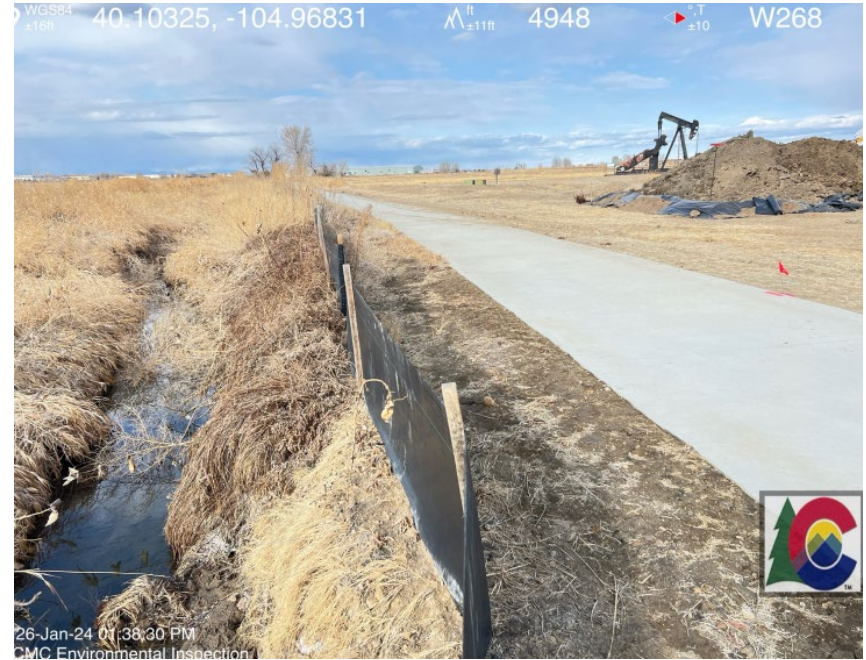
Photo 24 - Godding Hollow stream

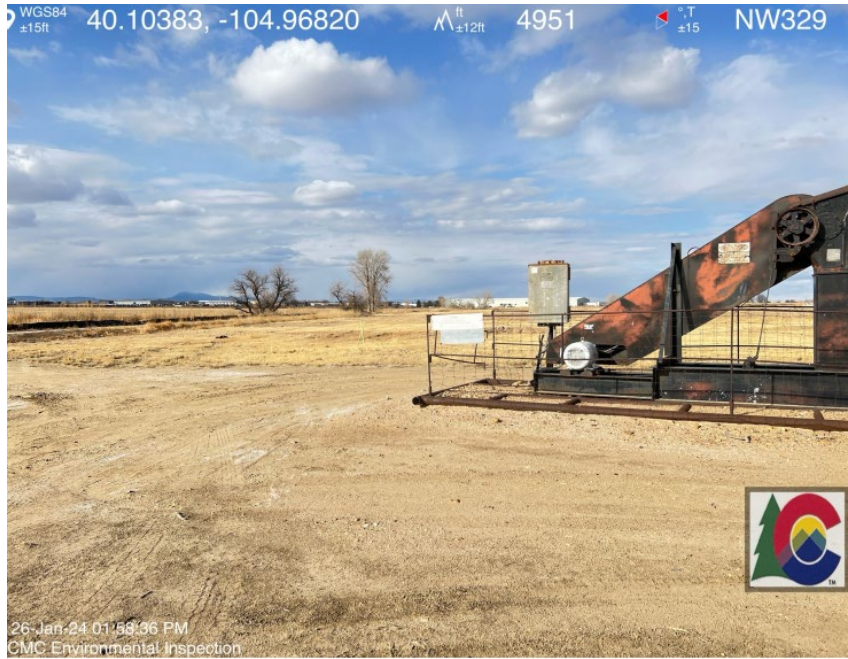
Photo 25 – Wellhead sign

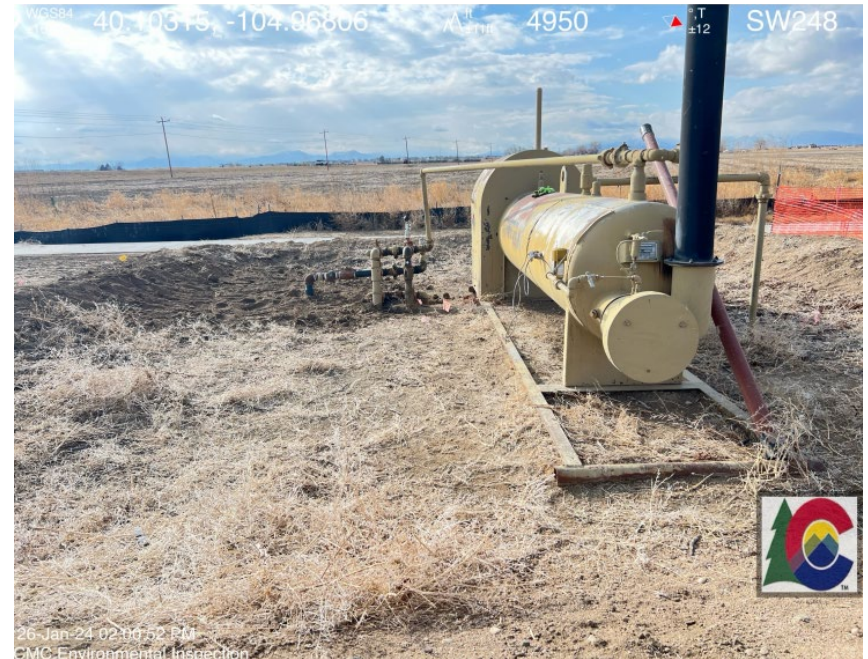
Photo 26 - Separator/weeds

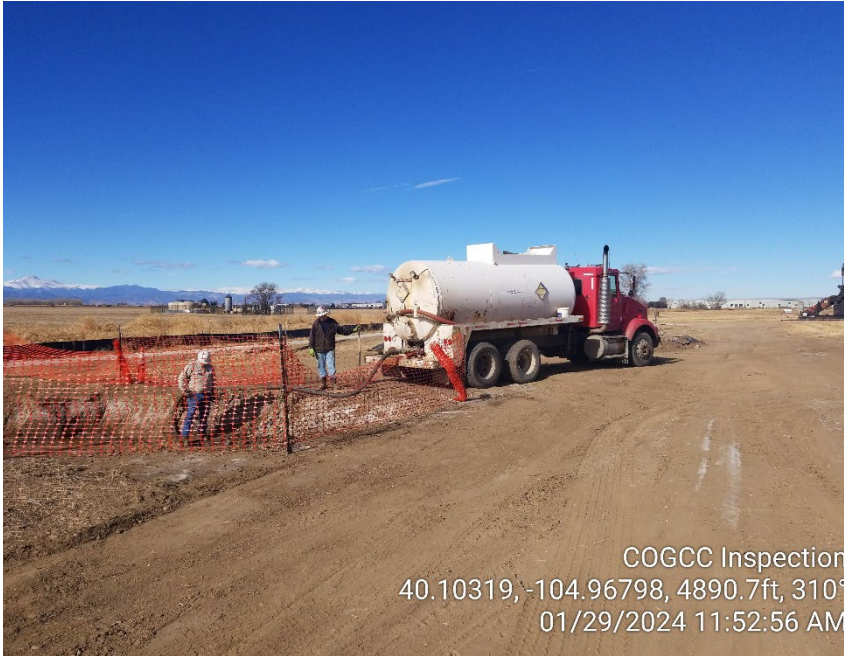
Photo 27 – Spill area 1/29/2024

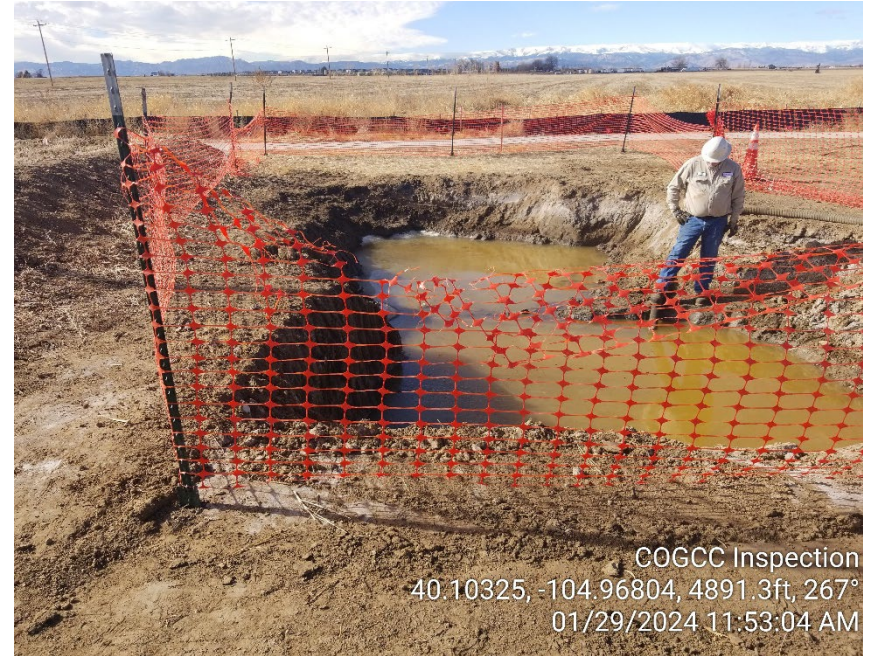
Photo 28 - Open excavation 1/29/2024

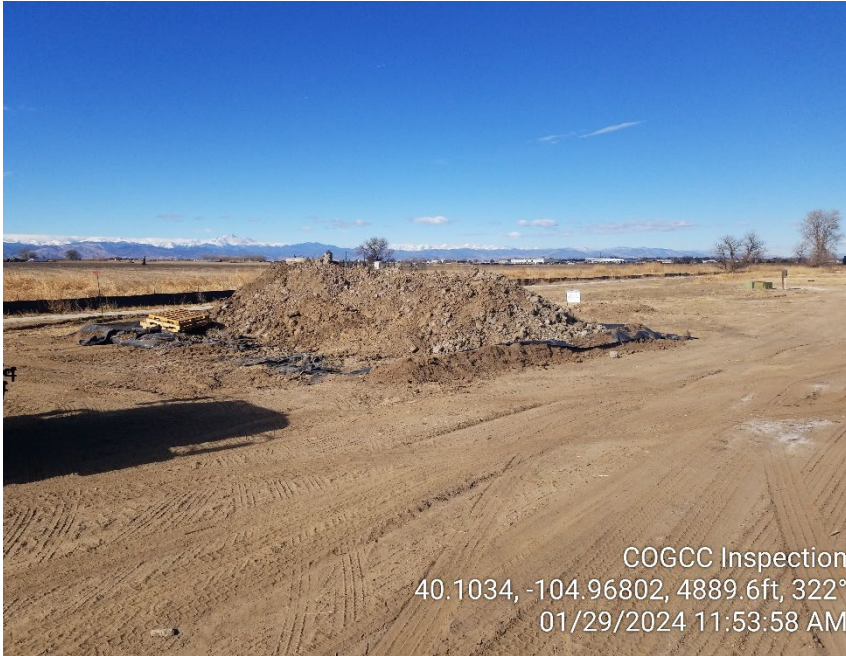
Photo 29– Soil Stockpile 1/29/2024

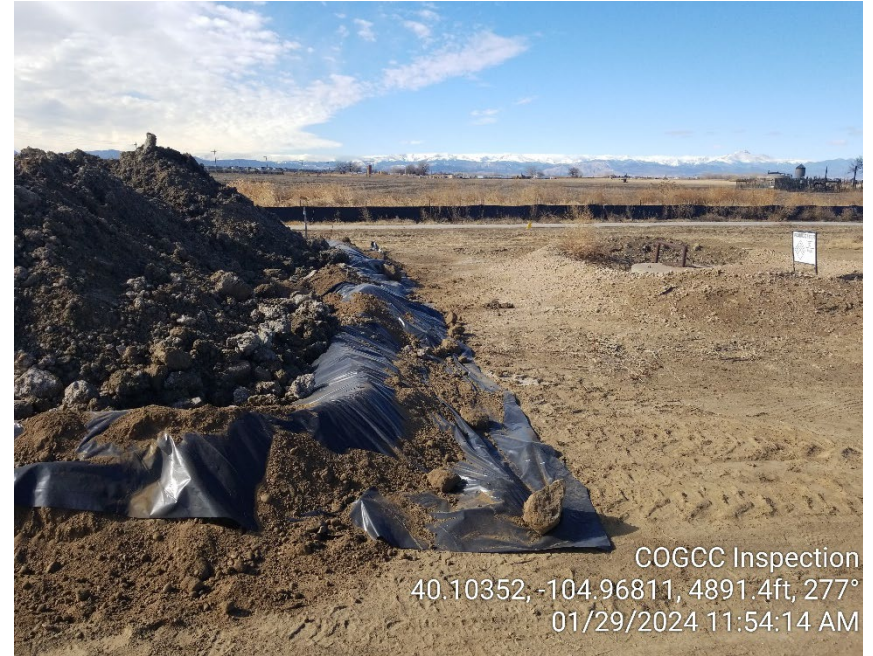
Photo 30 - Soil Stockpile 1/29/2024

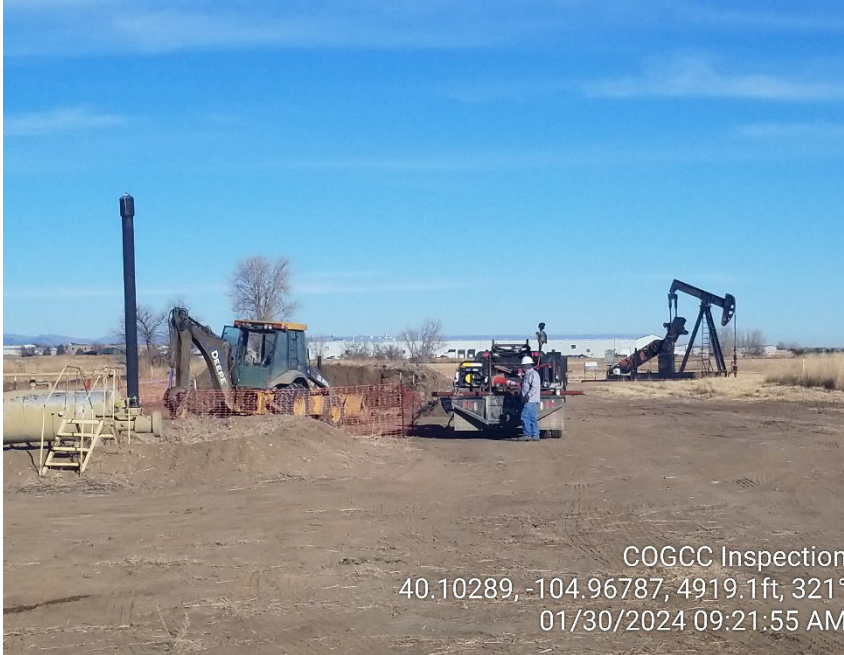
Photo 31 – Spill area 1/30/2024 AM. Flowline repair crew on site.

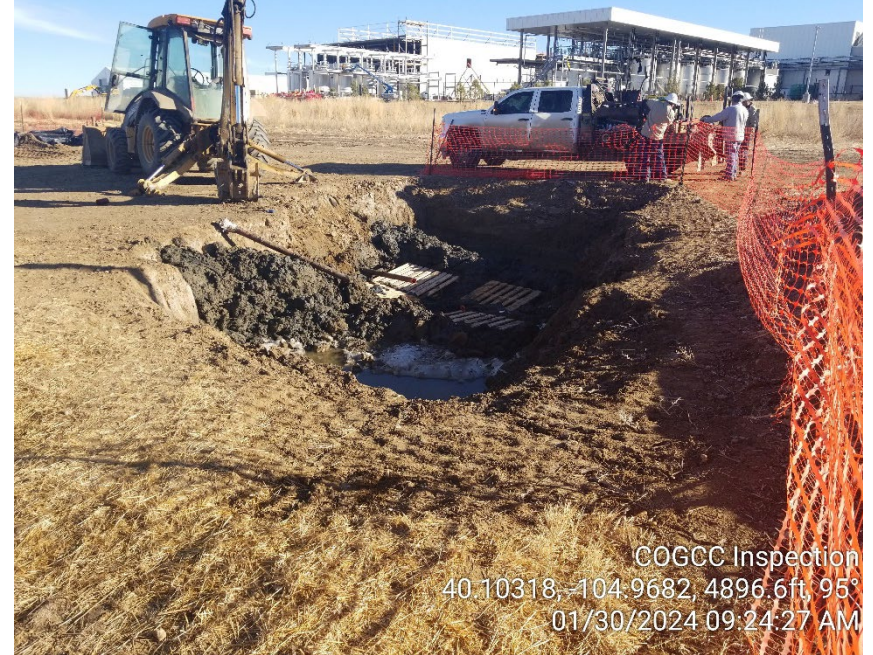
Photo 32 - Open excavation 1/30/2024 AM. Flowline repair in progress.

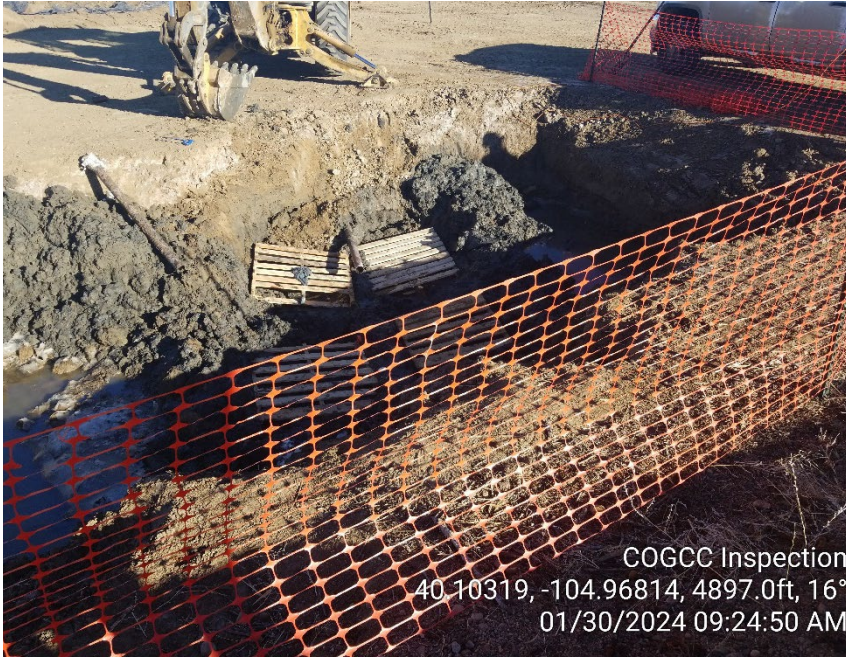
Photo 33 – Open excavation 1/30/2024 AM.

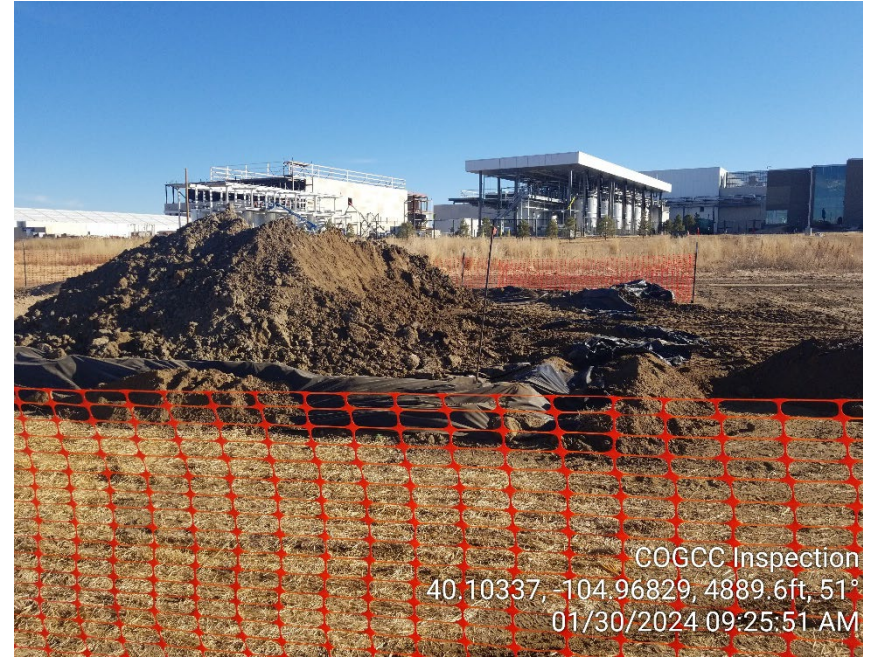
Photo 34 - Soil Stockpile 1/30/2024 AM

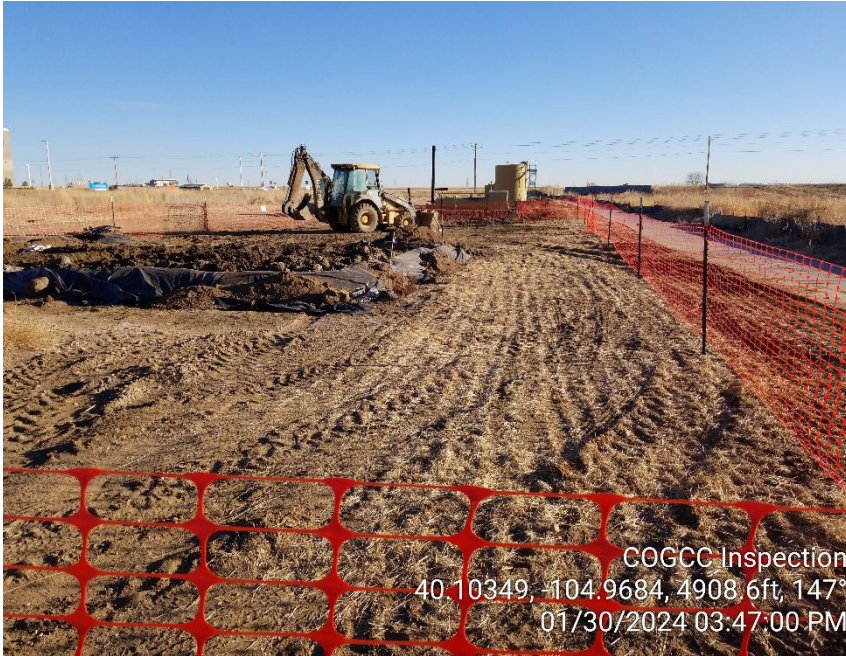
Photo 35– Spill area 1/30/2024 PM

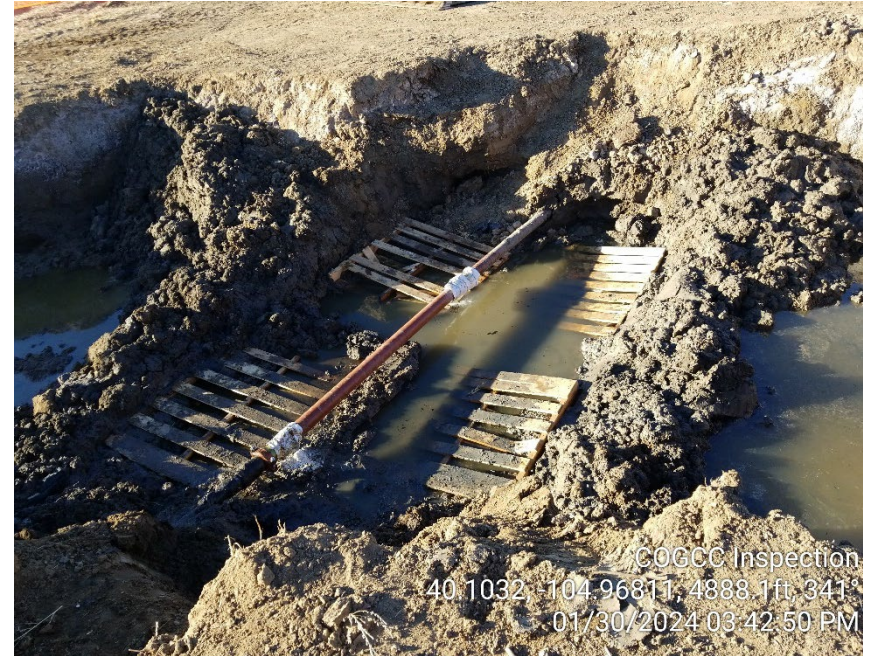
Photo 36 - Open excavation 1/30/2024 PM

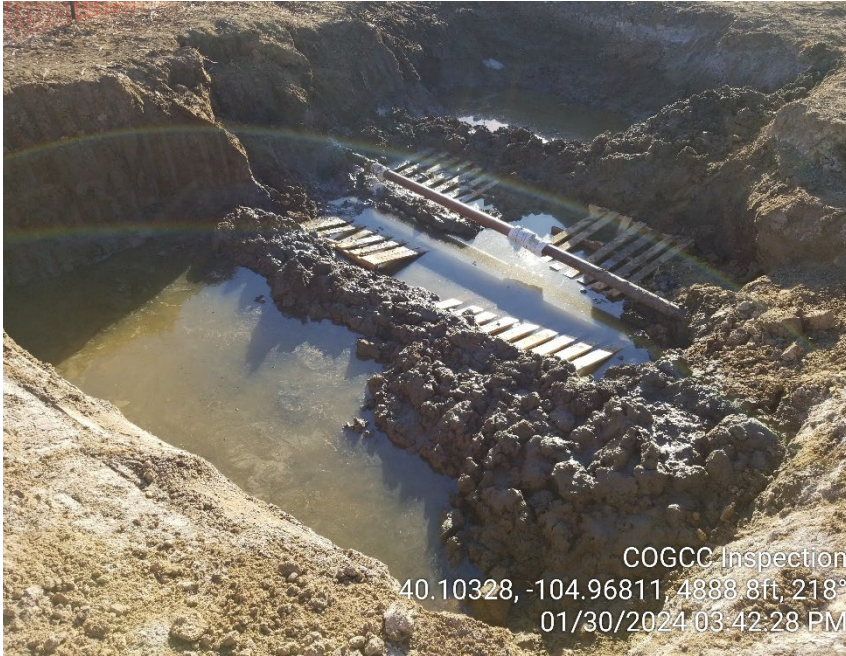
Photo 37 – Open excavation 1/30/2024 PM

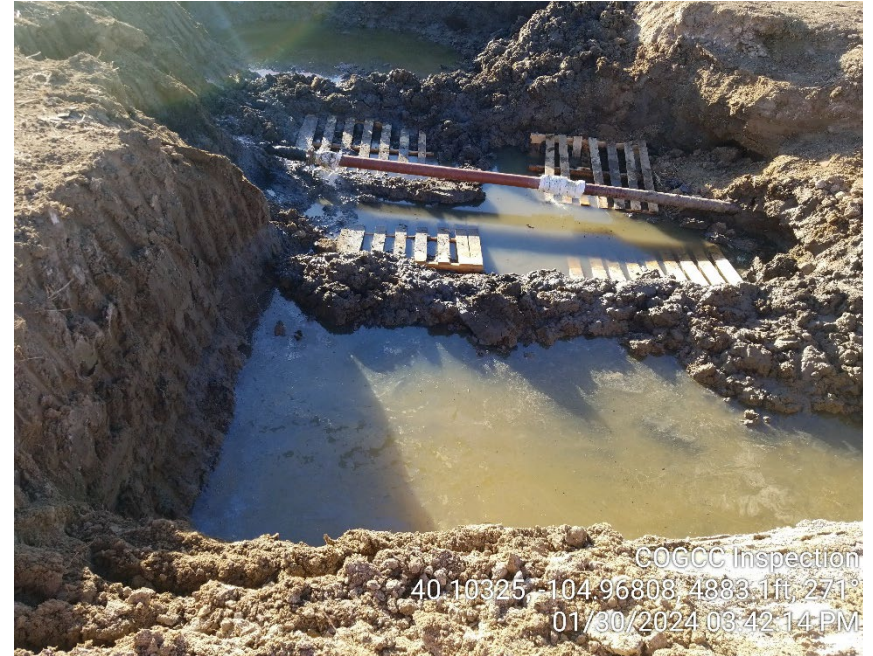
Photo 38 - Open excavation 1/30/2024 PM

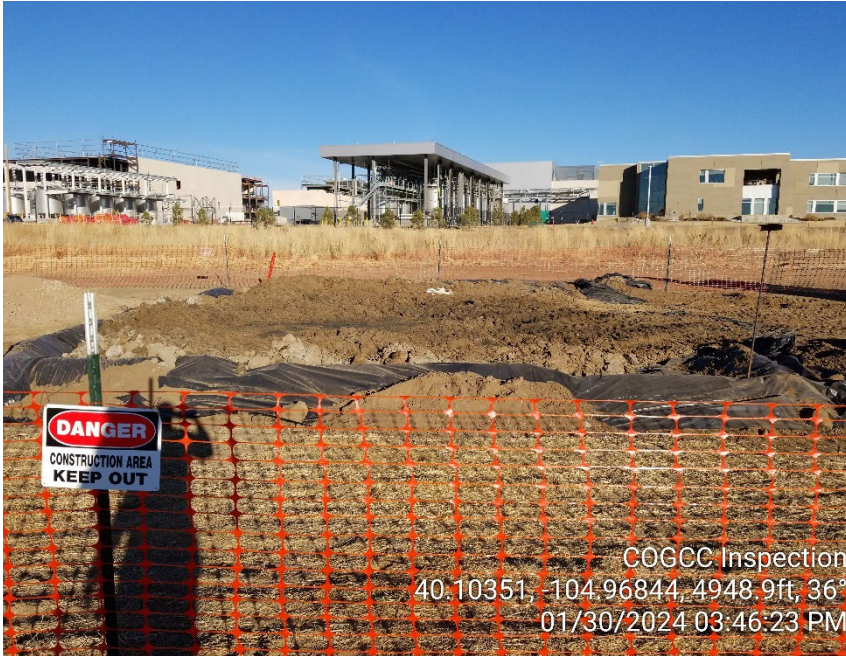
Photo 39 – Soil Stockpile 1/30/2024

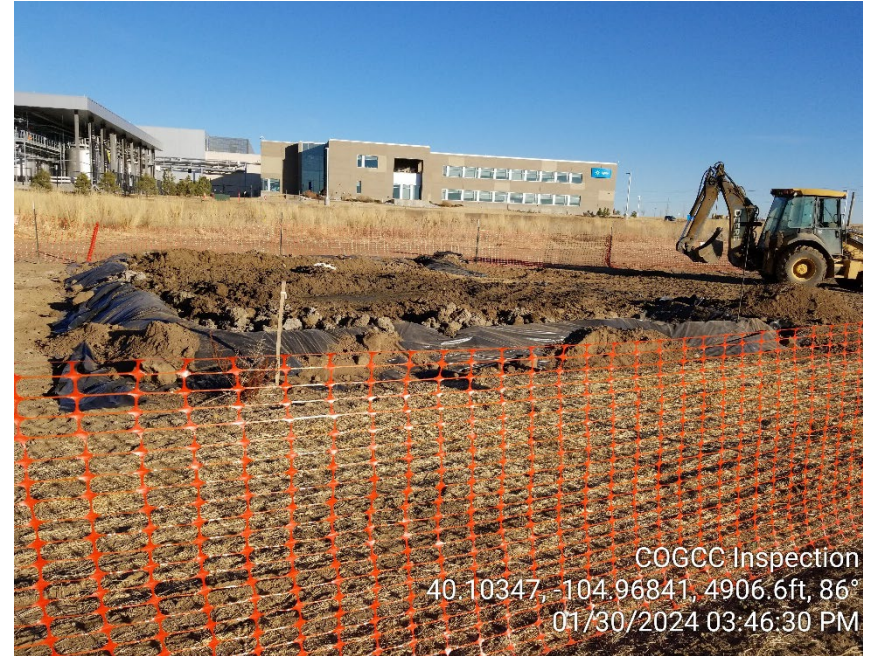
Photo 40 - Soil Stockpile 1/30/2024
