Inspection Photos

Location Name: CAERUS PICEANCE LLC SAVAGE 20-8 (PI20) Pad

Location #: 335039

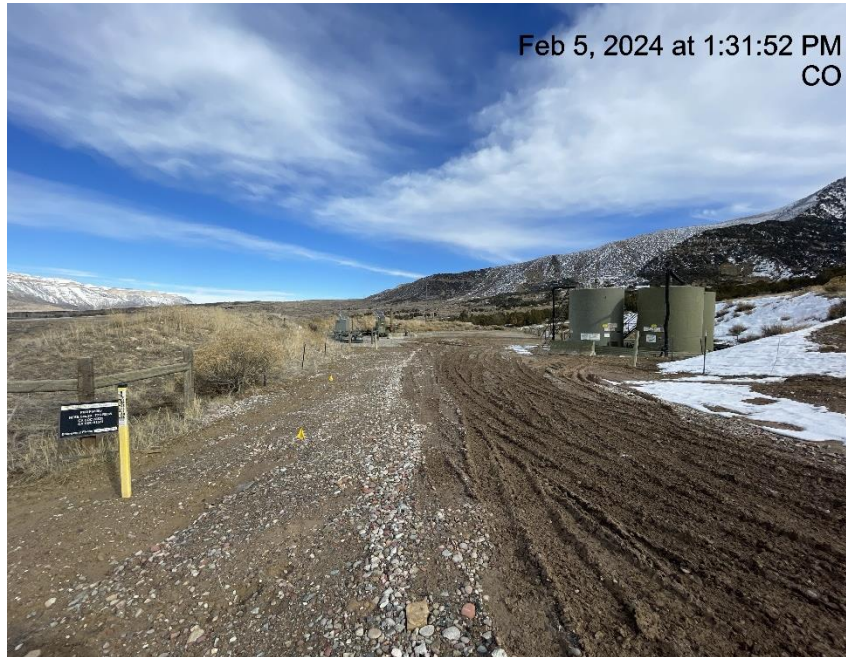
Photo # 5693 From entrance to location

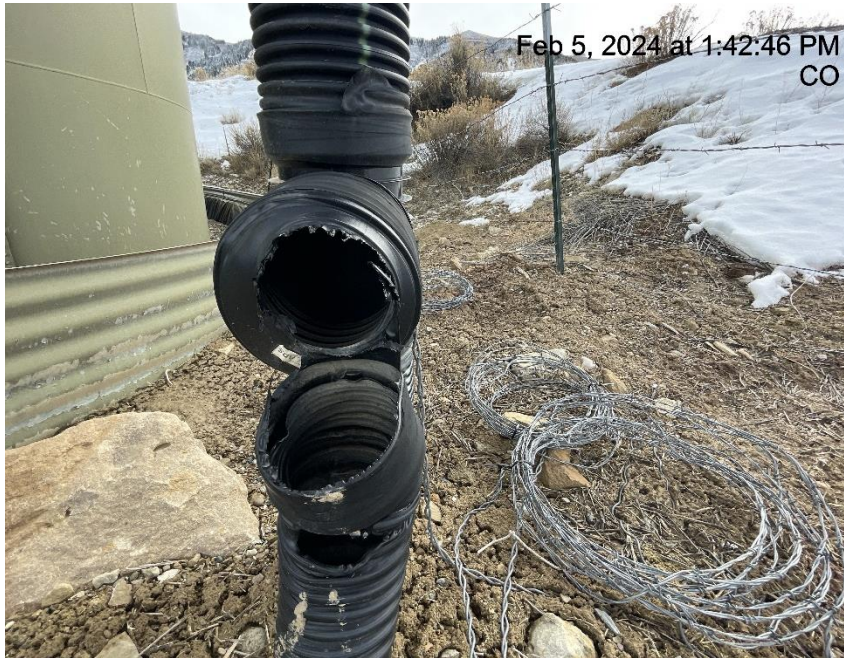
Photo # 5699 Flowline heating insulation open ended/wildlife hazard/available for entry by wildlife

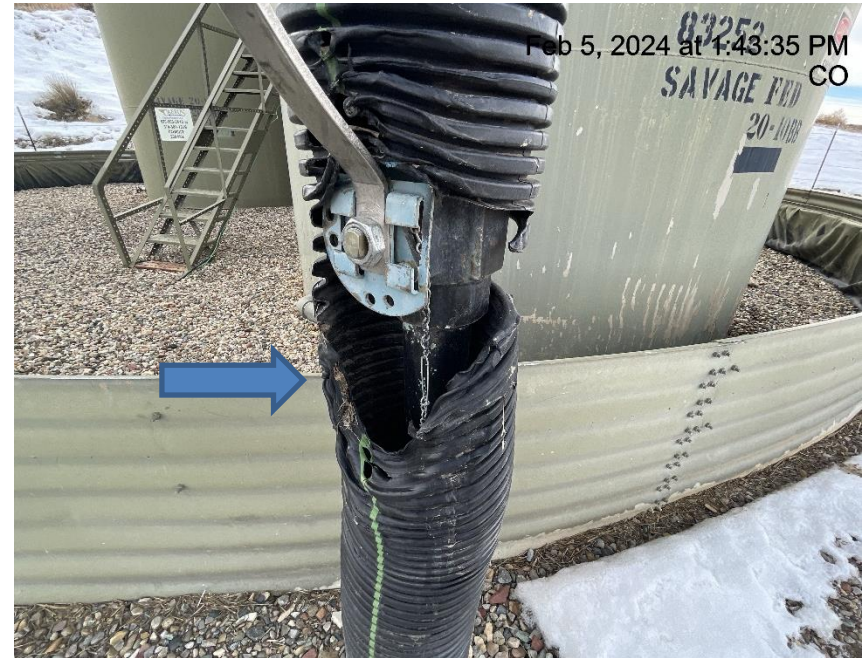
Photo # 5700 Hole in flowline heating insulation/wildlife hazard/available for entry by wildlife

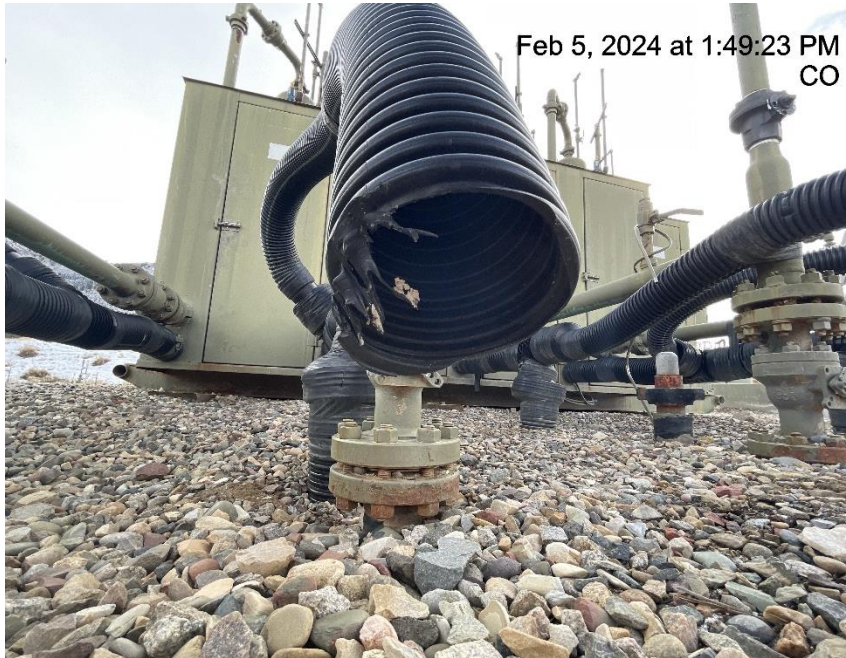
Photo # 5701 Flowline heating insulation open ended/wildlife hazard/available for entry by wildlife

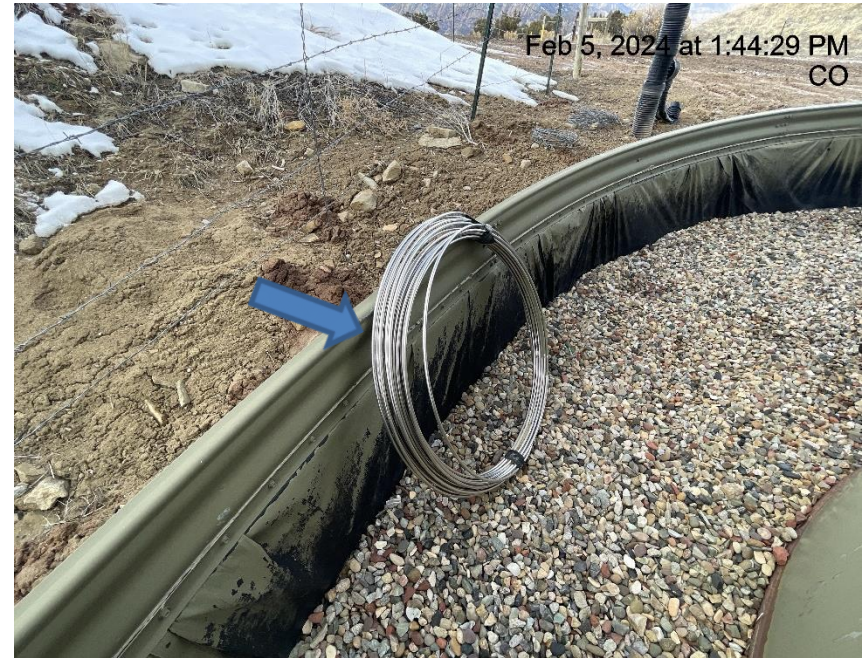
Photo # 5702 Debris

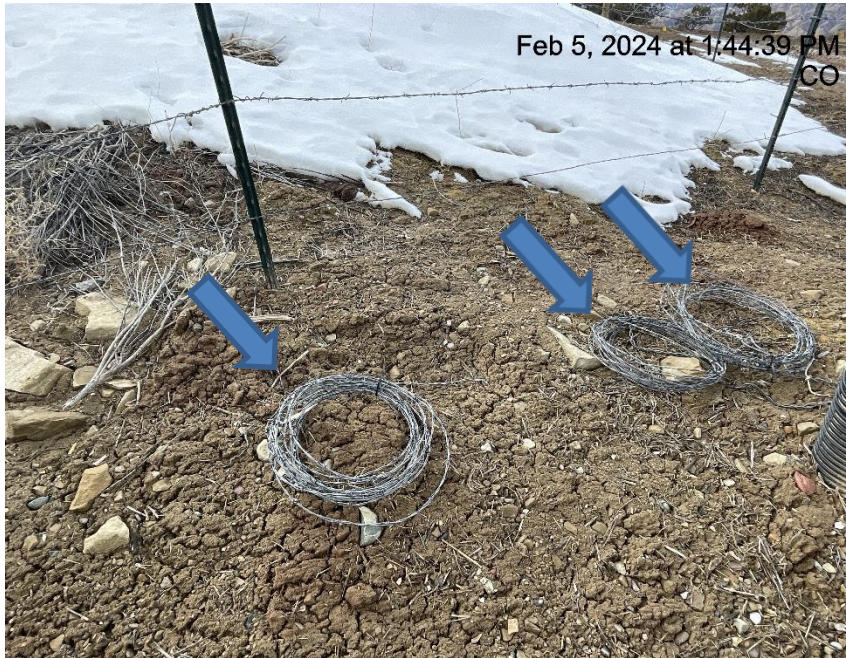
Photo # 5703 Debris

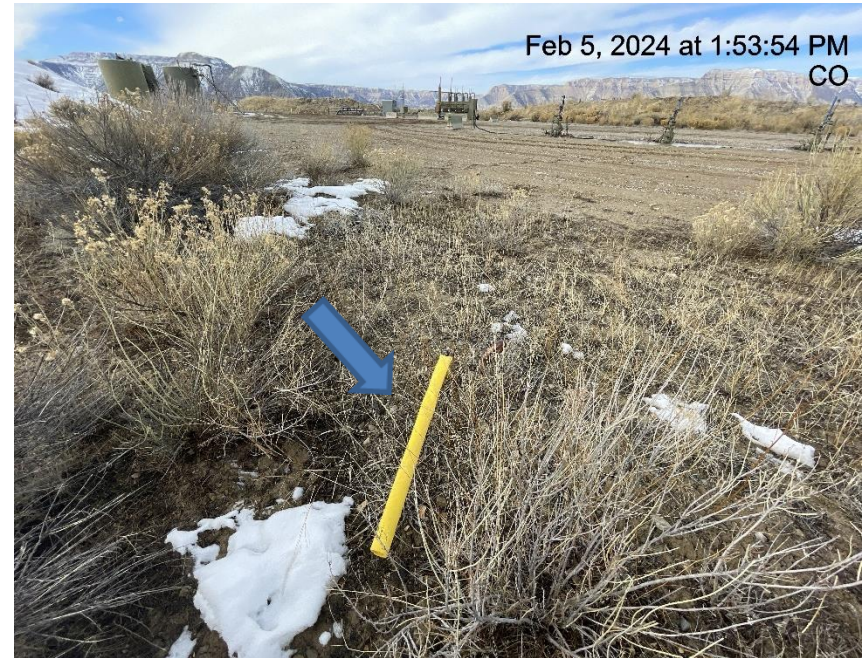
Photo # 5704 Improperly marked deadman
