Storm Water Management and Erosion control
Location Name: CAERUS PICEANCE LLC SAVAGE 20-8 (PI20) Pad
Location #: 335039

**Location Overview: Location is within High
Priority/Density/Black Bear Habitat areas. Location is
approximately 60 yards from Rule 411a Surface Water
External Buffer**

Section/Township/Range: 20 7S95W

COLORADO
Energy & Carbon Management
Commission
Department of Natural Resources

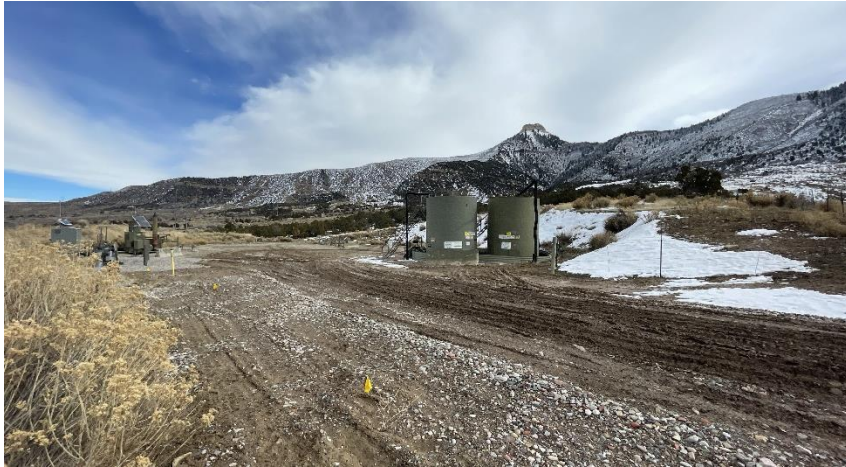
North West corner of location.

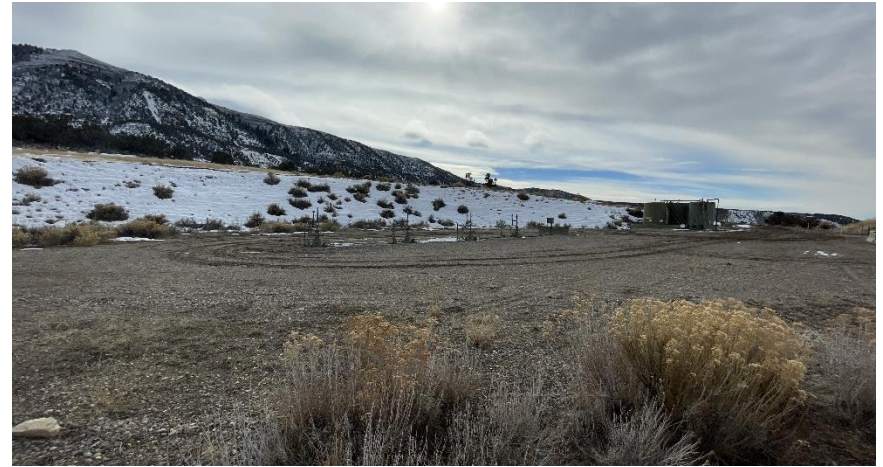
North East corner of location.

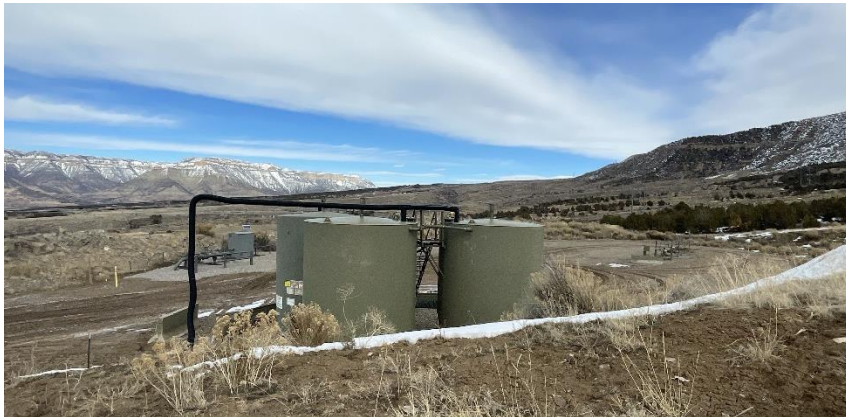
South West corner of location.

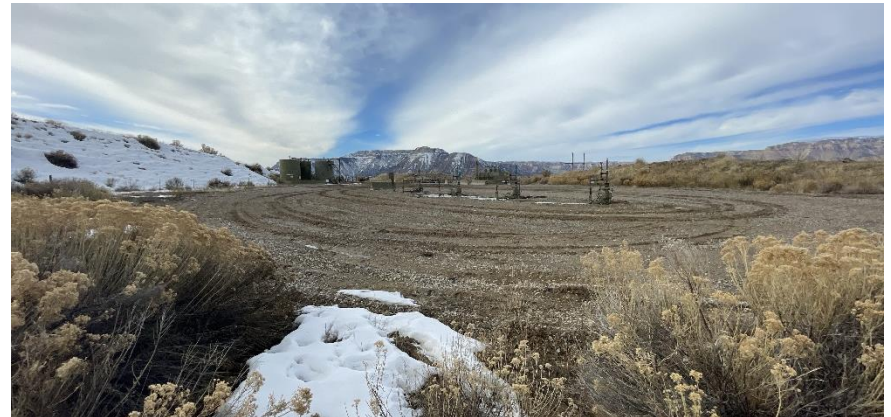
South East corner of location.

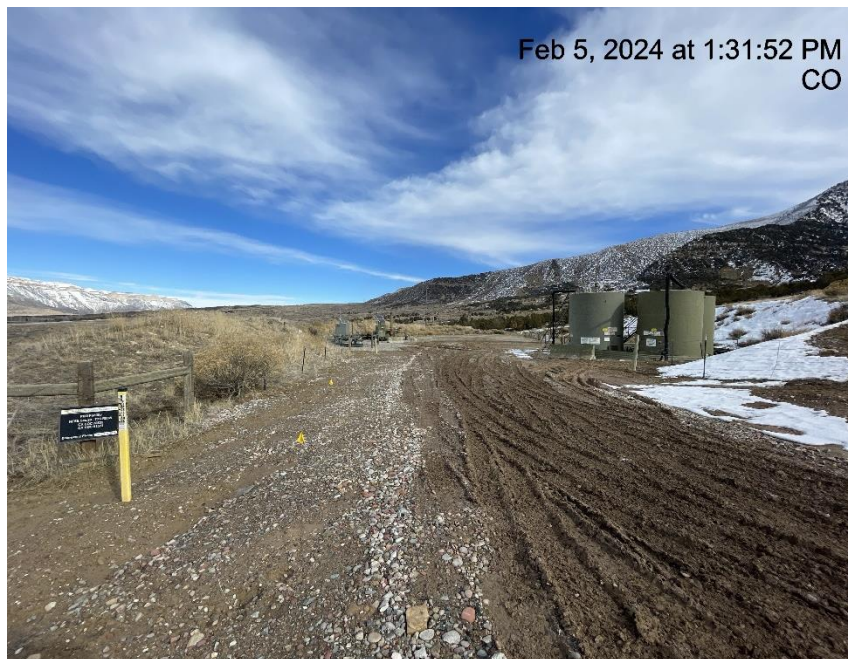
Photo # 5705 Lack of stabilization/compaction/insufficient tracking BMP's at entrance to location

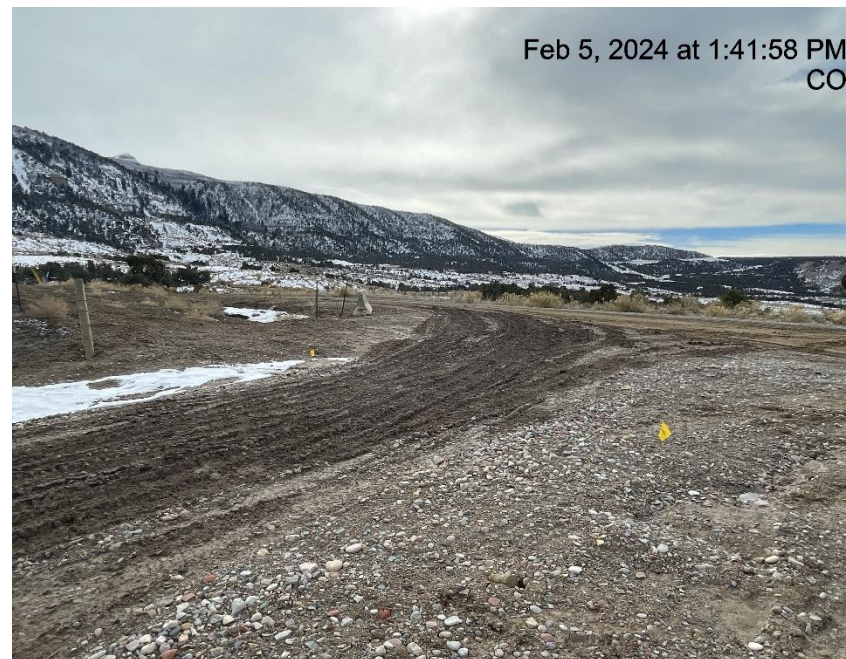
Photo # 5706 Lack of stabilization/compaction/insufficient tracking BMP's at entrance to location

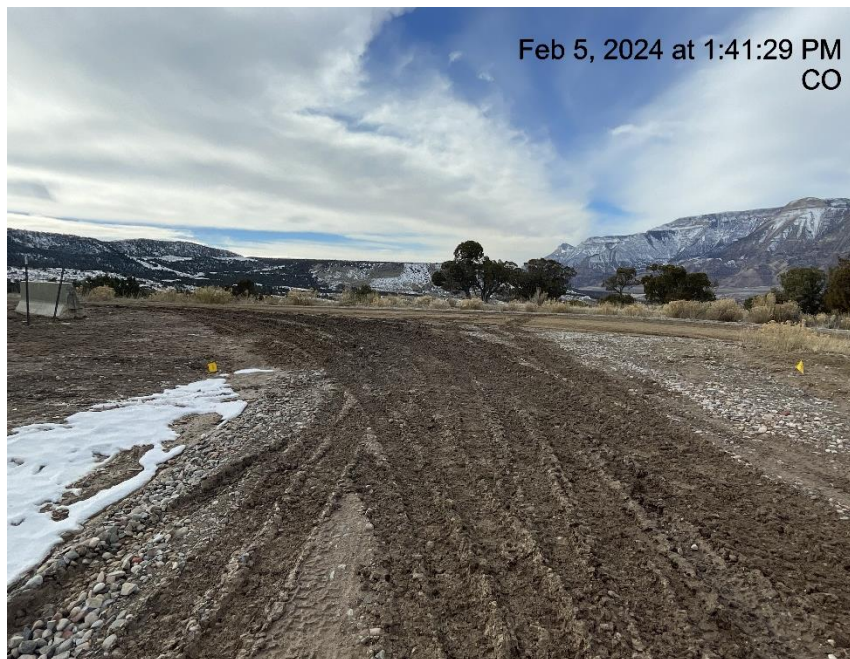
Photo # 5707 Lack of stabilization/compaction/insufficient tracking BMP's at entrance to location

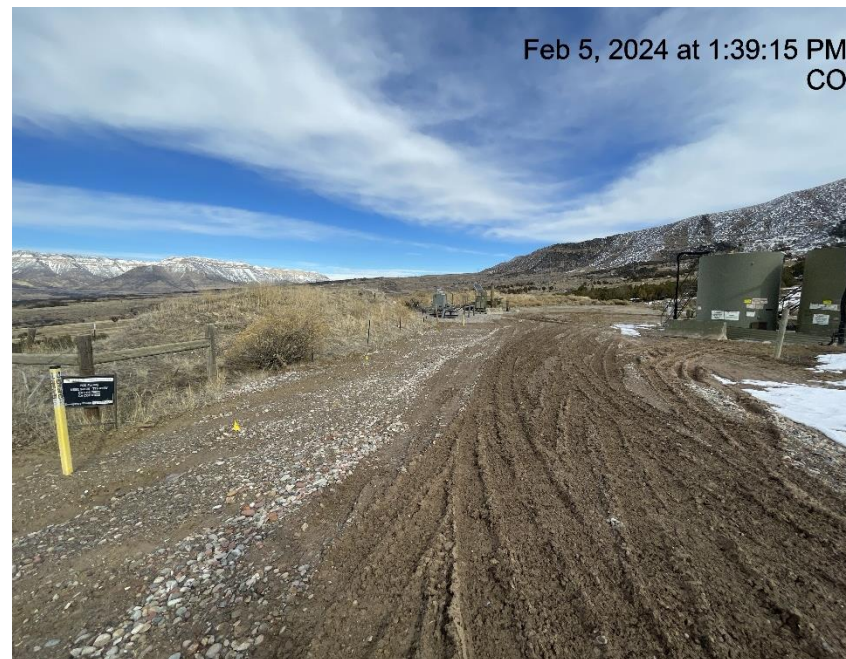
Photo # 5708 Lack of stabilization/compaction/insufficient tracking BMP's at entrance to location

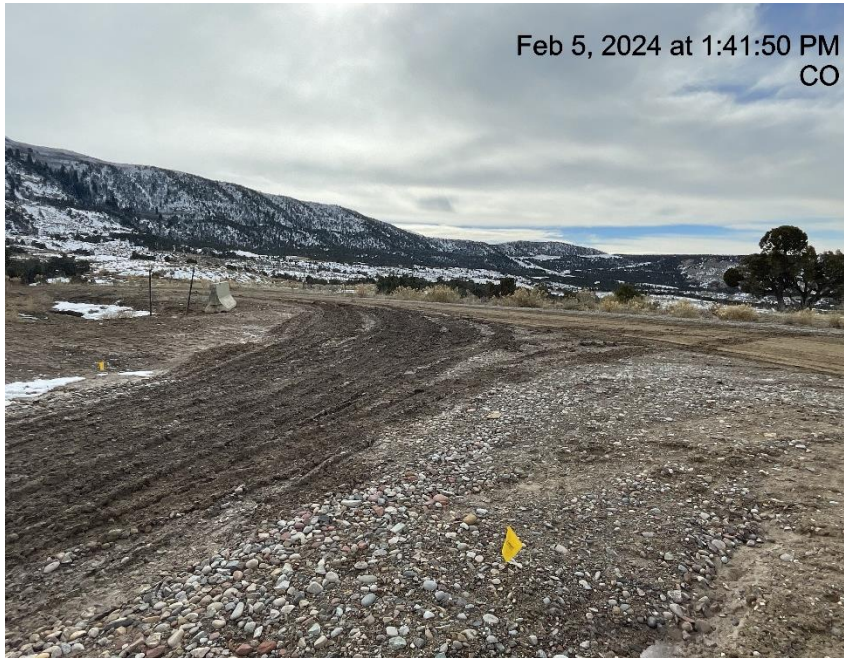
Photo # 5709 Lack of stabilization/compaction/insufficient tracking BMP's at entrance to location

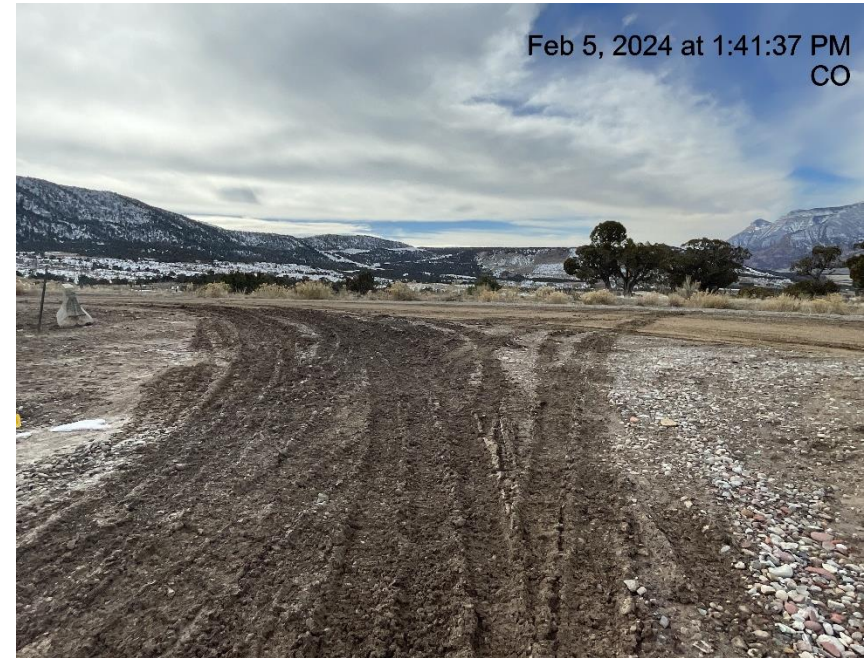
Photo # 5710 Lack of stabilization/compaction/insufficient tracking BMP's at entrance to location

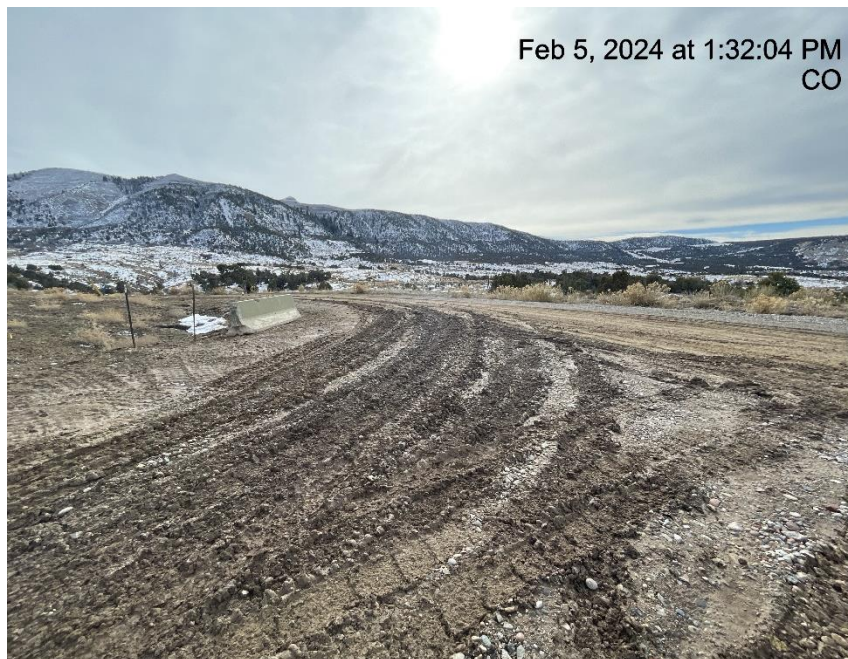
Photo # 5711 Lack of stabilization/compaction/insufficient tracking BMP's at entrance to location/tracking onto lease road

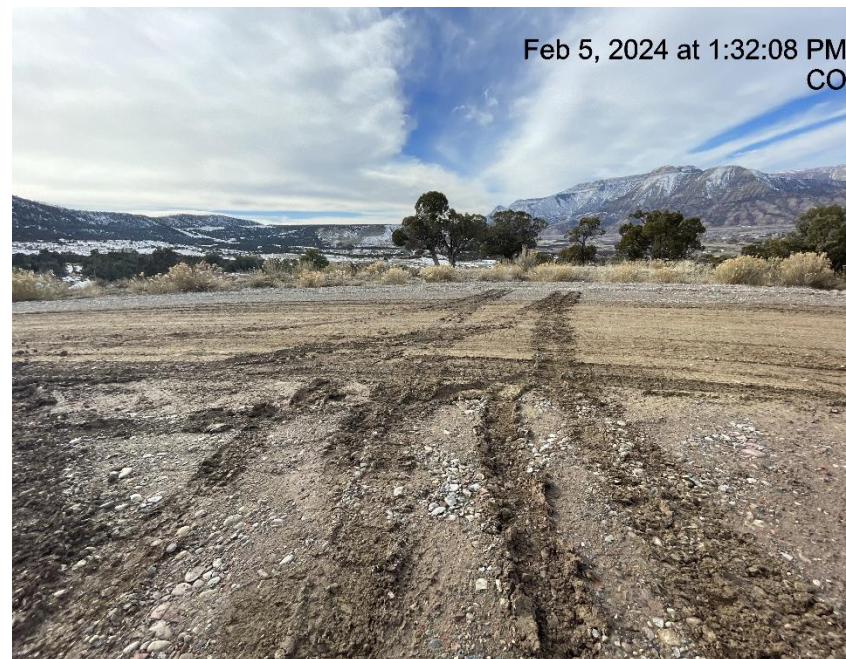
Photo # 5712 Lack of stabilization/compaction/insufficient tracking BMP's at entrance to location/tracking onto lease road

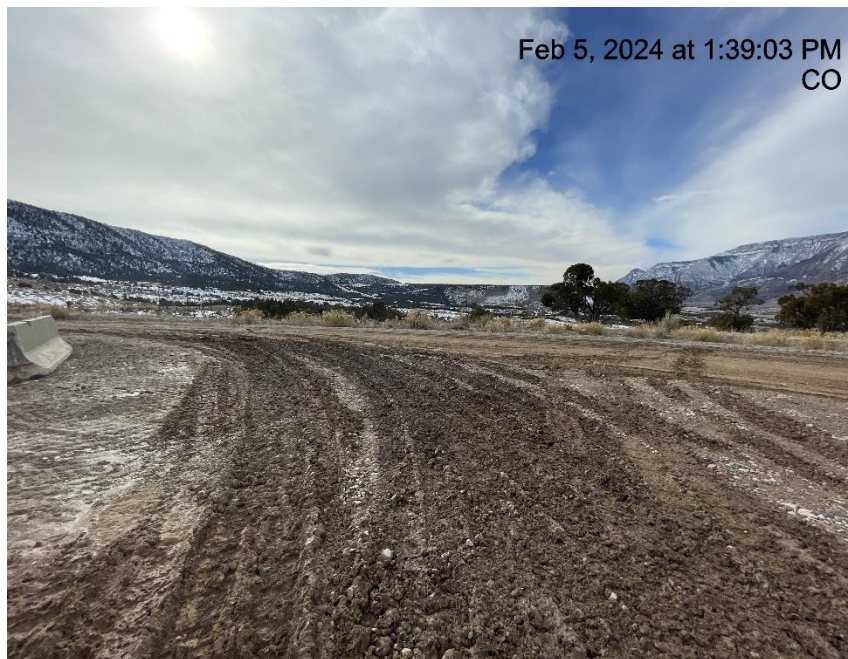
Photo # 5713 Lack of stabilization/compaction/insufficient tracking BMP's at entrance to location/tracking onto lease road

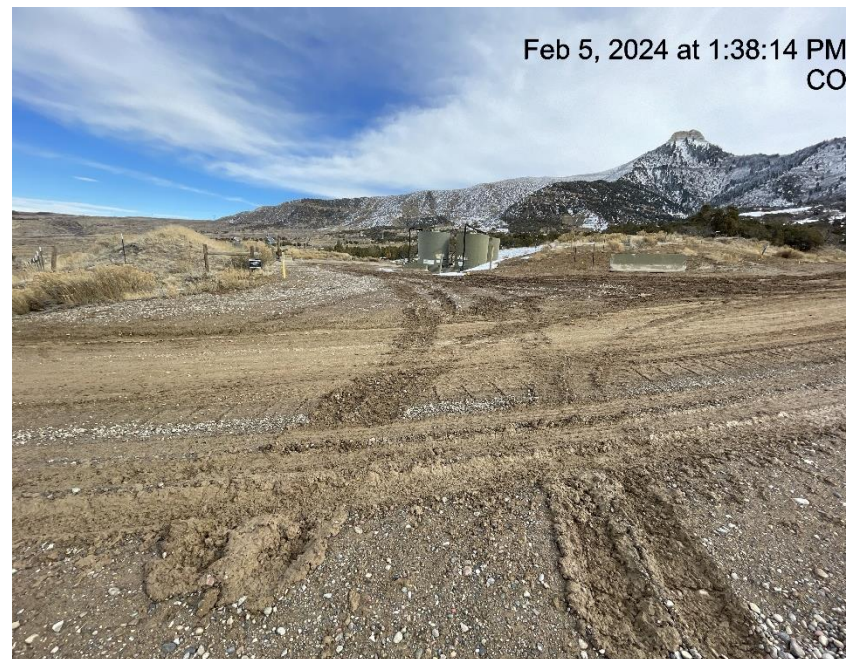
Photo # 5714 Lack of stabilization/compaction/insufficient tracking BMP's at entrance to location/tracking onto lease road

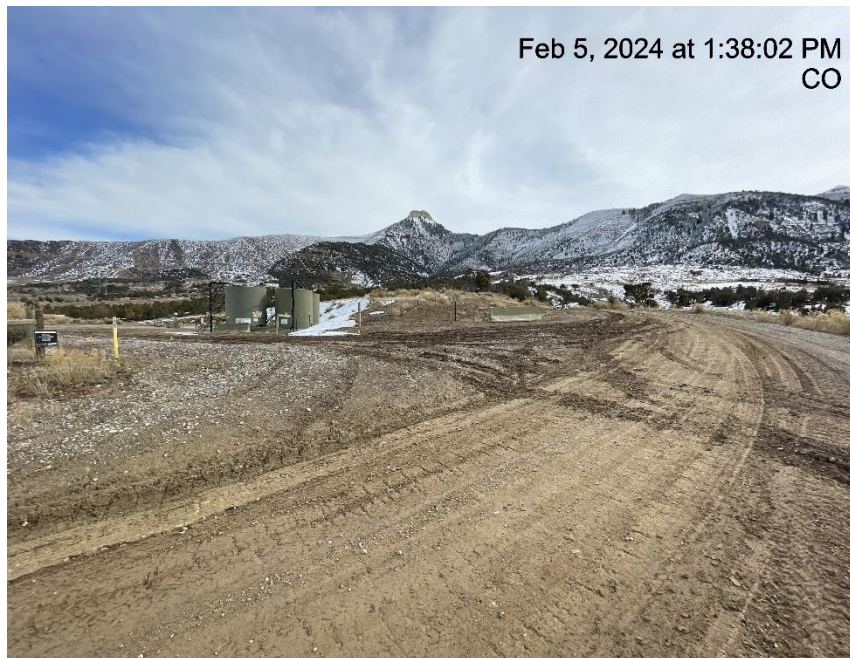
Photo # 5715 Lack of stabilization/compaction/insufficient tracking BMP's at entrance to location/tracking onto lease road

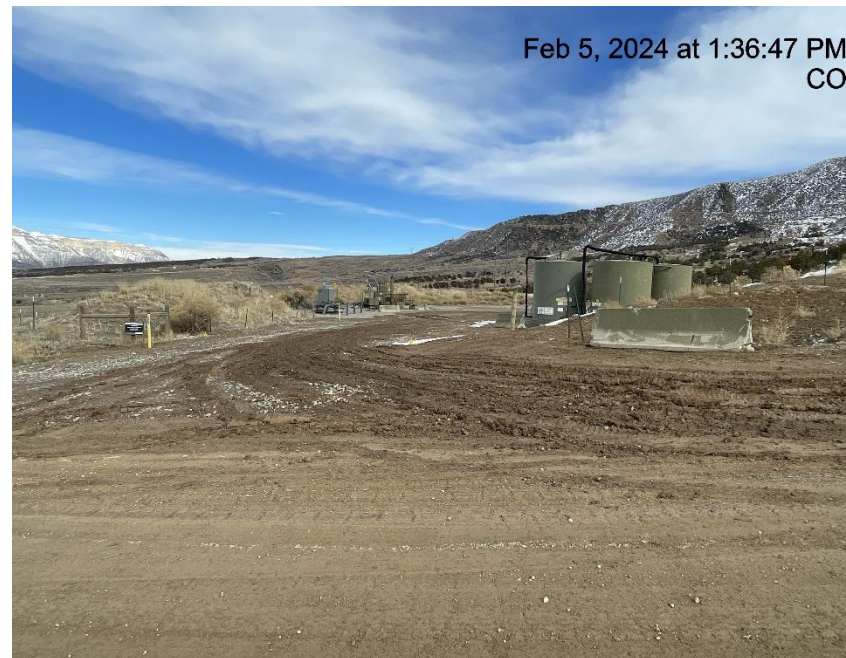
Photo # 5716 Lack of stabilization/compaction/insufficient tracking BMP's at entrance to location/tracking onto lease road

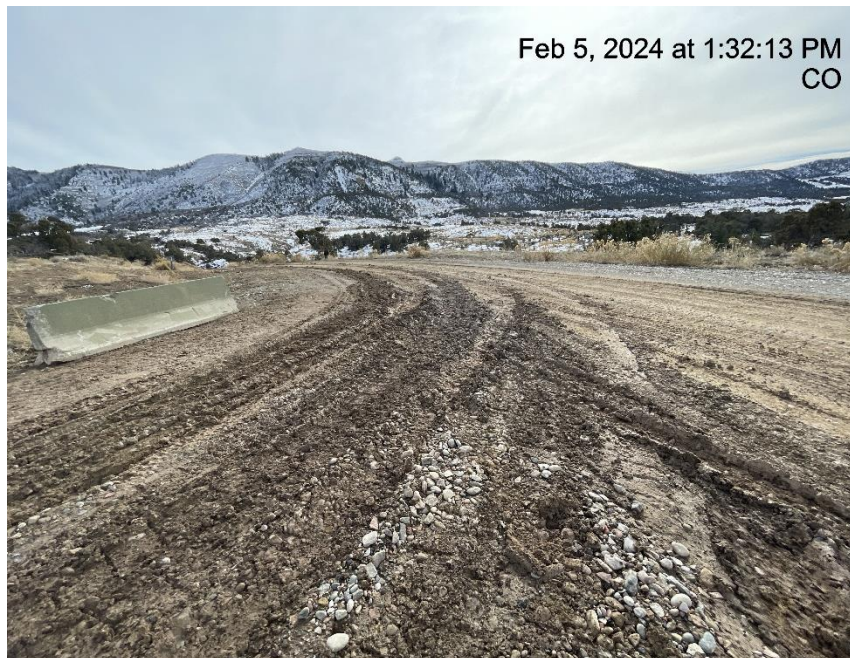
Photo # 5717 Insufficient tracking BMP's at entrance to location/tracking onto lease road

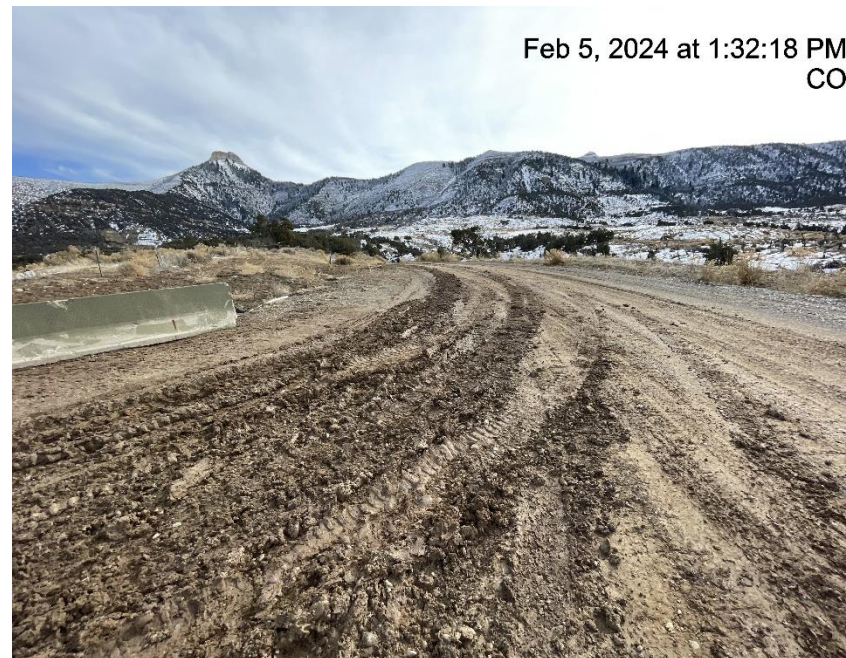
Photo # 5718 Insufficient tracking BMP's at entrance to location/tracking onto lease road

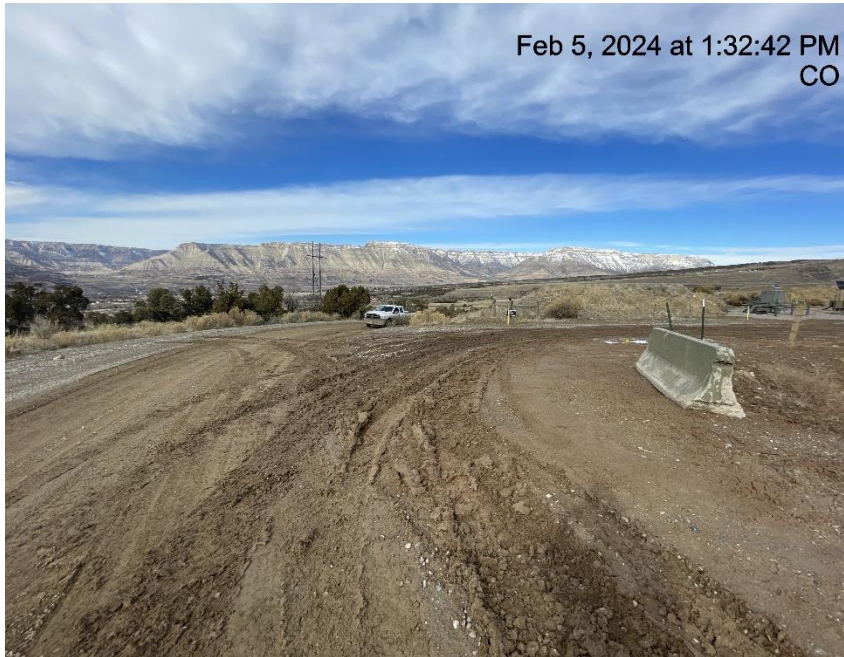
Photo # 5719 Insufficient tracking BMP's at entrance to location/tracking onto lease road

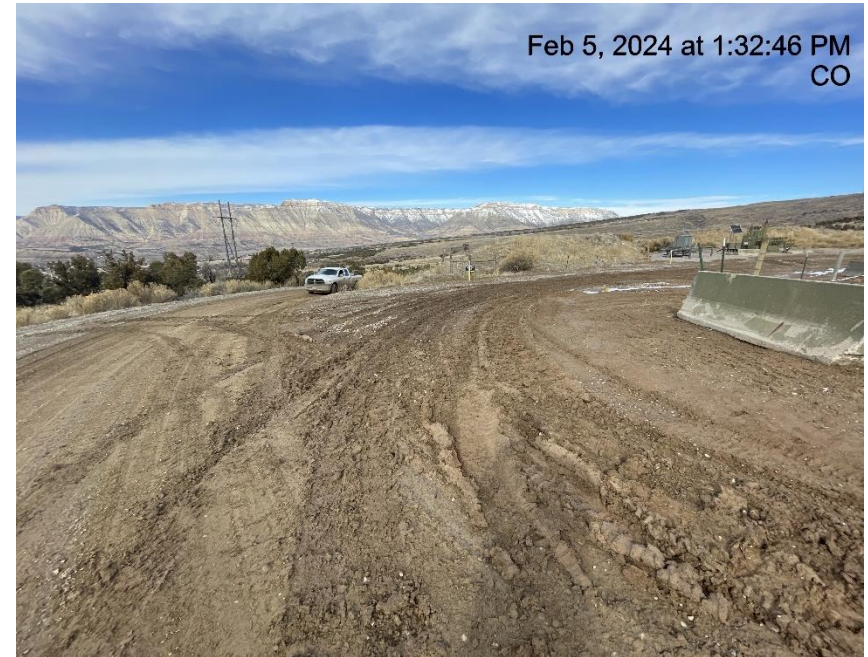
Photo # 5720 Insufficient tracking BMP's at entrance to location/tracking onto lease road

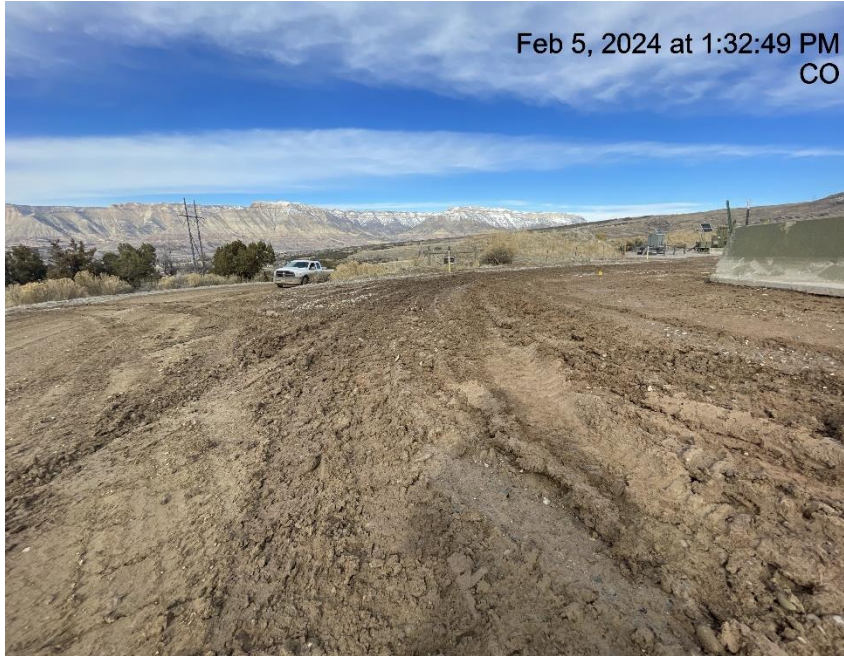
Photo # 5721 Insufficient tracking BMP's at entrance to location/tracking onto lease road

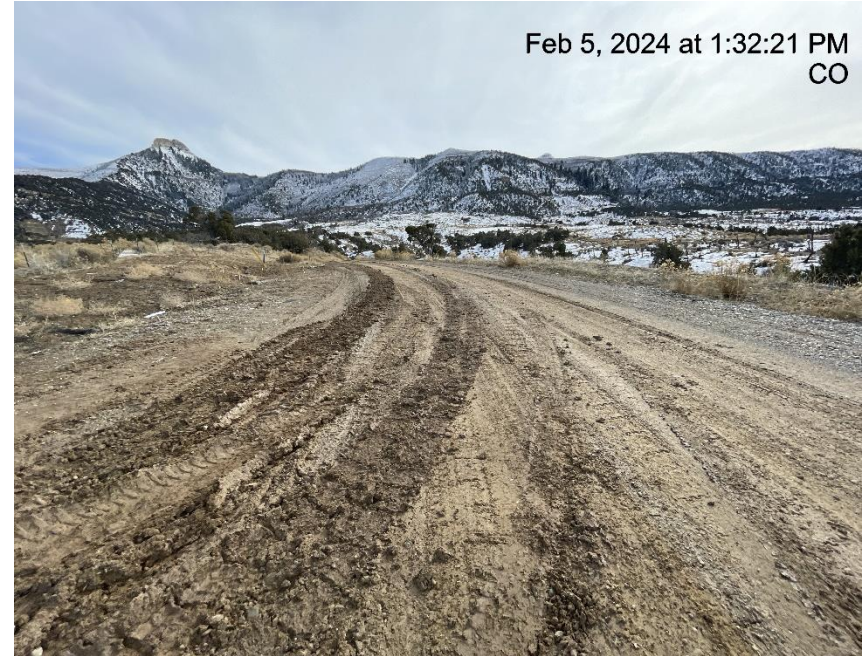
Photo # 5722 Insufficient tracking BMP's at entrance to location/tracking onto lease road

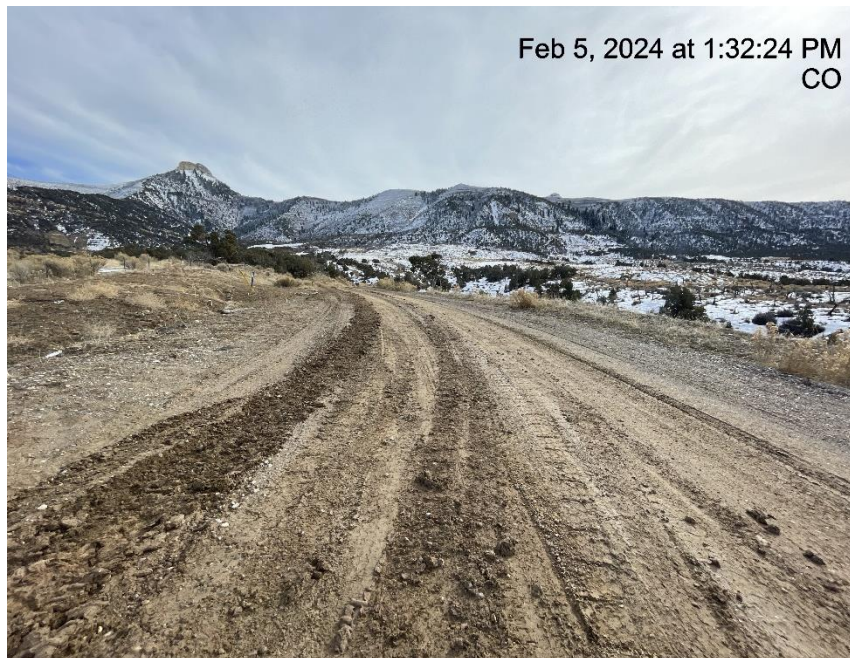
Photo # 5723 Insufficient tracking BMP's at entrance to location/tracking onto lease road

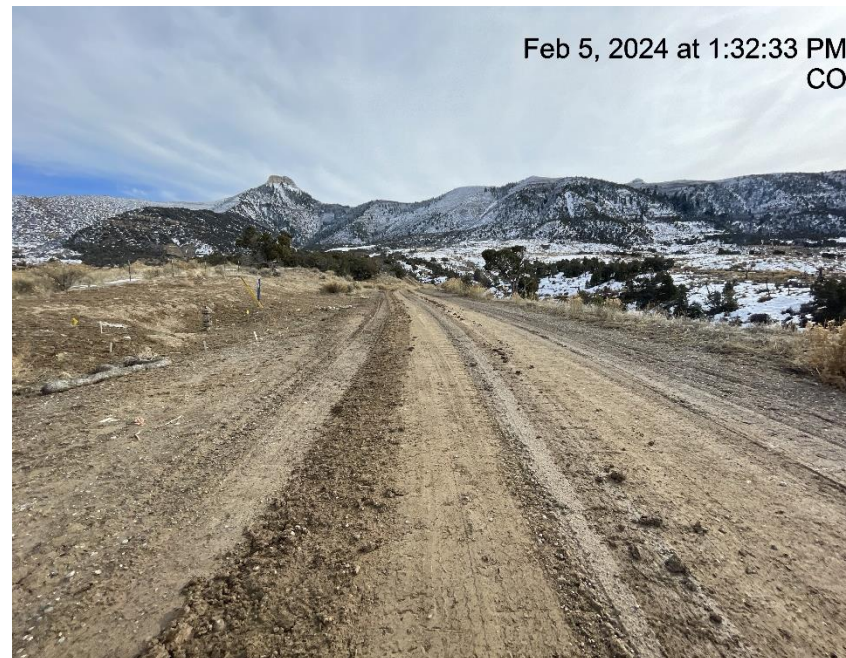
Photo # 5724 Insufficient tracking BMP's at entrance to location/tracking onto lease road

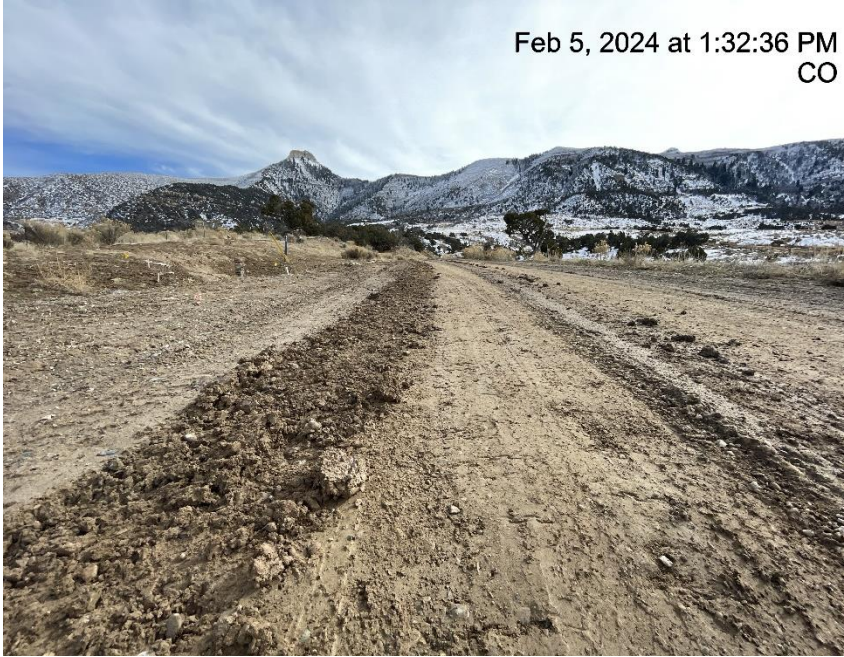
Photo # 5725 Insufficient tracking BMP's at entrance to location/tracking onto lease road

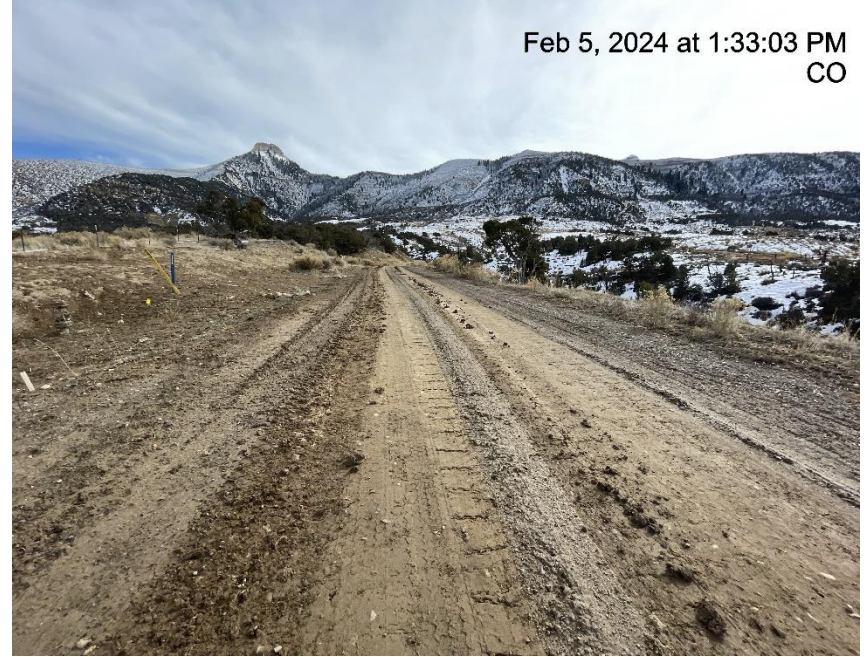
Photo # 5726 Insufficient tracking BMP's at entrance to location/tracking onto lease road

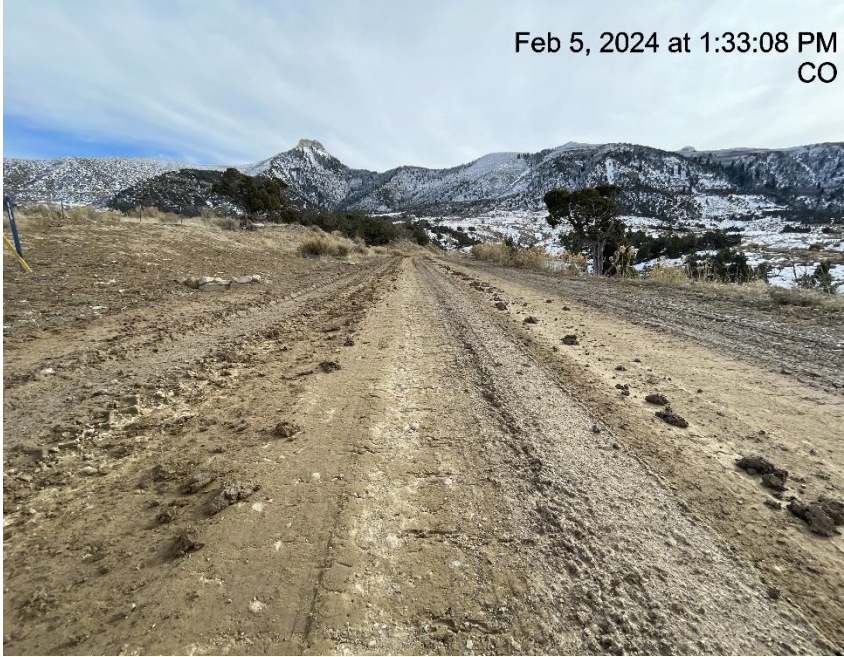
Photo # 5727 Insufficient tracking BMP's at entrance to location/tracking onto lease road

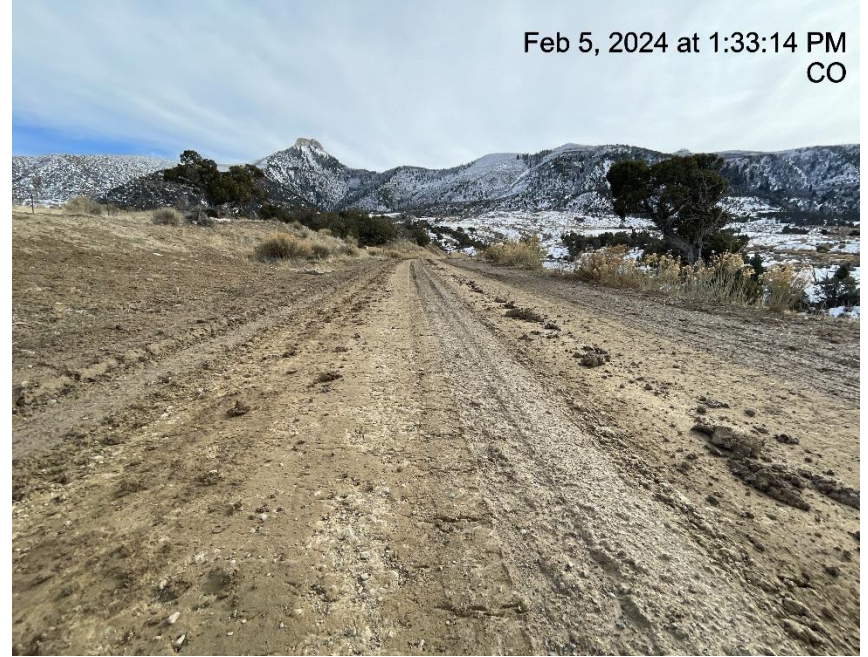
Photo # 5728 Insufficient tracking BMP's at entrance to location/tracking onto lease road

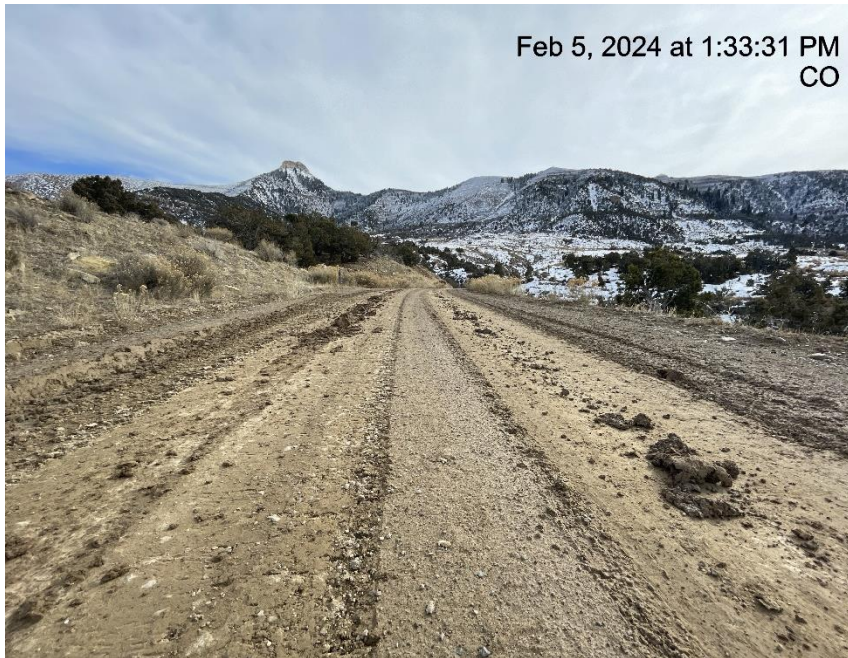
Photo # 5729 Insufficient tracking BMP's at entrance to location/tracking onto lease road

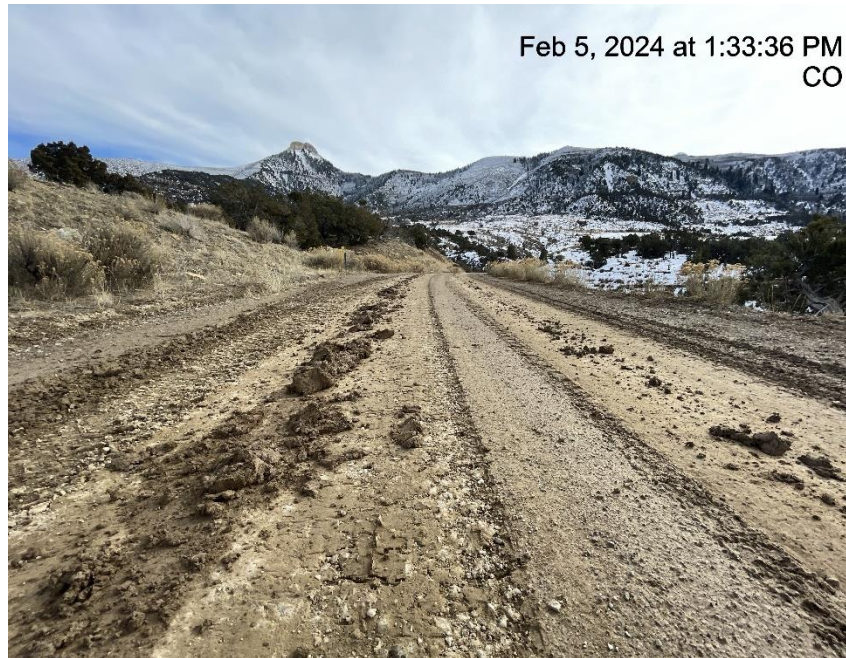
Photo # 5730 Insufficient tracking BMP's at entrance to location/tracking onto lease road

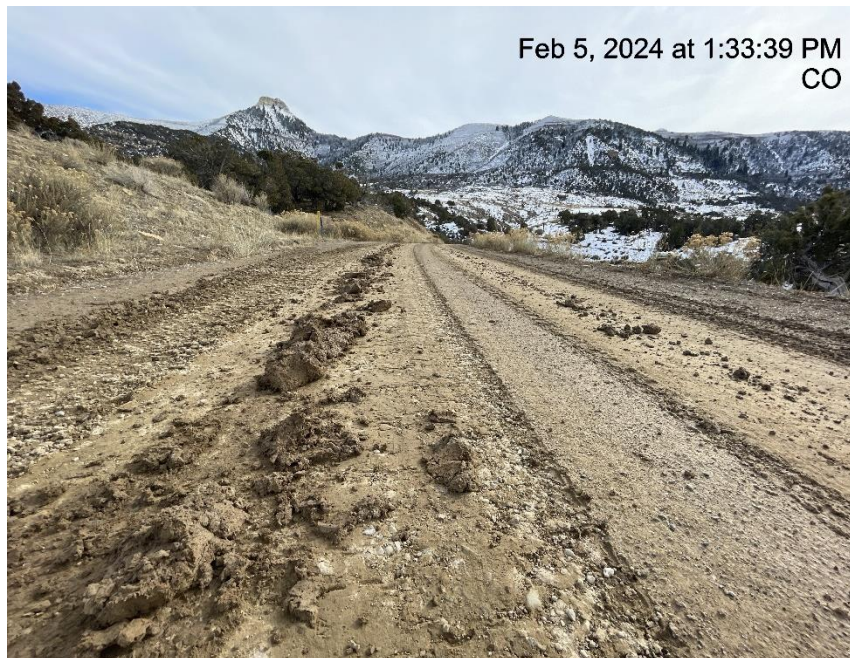
Photo # 5731 Insufficient tracking BMP's at entrance to location/tracking onto lease road

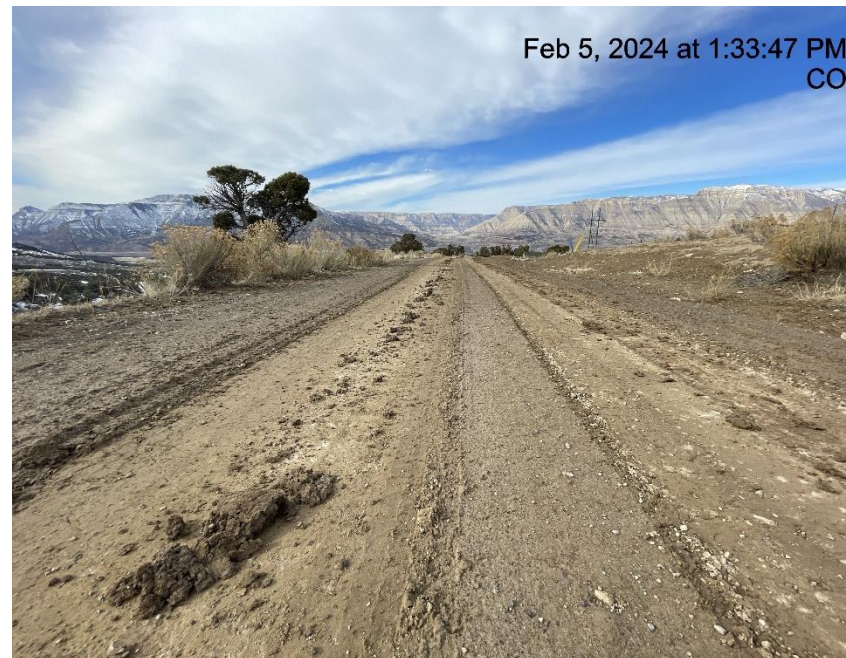
Photo # 5732 Insufficient tracking BMP's at entrance to location/tracking onto lease road

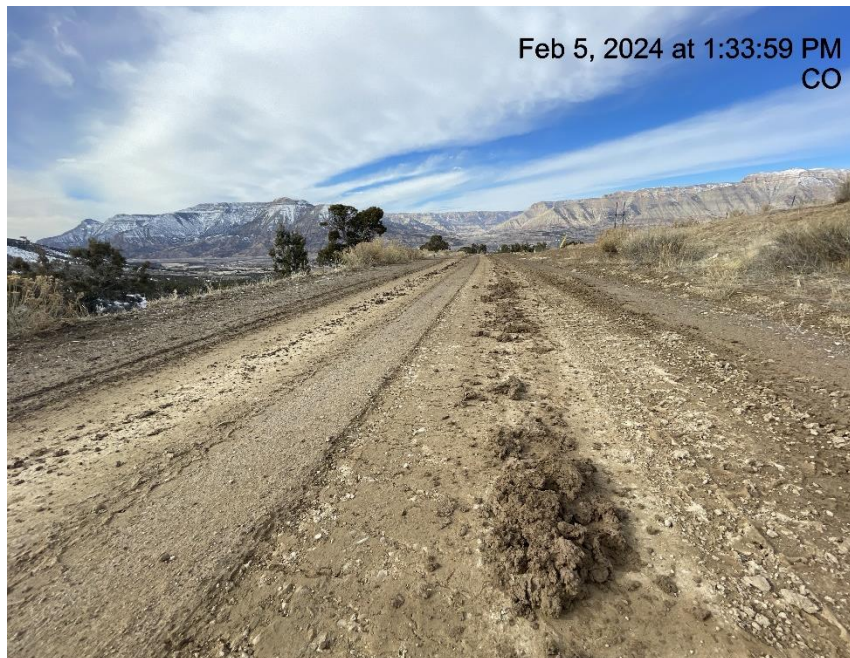
Photo # 5733 Insufficient tracking BMP's at entrance to location/tracking onto lease road

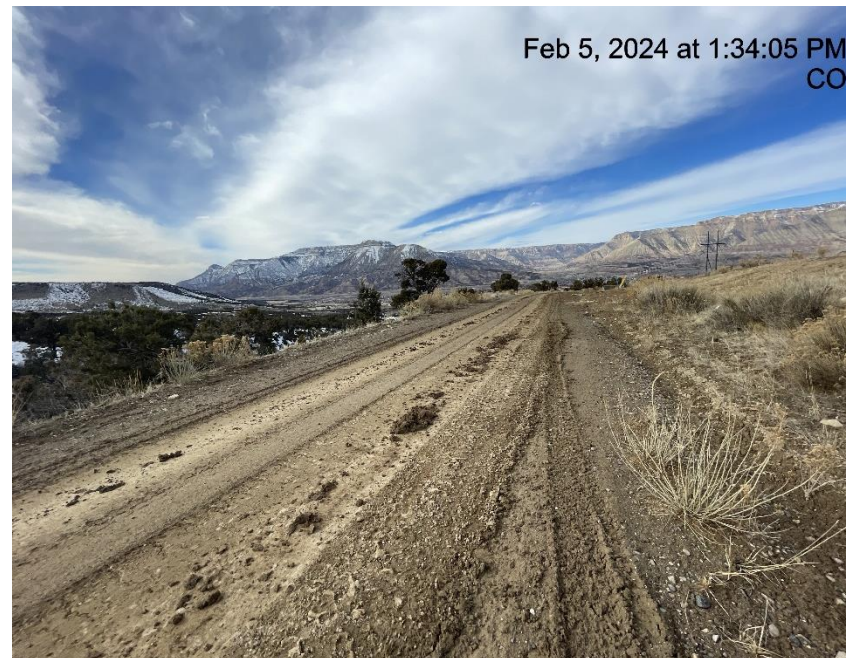
Photo # 5734 Insufficient tracking BMP's at entrance to location/tracking onto lease road

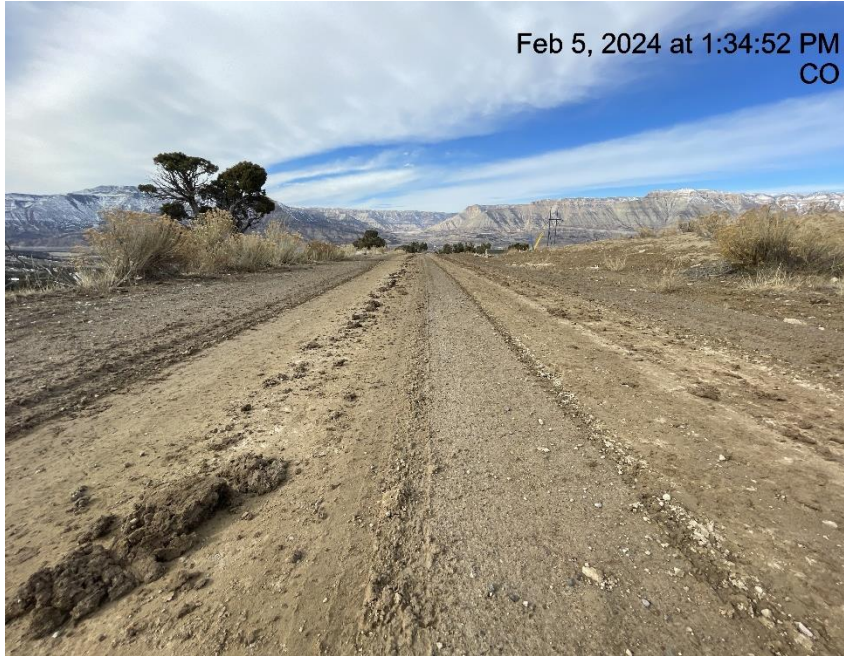
Photo # 5735 Insufficient tracking BMP's at entrance to location/tracking onto lease road

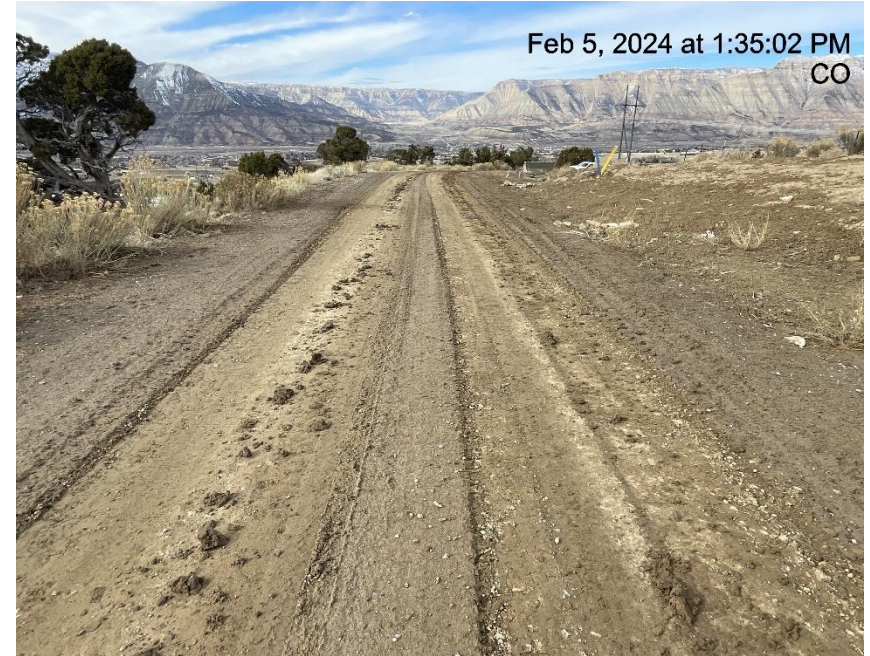
Photo # 5736 Insufficient tracking BMP's at entrance to location/tracking onto lease road

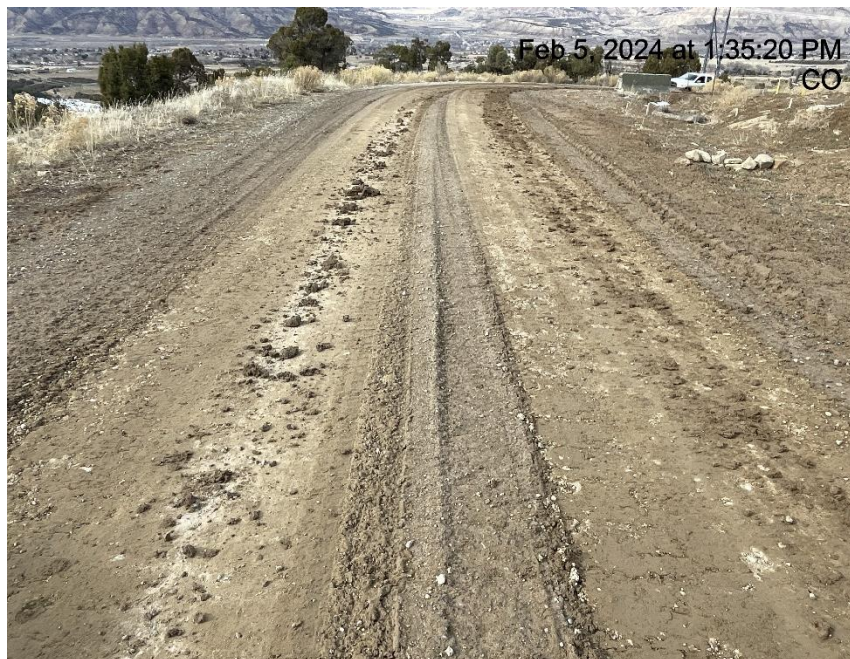
Photo # 5737 Insufficient tracking BMP's at entrance to location/tracking onto lease road

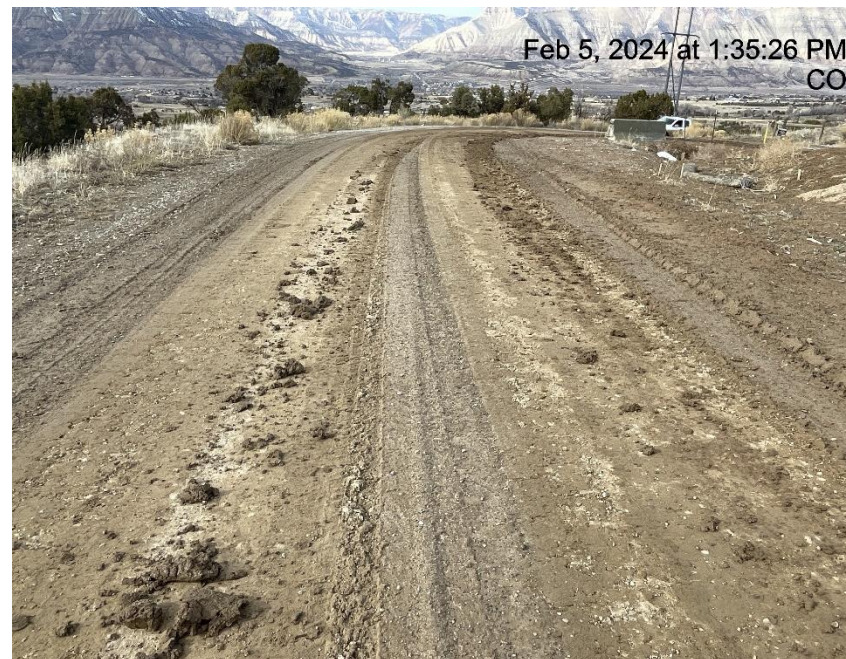
Photo # 5738 Insufficient tracking BMP's at entrance to location/tracking onto lease road

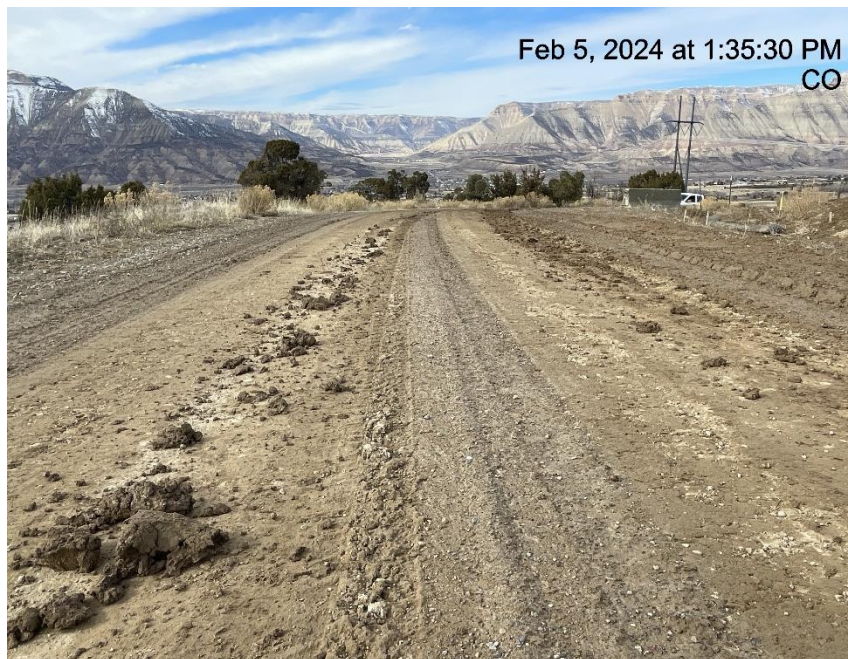
Photo # 5739 Insufficient tracking BMP's at entrance to location/tracking onto lease road

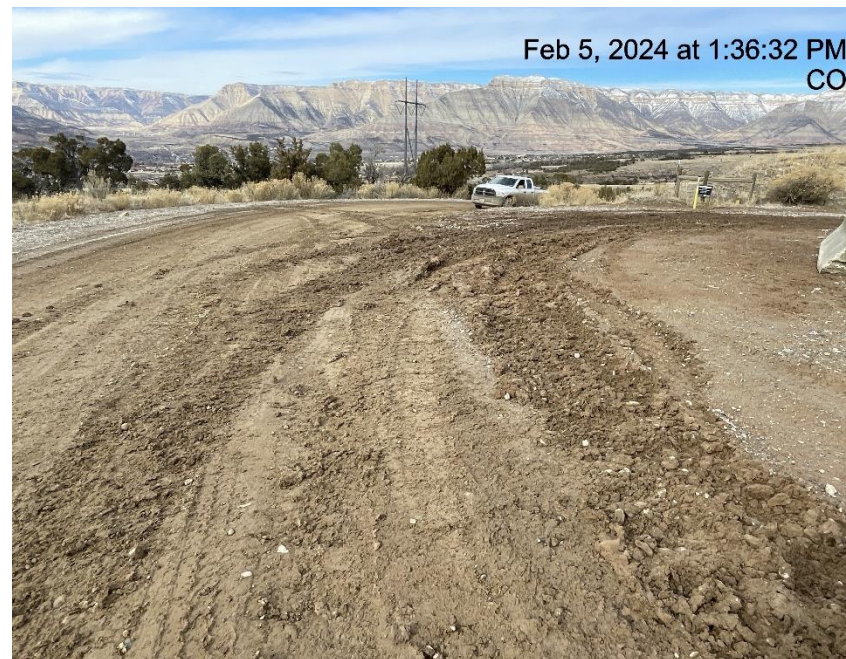
Photo # 5740 Insufficient tracking BMP's at entrance to location/tracking onto lease road
