Storm Water Management and Erosion control
Location Name: CAERUS PICEANCE LLC SAVAGE 20-8 (PI20) Pad
Location #: 335039

**Location Overview: Location is within High
Priority/Density/Black Bear Habitat areas. Location is
approximately 60 yards from Rule 411a Surface Water
External Buffer**

Section/Township/Range: 20 7S95W

COLORADO
Energy & Carbon Management
Commission
Department of Natural Resources

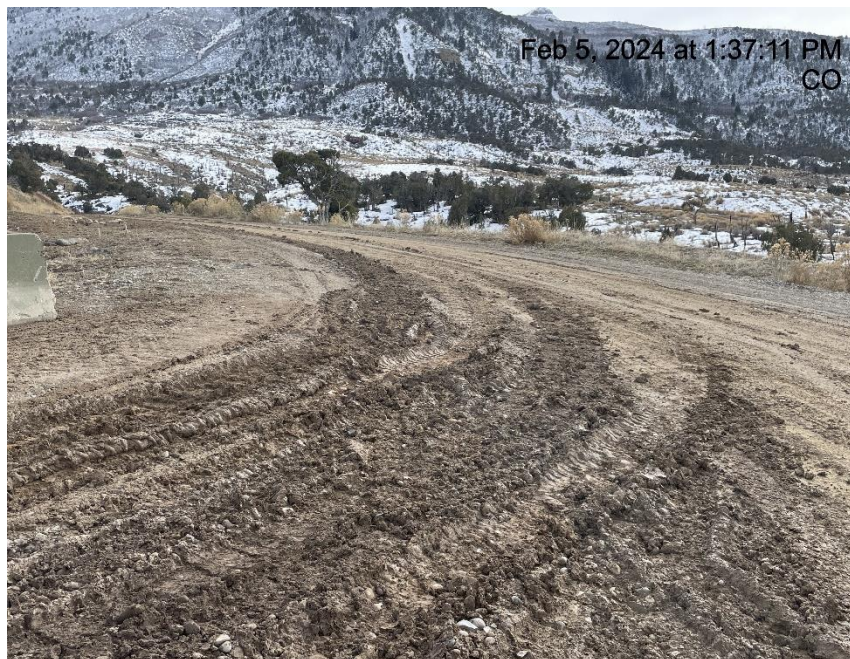
Photo # 5741 Insufficient tracking BMP's at entrance to location/tracking onto lease road

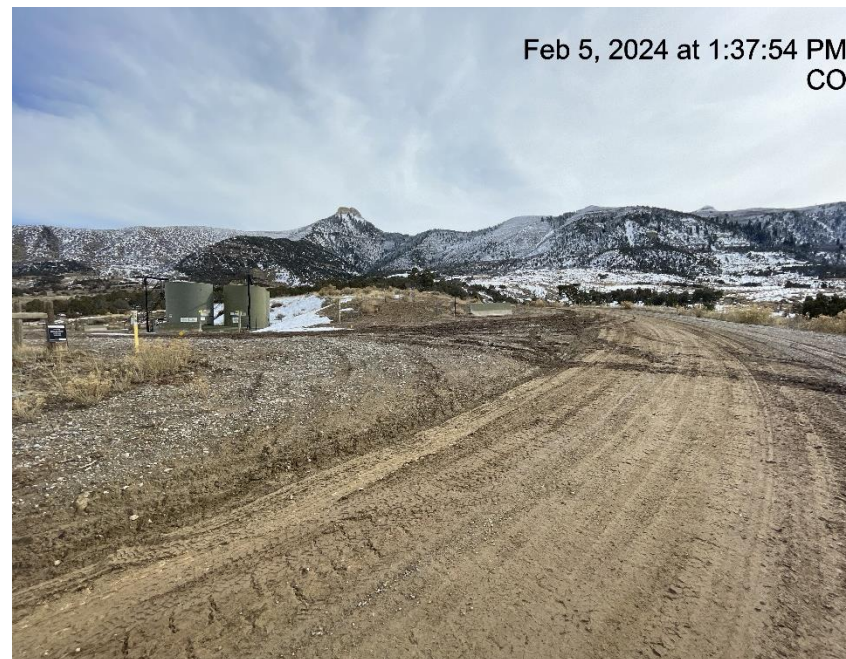
Photo # 5742 Insufficient tracking BMP's at entrance to location/tracking onto lease road

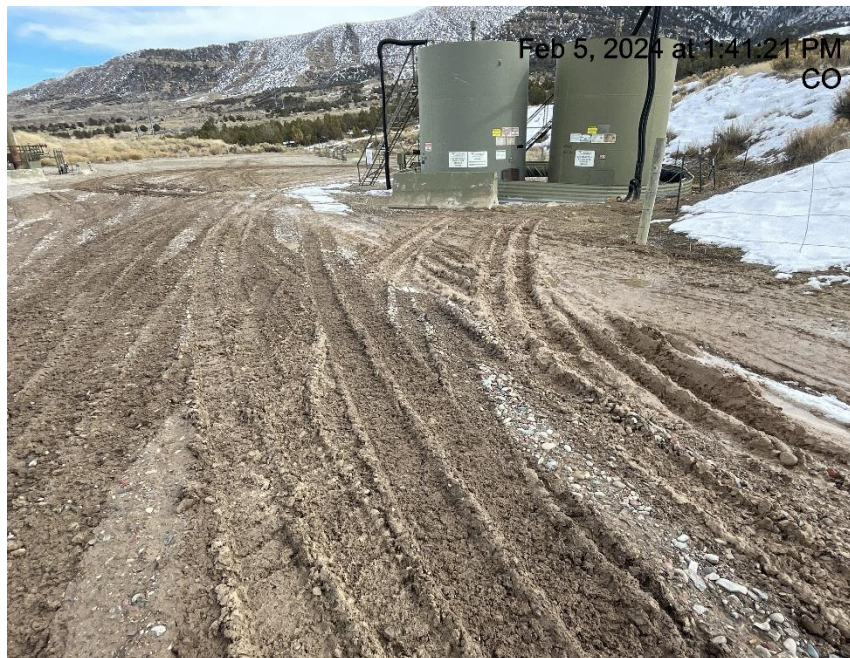
Photo # 5743 Lack of stabilization/compaction/insufficient tracking BMP's

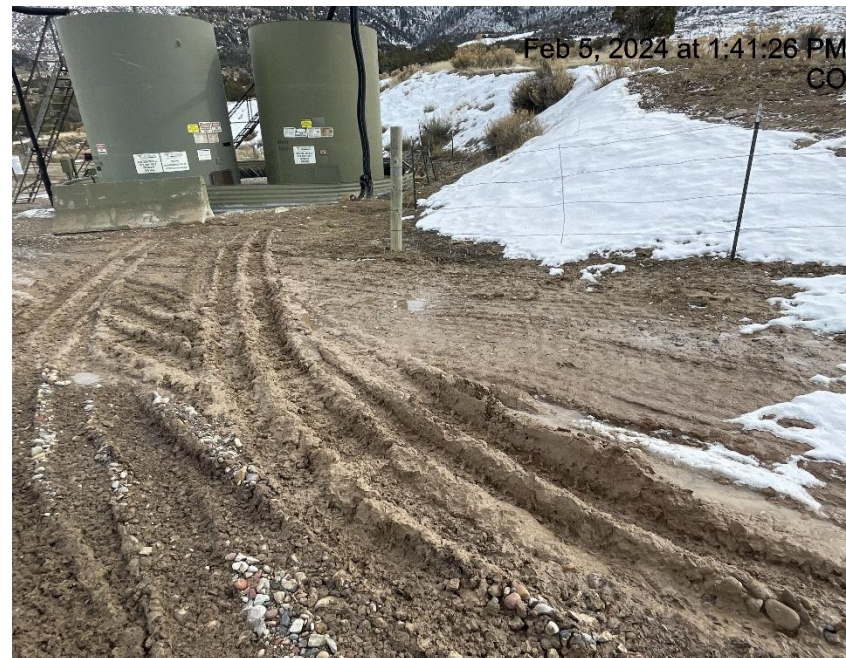
Photo # 5744 Lack of stabilization/compaction/insufficient tracking BMP's

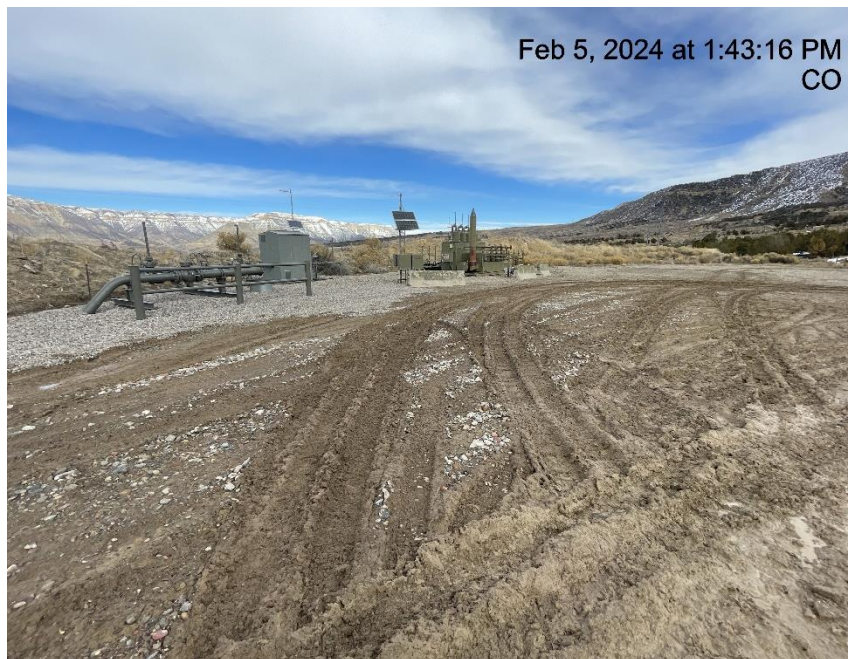
Photo # 5745 Lack of stabilization/compaction/insufficient tracking BMP's

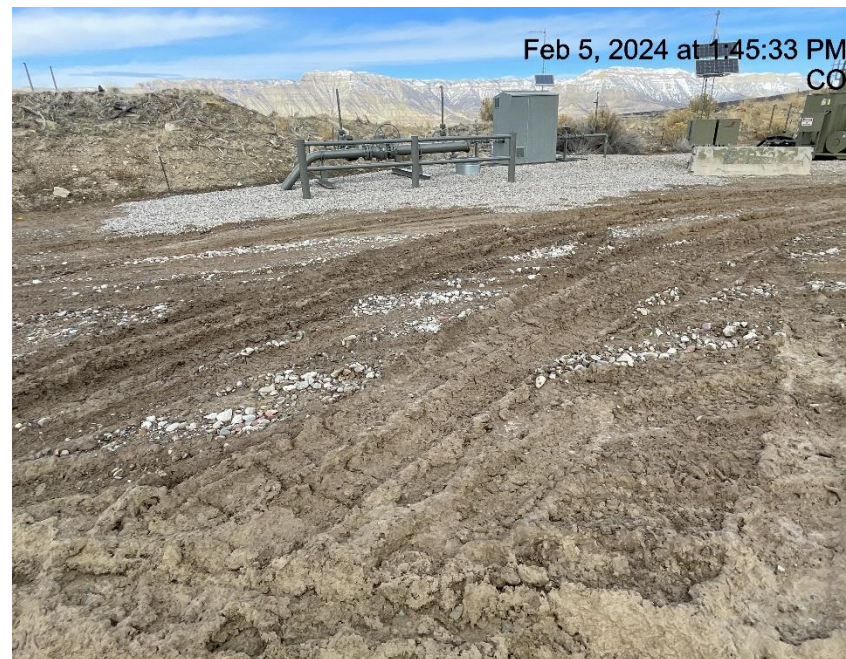
Photo # 5746 Lack of stabilization/compaction/insufficient tracking BMP's

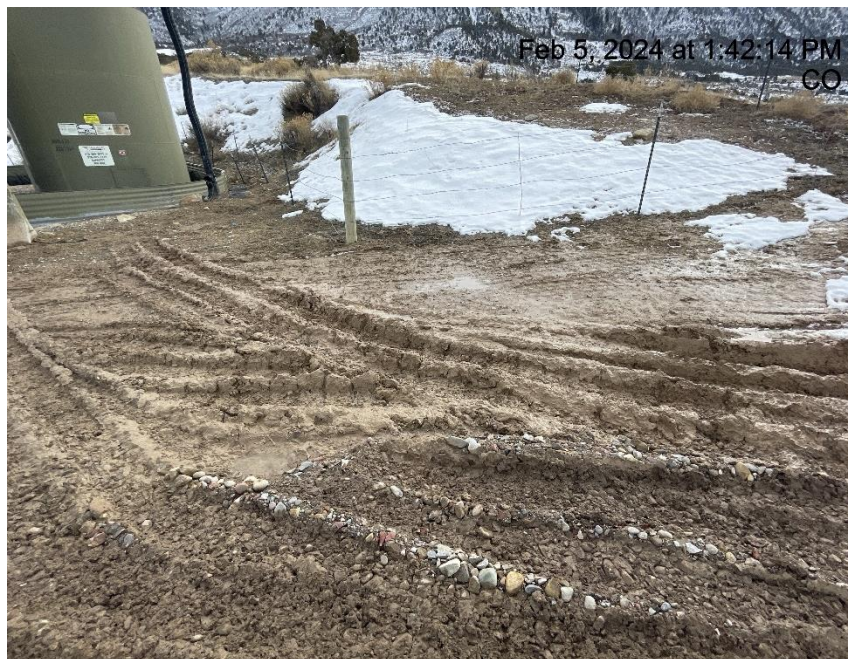
Photo # 5747 Lack of stabilization/compaction/insufficient tracking BMP's

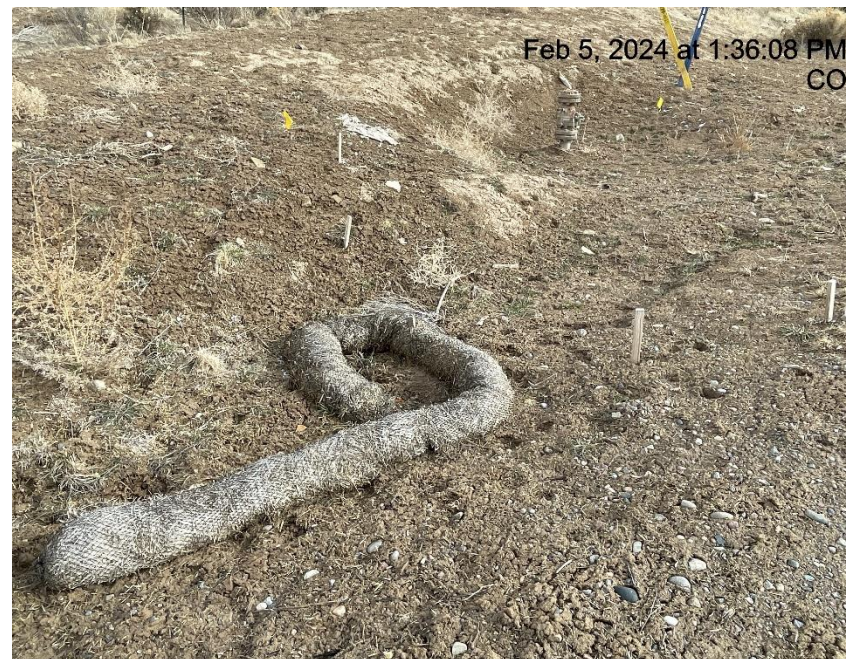
Photo # 5748 Wattle needs maintenance (on lease road near entrance to location)

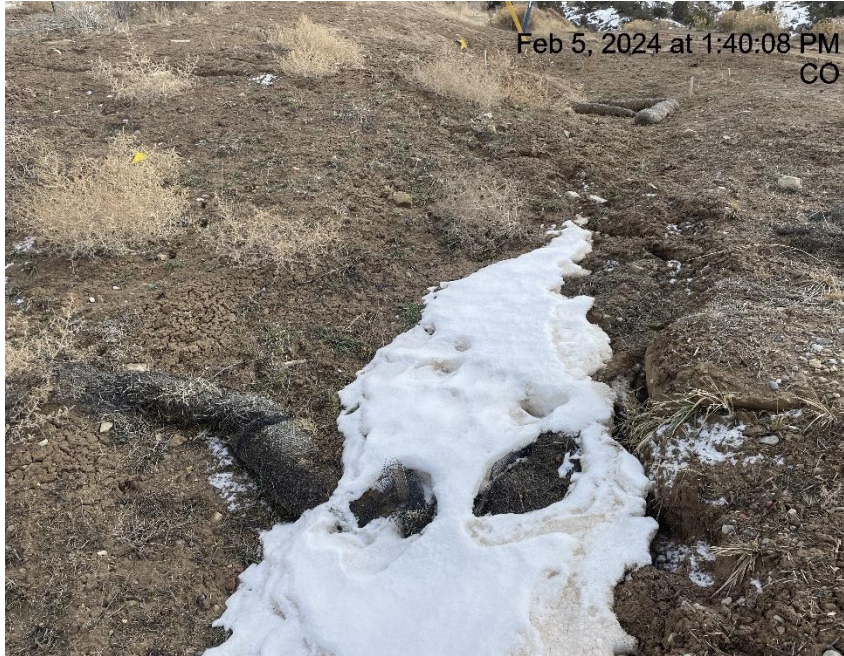
Photo # 5749 Wattle needs maintenance (on lease road near entrance to location)

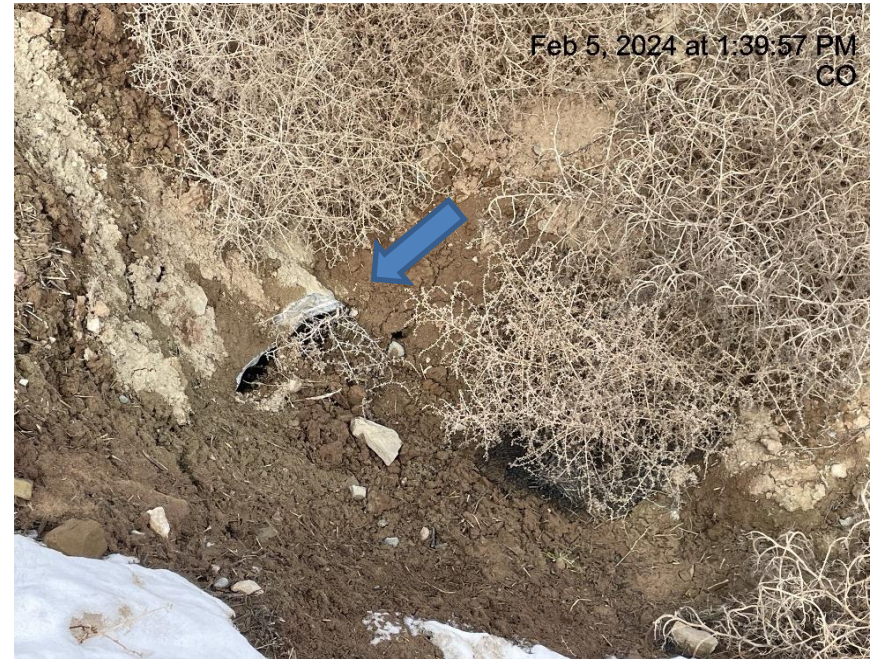
Photo # 5750 Culvert needs maintenance (near entrance to location)

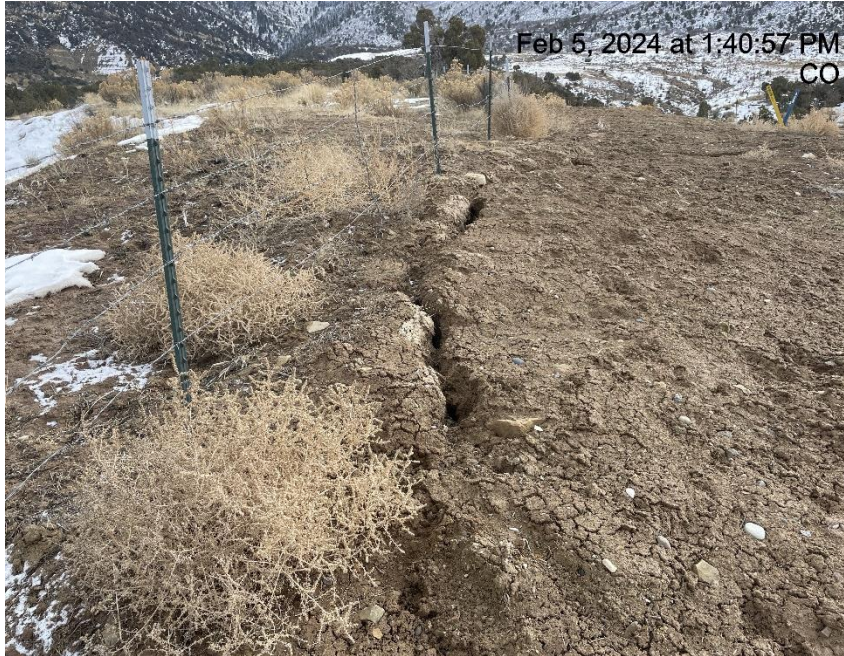
Photo # 5751 Soil starting to slough near fencing
