Inspection Photos Location: Tanner "E" 1 Facility ID: 321098 API #: 05-009-06450

Facility Type	Facility ID	Facility Name	Operator Name	Status	Field Name	Location	Location ID
WELL	05-009-06450	TANNER REC UNIT (E) 1	INVESTMENT EQUIPMENT LLC	11/11/2019	WELL	NE 1/4 10S40N	321098

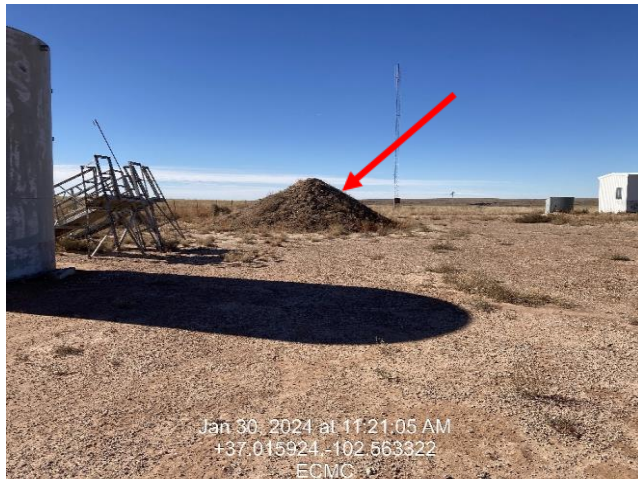
Photo 3 – Spoil Pile on south end of location

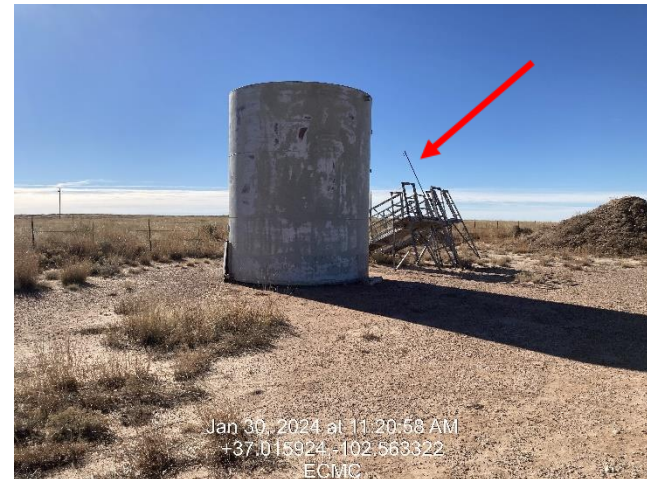
Photo 4 – Unused Equipment

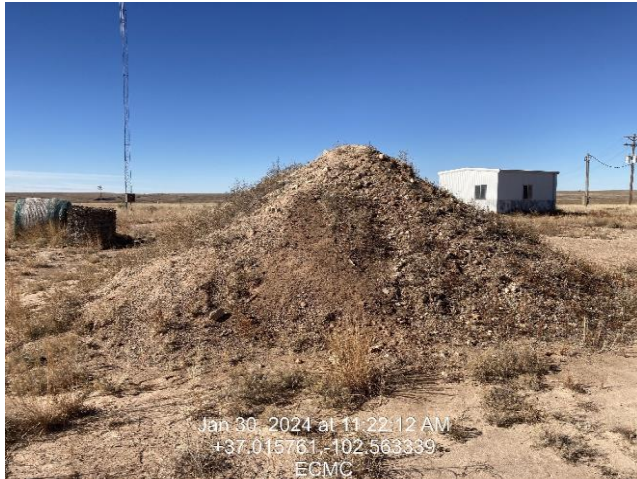
Photo 5 – Spoil Pile on south end of location

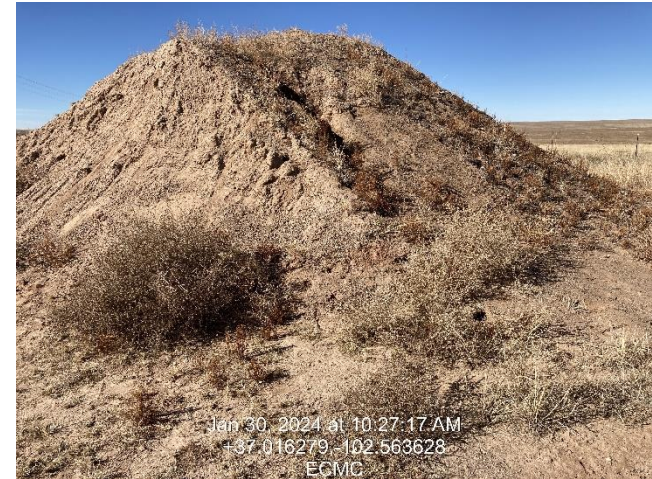
Photo 6 – Spoil Pile on location

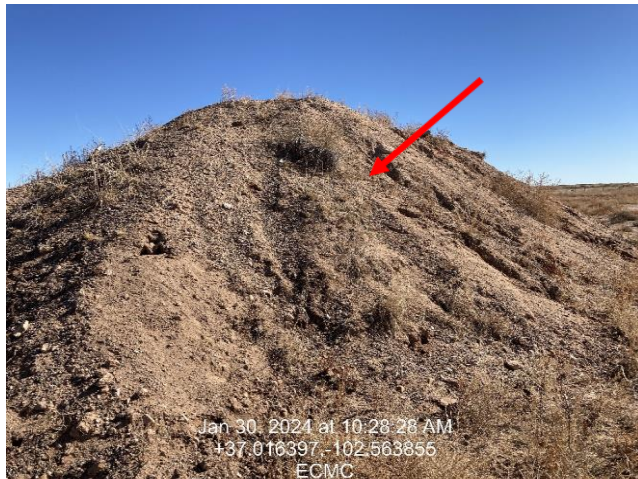
Photo 7 – Spoil Pile

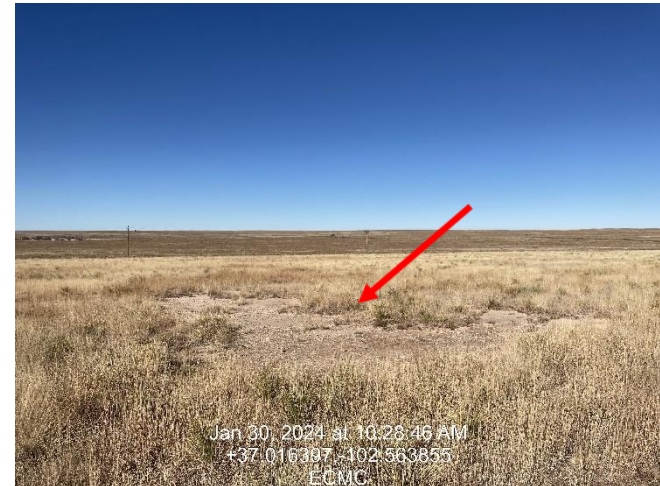
Photo 8 – Historical Impacts observed beyond fence line on north side of location

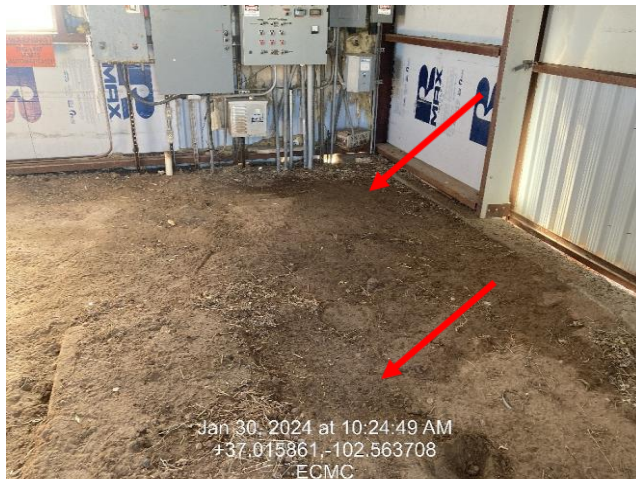
Photo 9 – Inside Building, Impacted soils observed

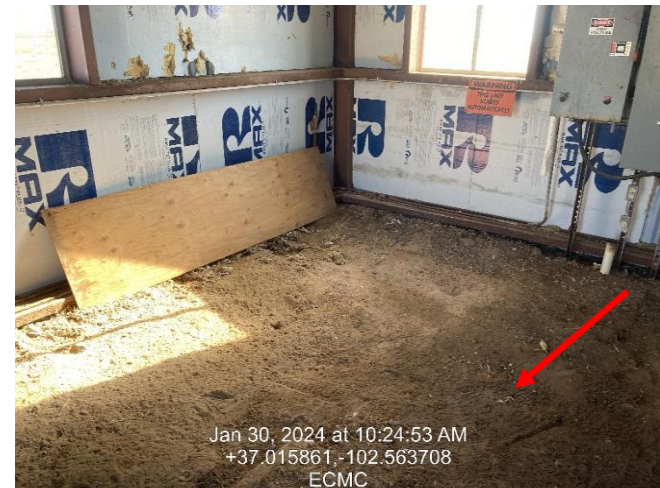
Photo 10 – Inside Building, Impacted soils observed

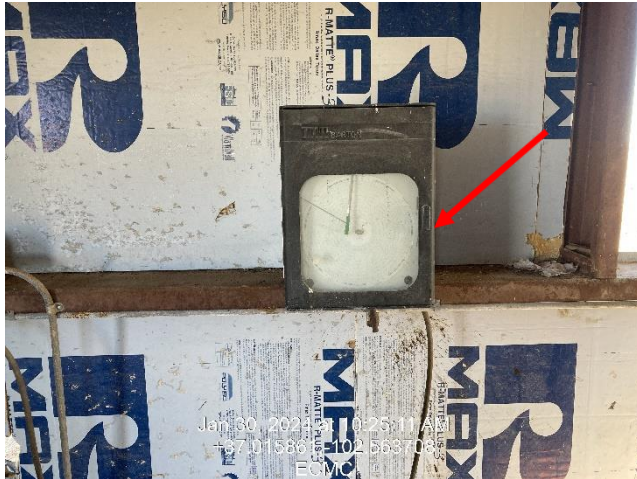
Photo 11 – Equipment in Skid Building

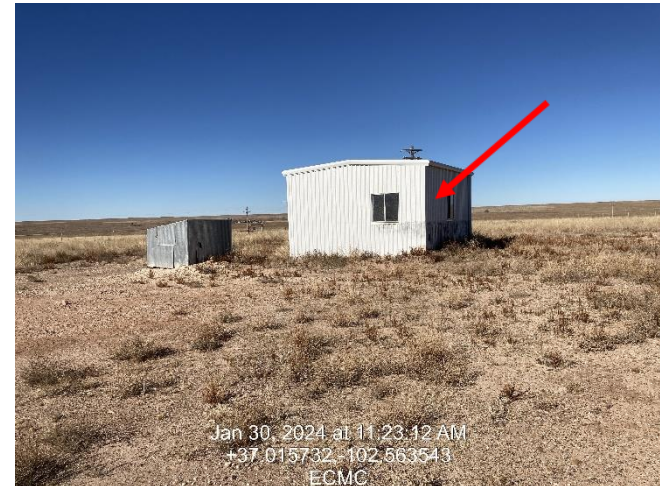
Photo 12 – Historical Building/Unused Equipment

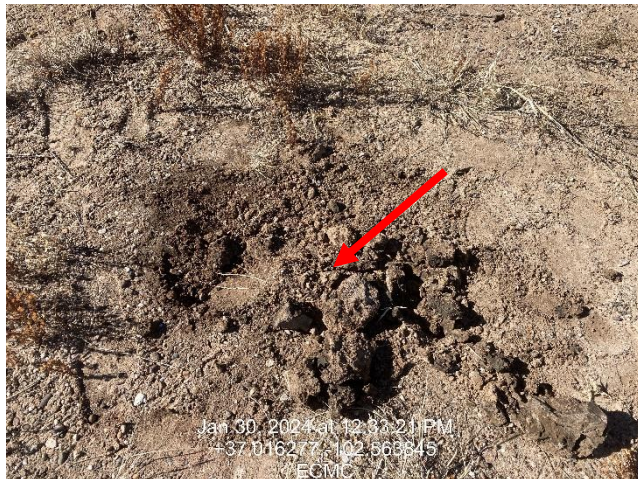
Photo 13 – Impacted soils on the North end of location

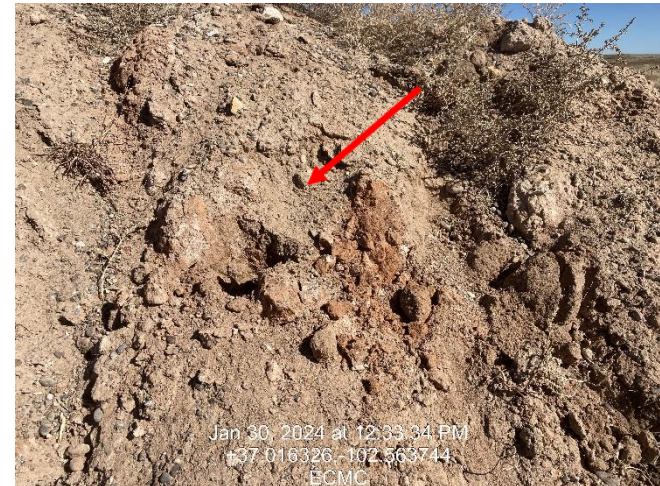
Photo 14 – Spoil Pile with impacted soils

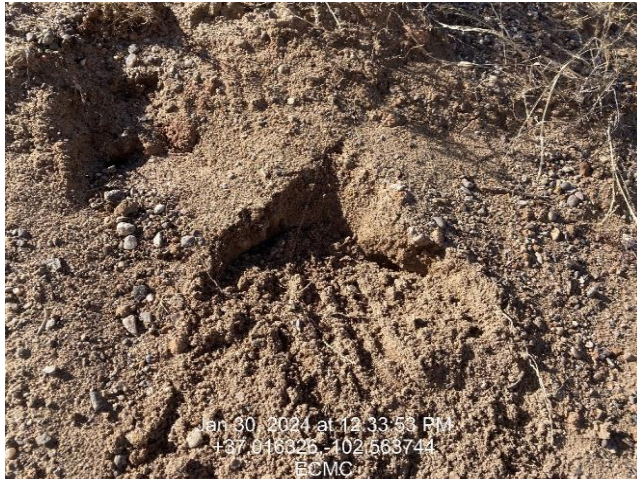
Photo 15 – Spoil Pile with impacted soils

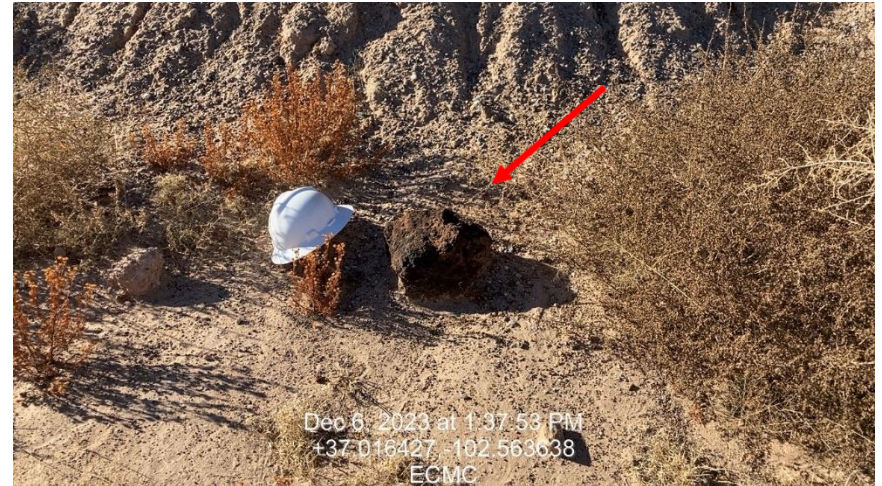
**Photo 16 – Impacted material next to mound of soil,
During the time of inspection on 1/30/2024 it was
noted the impacted material was no longer present**
