Inspection Photos

Location Name: CAERUS PICEANCE LLC, UNOCAL-66S96W/16LOT 13

Location ID: 335206

Date: 2/5/2024

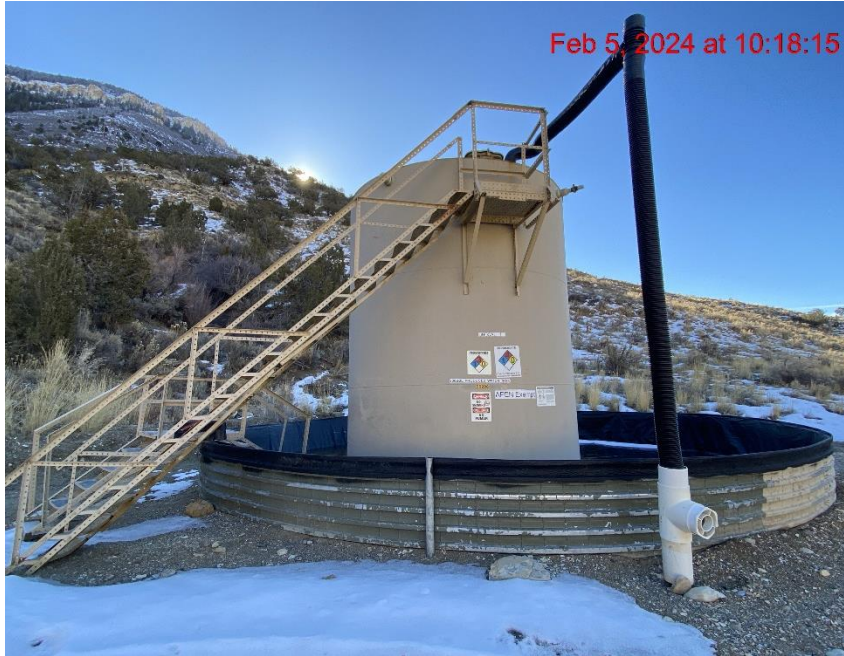
Tank Battery/No Battery Sign – Photo #09094

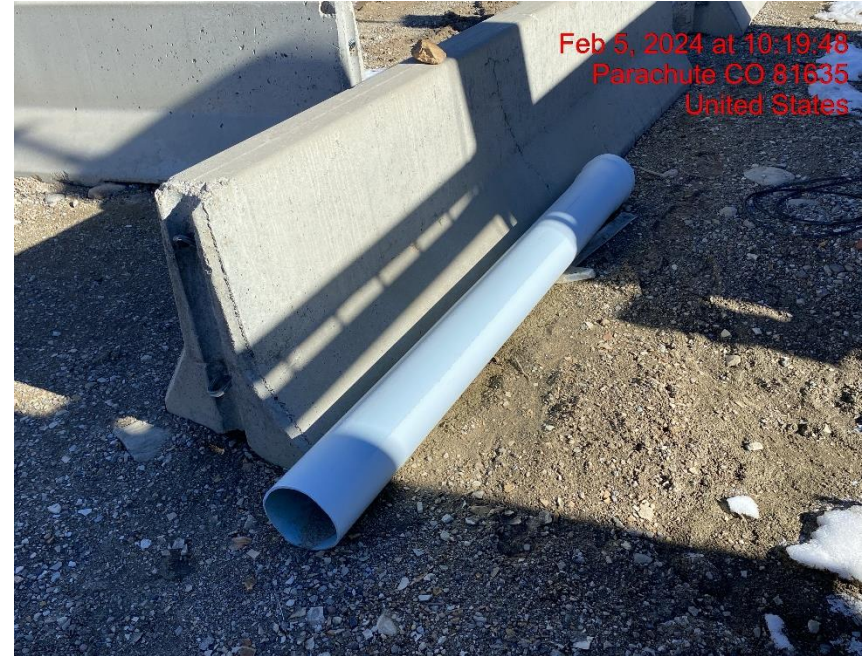
Debris Near Separators – Photo #09099

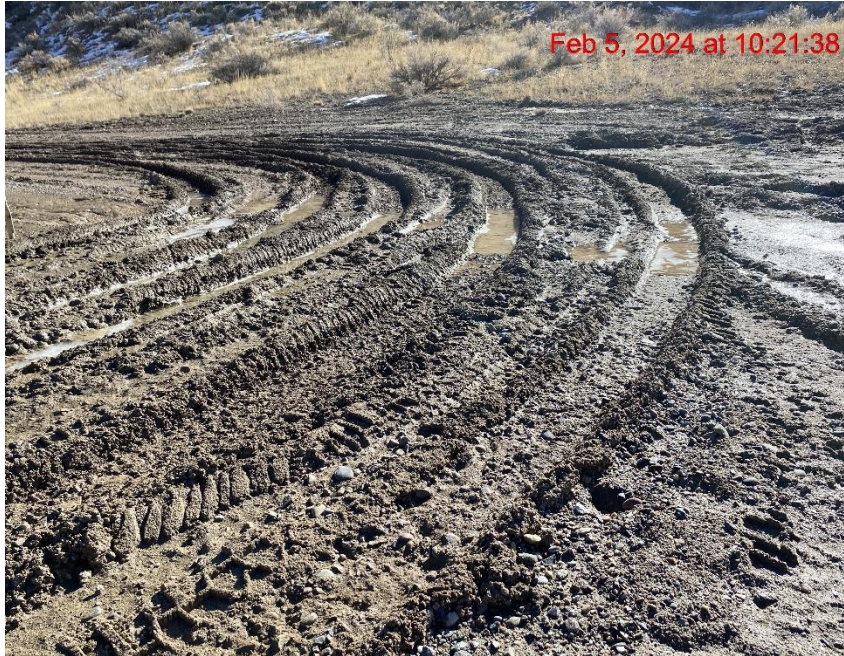
Lack of Stabilization – Photo #09102

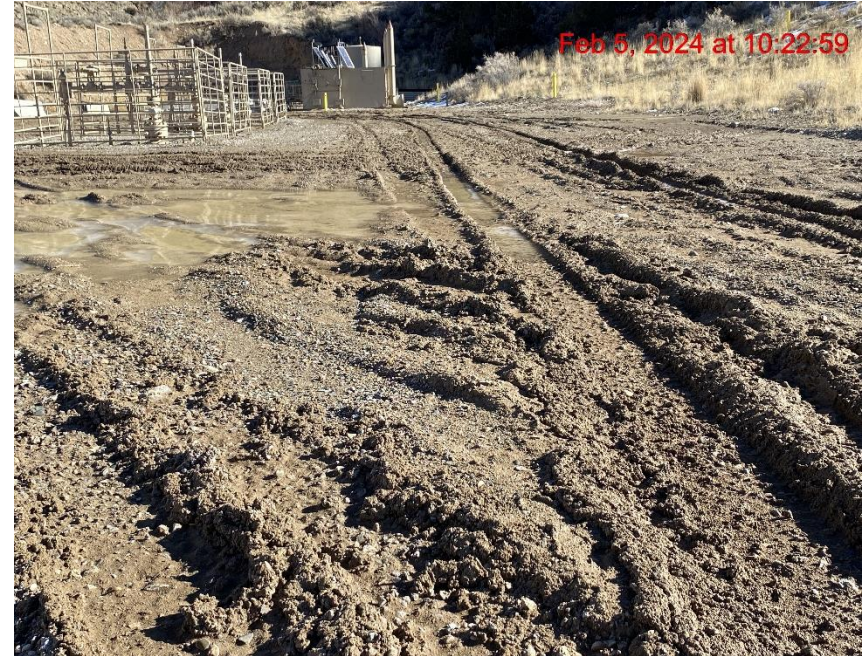
Lack of Stabilization – Photo #09104

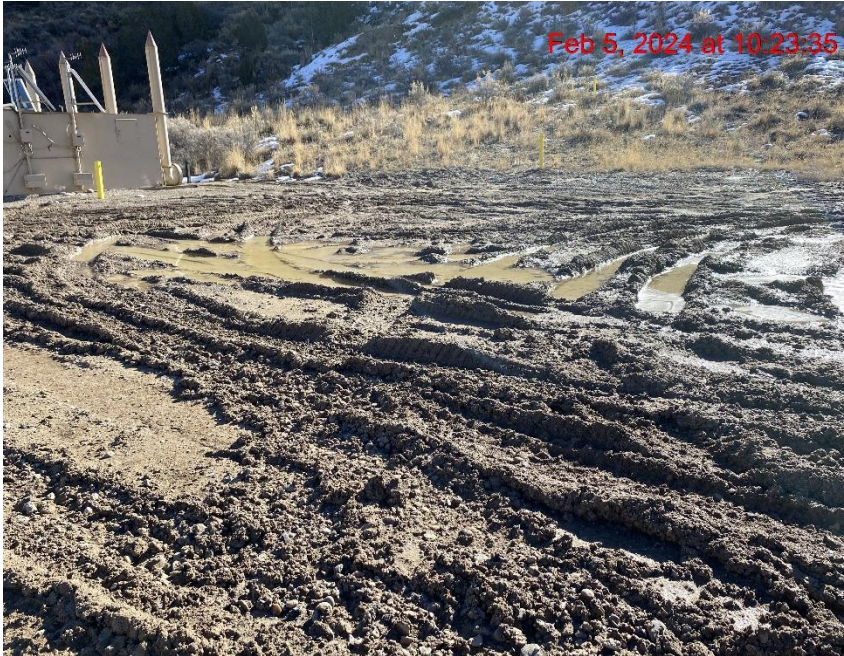
Lack of Stabilization – Photo #09105

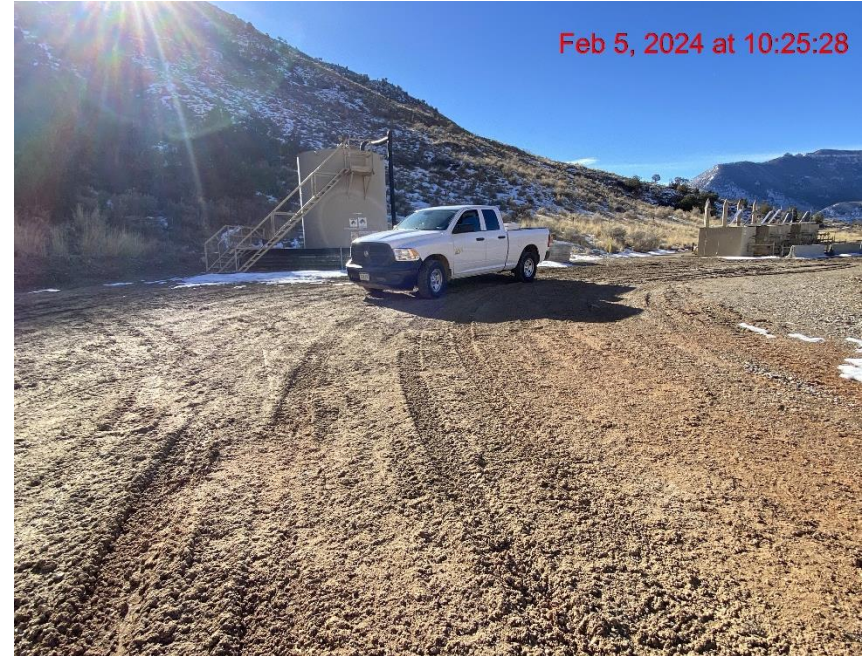
**Insufficient Vehicle Tracking BMPs at Location Entrance/Exit
– Photo #09106**
