Inspection Photos

Location Name: CAERUS PICEANCE LLC, UNCOAL-ENCANA-66S96W/17NESE

Location ID: 335684

Date: 2/5/2024

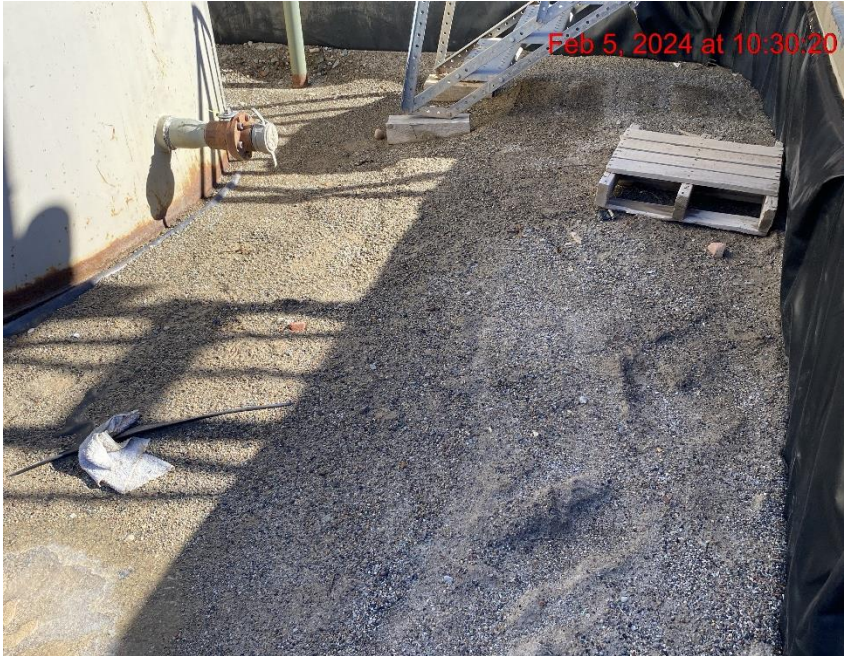
Debris – Photo #09112

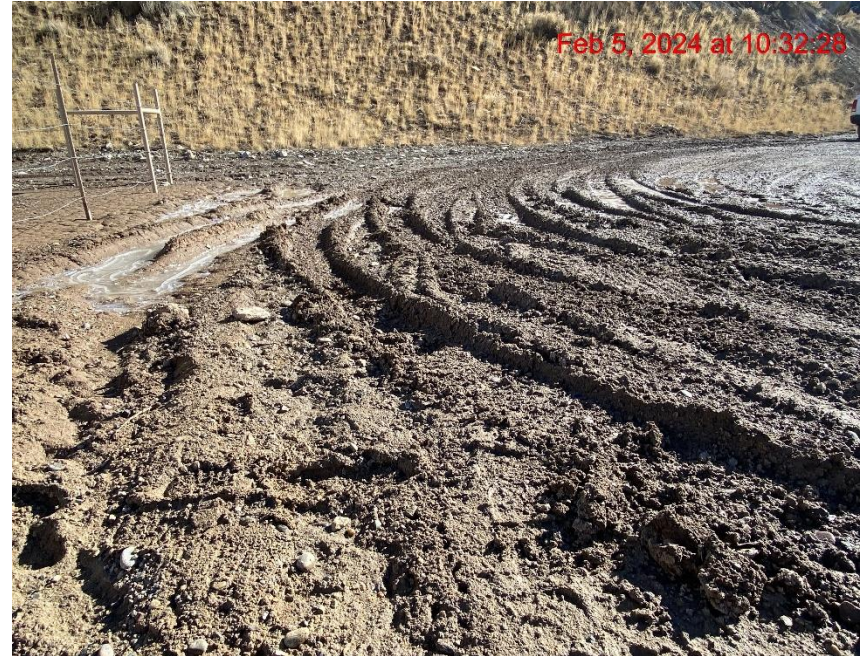
Lack of Stabilization – Photo #09117

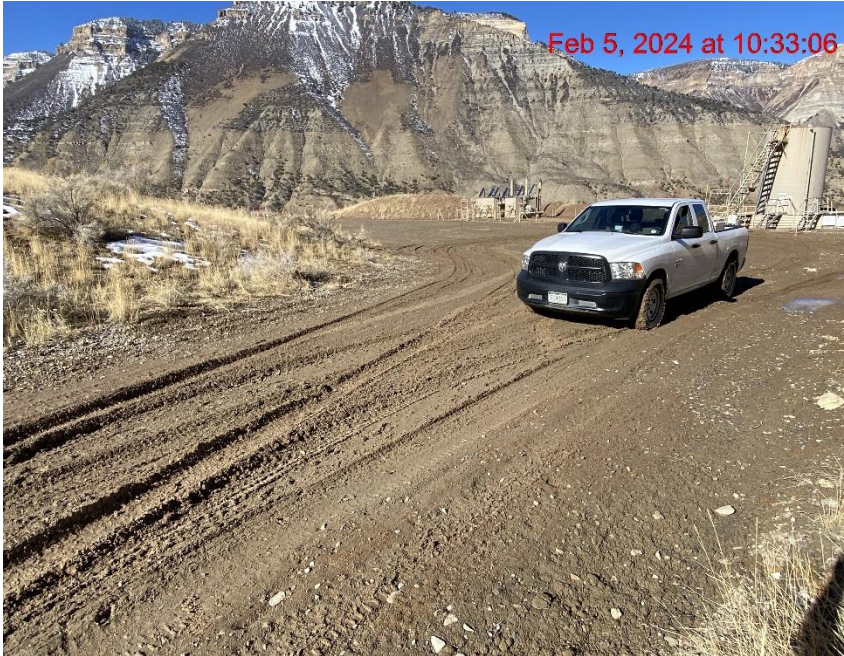
**Insufficient Vehicle Tracking BMPs at Location Entrance/Exit
– Photo #09118**

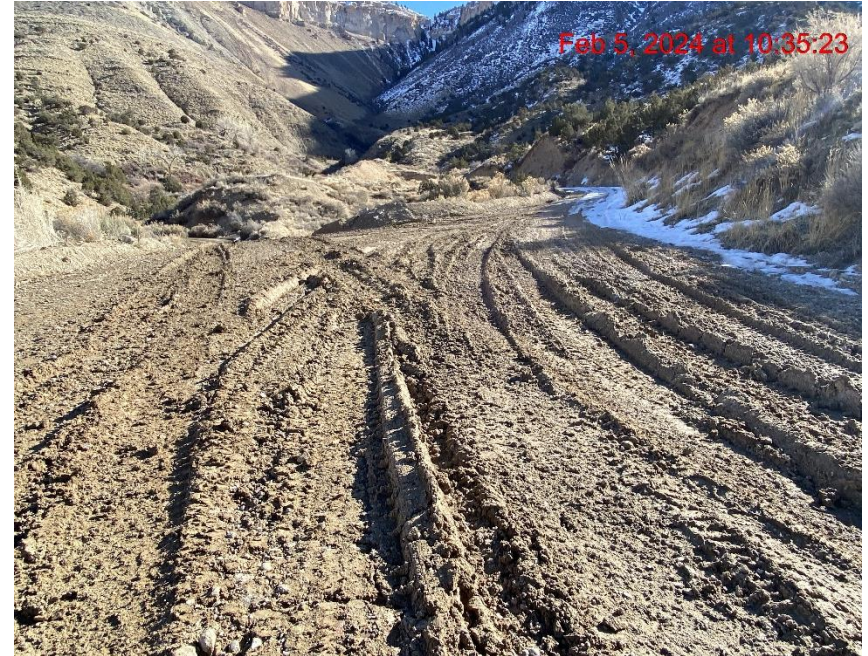
Lease Road Lacks Stabilization – Photo #09119
