Storm Water Management and Erosion control
Location Name: CAERUS PICEANCE LLC SHIDELER 19-8 (H19) Pad
Location ID: 334886

**Location Overview: Location is within High
Priority/Density/Black Bear Habitat areas. Drainage
contributes to Middle Mamm Creek.
Section/Township/Range: 19 7S92W**

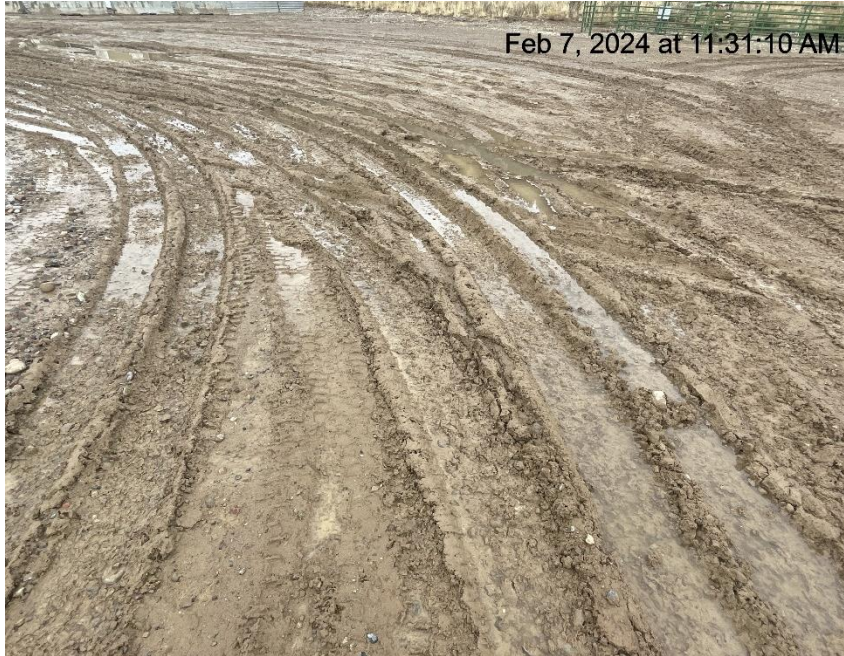
Photo # 5901 Lack of stabilization/compaction/insufficient tracking BMP's

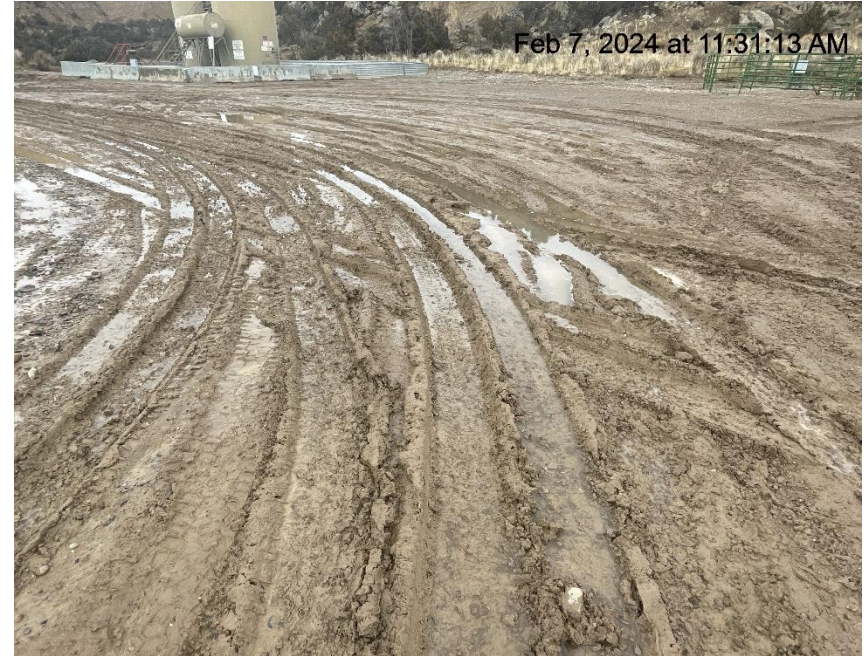
Photo # 5902 Lack of stabilization/compaction/insufficient tracking BMP's

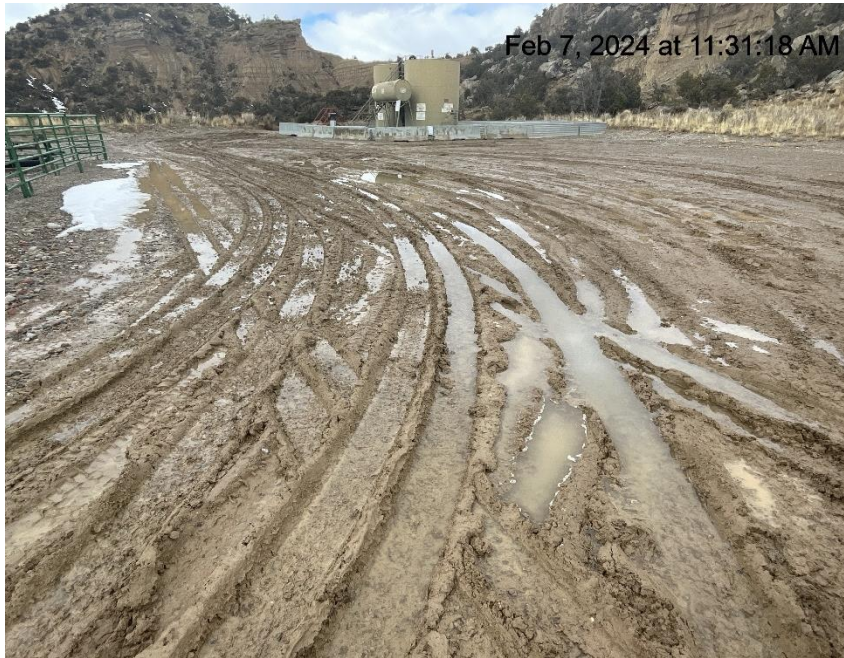
Photo # 5903 Lack of stabilization/compaction/insufficient tracking BMP's

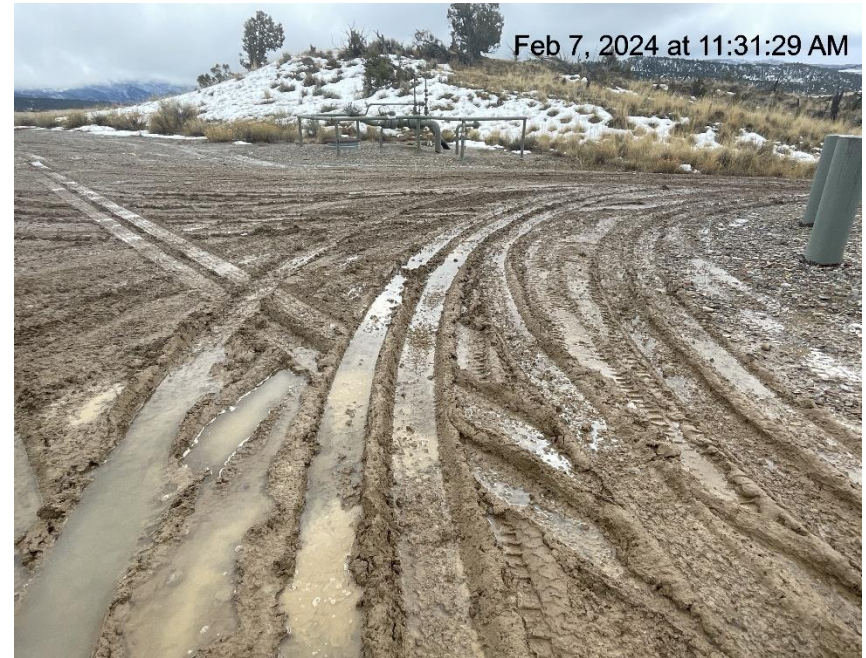
Photo # 5904 Lack of stabilization/compaction/insufficient tracking BMP's

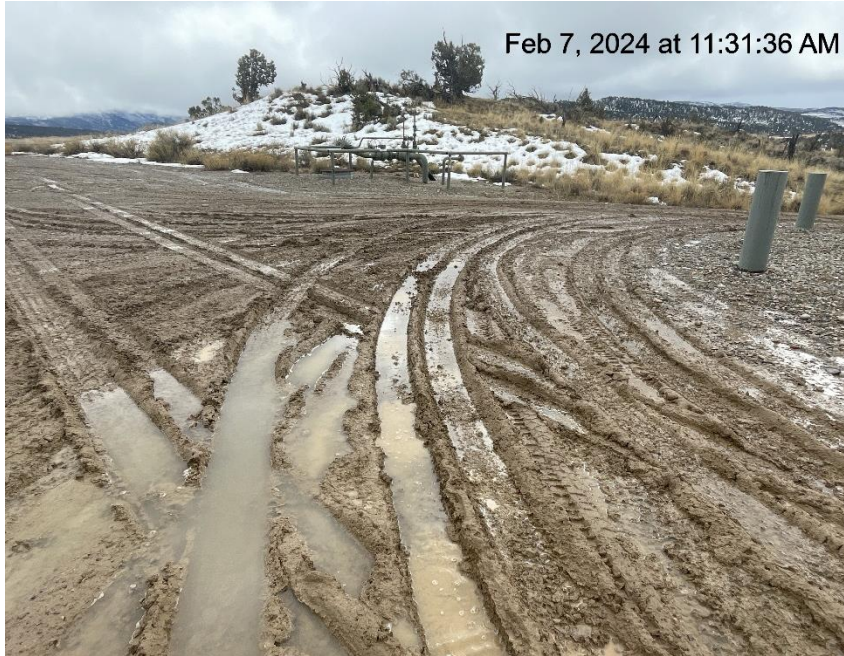
Photo # 5905 Lack of stabilization/compaction/insufficient tracking BMP's

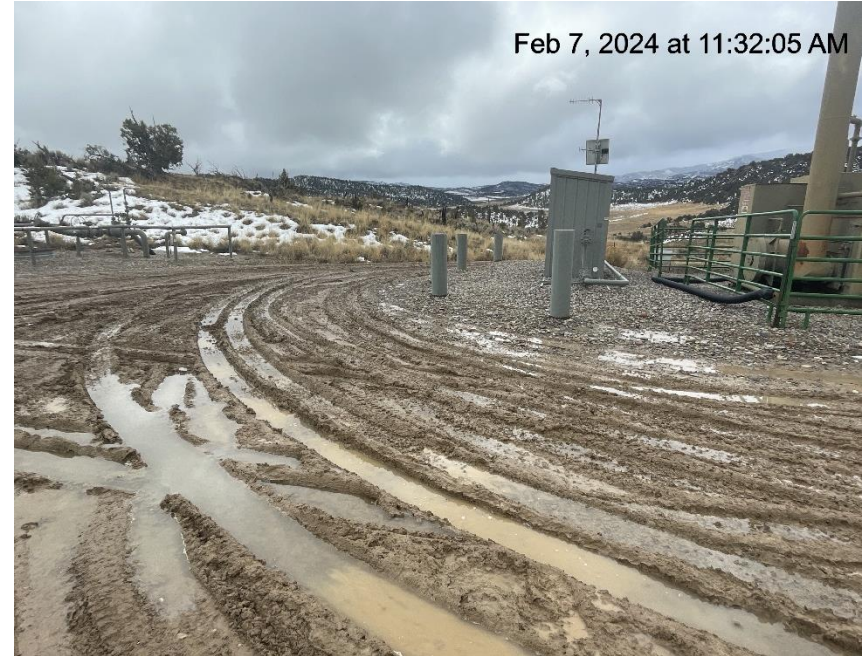
Photo # 5906 Lack of stabilization/compaction/insufficient tracking BMP's

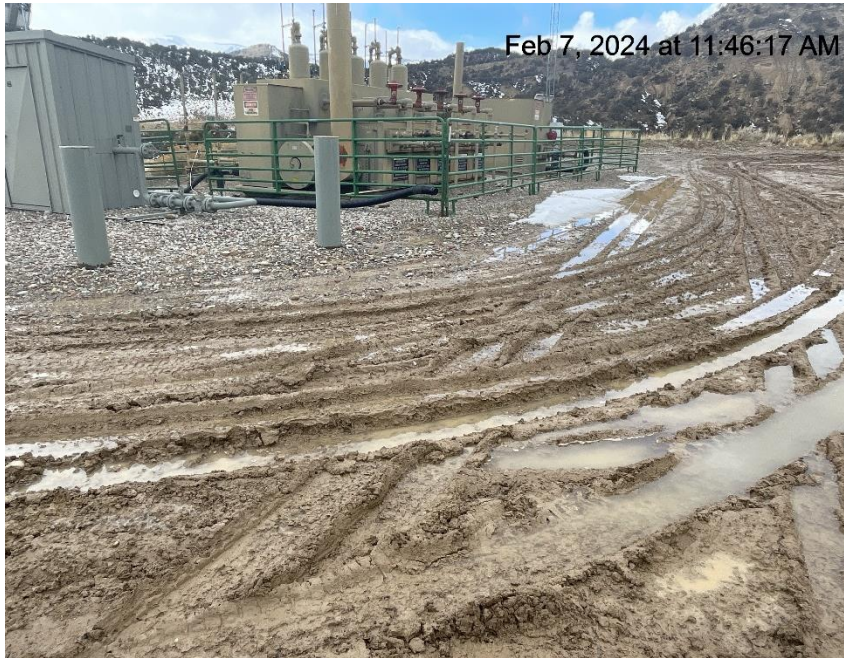
Photo # 5907 Lack of stabilization/compaction/insufficient tracking BMP's

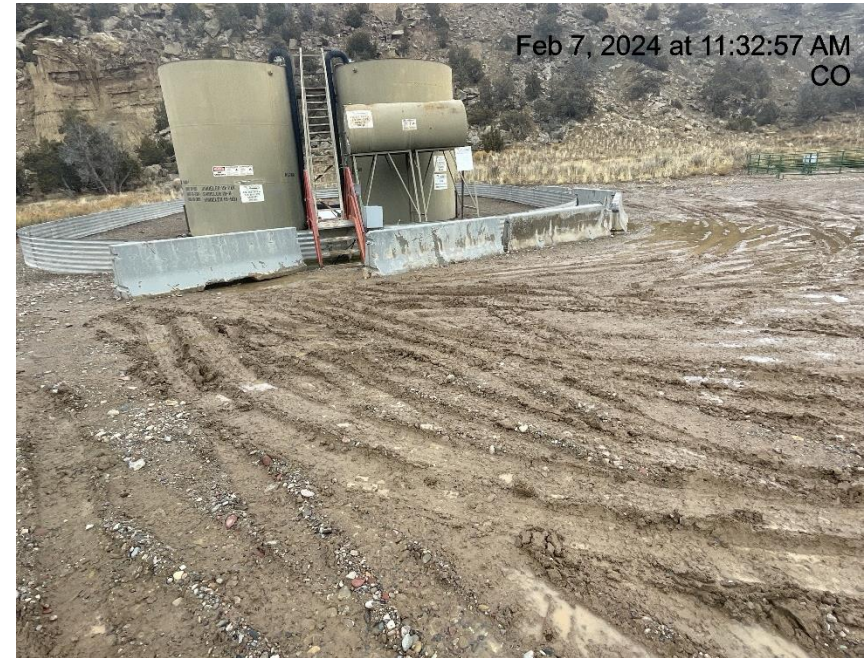
Photo # 5908 Lack of stabilization/compaction/insufficient tracking BMP's

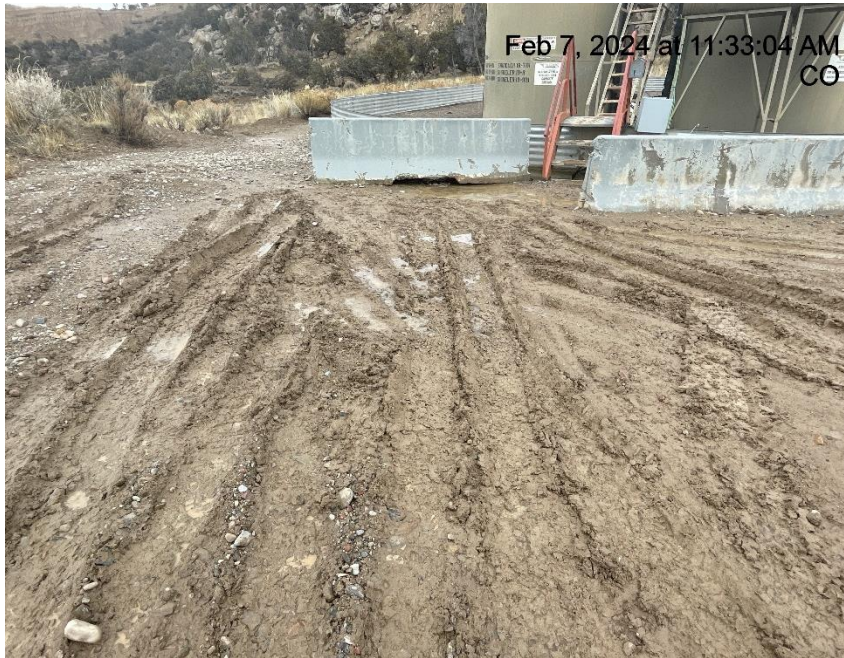
Photo # 5909 Lack of stabilization/compaction/insufficient tracking BMP's

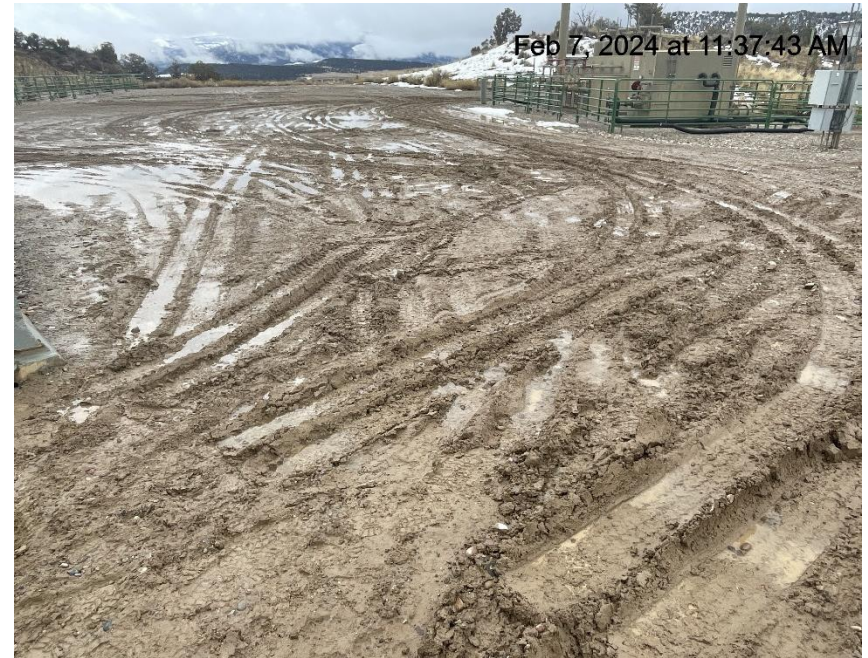
Photo # 5910 Lack of stabilization/compaction/insufficient tracking BMP's
