# Inspection Photos

Loc: 321575

Operator: MULL DRILLING COMPANY INC

Inspection Date: 2/7/2024

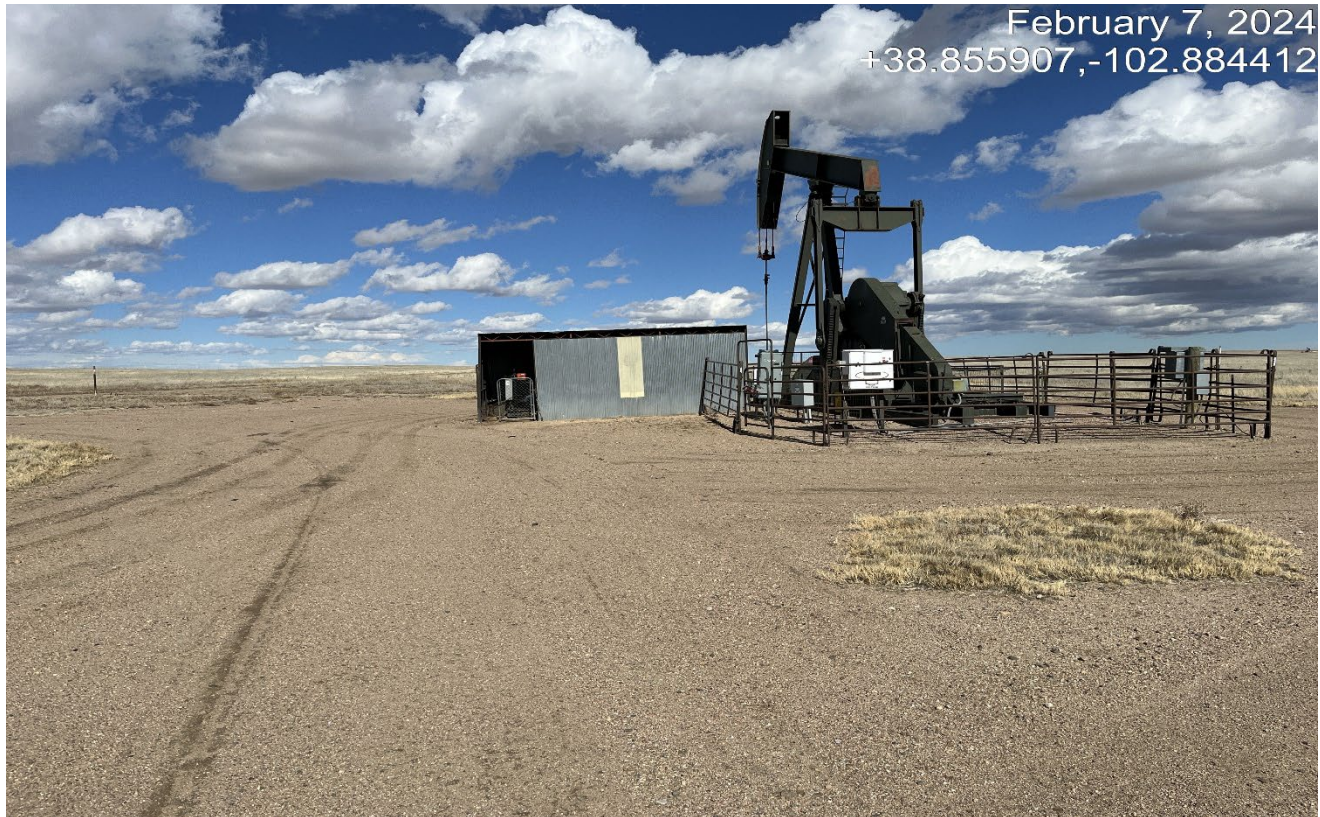
**Photo 1.** Facing north toward wellsite location.

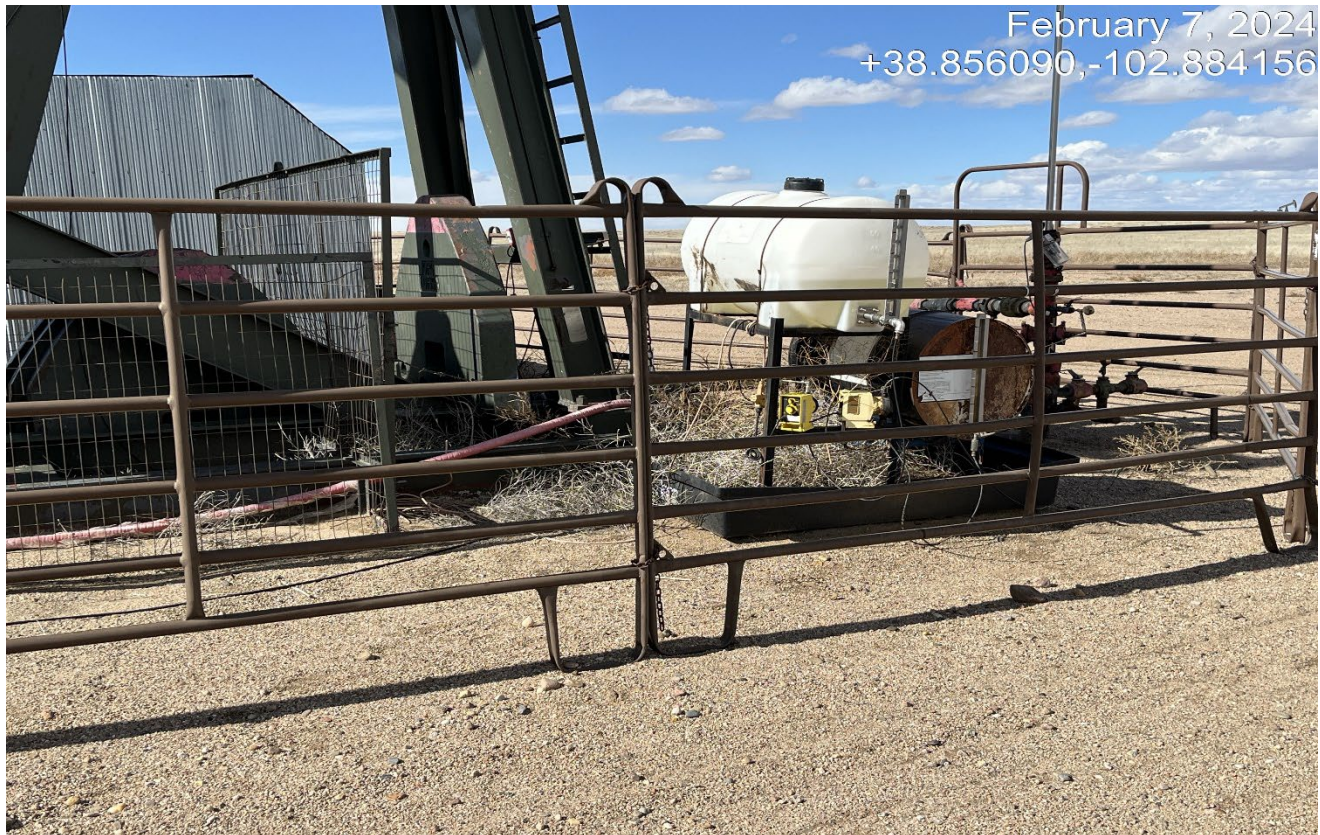
**Photo 2.** There is weed debris around the equipment that needs to be removed.

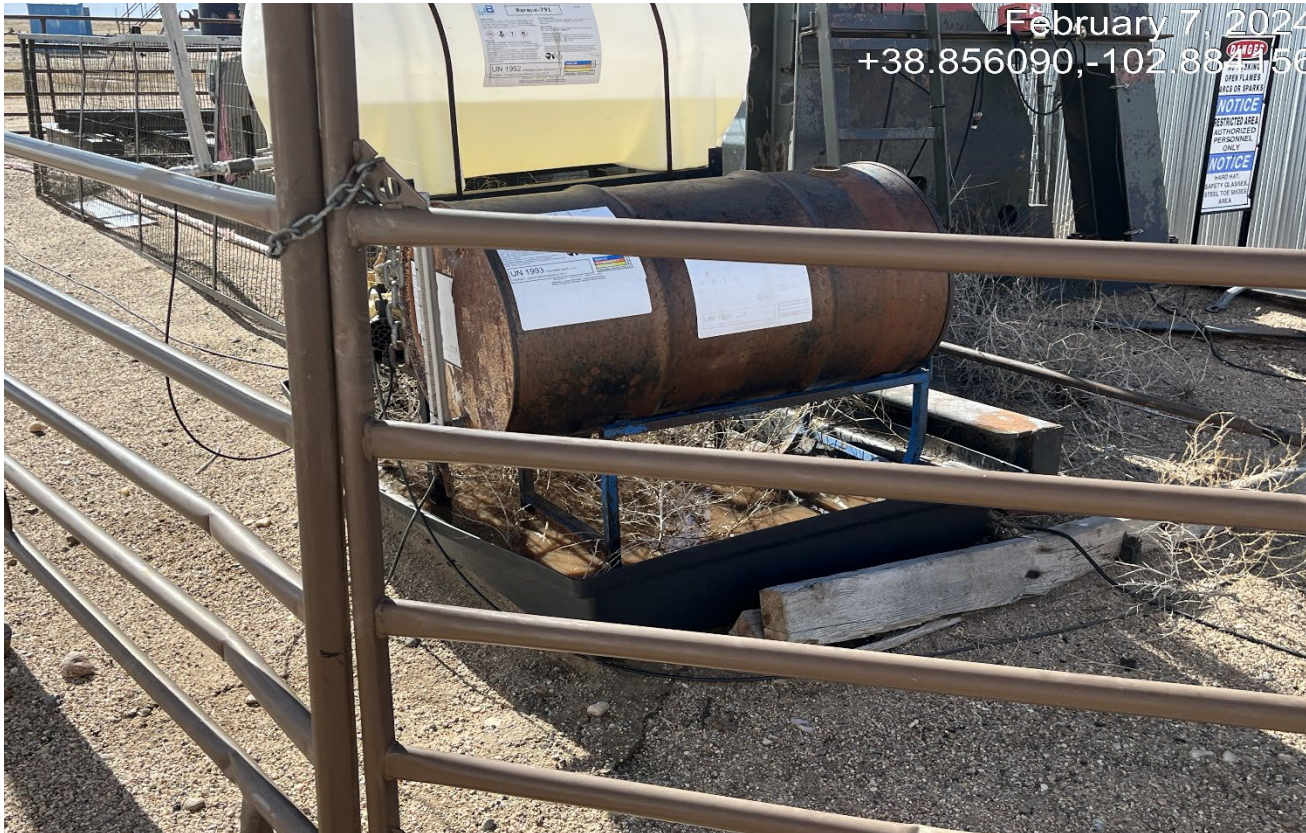
**Photo 3.** There is oily fluids inside the secondary containment of the barrels.

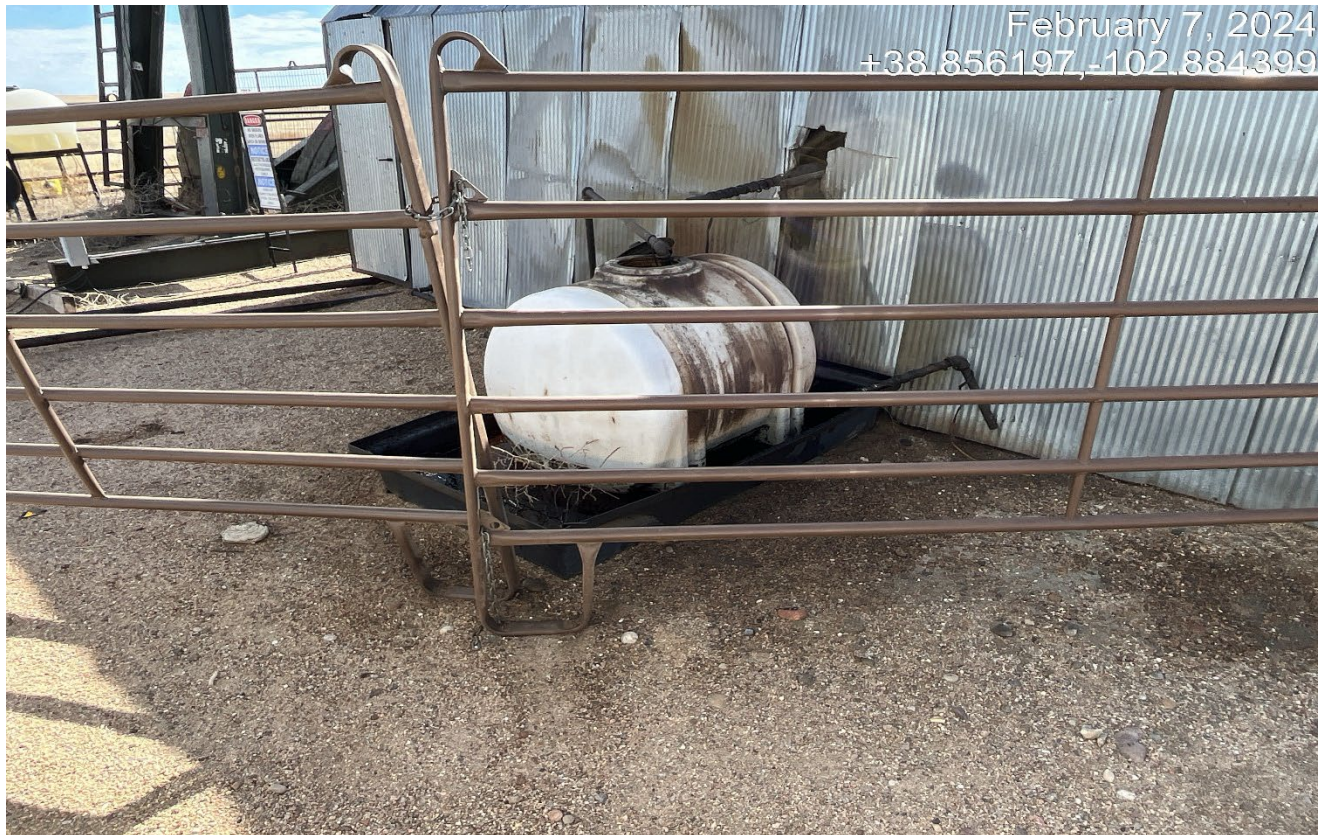
**Photo 4.** There is oily fluids inside the secondary containment of this white tank. There is oil staining on the ground and the lid is not secured.
