Inspection Photos

Loc: 321574

Operator: MULL DRILLING COMPANY INC

Inspection Date: 2/7/2024

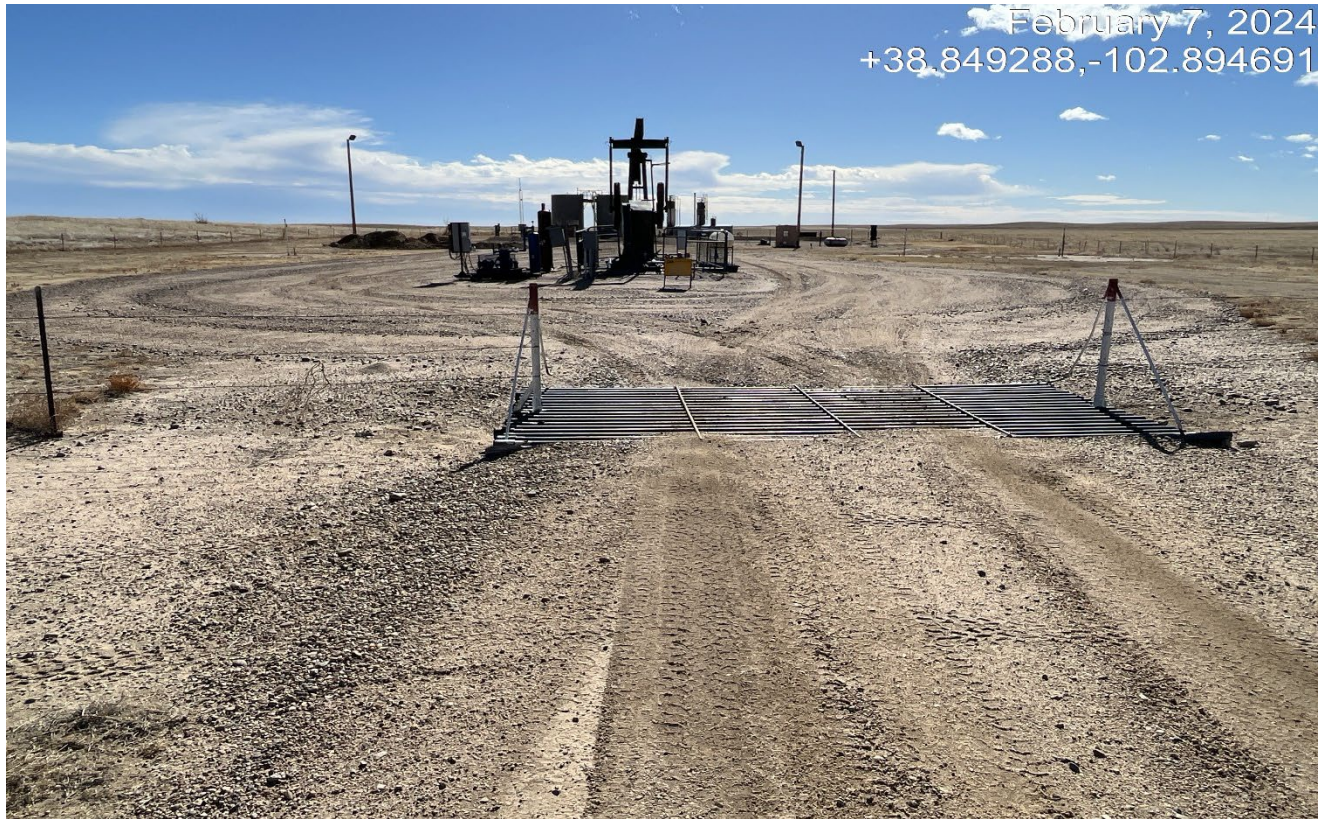
Photo 1. Facing south toward wellsite location.

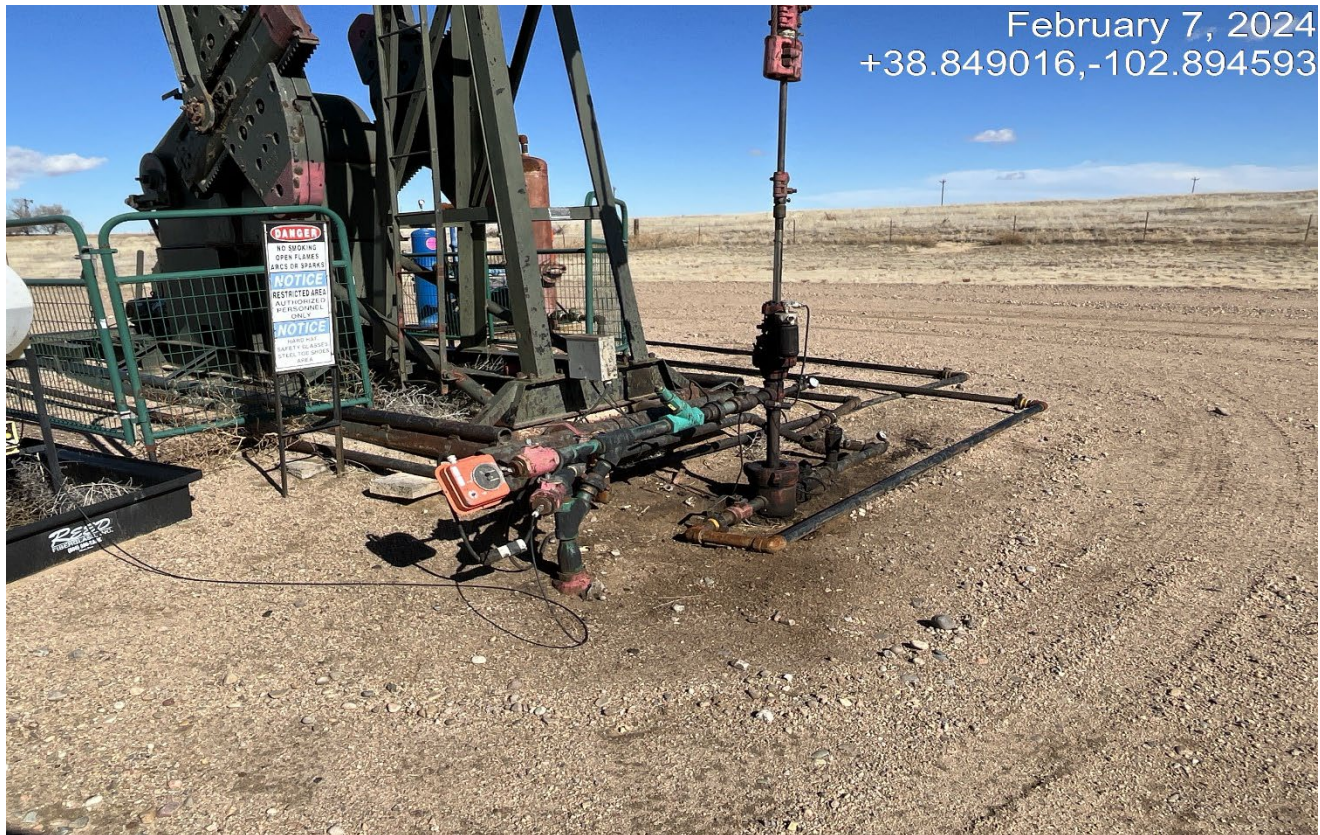
Photo 2. Facing toward the wellhead. There are stained soils at wellhead that should be cleaned up.

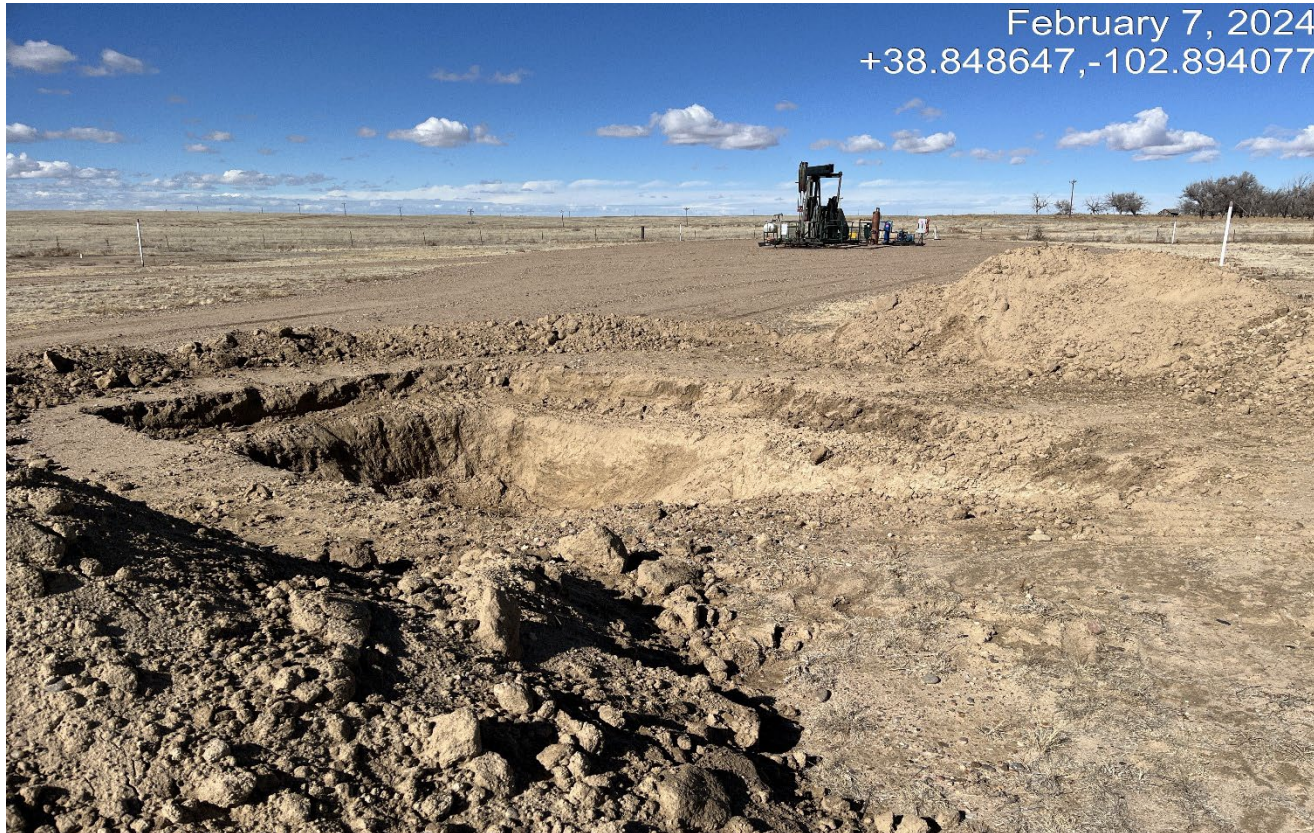
Photo 3. Facing northwest. There is an open excavation along the pipeline. This area should be marked with cones or safety fence to prevent accidental entry. .

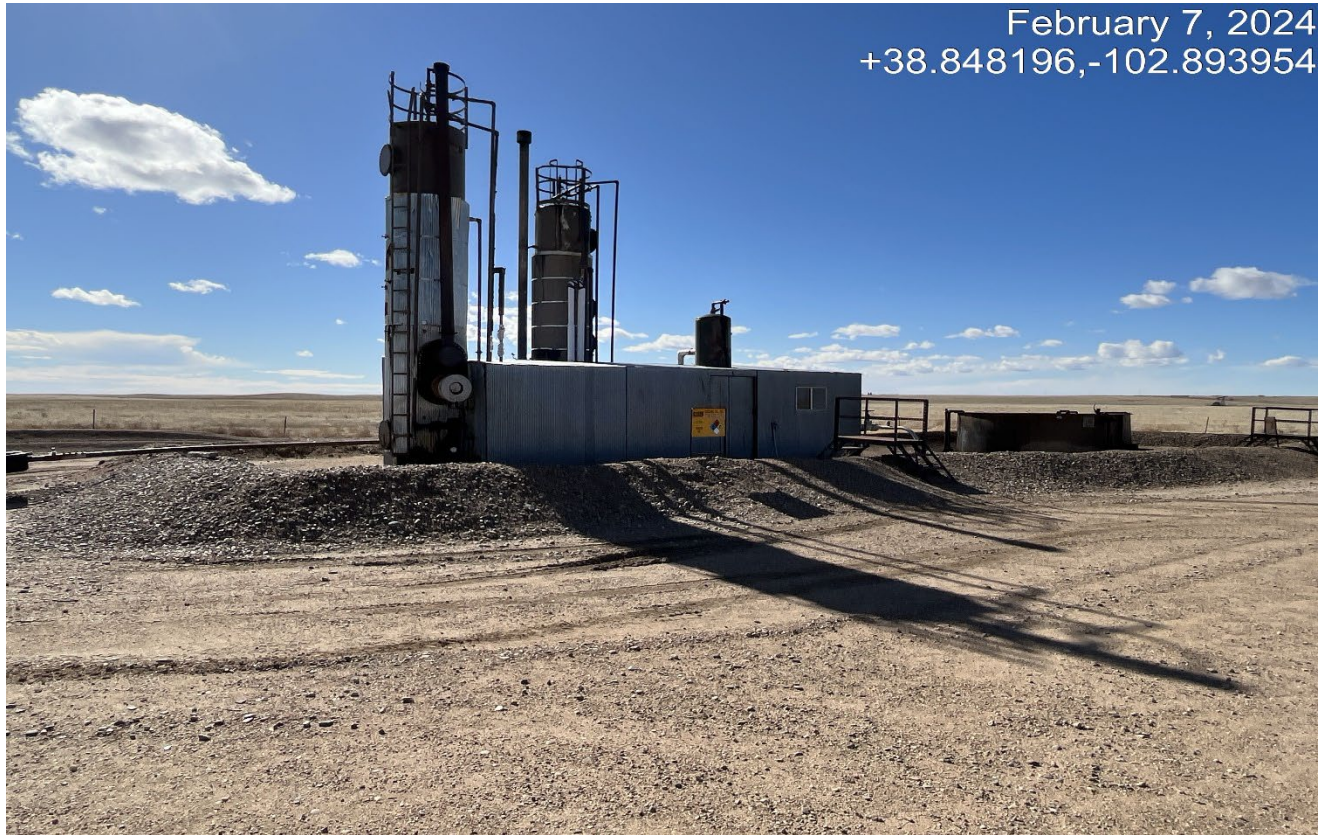
Photo 4. Facing toward the equipment at the south side of the location..

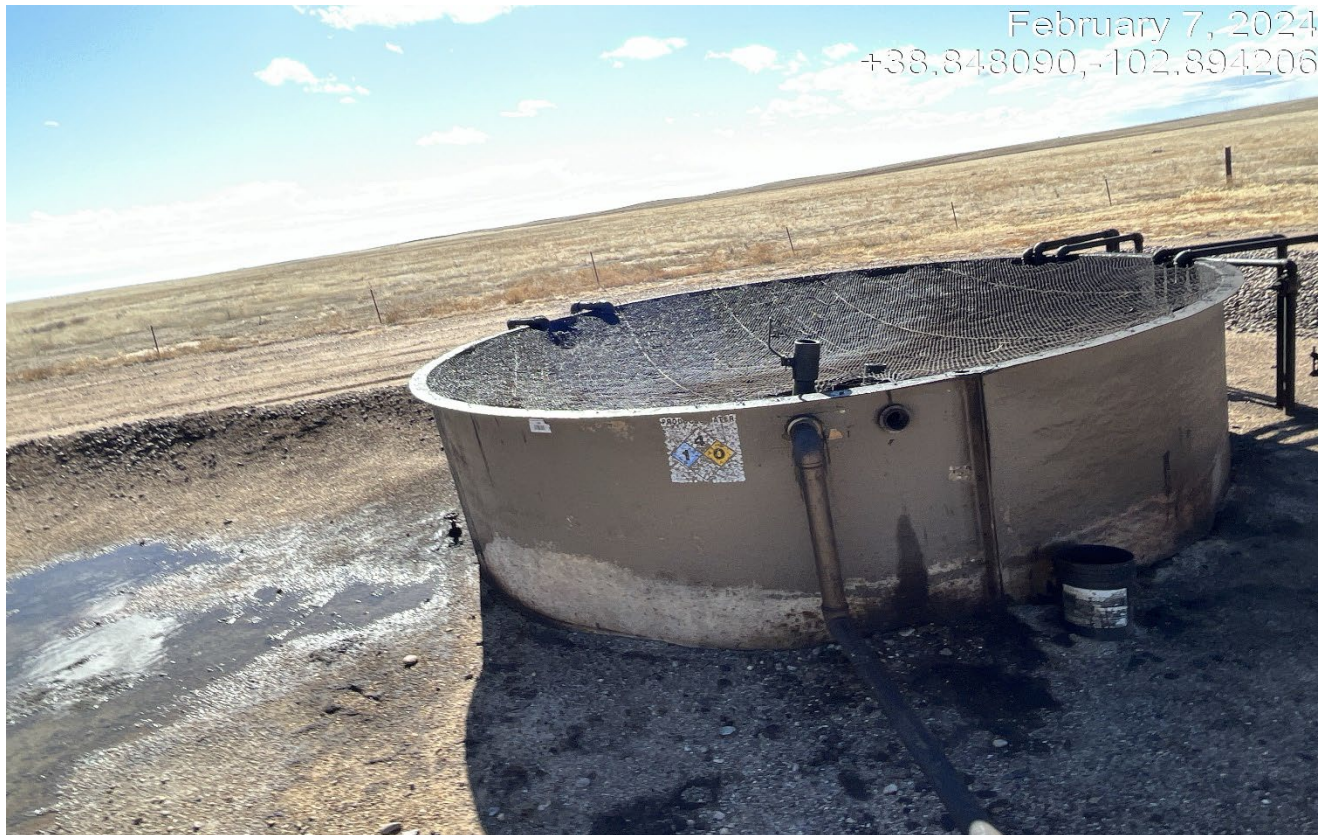
Photo 5. The open top tank is adequately netted. There was a spilled that occurred and oily soils need to be cleaned up.

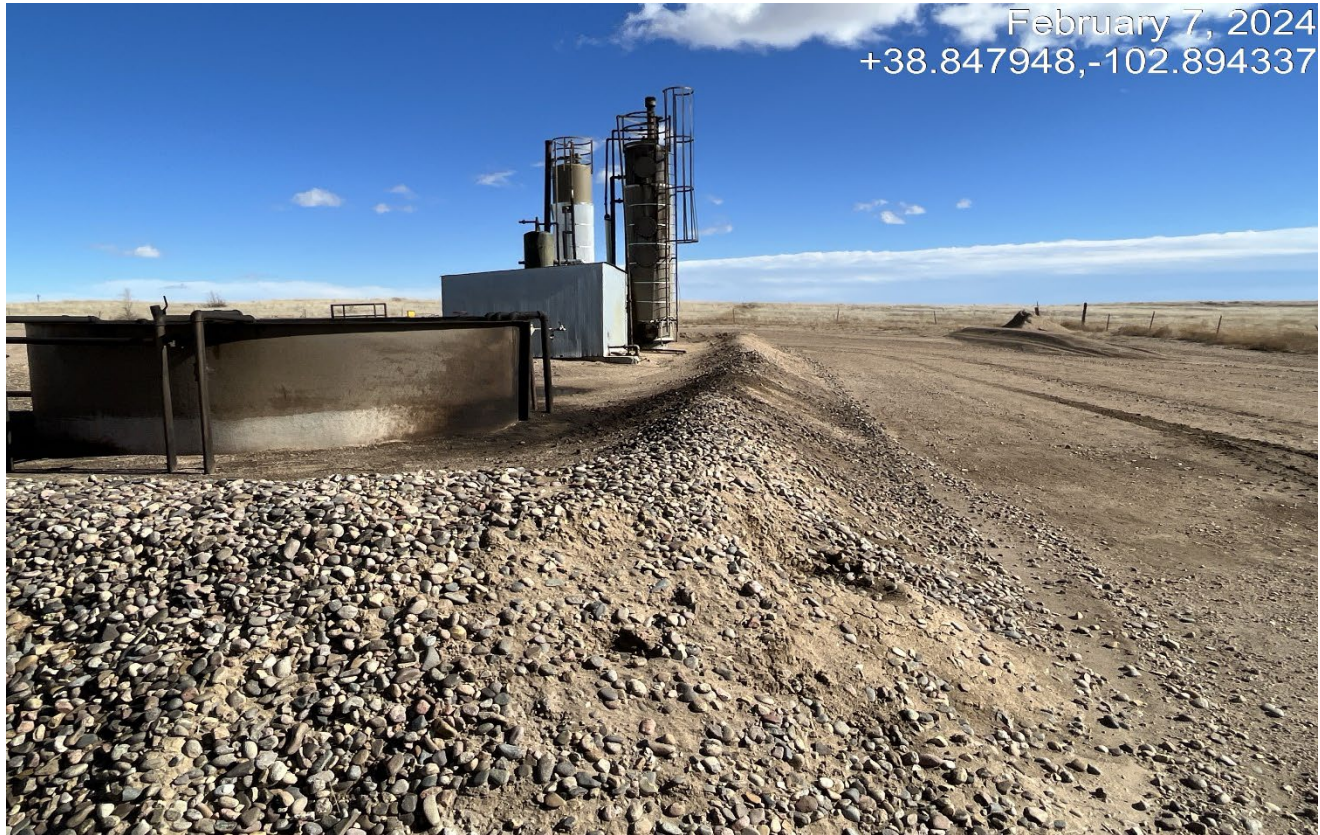
Photo 6. Facing east toward the backside of the open top tank. It appears some staining is along the outside of the berm.

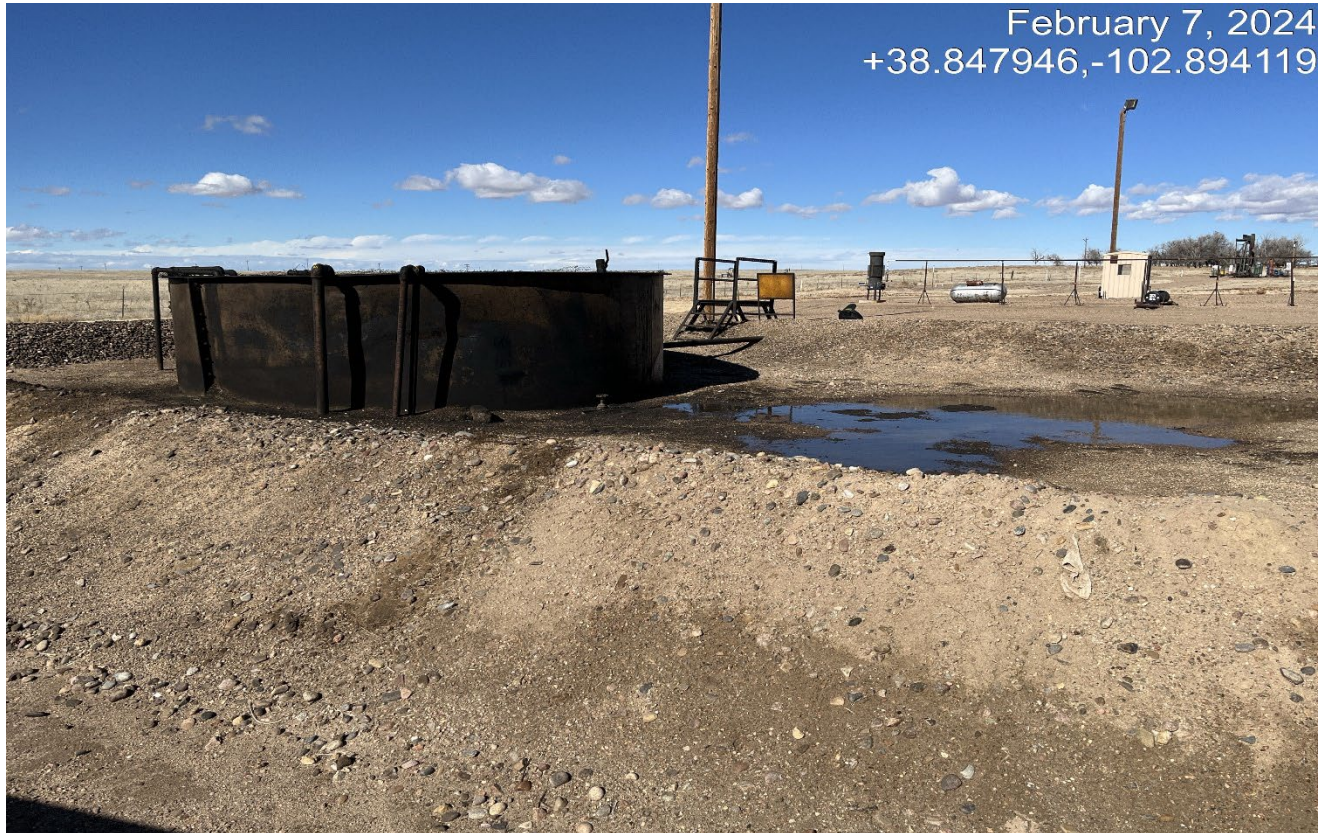
Photo 7. Facing toward the backside of the open top tank. Stained soils will need to be cleaned up..
